MHD – Route 1

File No.: 199500378

City and State: Foxboro, MA

199500378 MHD – Route 1 Foxboro and Wrentham, MA 7/10/02

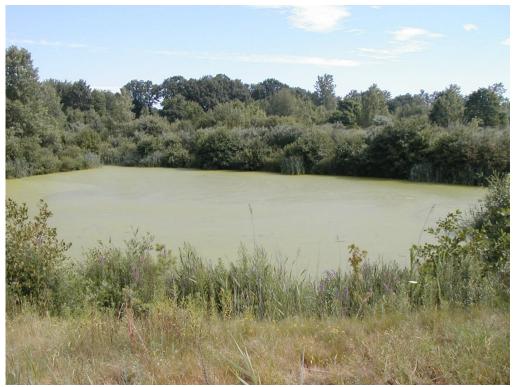
Foxboro site looking west across pond from east side next to Route 1. Outlet is in the distance on the left side. Note coverage by duckweed.

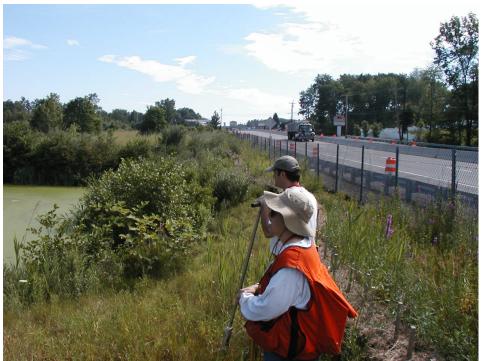
Foxboro site looking north at east side of pond to show proximity to Route 1. Culvert outlet is beyond shrubs in foreground.

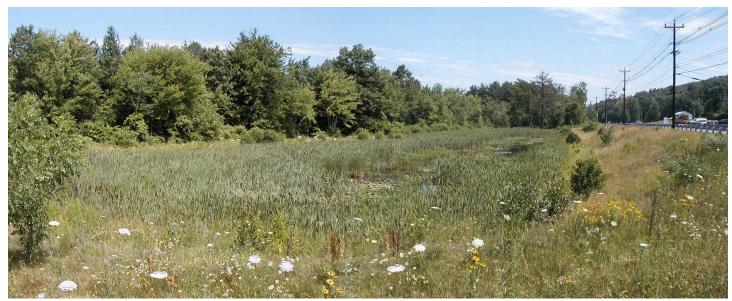
Wrentham site looking northwest and north from southeast corner of site.

Route 1 is on the right.

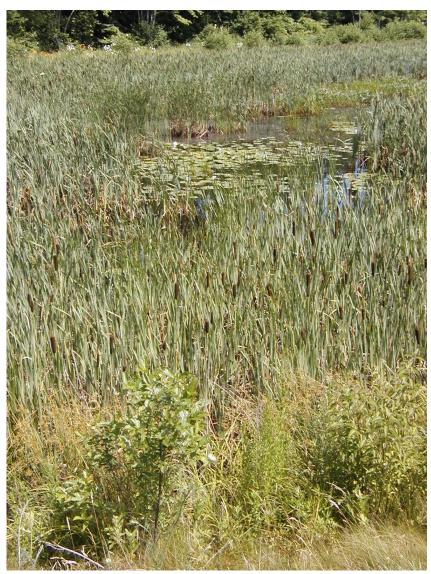
Wrentham site looking west from east side across portion of ponded area.
