NH DOT, I-95 – Route 33 Interchange

File No.: 199800381

MITIGATION SITE FIELD DATA FORM

Site Name: I 95- Rt. 33 Interchange (Pease Tradesport) File No. 199800381

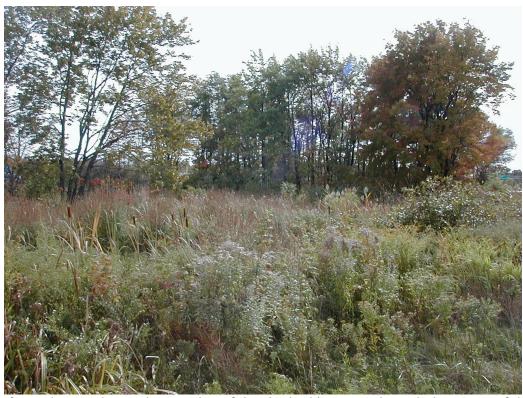
Taken from close to the northwest edge of the site looking west through the center of the site.

Trees were pre-existing.

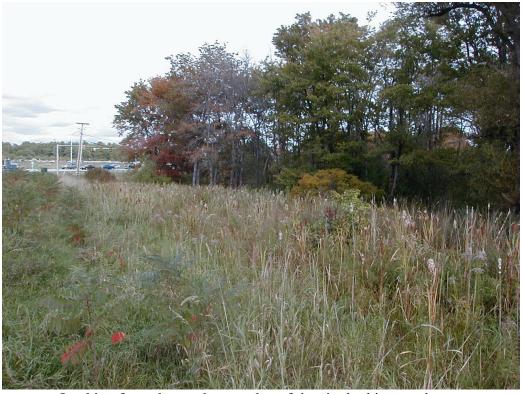
Looking from the northwest edge of the site looking northeast.

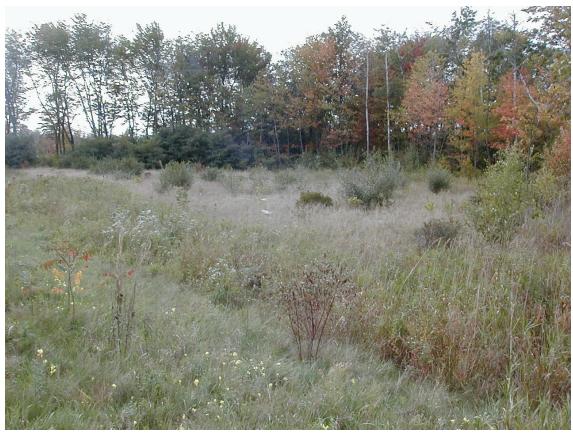
Facing south into the creation area where the site is particularly hydrology-challenged.

A berm or old maintenance road is visible on the left.

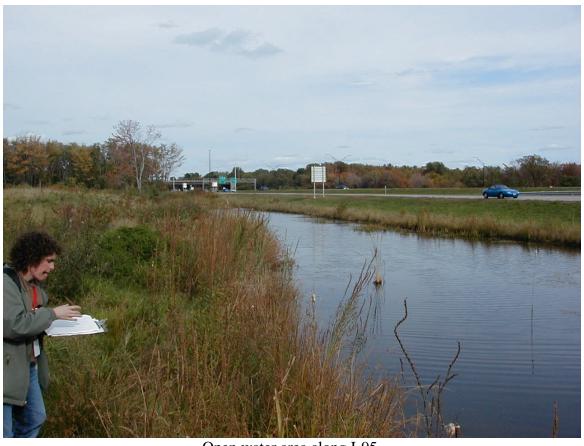
Open water area along I-95.
