# NH DOT – Route 106

**File No.:** 199300836

**City and State:** Gilmanton, NH

MITIGATION SITE FIELD DATA FORM

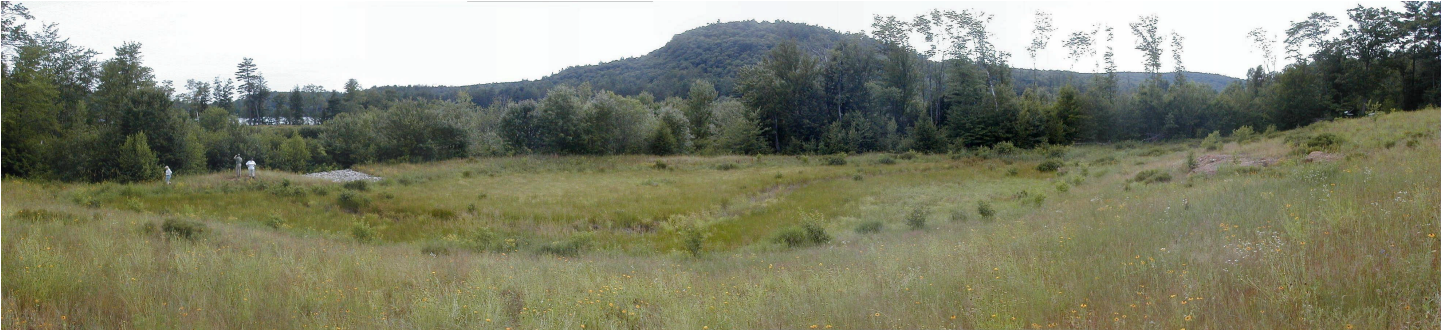
Southeasternmost area (Area A) (closest to Rt. 106) looking southwest, west, and northwest from northeast slope. Remainder of site is behind line of trees in the distance.

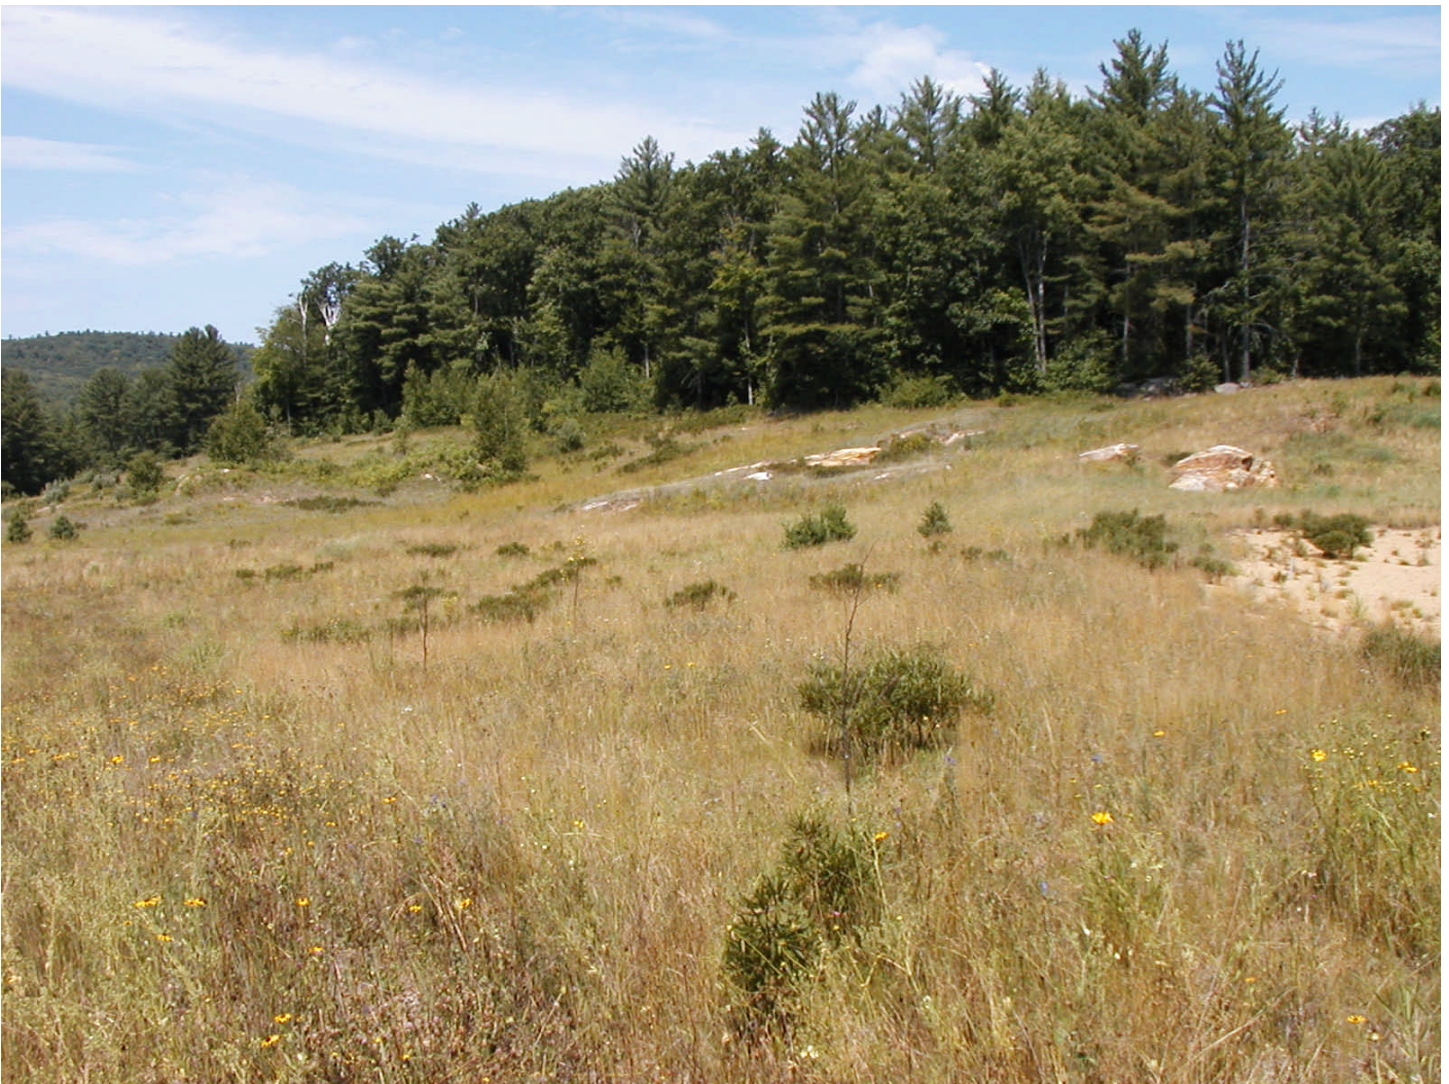
Two groundwater seeps were evident on slopes north and northeast of the constructed wetlands. The northwesternmost seep included several species including *Juncus effusus* and *Drosera rotundifolia* plants.

View of slope at north end of site, central portion.  
There are several seepage wetlands along it (yellow-green areas)

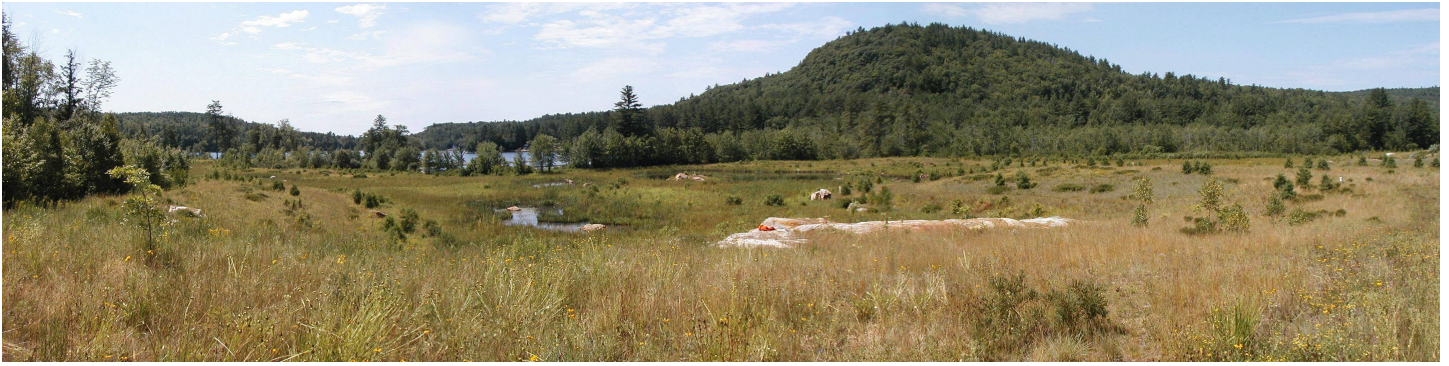
Looking southeast, south, and west from just north of the rock outcrop (center of photo) which is north of Area B. Rocky Pond is in the distance on the left. Southeastern area (Area A) is off the photo to the left.

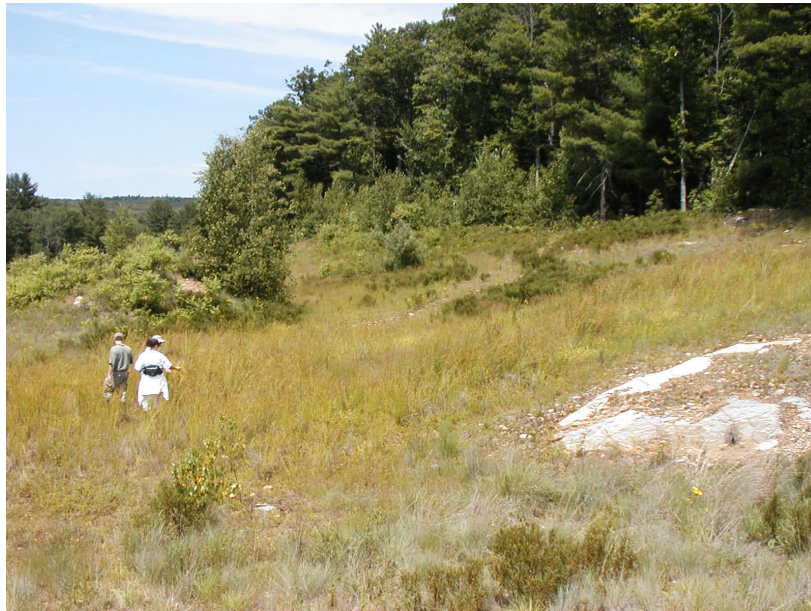
Seepage wetland not in the design. This one is located north of the cell (Area C) between the large central area (Area B) and the westernmost area (Area E).

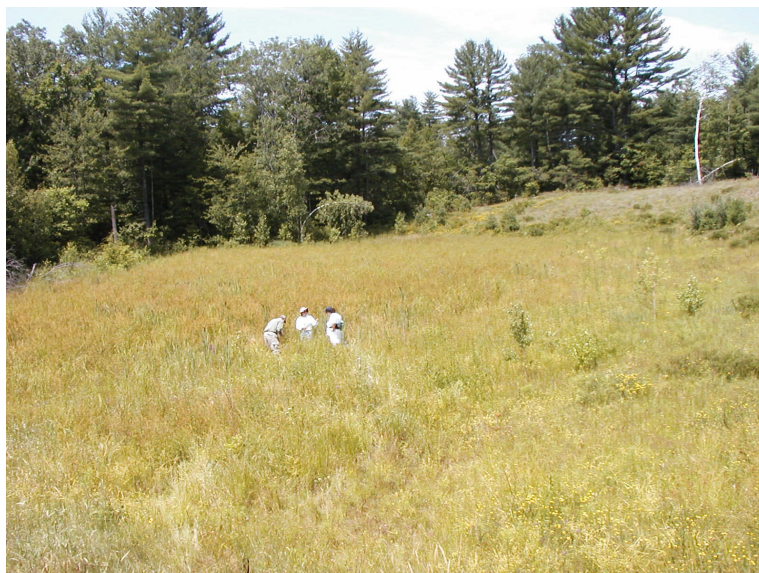
“E” Pond is six inches deep. There is a natural wetland adjacent to “E” Pond; water flows from the pond to the wetland although a wide, shallow riprapped overflow channel was constructed on the south end of the area.

Looking west across the northwesternmost area (Area E).

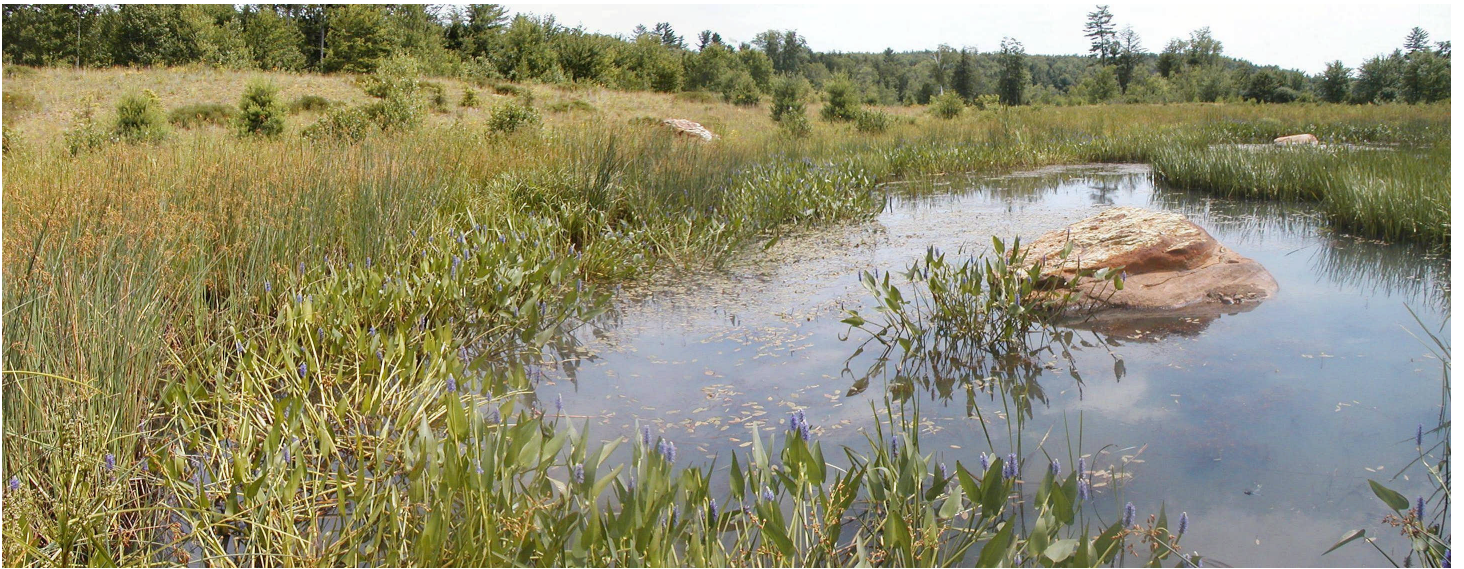
Looking southeast and south at the pool at the northeast corner of Area B.  
A pickerel was observed among the pickerelweed.

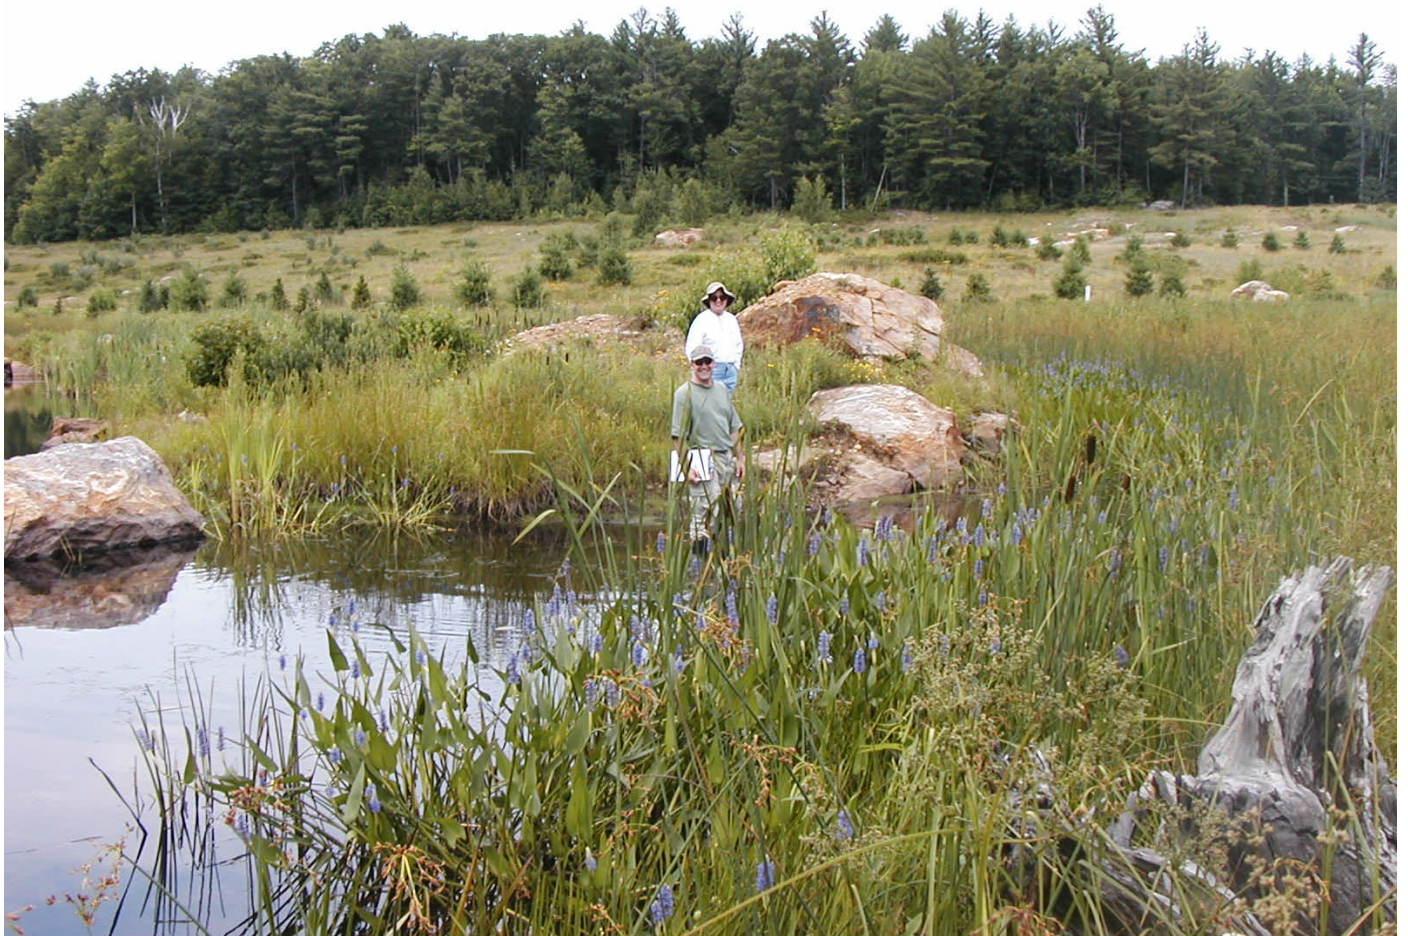
Looking north across Area B from near the connection to Rocky Pond along the southwest side of the site.
