ME DOT – Orrington Bypass

File No.: 199301389

MITIGATION SITE FIELD DATA FORM

Site Name: ME DOT Orrington Bypass File No. 199301389

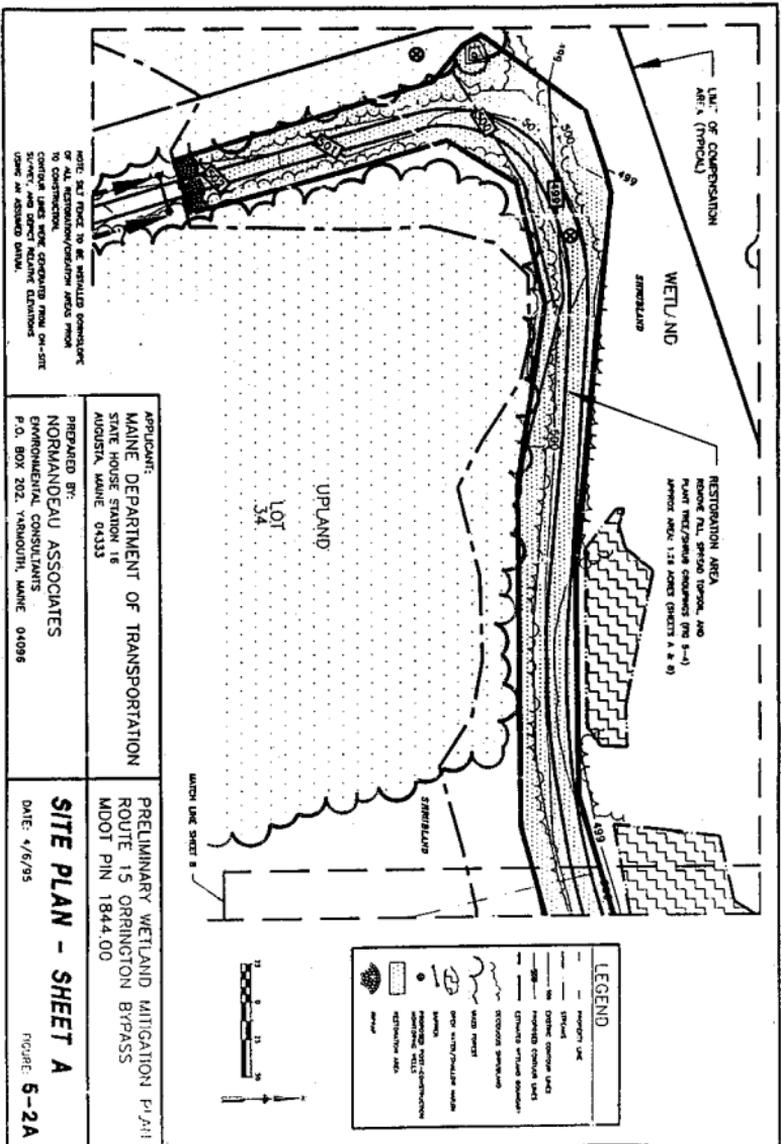
SITE PLAN - SHEET A
 DATE: 4/6/95
 FIGURE: 6-2A

PRELIMINARY WETLAND MITIGATION PLAN
 ROUTE 15 ORINGTON BYPASS
 MDOT PIN 1844.00

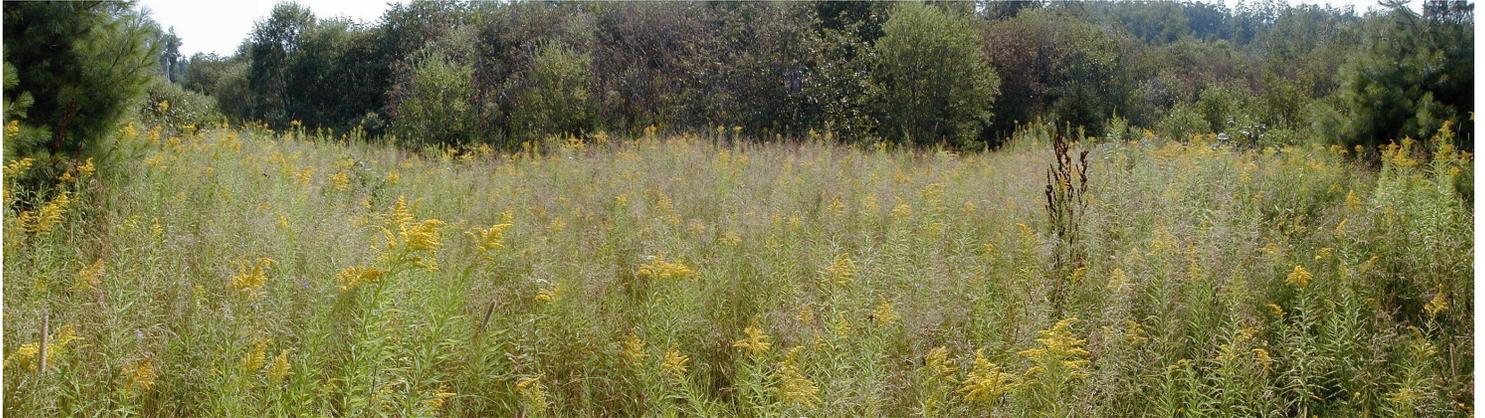
Eastern site, which is just west of the bus turnaround, looking southeast and southwest from center of site. Most of this area is not wetland.

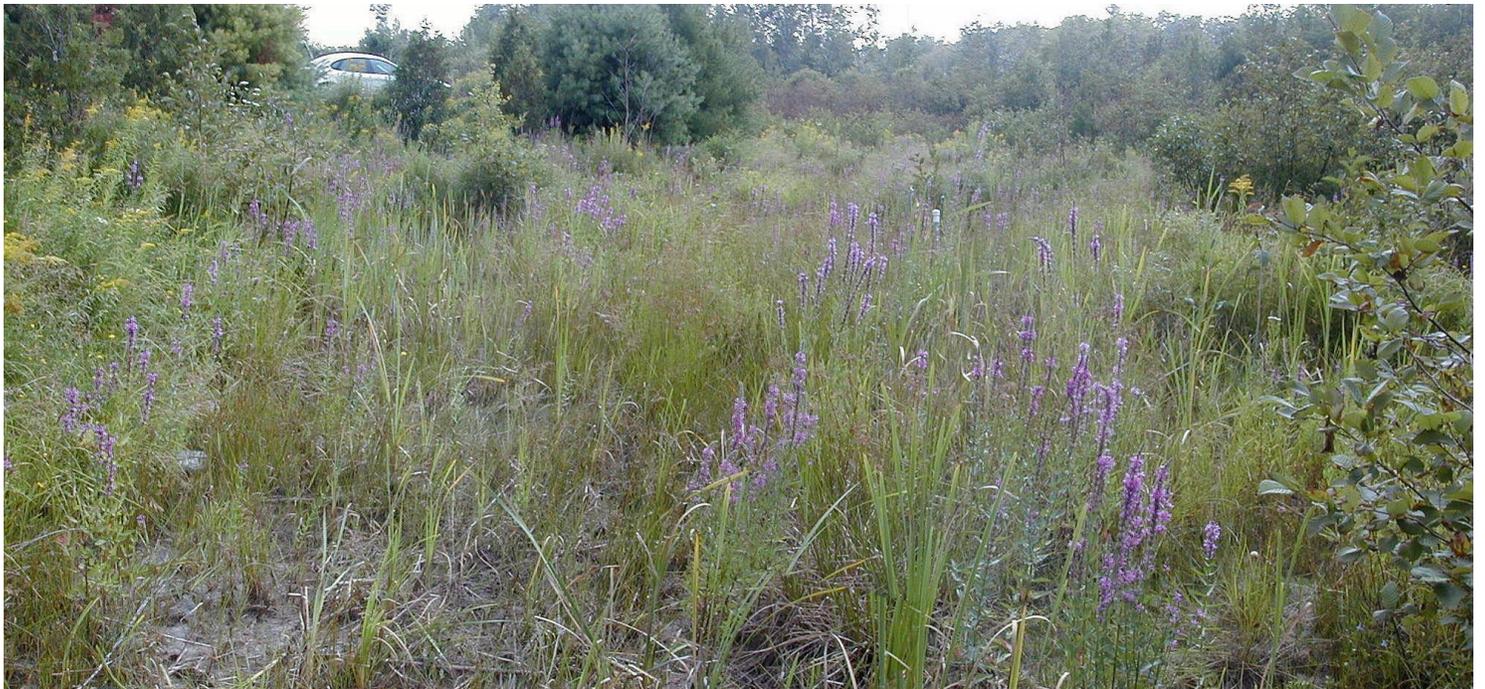
Eastern site looking southeast and south from the northern edge. This entire area is wet. Note car which is parked in the bus turnaround.

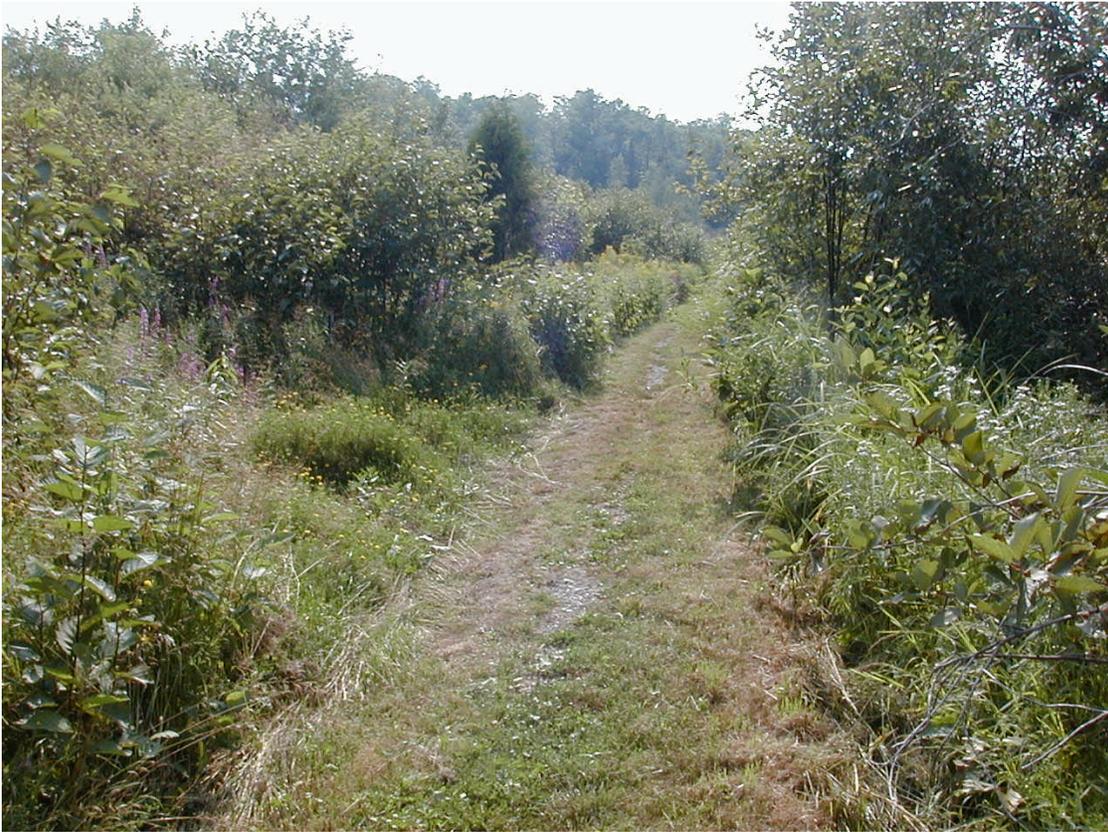
Looking west down the trail from the east end.

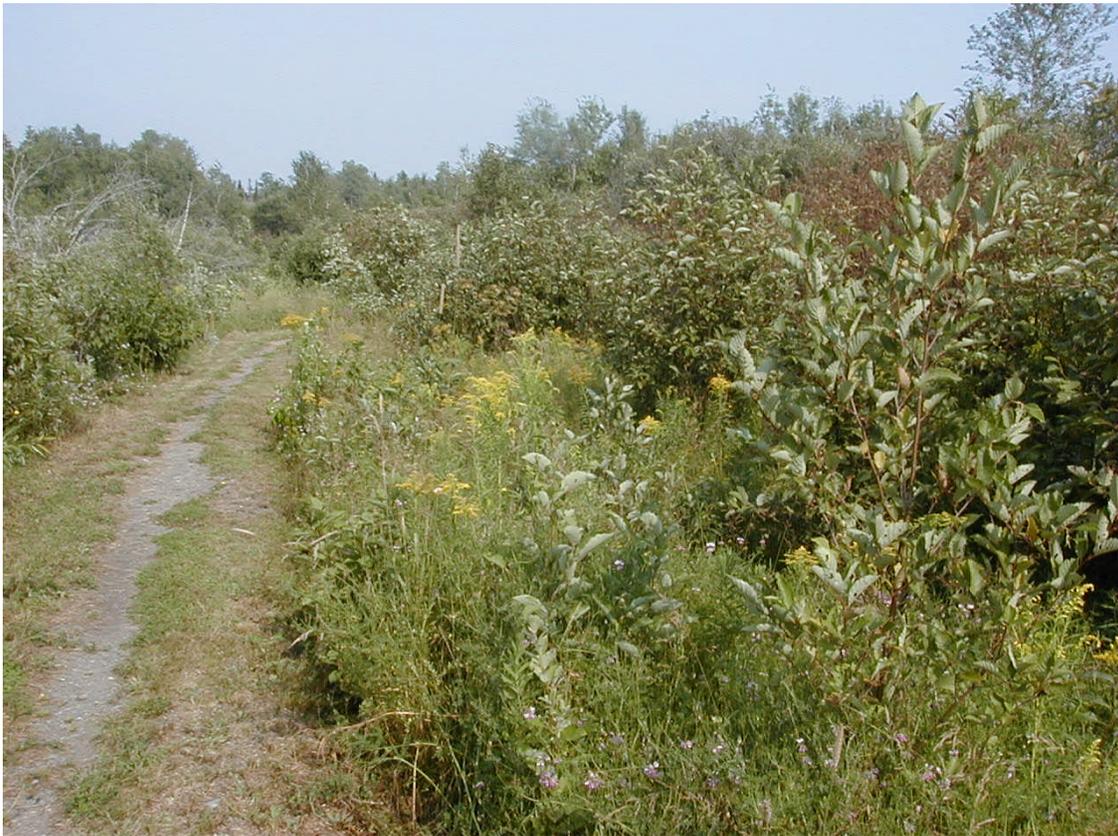
Looking east down the trail from near the west end. Note pruning to widen the trail.

The restored site has a six-foot wide pedestrian path that is regularly mowed. The mowing maybe cut into the wetland, especially in one place where a 25' square area was mowed next to the natural wetland. Trees were also cut down that had been growing on the edge of the wetland near the path.
