Michael McCoy Pizza Restaurant

File No.: 198300449

MITIGATION SITE FIELD DATA FORM

Site Name: Mike's Pizza **File No.:** 198300449

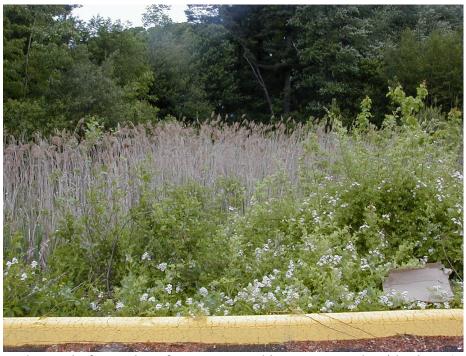
Looking northeasterly from edge of restaurant parking area over the side slope (covered with *Rosa multiflora*), the mitigation site vegetated with *Phragmites australis*, towards the scrub-shrub wetland associated with Maple Meadow Brook.

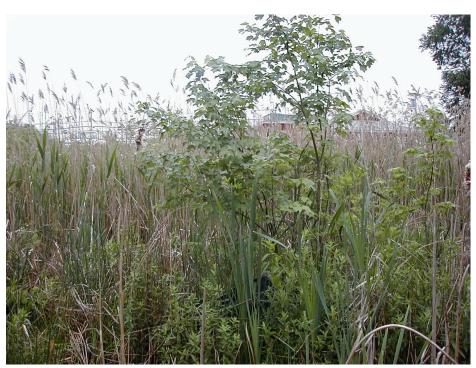
Looking southerly from the northern edge of the mitigation site back toward the pizza restaurant.
