Polpis Bike Path

File No.: 199201570

City and State: Nantucket, MA

MITIGATION SITE FIELD DATA FORM

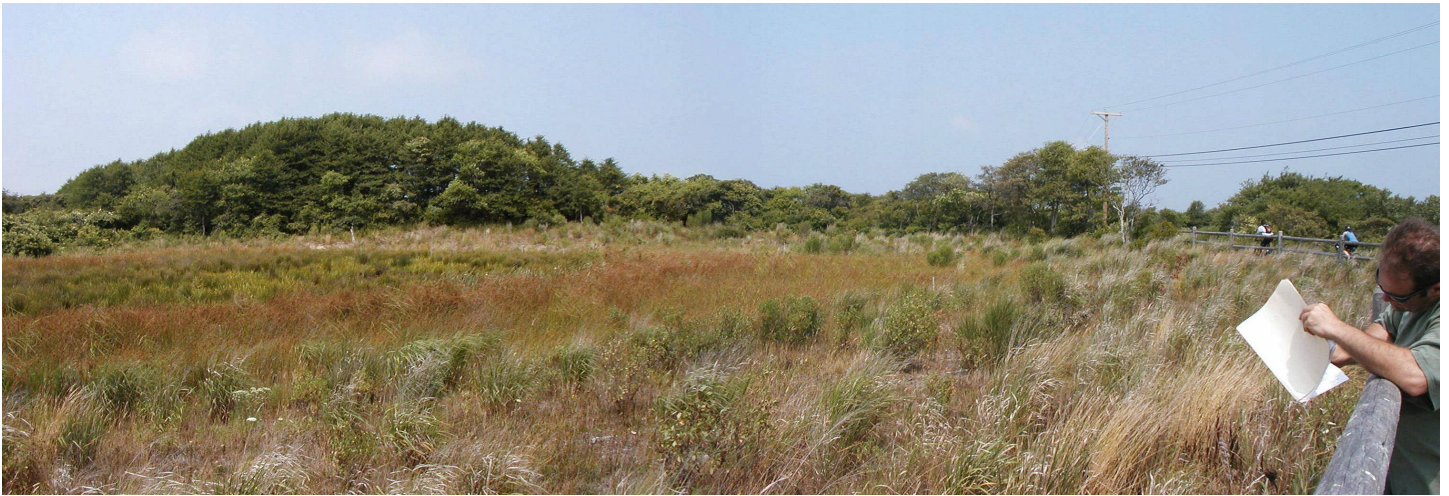
Looking west and north from near the entrance. Subarea C is in the foreground; subarea B is behind it.

There appear to be design problems with this site based on hydrology and possibly a nutrient-poor soil. Subarea C was supposed to be a shrub wetland but vegetation was more characteristic of a shallow marsh. Subarea B was supposed to be a wet meadow but is much wetter and was dominated by *Sparganium*. Woody species mortality was observed in 1998 but they have not been replaced. Area D was noticeably barren of vegetation. Based on deep deer prints, the area (D/D1) had been muddy earlier in the season.

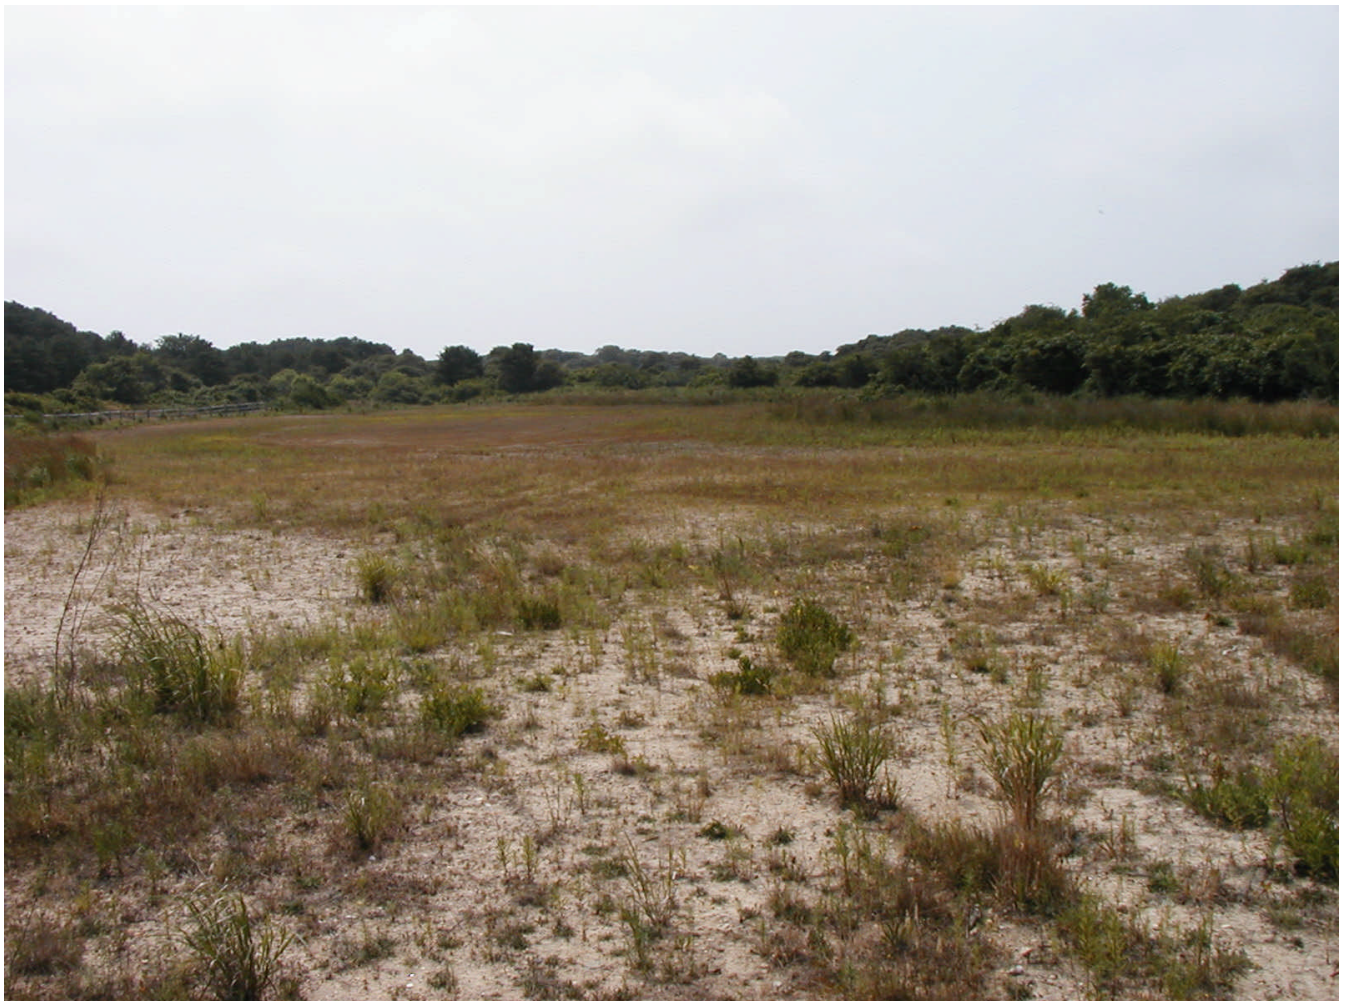
Area D in the foreground; D-1 is in the background

There was no rain for six weeks prior to this site visit. The site is south of Polpis Road and the Polpis Bike Path. It is surrounded by a dirt road and a wooden fence. Area D was bone dry to five inches at which point moist sand was found. Almost no vegetation was supported in this area. Between Area D and C is a pond that is referred to in the planting plan as a mudhole. The site becomes increasingly wet from Area C to Area B. Area C/B contained a 300 square foot ponded area. Area A was dry but supported shrub/scrub wetland vegetation.

A monitoring well was installed in a 21-inch hole in Area D. Slots begin 5 inches below ground and the well sits 10 inches above ground.

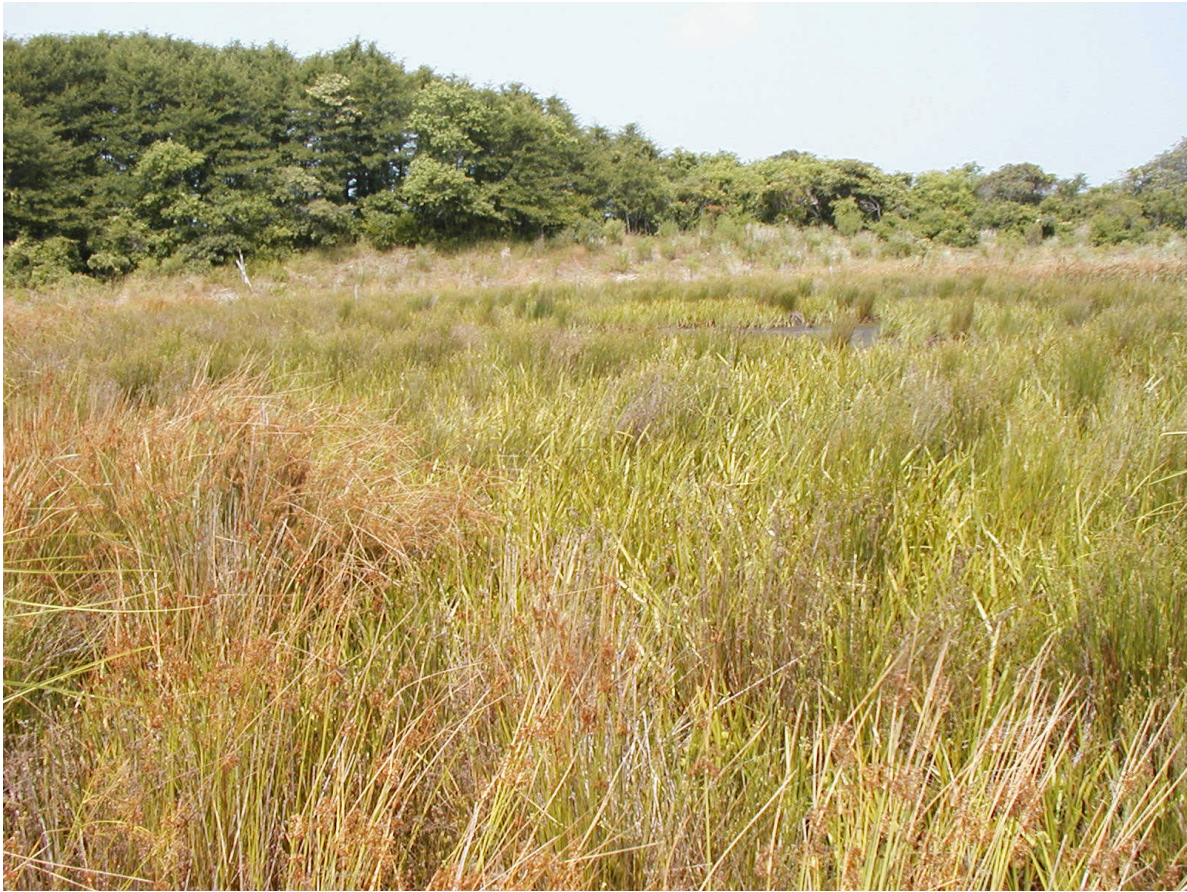
Subarea B in the foreground; subarea A in the background.

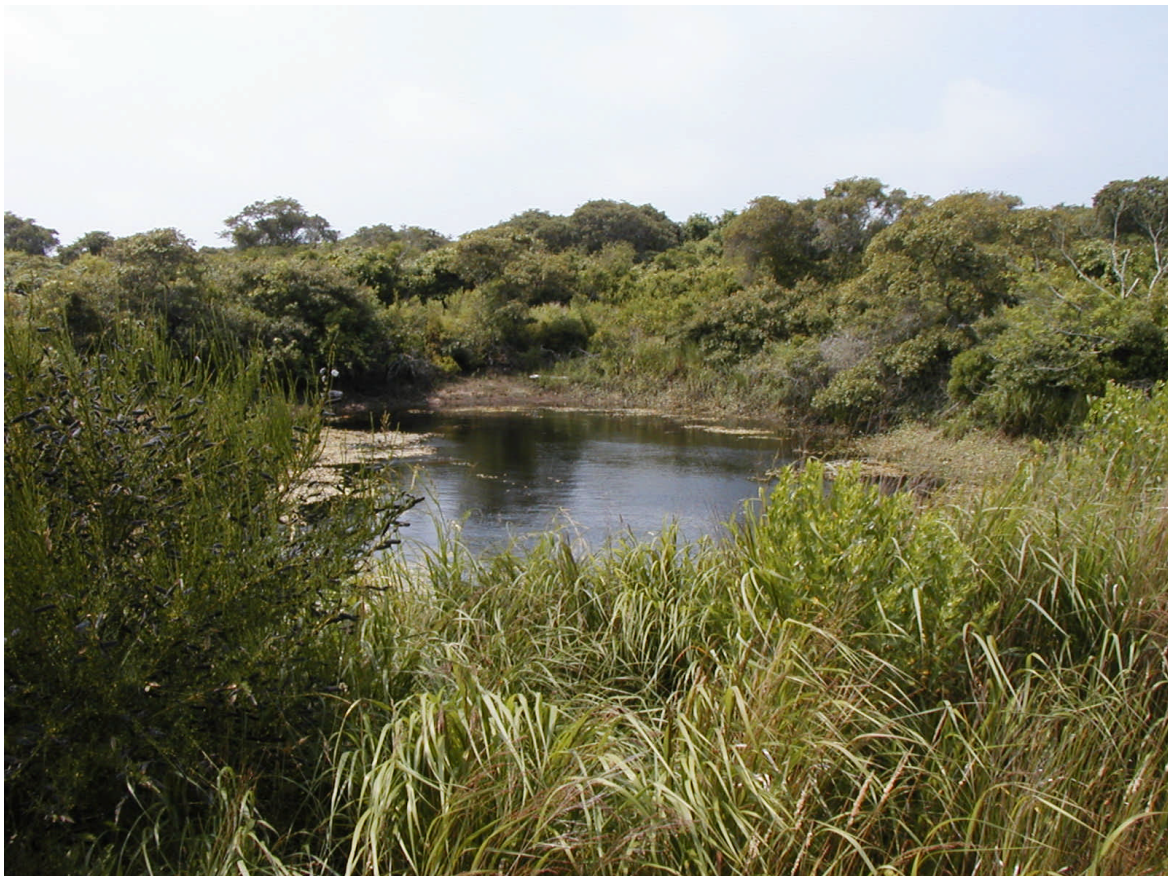
Area referred to as the “Mud Hole” on the plan
