Richard Russo

File No.: 199700270

MITIGATION SITE FIELD DATA FORM

199700270
Richard Russo
Guilford, CT
8/26/02

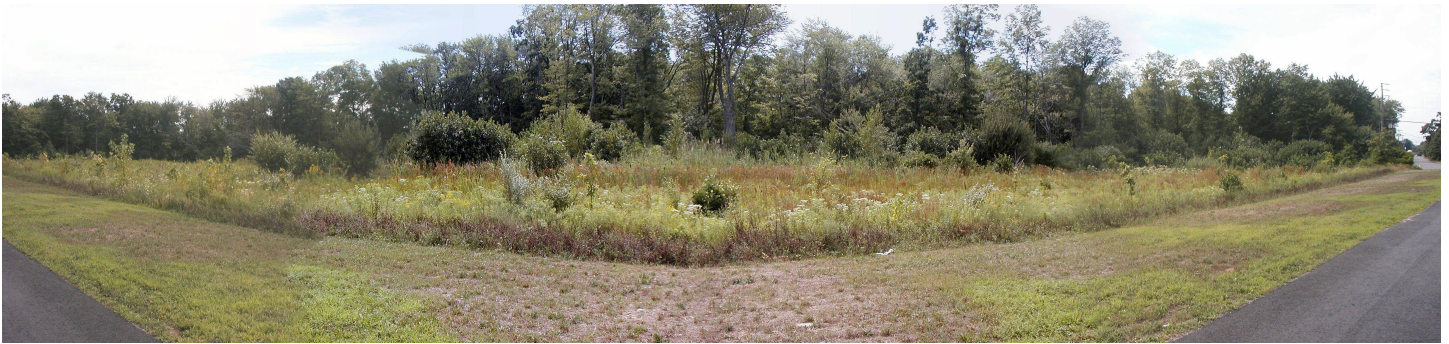
Panorama taken from the north side of the site looking east, south, and west.
Soundview Avenue is on the far right in the distance. Site ends at treeline.
Pond (see below) is in back of the far left area.

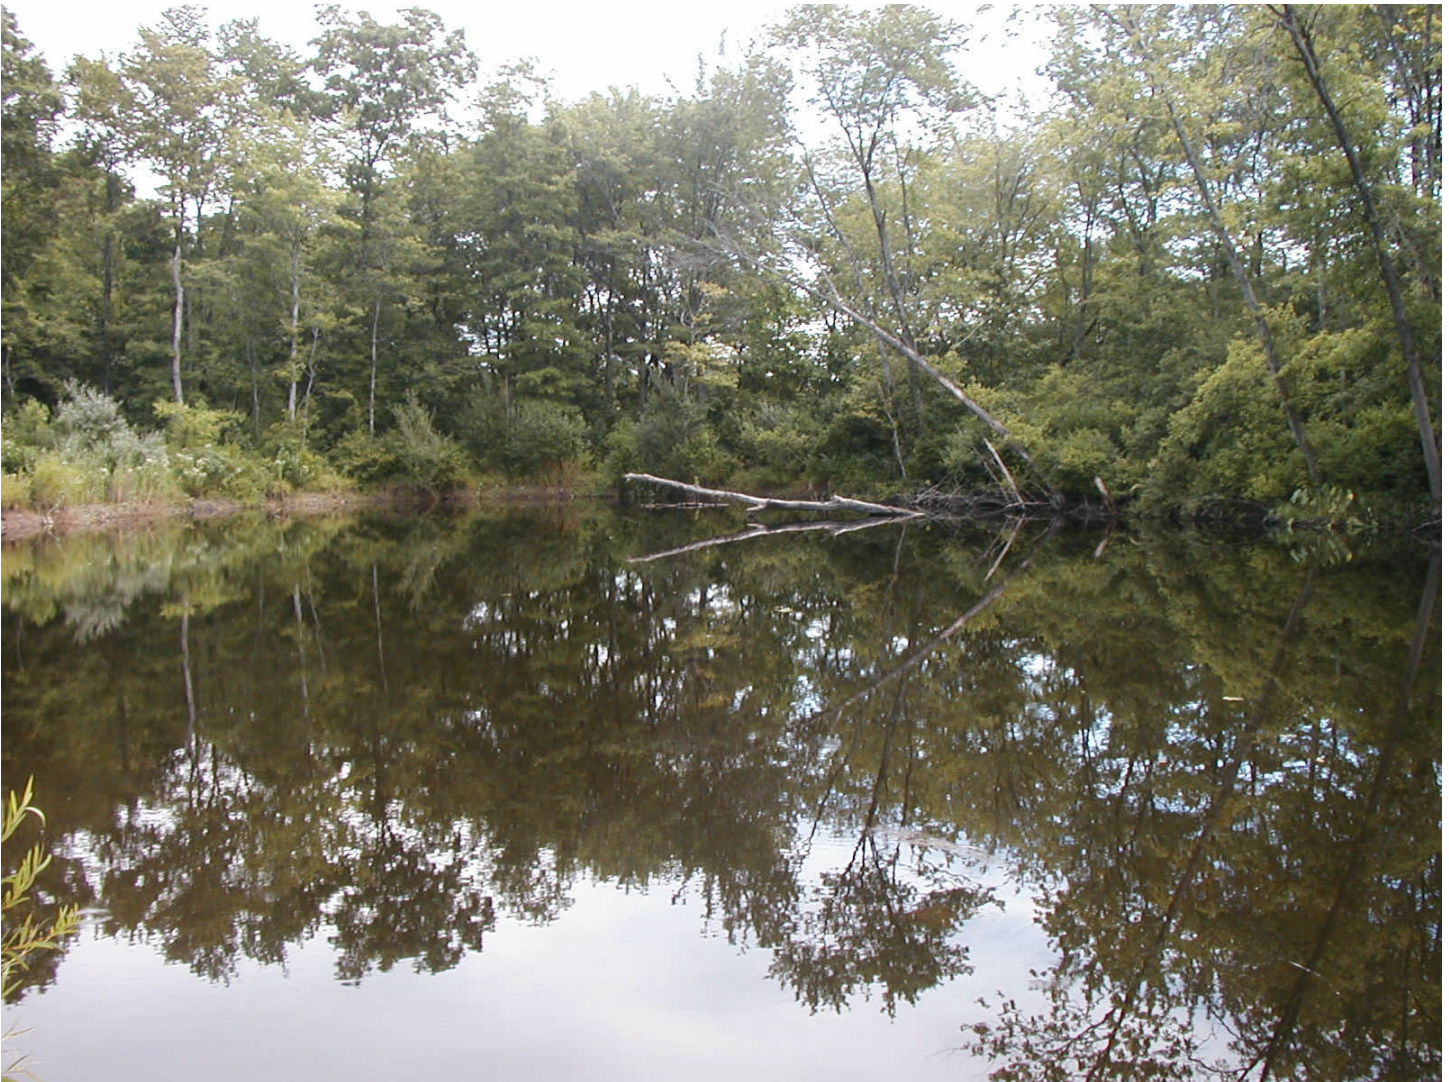
Excavated pond just south of wetland area. Taken looking southeast.
Railroad line is behind the row of trees on the right half of the photo.
