River Woods Health Care

File No.: 199010690

City and State: Exeter, NH

MITIGATION SITE FIELD DATA FORM

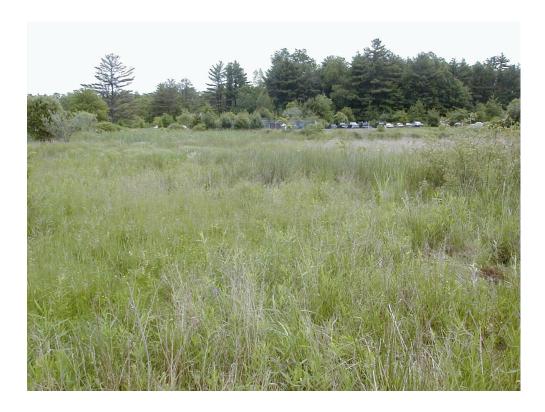
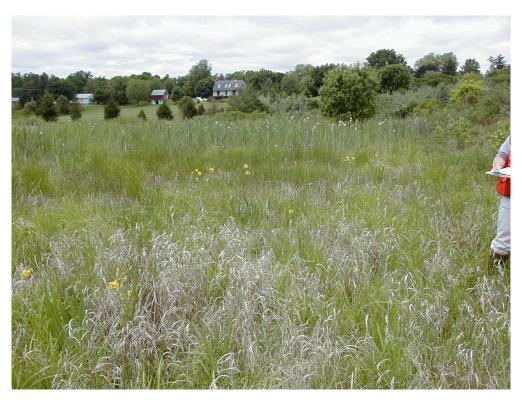
199010690 River Woods Health Care Exeter, NH 6/13/02

The created marsh was wetter than the restored marsh (depths of 3-5 inches versus 6-8 inches). It was impossible to visually detect a border between the created and restored wetlands.
