Robertson Airport

File No.: 198700124

MITIGATION SITE FIELD DATA FORM

Site Name: Robertson Airport File No. 198700124

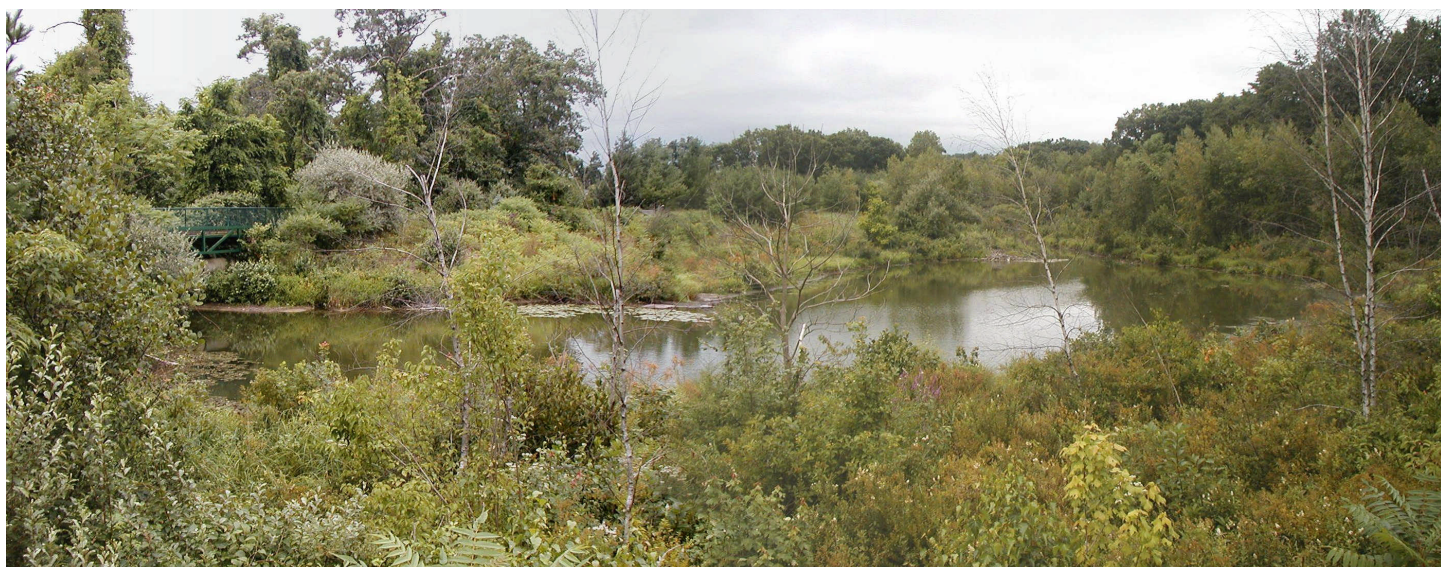
This site is located in the Tomasso Nature Preserve, accessible by gate (park in the municipal buildings area). It consists of two ponds that have a wetland fringe. The southern basin is mostly bordered by overhanging branches or bushes. Steep banks lead down to a mucky shoreline; muck is deeper than one foot. The Northern basin also has steep banks and there is some erosion on the northern slope. Due to topography there is a better mix of wetland types in this basin. Interpretive signs detail some of the wildlife and plants. There is a sign indicating the presence of fish.

Southern basin panorama. Site is just to the banks of the ponded area.

There may be more water on these sites than was planned for. The wetland type is supposed to be PEM and PSS but there is a significant amount of open water with no vegetation emerging from it.

A large clump of *Phragmites australis* and several small patches of *Lythrum salicaria* are on site and should be removed.

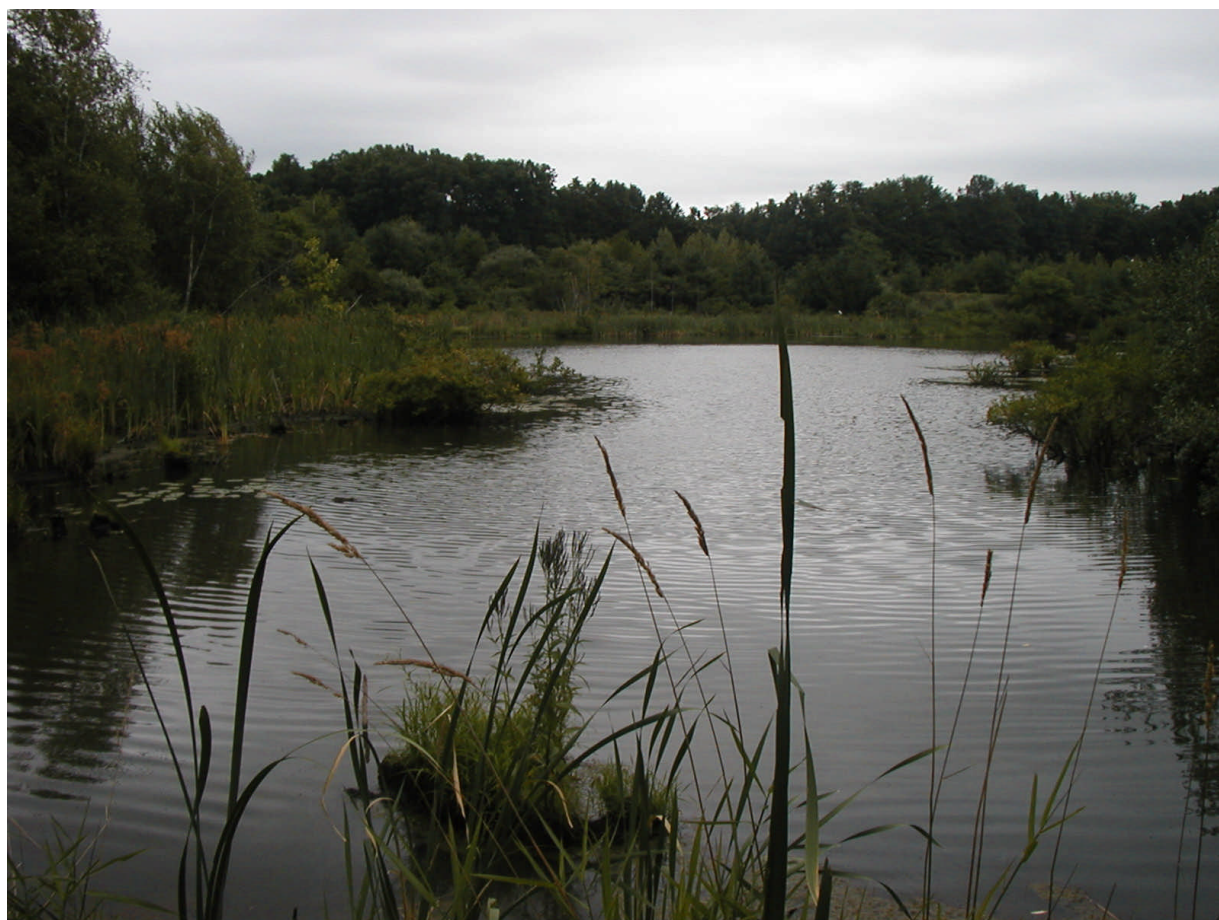
Northern basin
