# Town of Ridgefield

**File No.:** 199300436

## MITIGATION SITE FIELD DATA FORM

**Figure A-1, PAGE 2 OF 2**  
**MITIGATION PLANS**  
**RIDGEFIELD DIKE/BYPASS ROAD**  
**JUNE 6, 1996**

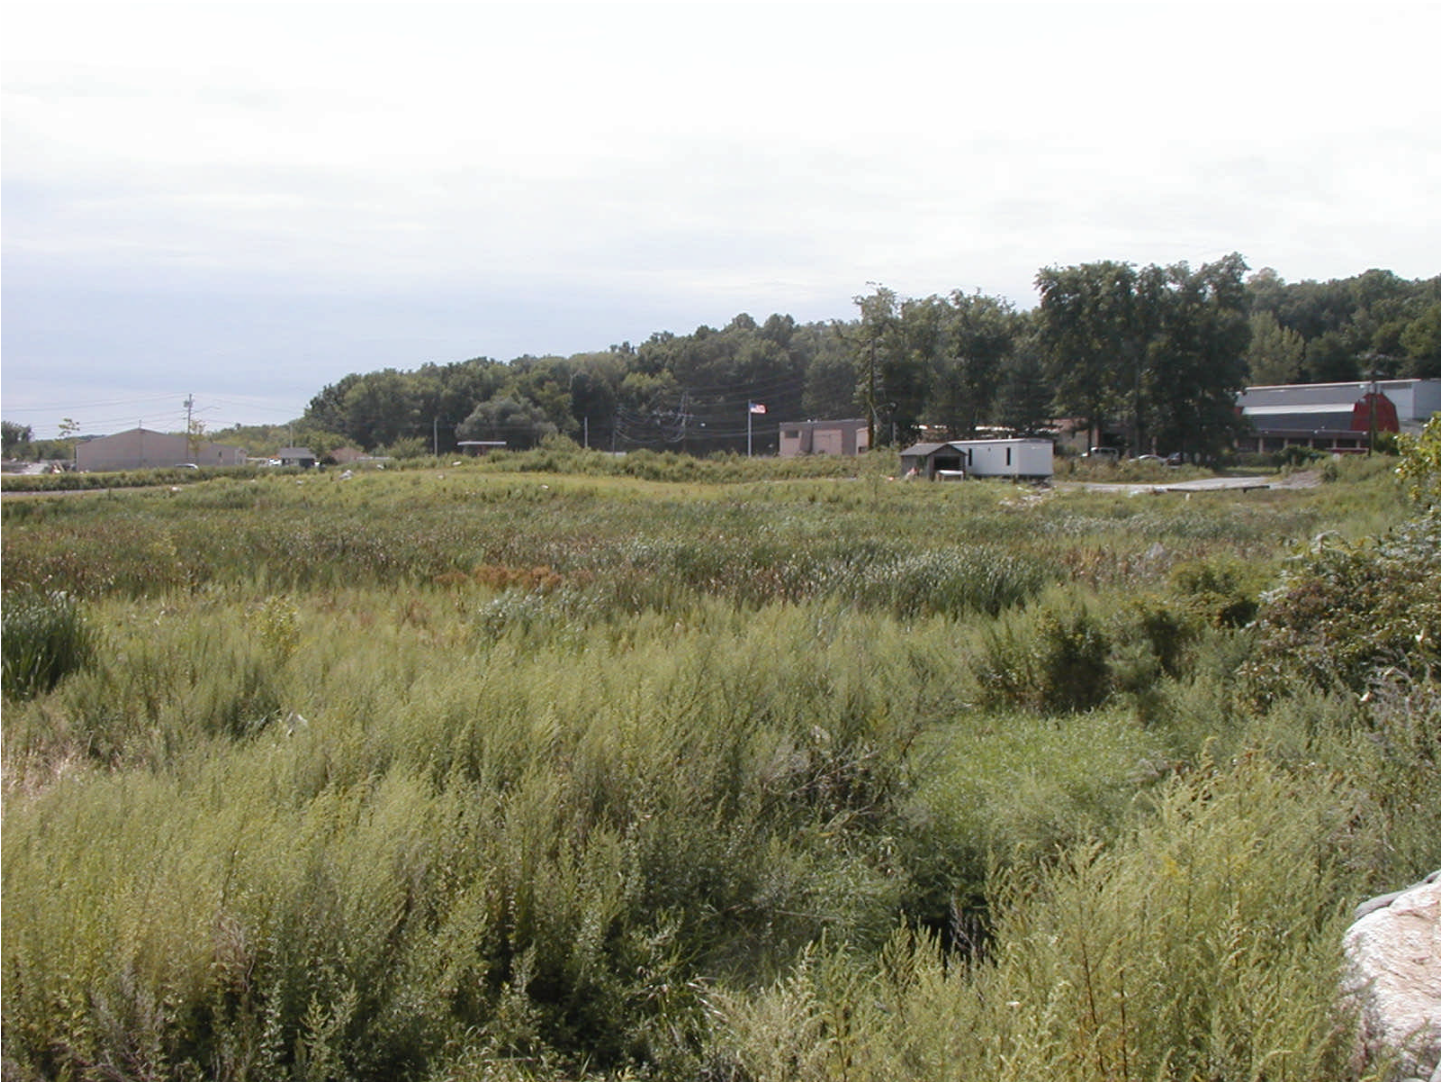
199300436  
Town of Ridgefield  
Ridgefield, CT  
8/28/02

*Phragmites australis* dominates the northern part of this site. An orange fence and a siltation fence were lying on the ground. Vegetative diversity is low, perhaps due to the dominance of *Typha latifolia* and *Phragmites australis* and very wet conditions.

Looking southeasterly from the edge of the road which was the subject of the permit.
