Wallace Camp Auto

File No.: 199501767

MITIGATION SITE FIELD DATA FORM

199501767
Wallace Camp Auto
Westbrook, ME
7/30/02

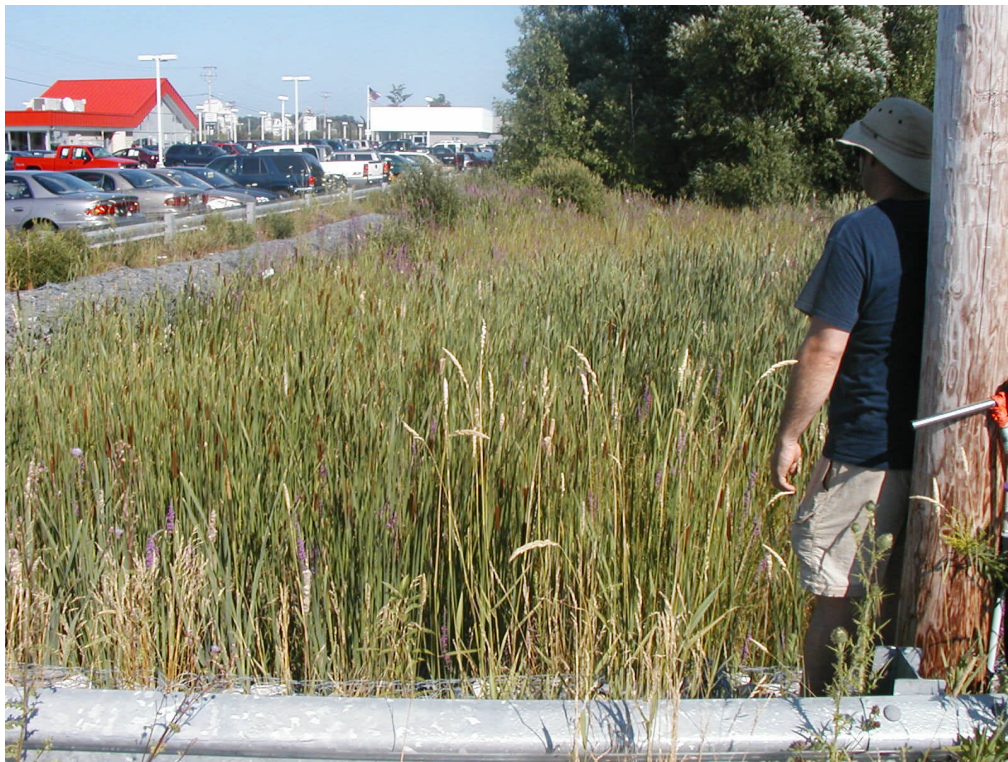
Looking easterly. This shows the proximity of the mitigation to the project.

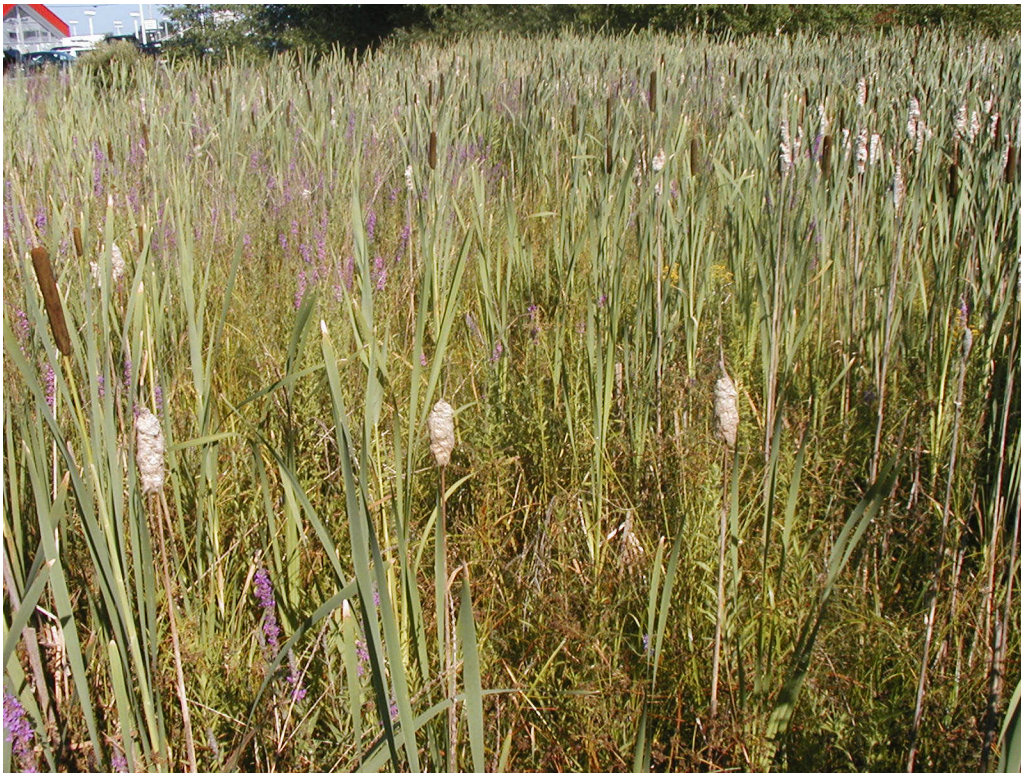
Several of the species that were in the planting plan were not observed in the mitigation site, including *Sambucus canadensis* and *Cornus amomum*. The site was designed to be a scrub/shrub wetland but is in fact an emergent marsh. The site has a large patch of *Phragmites australis* and *Lythrum salicaria* which dominate in different sections.

Note *Lythrum salicaria* mixed with *Typha latifolia* and other species in this easterly view.
