AMENDMENT #5 TO THE VERMONT IN-LIEU FEE PROGRAM INSTRUMENT

Duren Mountain Swamp Mitigation Plan for The Connecticut River Service Area

Ducks Unlimited Vermont In-Lieu Fee Program

DATE: 26 September 2019

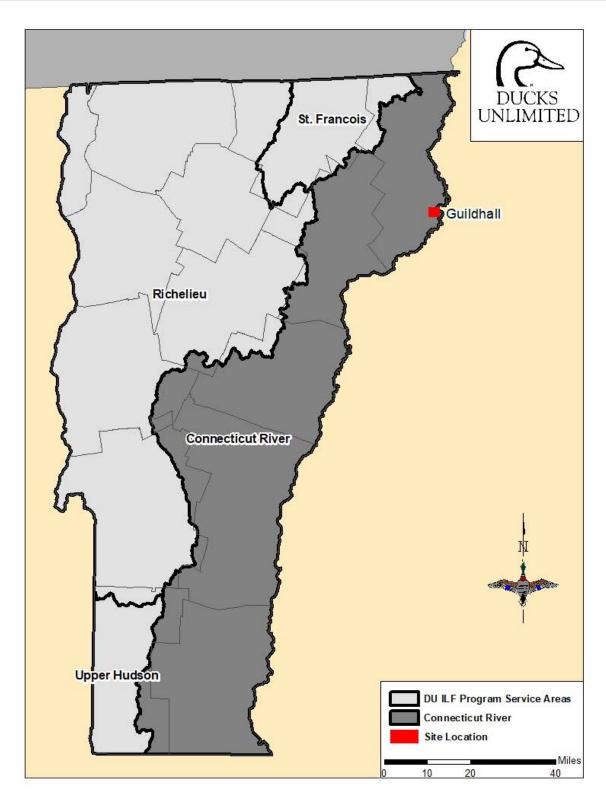
Figure 1. Site Location and Service Area.

Approximate Coordinates Latitude: 44°32′25″ N, 71°35′08″ W. The Connecticut River ILF Service Area (Upper Connecticut River – HUC 010801 and Lower Connecticut River – HUC 010802) is shown in dark gray shading.

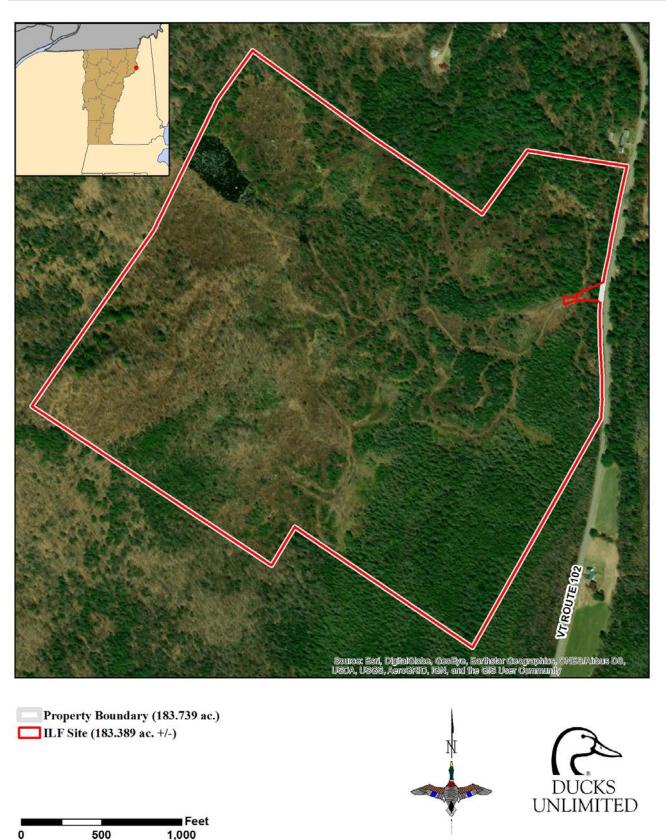
<u>Figure 2. View of the ILF Site.</u> The site is accessed from a gravel driveway to the west of Vermont Route 102 approximately 2.6 miles to the north of US Route 2. DU owns the property.

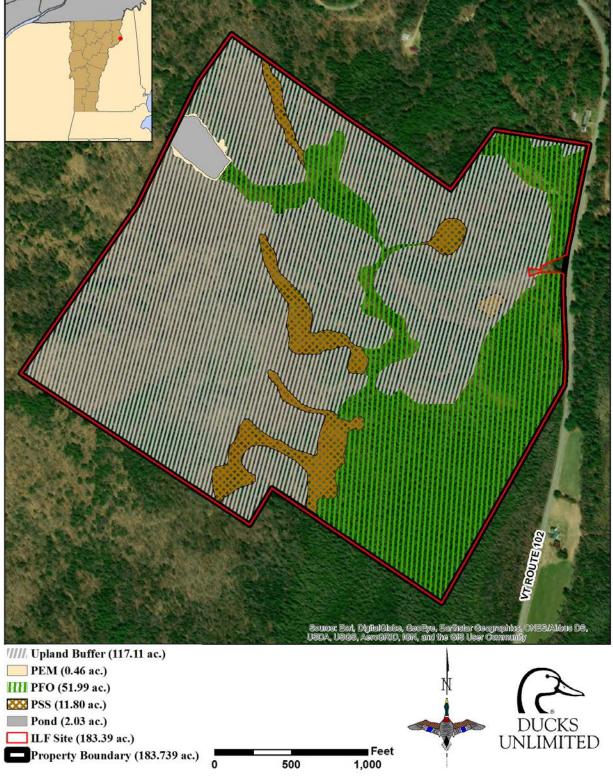
Figure 3. Credit Generation Map

The site is expected to produce 11.12 credits based on established credit-production ratios used in the New England District.

Based on established credit ratios used in the New England District this site produces 11.12-credits (Figure 3, Table 1). Credits produced in excess of direct costs to implement the project will remain in the Connecticut River ILF Service Area account and will only be used for additional mitigation.

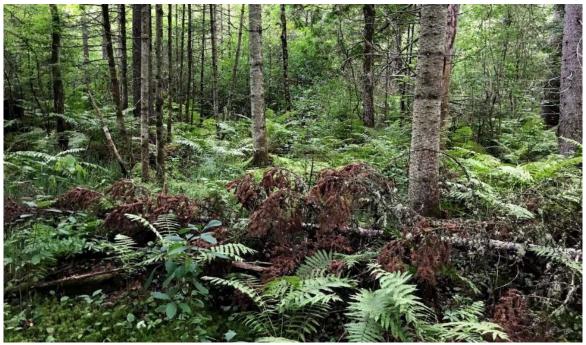
A northern white cedar swamp at Guildhall. An S-3 community in Vermont, as designated by the Natural Heritage Program. Rare plant species were found on site during an August 2018 botanical survey conducted by DU biologists.

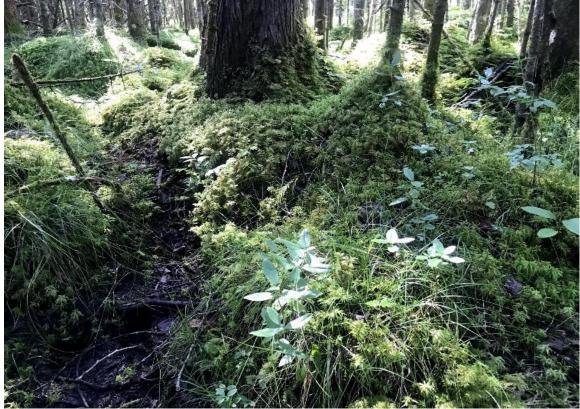
Duren Mountain Swamp - a northern white cedar swamp in the town of Guildhall. The cedar swamp has excellent microtopography and is dominated by mosses and liverworts.

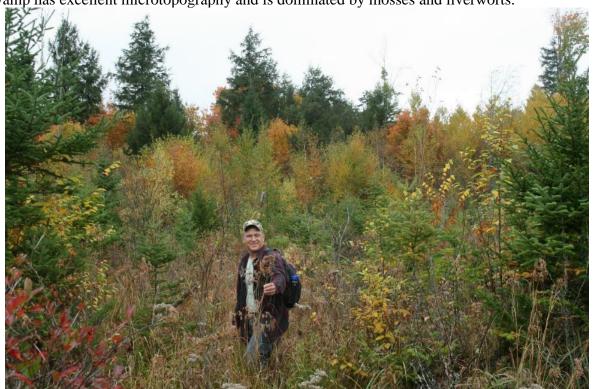
Abies balsamea, Betula spp., in one of the shrub wetlands onsite.

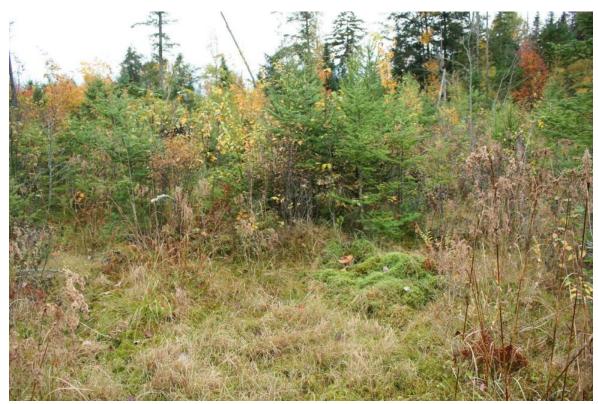
Scirpus cyperinus and mosses and sedges (Carex spp.) are found in fenny-PSS areas.

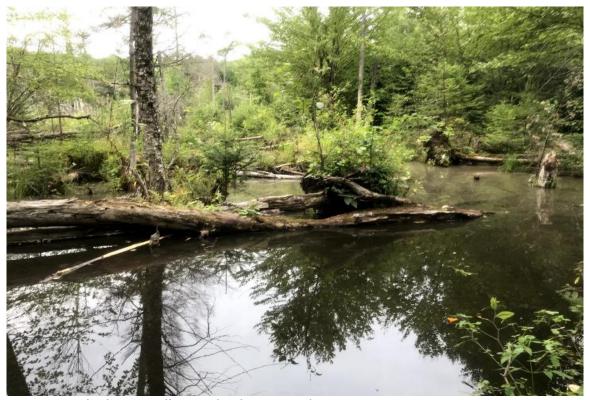
Beaver were actively expanding wetland areas on the property.

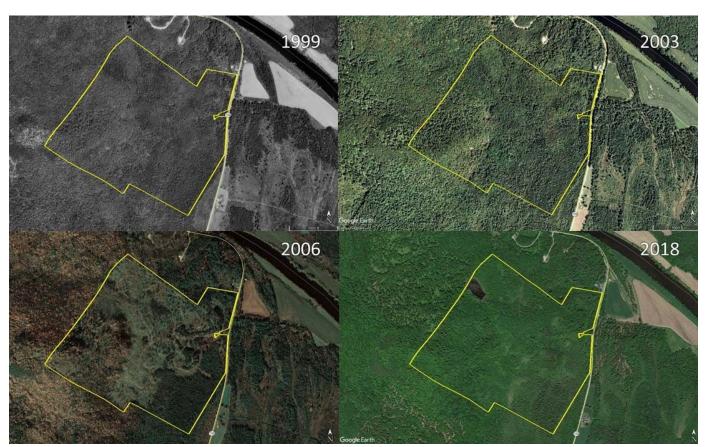
Figure 4. Contemporary and Historic Conditions.

Historic aerial imagery from the ILF site from 1999-2018, show that other than logging in 2006, the land-use has remained relatively stable.

This site has largely been maintained in a wooded state. The most recent logging on the site occurred in 2006. Aerial imagery provides a recent historical landuse perspective (Figure 4). There are no structures present at the site.

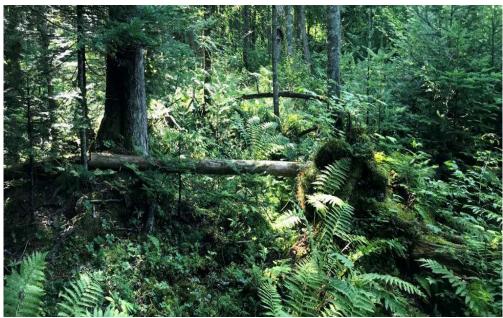
Forested wetland W-1. DPW1 was dominated by red maple (*Acer rubrum*), balsam fir (*Abies balsamea*), and northern white-cedar (*Thuja occidentalis*). Understory included common winterberry (*Ilex verticillata*), moss (*Sphagnum* spp.), hairy wood-rush (*Luzula acuminata*), and other hydrophytes. Primary hydrology indicators included a high-water table and saturation. A histosol (mucky peat) was the hydric soil indicator.

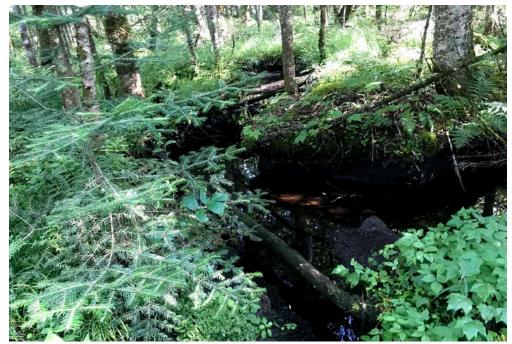
Forested wetland W-1. DPW2 was dominated by yellow birch (*Betula alleghaniensis*), black ash (*Fraxinus nigra*), and balsam fir (*Abies balsamea*). Understory included red maple (*Acer rubrum*), American mountain-ash (*Sorbus americana*), alternate-leaf dogwood (*Cornus alternifolia*), dwarf red raspberry (*Rubus pubescens*), heart-leaf foamflower (*Tiarella cordifolia*), hay-scented fern (*Dennstaedtia punctilobula*), and other hydrophytes. Primary hydrology indicators included a high water table and saturation.

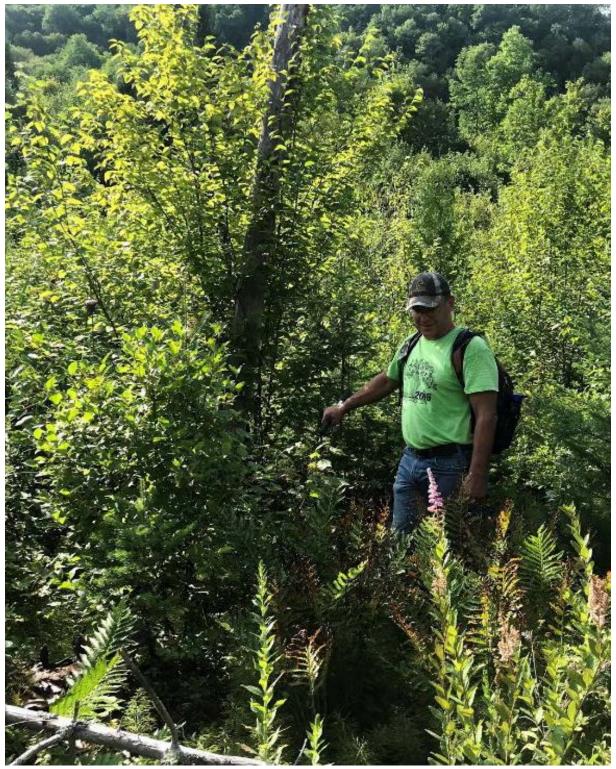
Scrub-shrub wetland W-4. DPW3 was dominated by beaked hazelnut (*Corylus cornuta*) and quaking aspen (*Populus tremuloides*). Understory included sensitive fern (*Onoclea sensibilis*), flat-top goldentop (*Euthamia graminifolia*), steeplebush (*Spiraea tomentosa*), eastern marsh fern (*Thelypteris palustris*), and other hydrophytes. The primary hydrology indicator was saturation. A histosol was the hydric soil indicator.

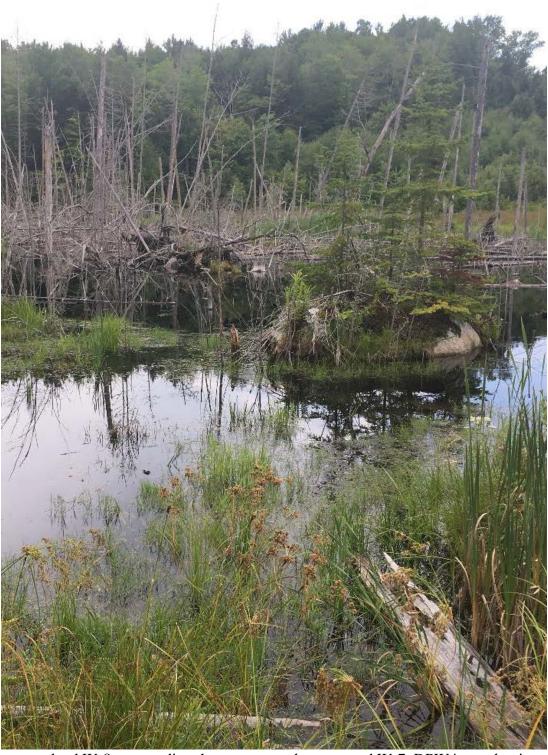
Emergent wetland W-8 surrounding the open water beaver pond W-7. DPW4 was dominated by woolgrass (*Scirpus cyperinus*), jewelweed (*Impatiens capensis*), sweetscented joe pye weed (*Eutrochium purpureum*), wrinkle-leaf goldenrod (*Solidago rugosa*), broadleaf cattail (*Typha latifolia*), flat-top goldentop (*Euthamia graminifolia*), and nodding sedge (*Carex gynandra*). Primary hydrology indicators included surface water, a high water table, and saturation. Sandy mucky mineral was the hydric soil indicator.

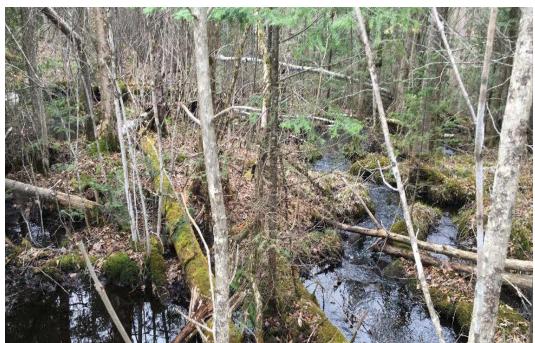
Forested wetland W-1. DPW5 was dominated by yellow birch (Betula alleghaniensis) and black ash (Fraxinus nigra). Understory included paper birch (Betula papyrifera), rough bent (Agrostis scabra), jewelweed (Impatiens capensis), and other hydrophytes. Primary hydrology indicators included a high water table and saturation. A histosol was the hydric soil indicator.

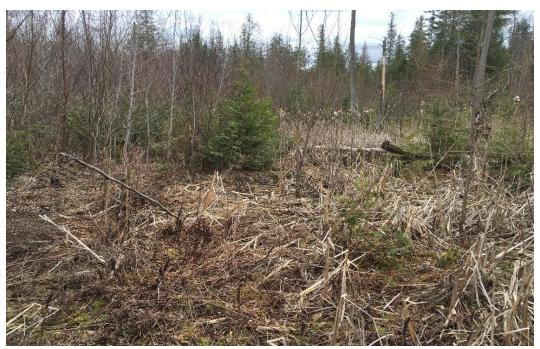
Scrub-shrub wetland W-2. DPW6 was dominated by gray birch (*Betula populifolia*), red maple (*Acer rubrum*), and northern white-cedar (*Thuja occidentalis*). Understory included sensitive fern (*Onoclea sensibilis*), soft rush (Juncus effusus), nodding burr-marigold (*Bidens cernua*), steeplebush (*Spiraea tomentosa*), and other hydrophytes. Primary hydrology indicators included a high water table and saturation. A histic epipedon and black histic were the hydric soil indicators.

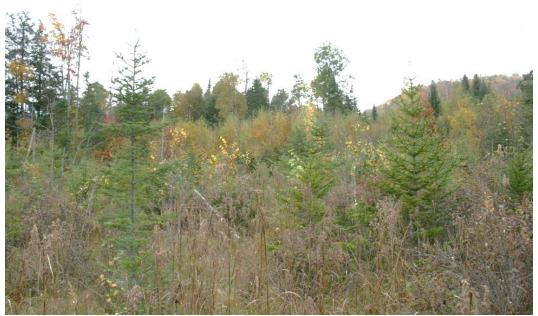
Scrub-shrub wetland W-5. DPW7 was dominated by balsam fir (*Abies balsamea*), red maple (*Acer rubrum*), red spruce (*Picea rubens*), eastern hemlock (*Tsuga canadensis*), and paper birch (*Betula papyrifera*). Understory included moss (*Sphagnum* spp.), eastern marsh fern (*Thelypteris palustris*), woolgrass (*Scirpus cyperinus*), and other hydrophytes. Surface water, a high water table, and saturation indicated wetland hyrdology. Hydric soil was indicated by a histosol.

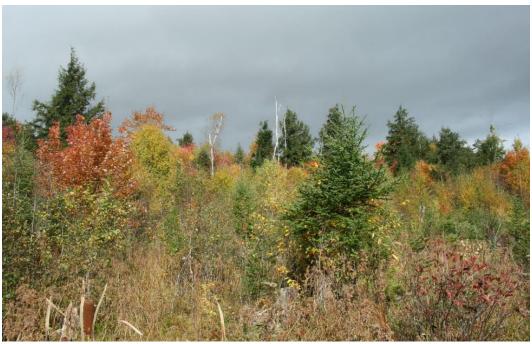
Scrub-shrub wetland W-6. DPW8 was dominated by balsam fir (*Abies balsamea*), yellow birch (*Betula alleghaniensis*), eastern hemlock (*Tsuga canadensis*), and black ash (*Fraxinus nigra*). Understory included dwarf red raspberry (*Rubus pubescens*), bristly-stalk sedge (*Carex leptalea*), cinnamon fern (*Osmundastrum cinnamomeum*), and other hydrophytes. Surface water, a high water table, and saturation indicated wetland hydrology. A histosol was the hydric soil indicator.

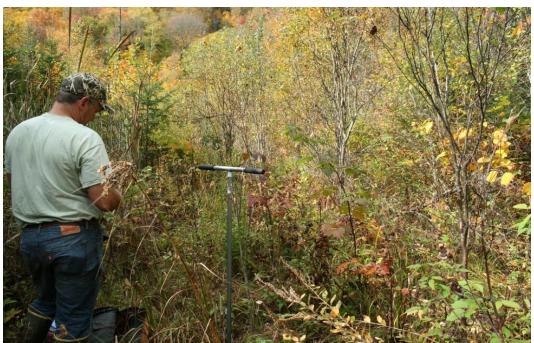
Scrub-shrub wetland W-3. DPW9 was dominated by balsam fir (*Abies balsamea*), speckled alder (*Alnus incana*), steeplebush (*Spiraea tomentosa*), and yellow birch (*Betula alleghaniensis*). Understory included shallow sedge (*Carex lurida*), dwarf red raspberry (*Rubus pubescens*), and other hydrophytes. High water table and saturation indicated wetland hydrology. A histosol was the hydric soil indicator.

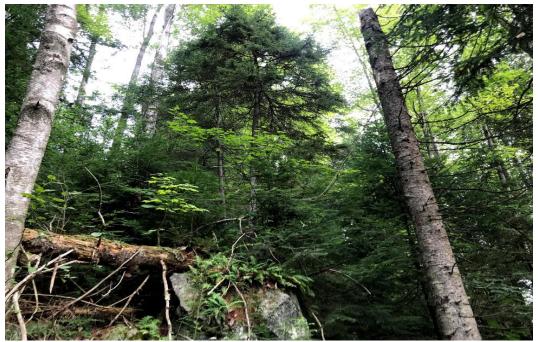
DPU1. This upland point was dominated by striped maple (*Acer pensylvanicum*), mountain maple (*Acer spicatum*), yellow birch (*Betula alleghaniensis*), and evergreen wood fern (*Dryopteris intermedia*).

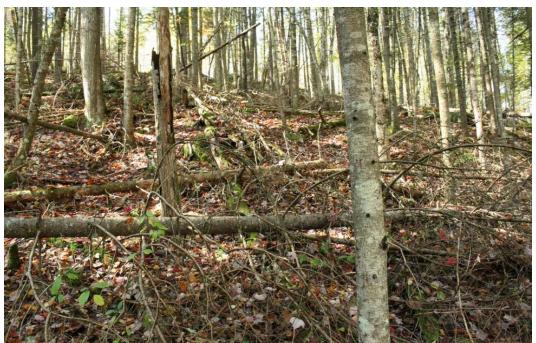
DPU2. This upland point was dominated by red spruce (*Picea rubens*), paper birch (*Betula papyrifera*), and Canada yew (*Taxus canadensis*).

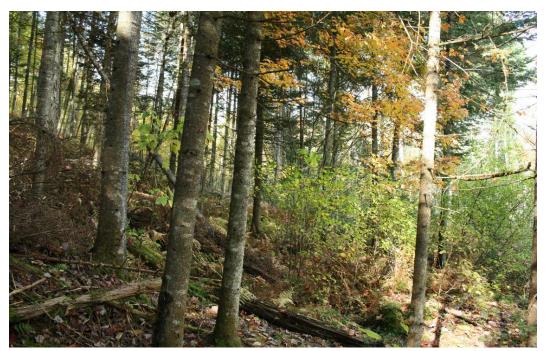
DPU3. This upland point was dominated by balsam fir (*Abies balsamea*), red spruce (*Picea rubens*), American beech (*Fagus grandifolia*), red maple (*Acer rubrum*), false lily-of-the-valley (*Maianthemum canadense*), and wild sarsaparilla (*Aralia nudicaulis*).
