Stratford Corporate Campus
Stratford (Fairfield County), Connecticut

TIDAL WETLAND RESTORATION
ANNUAL MONITORING REPORT NUMBER 1

DEPARTMENT OF THE ARMY PERMIT NO.
CENAE-CO-R-199800335 and
CT DEPARTMENT OF ENVIRONMENTAL PROTECTION
PERMIT NOS.
199800774-SG, IW-98-102 & WQC-199800778

JANUARY 2007

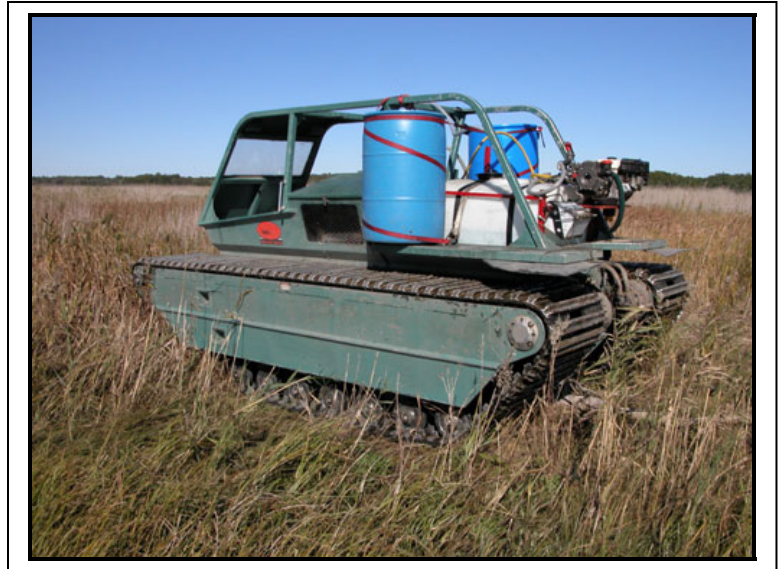
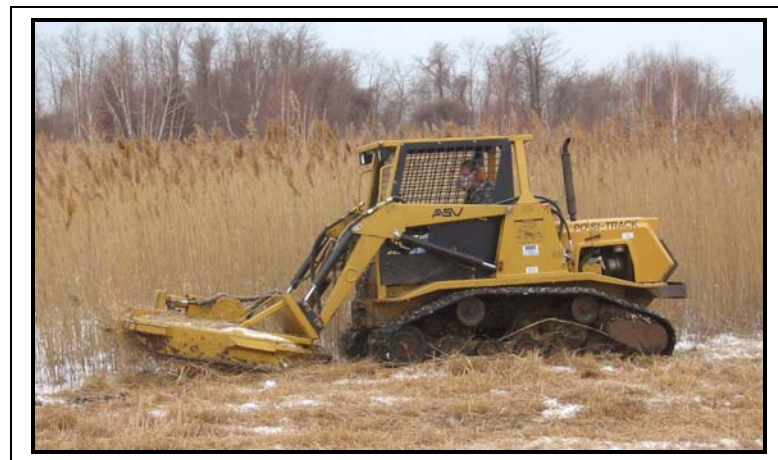
Phragmites australis (common reed) at each restoration site initially was treated with a 3% solution of Dow Agrosience Glypro® (EPA Registration # 62719-324) containing 53.8% glyphosate [N-(phosphonomethyl) glycine] as the active ingredient. The glyphosate also contained a 0.005% solution of CWC (CWC Chemical Company, Inc.) Surfactant 90 as a wetter/spreader adjuvant. The herbicide was applied/sprayed onto the *Phragmites* from a herbicide container-mounted low ground pressure tracked vehicle, such as the Marsh Master II Amphibious vehicle pictured at right.

Approximately 15 – 30 days following the glyphosate applications, the *Phragmites* was cut and mulched with a rotary mower, such as the front-mounted mower pictured at left. As pictured in the photograph below, soil erosion/sediment controls then were installed, with an emphasis on sites designated for the stockpiling of excavated material proximate to the Refuge.

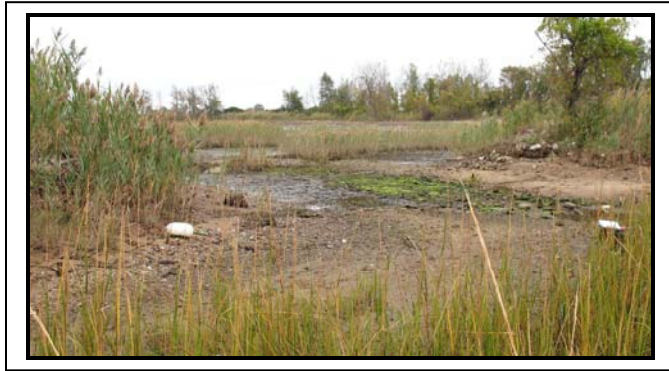
Dike Breach at Restoration Site 4 and Tidal Connection to Johnson's Creek

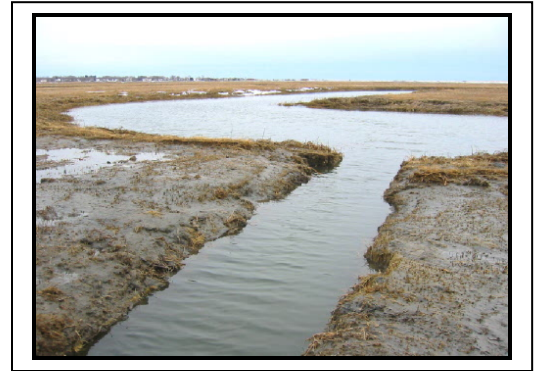
Dike Breach at Restoration Site 3 and Connection to Tidal Creek

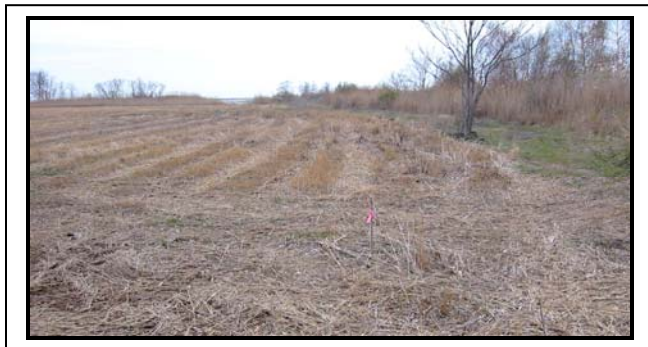
The construction of Restoration Site 1 was completed on 17 January 2006. As evidenced by the post cutting & mulching photograph at left (looking south towards Lewis Gut), Site 1 formerly consisted exclusively of *Phragmites australis*.

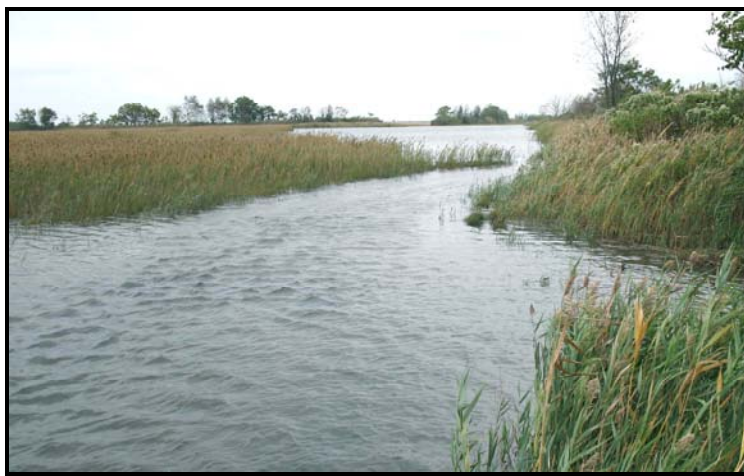
To date, tidal influence has been restored to the site, as evidenced by observations made on 11 October 2006 and the photograph at right (looking south towards Lewis Gut). In as much as the site was observed during high tide, no estimate of the vegetative coverage accrued since project completion was feasible.

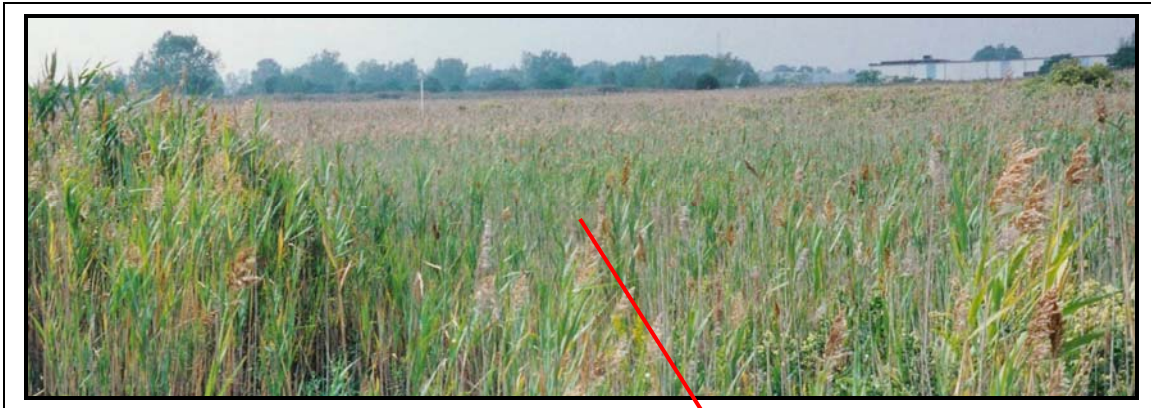
As indicated in the pre-construction photograph below (looking west), the 21+ acre Site 2 also consisted exclusively of *Phragmites australis* prior to restoration.

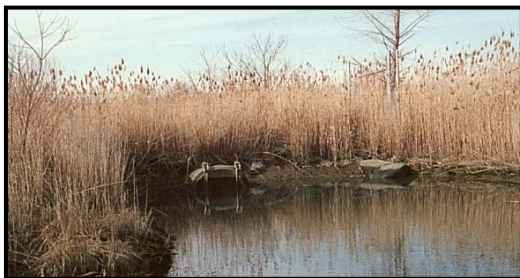
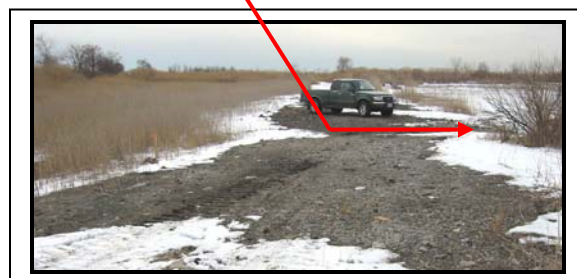
This *Phragmites*-dominated wetland also was isolated from tidal influence by a tide gate located in the northeastern portion of the site, as well as an unpaved road, as illustrated in the photographs below.

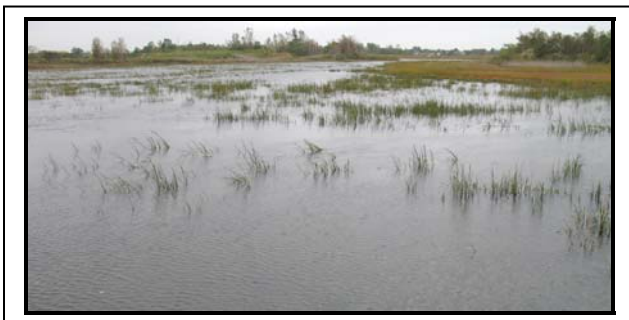
Upon the completion of site construction in October 2005, however, tidal influence to Site 2 was restored and *Spartina alterniflora* began to colonize the area during the 2006 growing season, as indicated in the photographs below.

Site 2 Northeast from Observation Deck

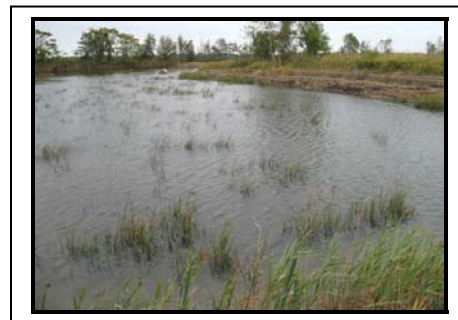
Site 2 Southeast from Observation Deck

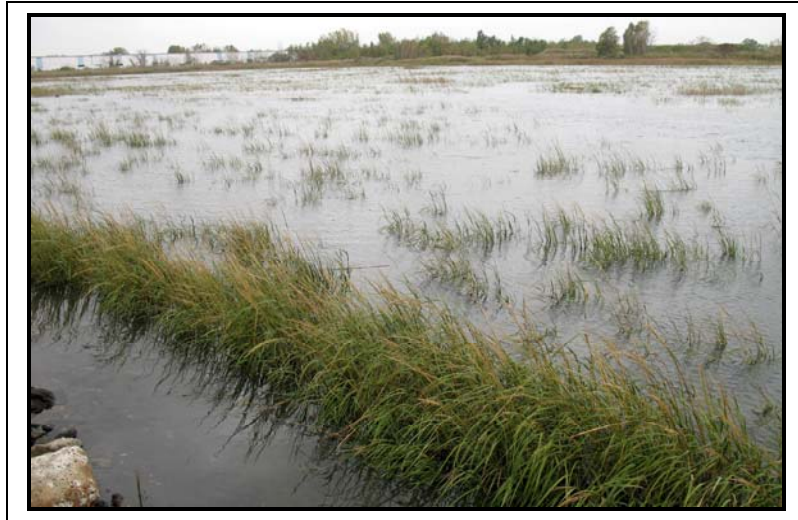
Site 2 West/Northwest from Observation Deck

Based on observations made during the 11 October 2006 monitoring event, Site 2 coverage with *S. alterniflora* presently is estimated to be approximately 5 – 10%.

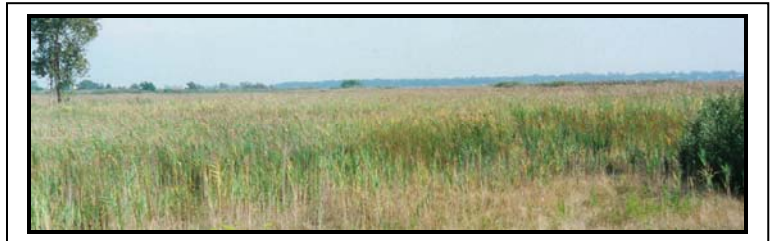
On 15 February 2005, Site 3 became the first restoration area to be completed. Like each of the other restoration sites, Site 3 formerly was dominated by *Phragmites australis* (see photograph at right, looking northeast towards Sikorsky Airport).

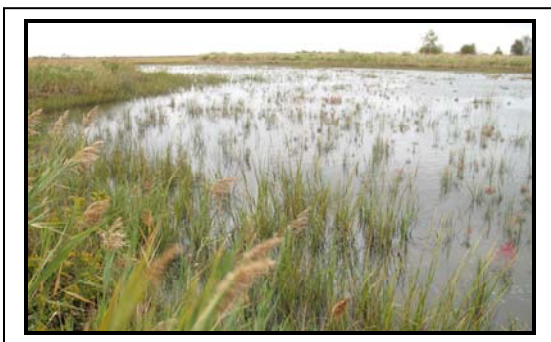
Again, based on observations made during the 11 October 2006 monitoring event and following two (2) growing seasons, Site 3 vegetative coverage presently is estimated at approximately $\pm 10\%$ (see photographs below).

Site 3 East/Southeast

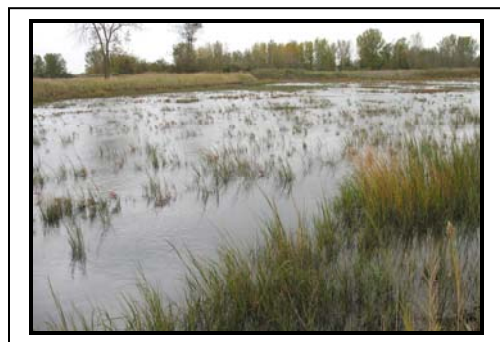
Site 3 West/Southwest

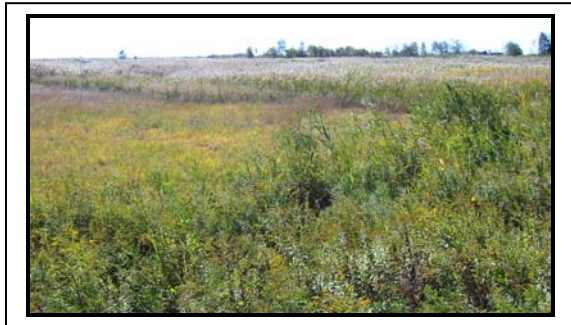
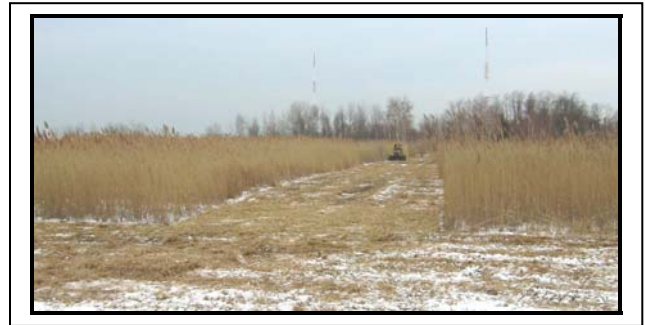
While the first site at which restoration construction commenced, Site 4 was the last site to be completed (see Table IV). Once again and, as indicated in the photographs below (looking southeast and south, left to right, towards Lewis Gut), *Phragmites australis* dominated pre-construction site conditions.

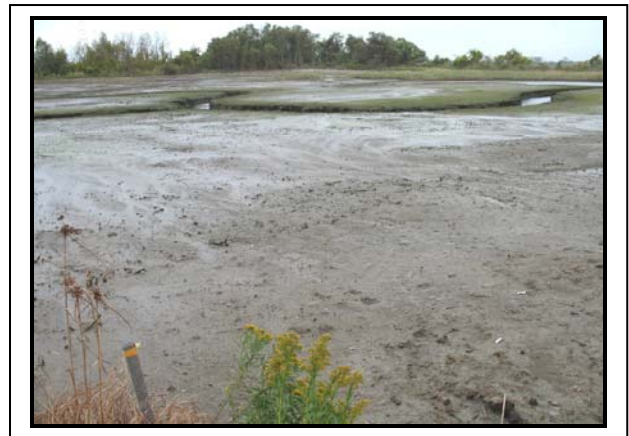
As evidenced by the photograph at right, Site 4 remains sparsely vegetated (< 5% coverage) after one (1) growing season. Some *Phragmites australis* also persists, primarily in the western portion of the site. However, it is anticipated that the daily influx of tidal waters over time, facilitated by the network of tidal creeks associated with this (see photographs below) and all other restoration sites, will elevate salinities and generate conditions favorable to the elimination of *Phragmites* and the establishment of salt marsh plant species, most notably *S. alterniflora*. This expectation will be addressed in Monitoring Report No. 2.

Site 4 Southwest

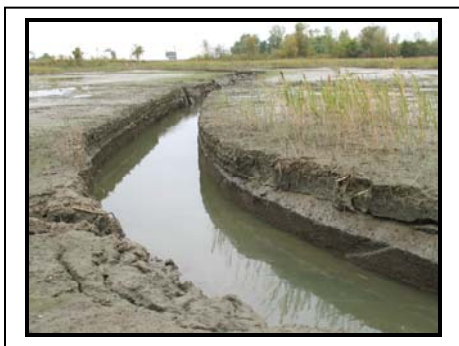
Site 4 Tidal Creek

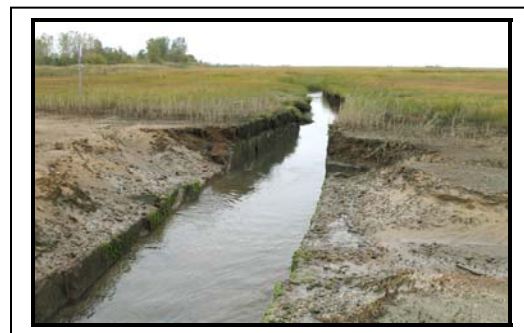
Site 4 Tidal Creek Connection to Lewis Gut
