**MAINE DEPARTMENT OF TRANSPORTATION**

**2006 POST-CONSTRUCTION  
MONITORING REPORT:**

**New Gloucester Mitigation Project  
(MDOT PIN 3517.90)**

**Compensation for Route 26 Reconstruction Project,  
Gray and New Gloucester  
(MDOT PIN 3517.20)**

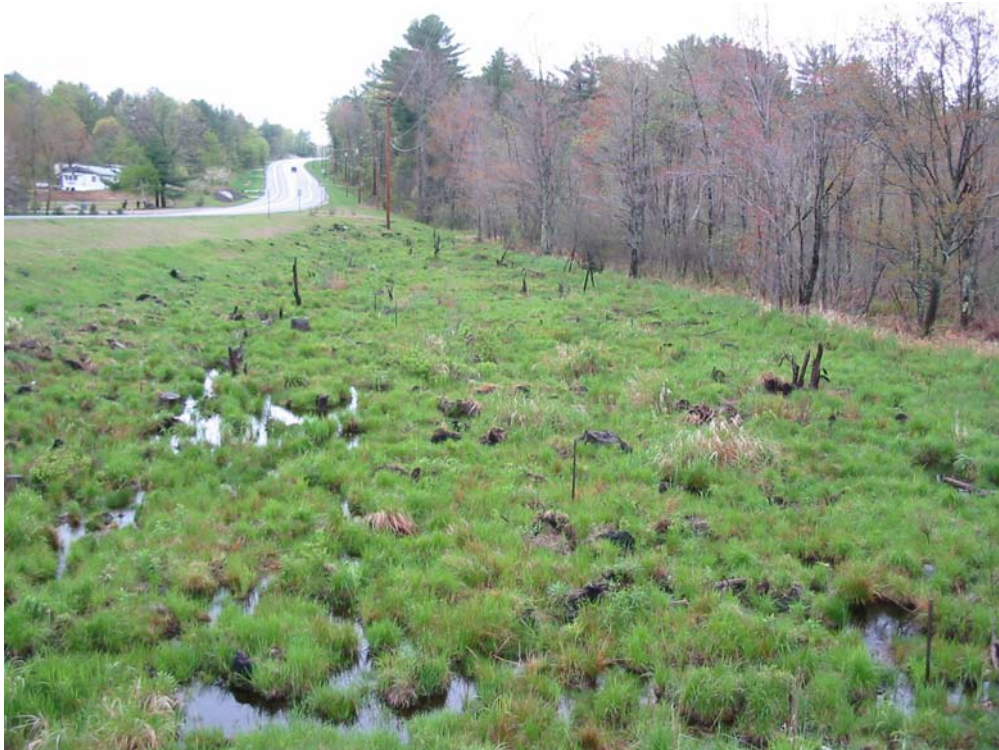
Photo 1. Mosquito Brook site restoration area in early spring. 5-16-06.

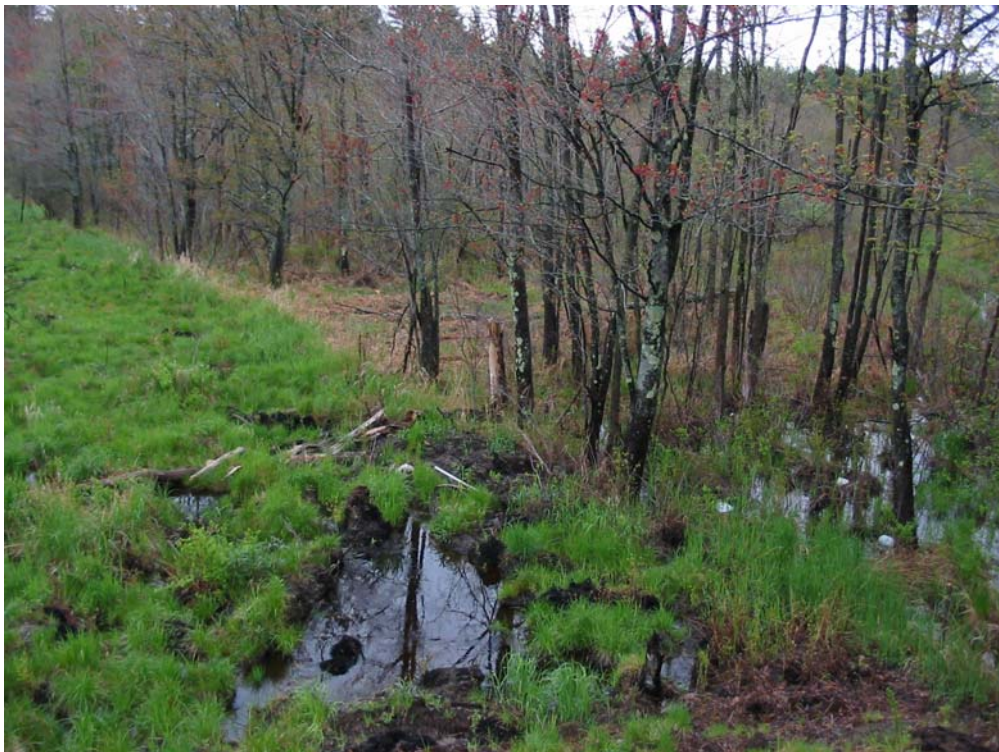
The salvaged wetland loam placed in the restoration area during construction was stable, and well vegetated. These highly organic soils have an irregular microtopography of hummocks and shallow pits. Soils within the restoration area were partially flooded in May and seasonally saturated in September.

Photo 2. Water ponded in shallow depressions within the Mosquito Brook restoration area and the adjacent reference wetland. 5-16-06.

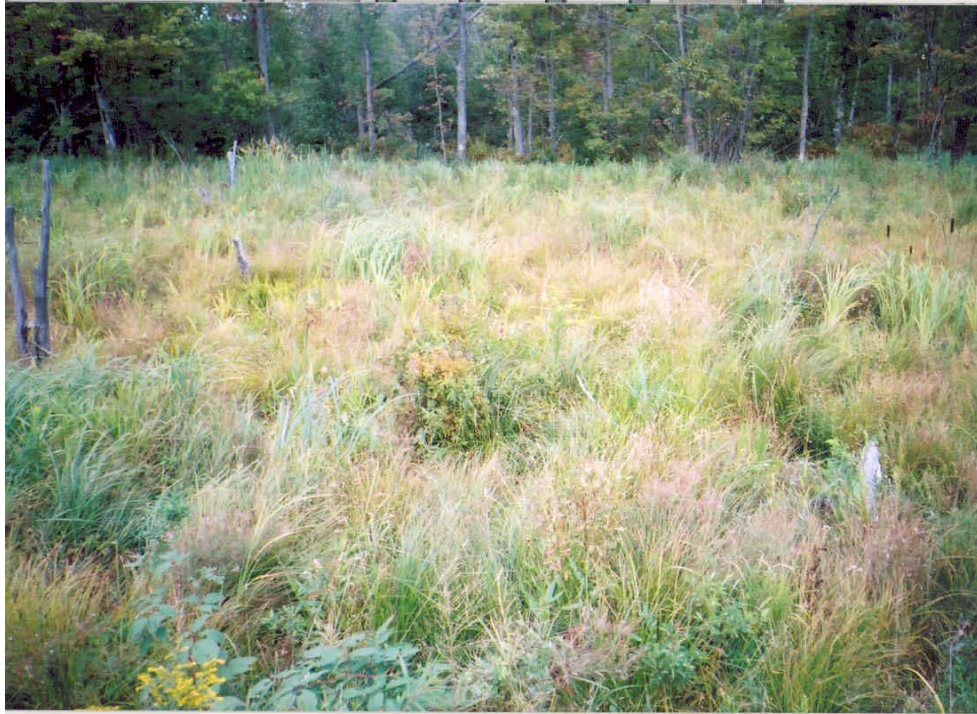
The restoration area was well vegetated with a mix of herbaceous plant species that sprouted from the salvaged loam and root masses/ plant clumps spread throughout the site. The restoration plan for the site relied on natural recruitment of wetland vegetation in place of plantings and a wetland seed mix. A dense cover of herbaceous vegetation has become established within the site. Wetland species noted during the site visit include royal fern (*Osmundia regalis*), swamp candles (*Lysimachia terrestris*), blue-joint grass (*Calamagrostis canadensis*), *Sparganium* sp. and other sedges and grasses. A complete plant list is included in Appendix B. Based on visual inspection, the site appears to meet the 80% cover standard.

Photo 3. Vegetative cover within the Mosquito Brook restoration area. 9-5-06..

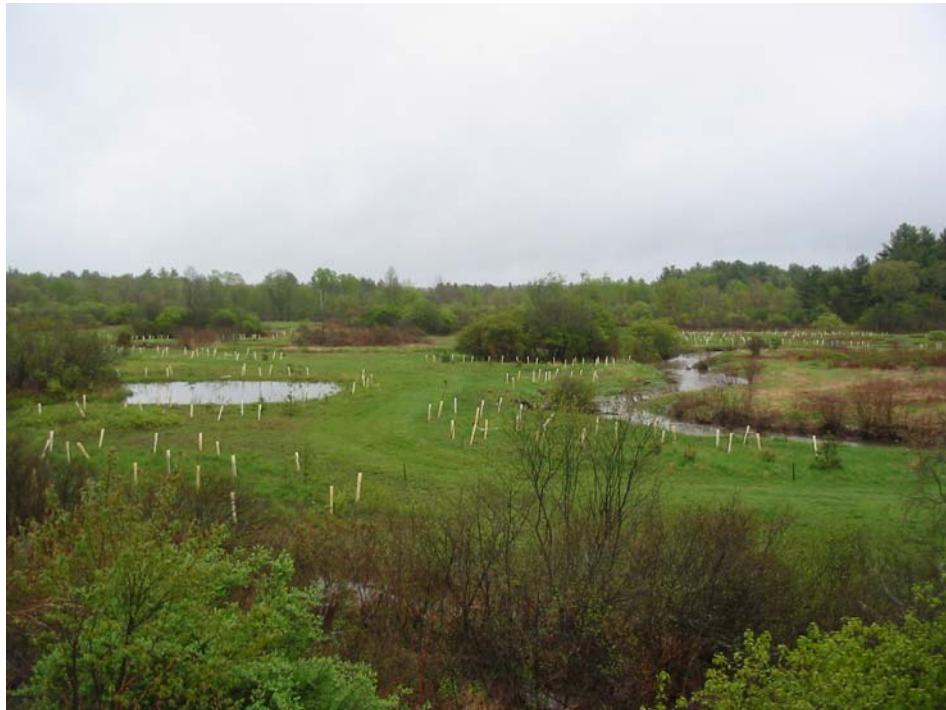
Photo 4. View of floodplain enhancement area at Royal River site from railroad embankment showing plant groups, shallow pool, and channel. 5-16-06.

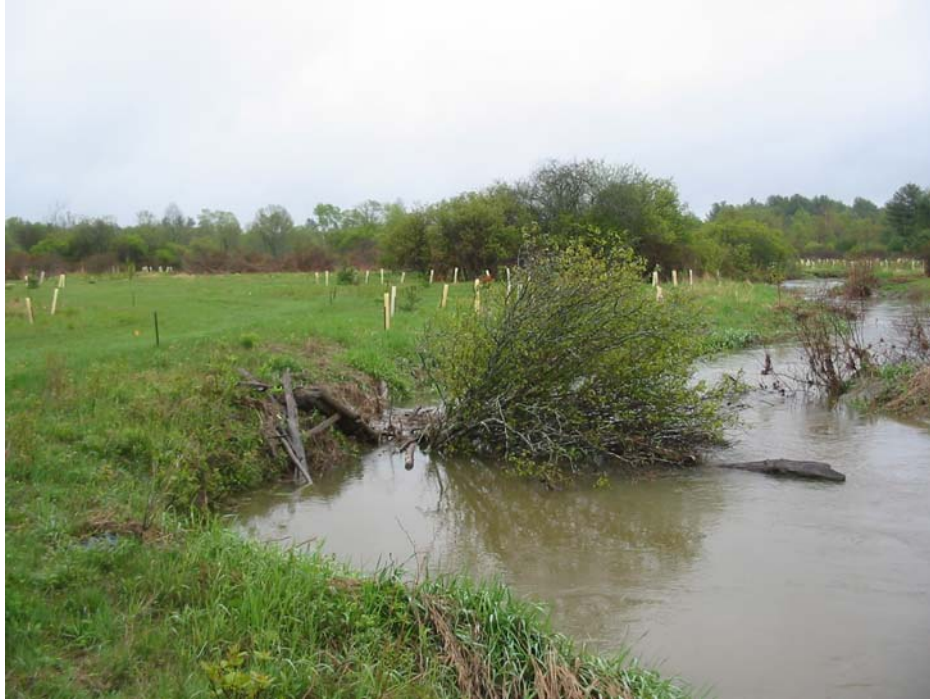
In early May, water levels in the Royal River were about three feet below the top of bank. Isolated incidents of bank or shrub slumping were noted along the streambank outside the limits of the stabilization areas. A large preexisting shrub clump near planting group number 5 pulled away from the bank during the winter of 2005-2006 and came to rest at the toe of slope. A previously undercut section of streambank near planting group 2 also failed, depositing large clumps of sod on the slope.

Photo 5. View of floodplain enhancement area showing large existing shrub clump that slid into the Royal River during the winter of 2005-2006. 5-16-06.

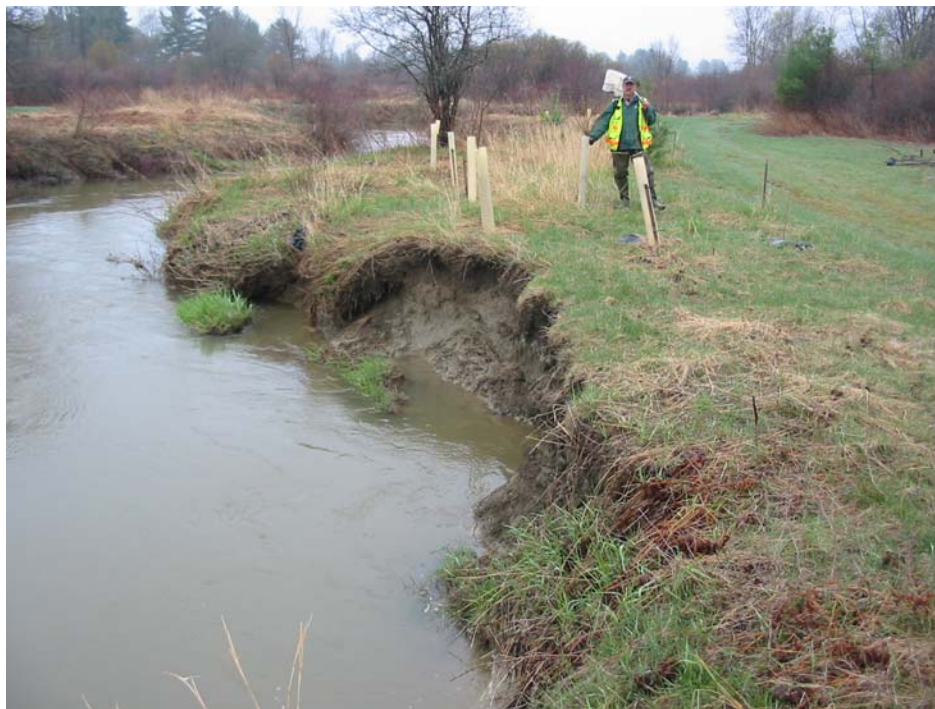
Photo 6. View of bank erosion near plant group 2 that occurred over the winter of 2005-2006. 5-3-06.

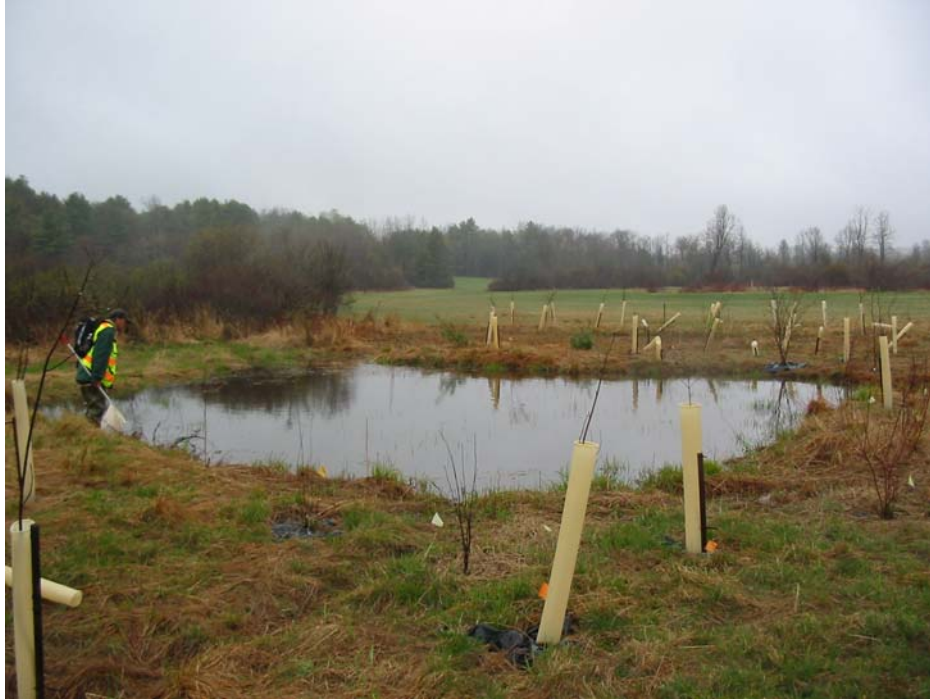
The shallow pools constructed in the floodplain were checked on May 3<sup>rd</sup> for signs of amphibian breeding activity. At the time of sampling, three out of four constructed pools contained water as did the reference pool. Wood frog (*Rana sylvatica*) tadpoles were noted in small numbers (<20) within Pool A as were 3 green frogs. Pool B contained approximately 8 wood frog egg masses attached to branches in the pool that had previously hatched. No spotted salamander egg masses or larvae were observed in any of the pools. A reference pool located adjacent to the enhancement area within clumps of reed canary grass contained a large number of wood tadpoles. Pool D located in the middle of the field surrounded by the large meander bend contained a small, shallow puddle in early May. The same pool had filled with water by mid-May, but by this point in the season it was too late to support breeding by obligate vernal pool species.

Photo 7. View of temporary ponding in shallow pool C and surrounding plant group during amphibian survey. 5-3-06.

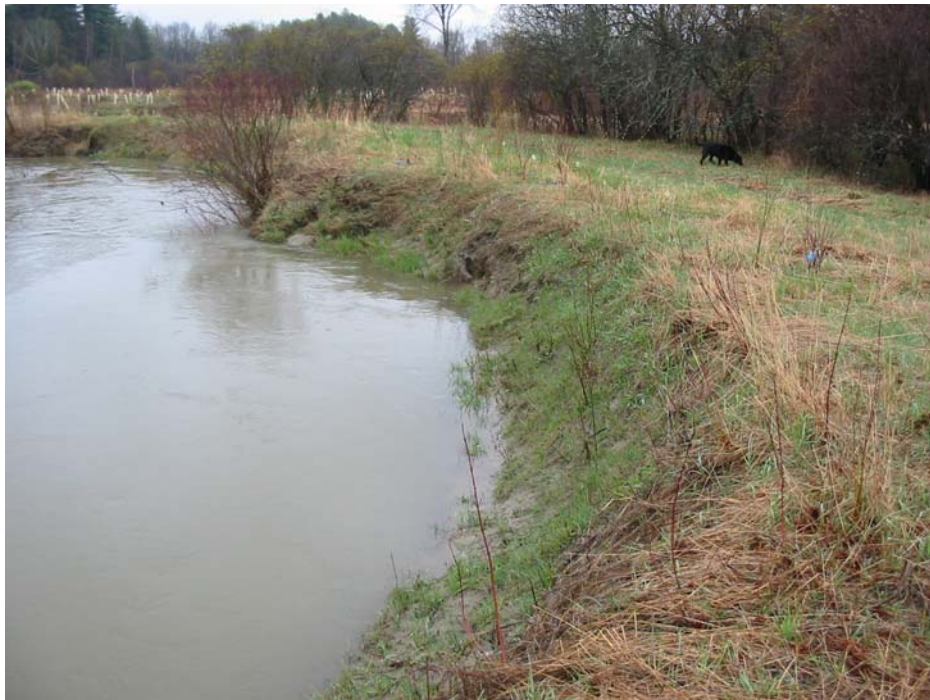
Photo 8. View downstream of upper section of streambank stabilization area when water level was about 3 feet below the top of bank. 5-3-06.

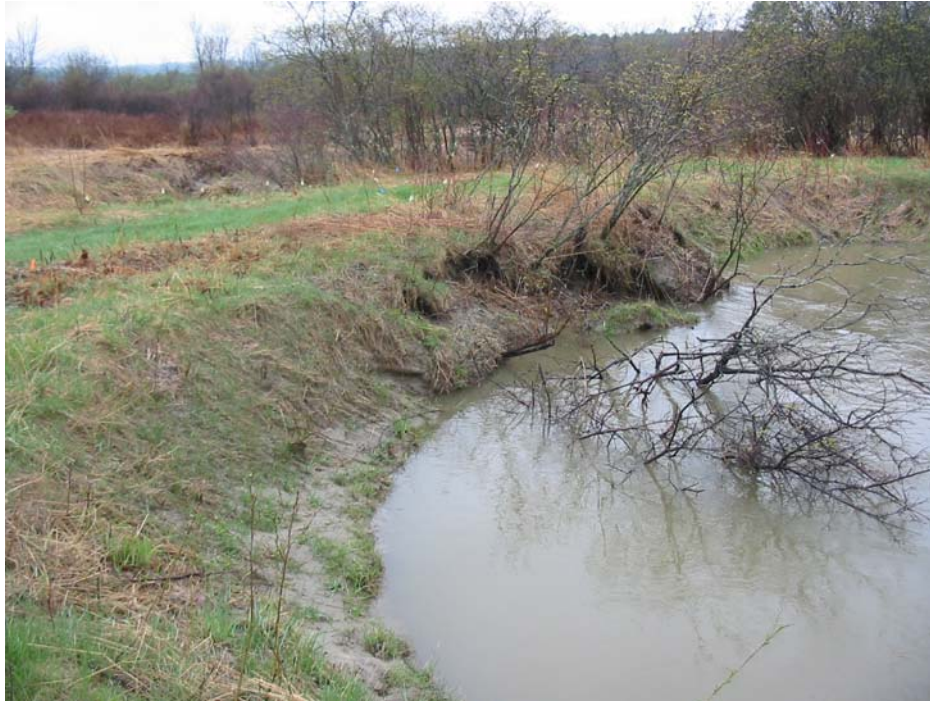
Photo 9. View upstream of lower section of streambank stabilization area showing bank scarring that resulted when large shrub clump located between two stabilization areas slid into river in 2004-2005. 5-3-06.

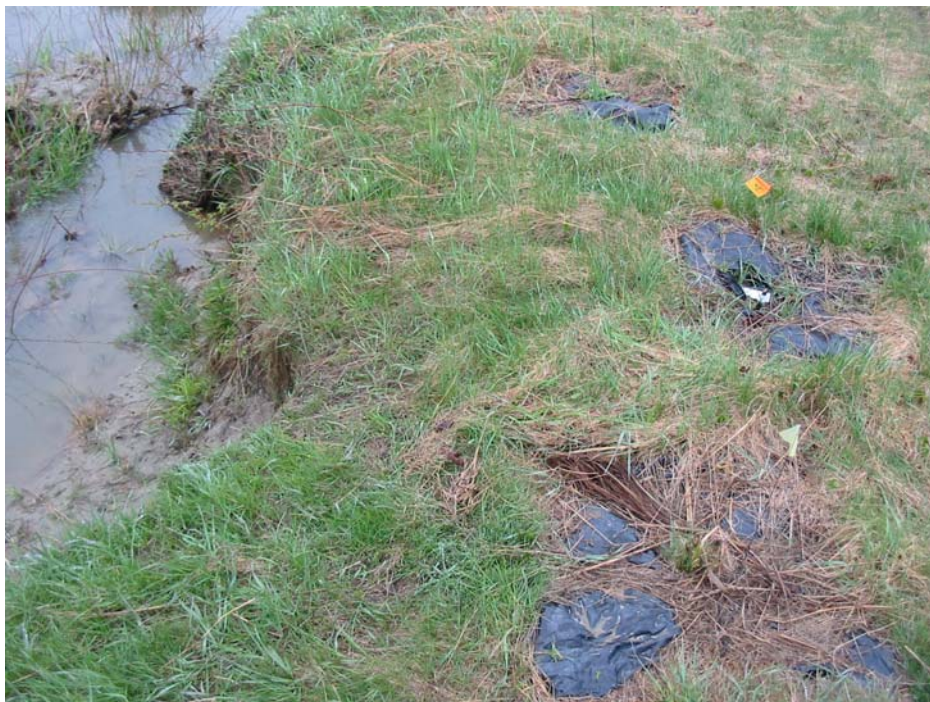
Photo 10. Mulch blankets marking the location of alder shrubs clipped by beaver. River is to the left of photo. 5-3-06.

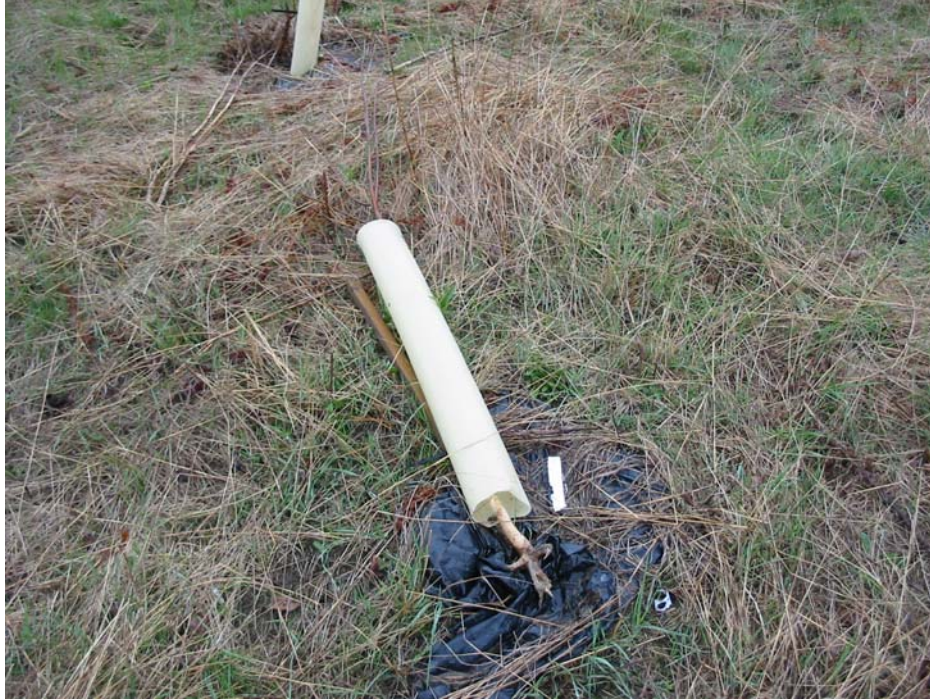
An assessment of the woody plant density within the plant groups indicated that the total woody plant density and the tree density had fallen below the performance standards mostly as a result of herbivory experienced during the winter of 2005-2006. The roots and stems of a number of trees, predominantly white ash, were girdled and killed by small rodents, probably voles, despite being enclosed in plastic tree protectors. The relatively warm conditions during the winter of 2005-2006 and the lack of snow cover may have exacerbated the damage. In addition, a number of alder and willow shrubs planted along sections of the streambank were clipped at the base by beaver. These areas were located near places where trails used by beaver emerge from the river and ascend the steep muddy bank. As first noted in 2004, browsing by beaver is likely to continue unless intensive control measures, such as repeated trapping or the location and destruction of dens, are implemented. Intensive control measures may be difficult to implement at this site because of the ability of the beaver to move freely upstream and downstream, and may require permission from adjacent property owners.

Photo 11. Remains of planted white ash showing vole damage to roots and stem despite enclosure in plastic tree protector. 5-3-06.

As a result of these findings, 50 replacement trees (3-4 foot) and 80 replacement shrubs (18-24 inch) were installed in October. Alders were not included in the plant list because of uncertainty over the availability of native species from the nursery. These replacements were intended to offset losses from herbivory that occurred in the winter of 2005-2006 and to keep the site on track to meet the performance standards. The plants were mulched with 4 inches of woodwaste mulch and plastic protectors were replaced on the tree species. Newly replaced plants and existing plants along the top of the streambank were hand sprayed with an environmentally safe animal repellent intended to deter additional browse by rodents, beaver, and deer.

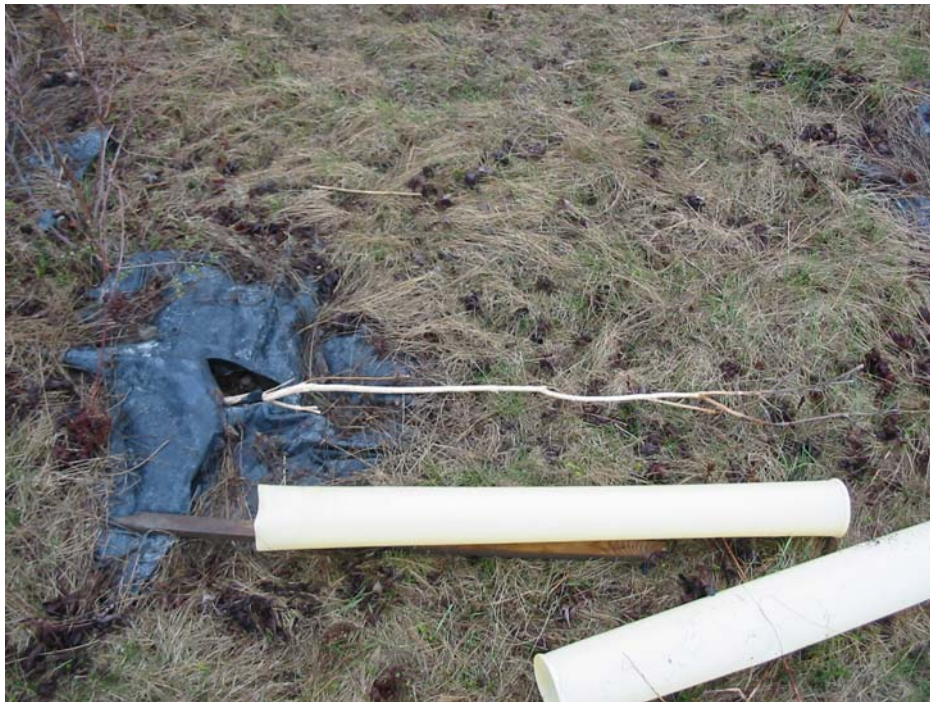
Photo 12. Planted white ash completely stripped of bark by voles. Tree was inside plastic tree protector. 5-3-06.

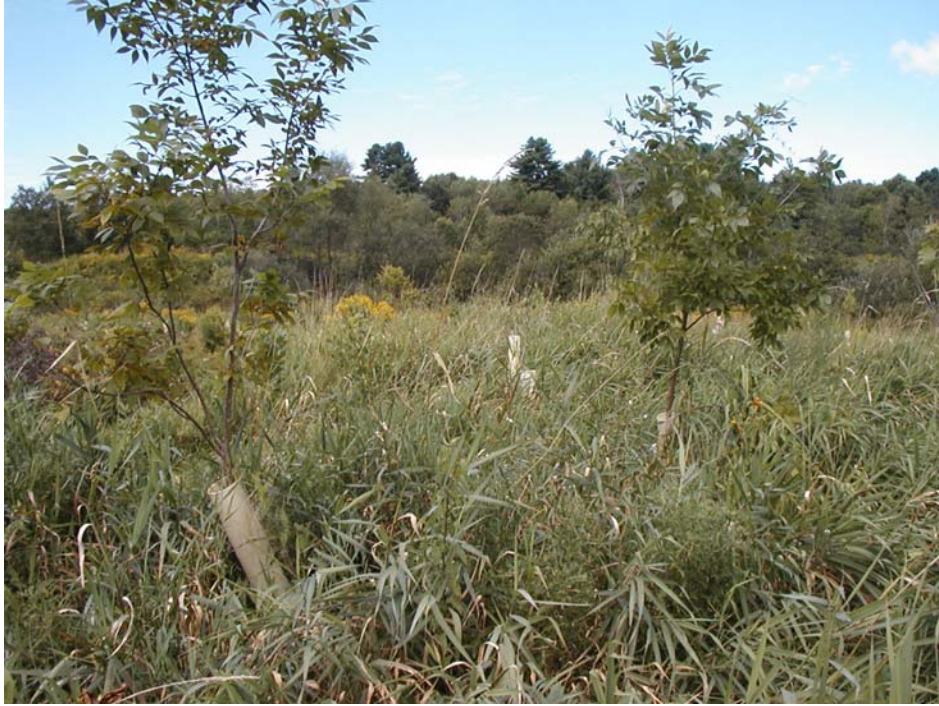
Photo 13. Several ash in planting group at the end of the growing season. 8-24-06.

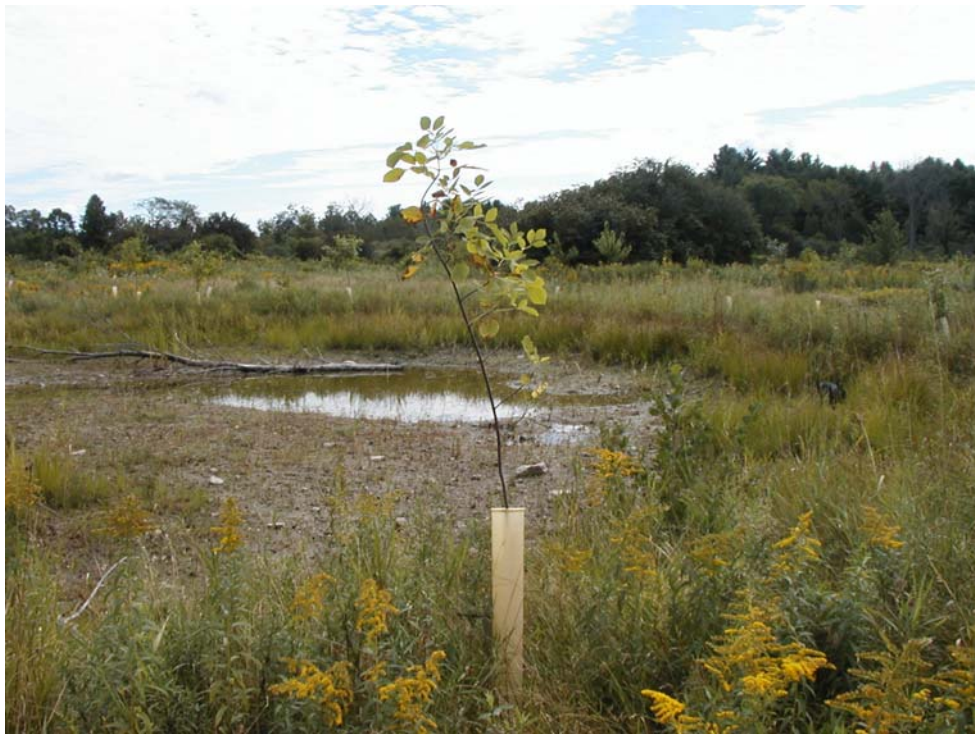
Photo 14. Several ash in planting group at the end of the growing season. 8-24-06.

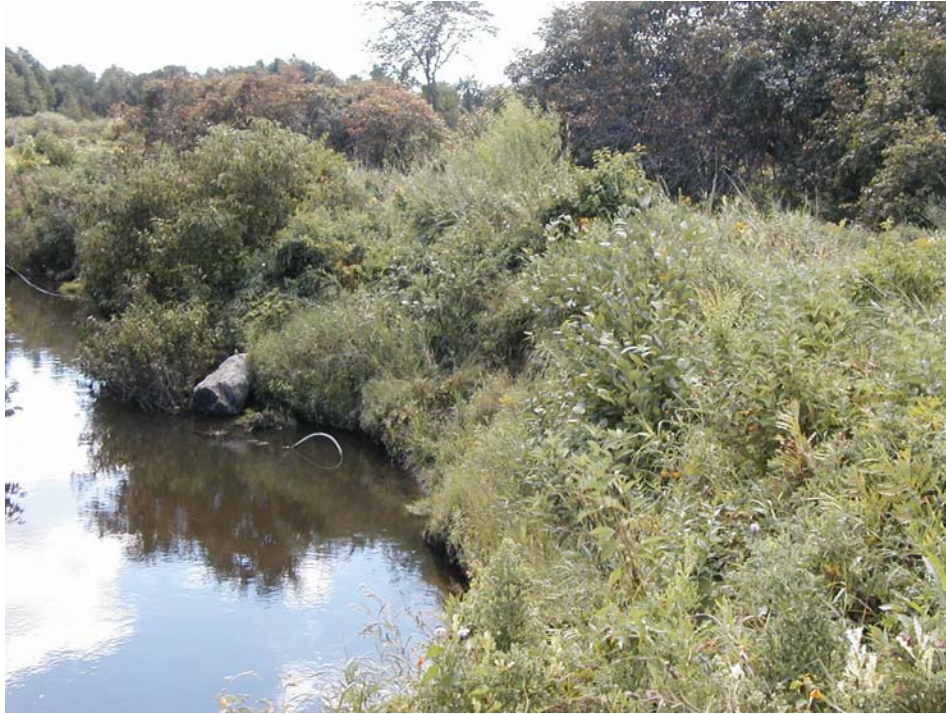
Photo 15. View downstream of middle section of streambank stabilization area at the end of the third growing season. Herbaceous vegetation is well established and many previously browsed tubelings have resprouted. 8-24-06.

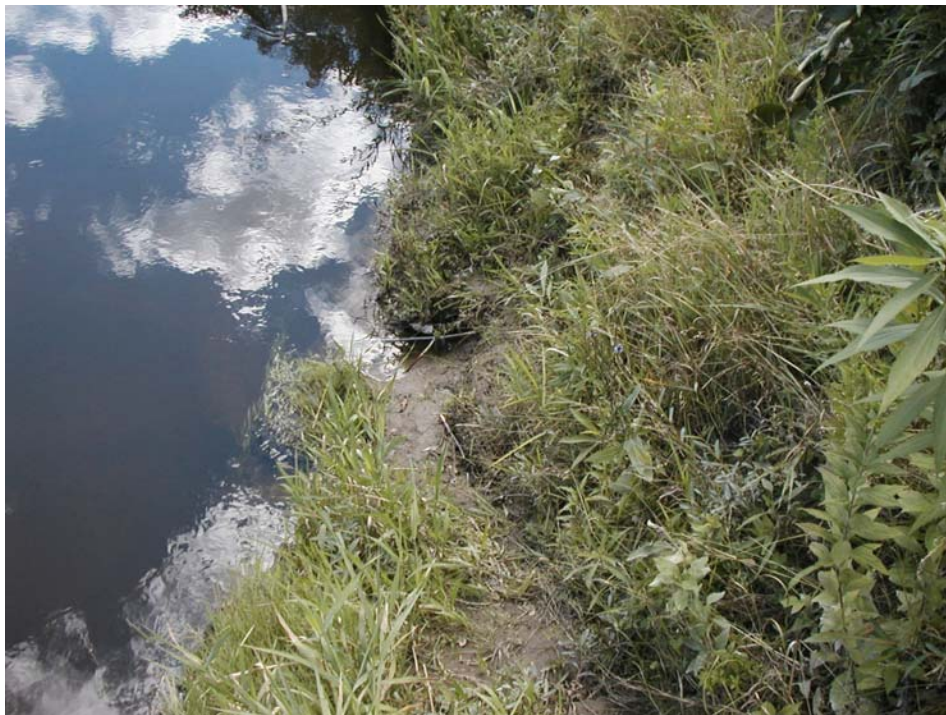
Photo 16. Close up of beaver trail through middle portion of streambank stabilization area. 8-24-06.

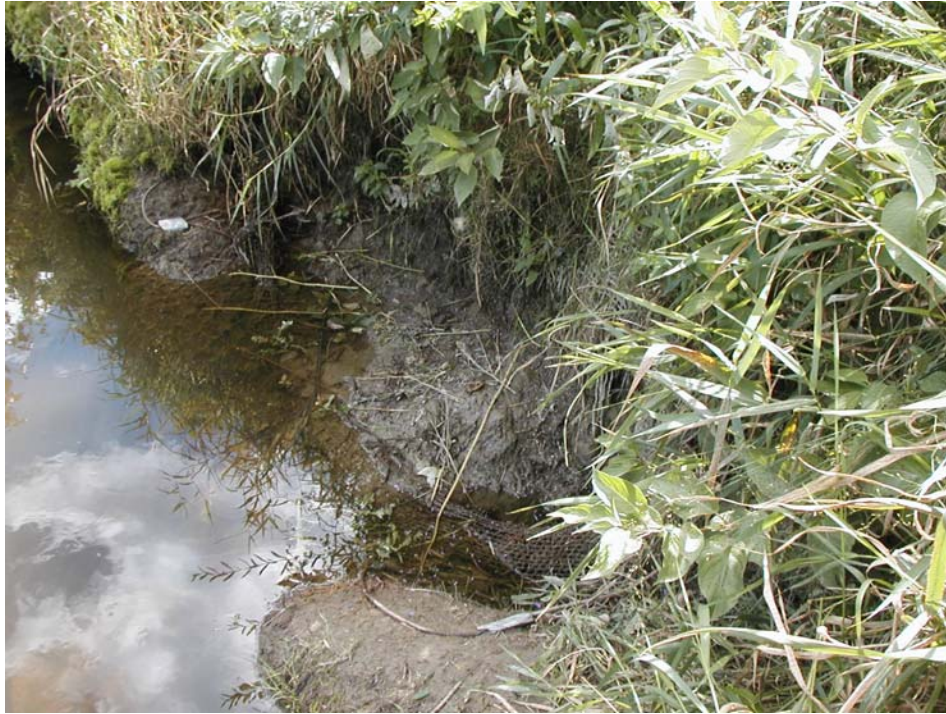
Despite the freeze-thaw conditions and repeated flooding that occurred over the winter of 2005-2006, the bioengineering measures and regraded slopes remained stable. However, slight damage to the coir log and slopes due to frost heaving or wildlife activities was noted within the stabilized section of the bank. Two slumps, approximately 2-3 feet long by 1 foot high were noted in the middle section of the stabilized bank. In addition, two short sections of the coir log had sagged approximately 1 foot as a result of beaver activity. It appears that beaver climb up on the log, then up the slope and over the narrow land bridge to reach the river on the other side. This activity does not appear to have compromised the integrity of the adjacent coir logs and blankets, but will be monitored again in 2007. The soils around these areas are well vegetated with a mix of herbaceous shrub and cover.

Photo 17. Close up of slump in coir log at toe as a result of beaver activity in middle section of streambank stabilization area. 8-24-06.

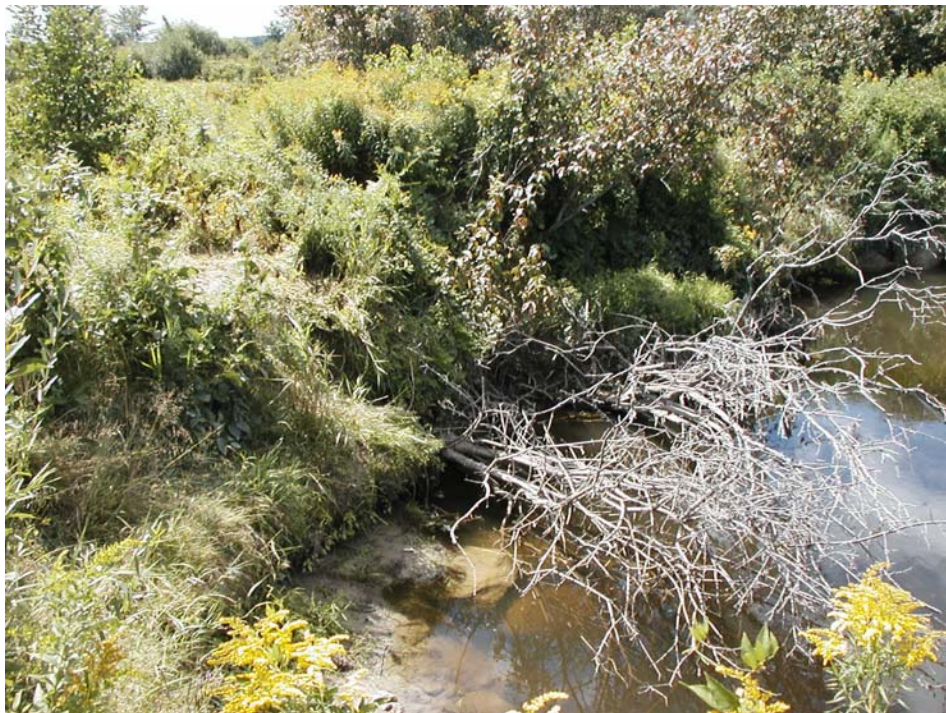
Photo 18. Downstream section of streambank stabilization area at the end of the third growing season showing vegetation regrowth around shrub clump that slumped previously. 8-24-06.

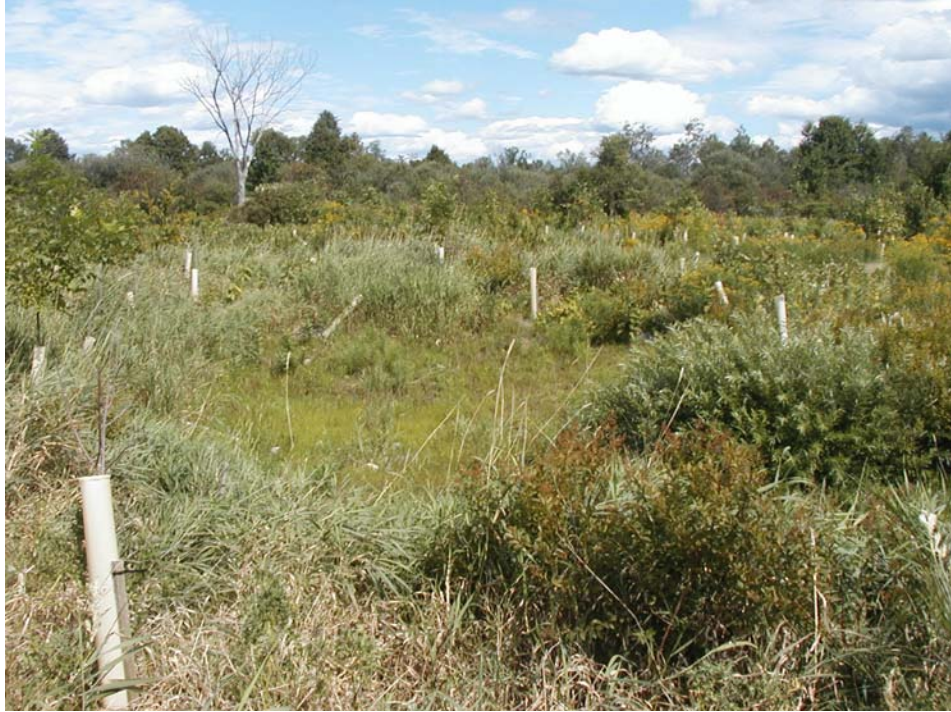
Photo 19. View of planted trees in plastic tree protectors and herbaceous growth around pool D in center of large meander bend in river. 8-24-06.
