CONSTRUCTION MONITORING AND AS-BUILT REPORT

Stoney Ridge Road Wetland Mitigation Site Ellsworth Lowe's Project Ellsworth, Maine

December 2007

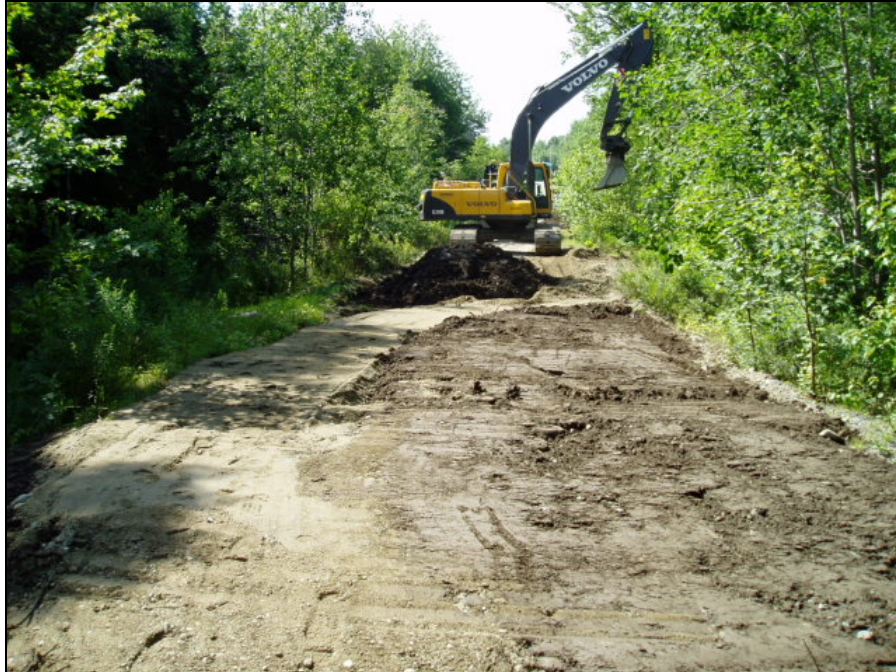
Photo 1. Excavator stripping gravel and adding topsoil in upland restoration area. Woodlot, July 25, 2007.

Upland Restoration: The contractor began at the east end of the upland restoration area by removing gravel, re-grading, and placing topsoil. This work was completed by an excavator, progressing down the hill towards the lower end of the gravel road at the intersection of the Deerfield Road. A minimum of one foot of gravel was removed throughout the upland restoration area. More than one foot was removed where the road banks were cut back to reduce the steepness of side slopes and to reduce the potential for erosion, and where water bars were constructed. The three water bars were constructed on the steeper section of restored roadway as a permanent erosion control measure to divert runoff into adjacent vegetated areas. The excavator left a meandering three-foot wide gravel path within the roadway as specified in the plans.

Following gravel removal and re-grading, the contractor installed a minimum of one foot of topsoil salvaged from the nearby Lowe's construction site. This material was spread using the excavator and was compacted only minimally with the bucket. Some micro-topography was built into the final grading in upland restoration areas, although not to the same degree as the wetland restoration area (see photos).

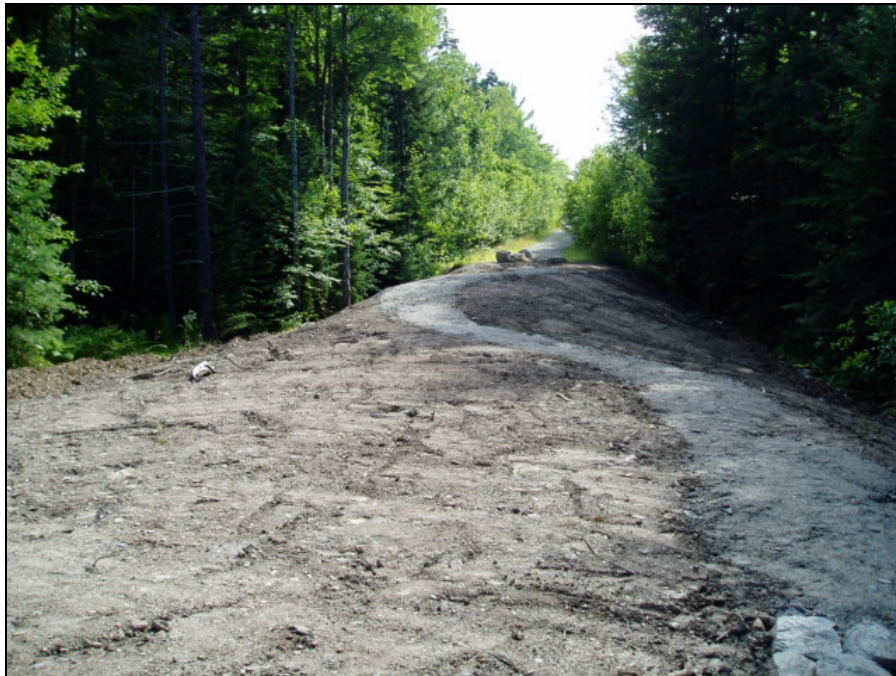
Photo 2. Eastern end of upland restoration, looking east, after re-grading and re-soiling. Lighter color is gravel path. Woodlot, July 25, 2007.

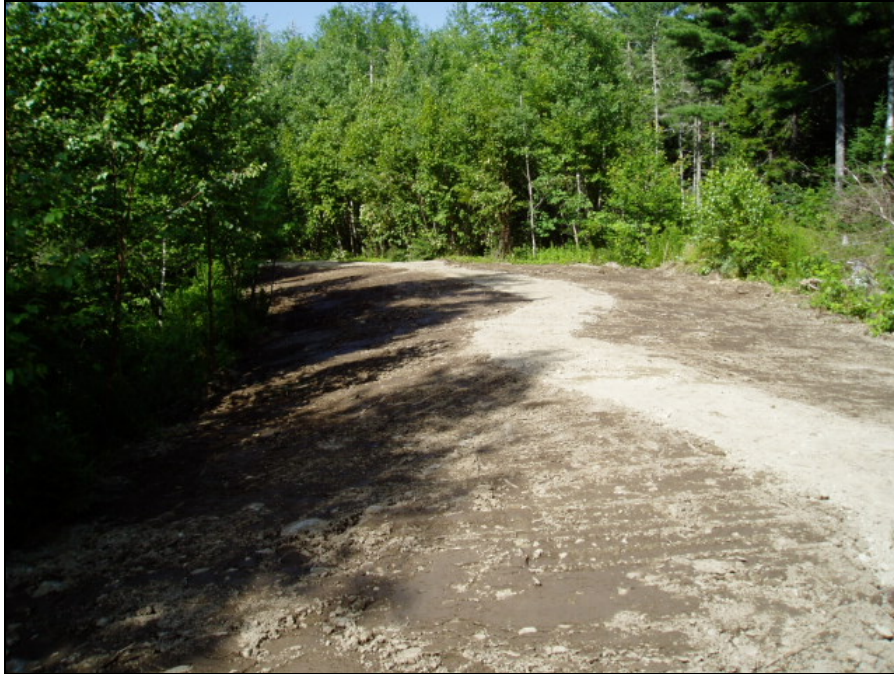
Photo 3. Newly-re-graded and re-soiled conditions in central portion of upland restoration area.
Woodlot, July 25, 2007.

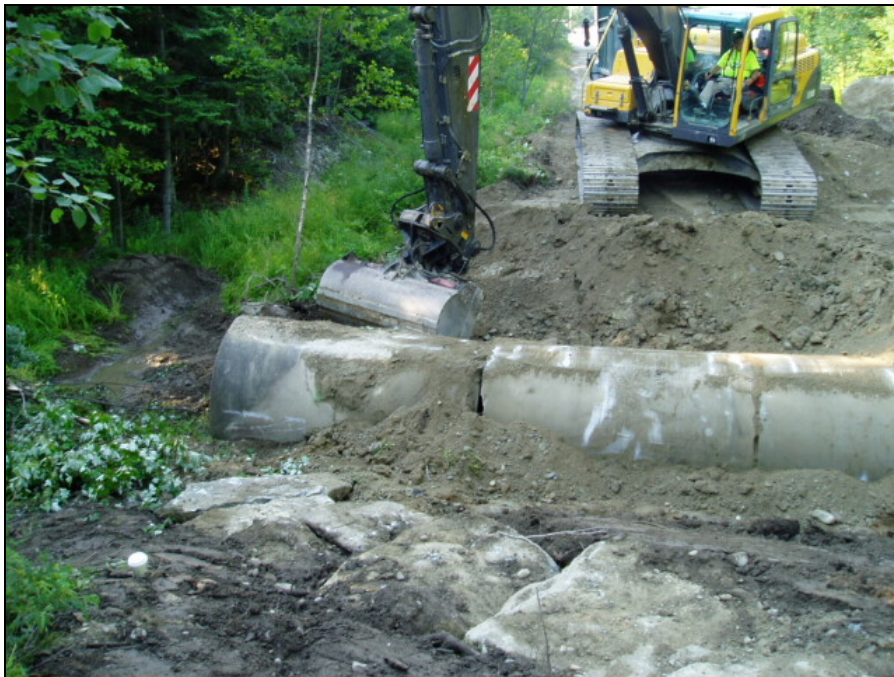
Photo 4. Removing 50-inch concrete culvert from wetland restoration area.
Woodlot, July 25, 2007.

Wetland Restoration: Wetland restoration involved removal of a section of the gravel road bed and a 50-inch diameter concrete culvert, followed by placement of topsoil and a rock path. This work was also done with an excavator. A Stantec wetland scientist was on-site to observe a portion of wetland restoration, and provided recommendations to the contractor regarding rough and finish grades, stream channel locations, and micro-topography. Observation of the original soil under the roadbed helped guide the vertical extent of roadbed excavation necessary to restore wetland conditions. The same topsoil used in the upland restoration areas was used for wetland restoration. Gravel and small rocks were used to form the stream channels (see photos).

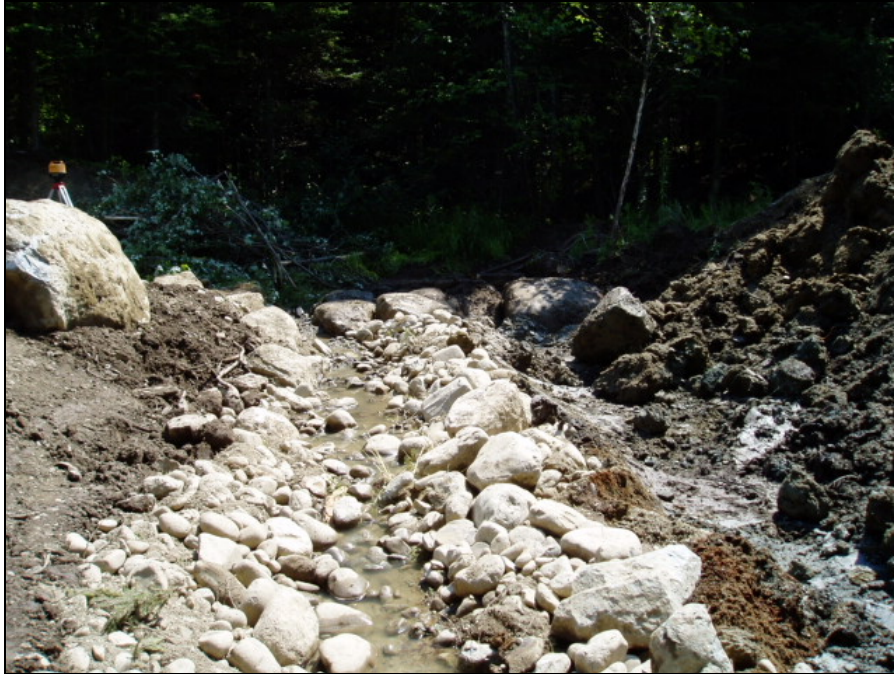
Photo 5. Re-established stream channel after culvert removal and placement of rocks, looking upstream (east). Woodlot, July 25, 2007.

As can be seen in the attached photographs, removal of the culvert and re-grading of the area between the two streams coming in from the north allowed the contractor to construct two new channels totaling approximately 150 linear feet. The restored channels merge just upstream of the undisturbed channel on the west side of the roadway (see Figure 3 and photos). The combined area of wetland and riparian buffer restoration closely matches the area of planned restoration, and is expected to provide the functions stated in the mitigation objectives.

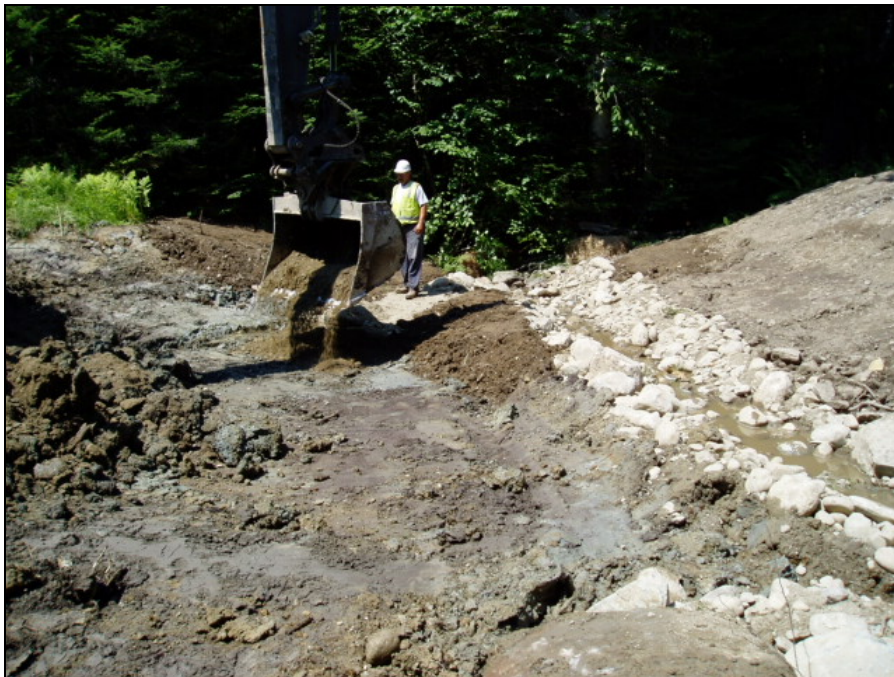
Photo 6. Adding topsoil to wetland restoration area, looking west (downstream). Re-established channel where culvert was is shown on right. Woodlot, July 25, 2007.

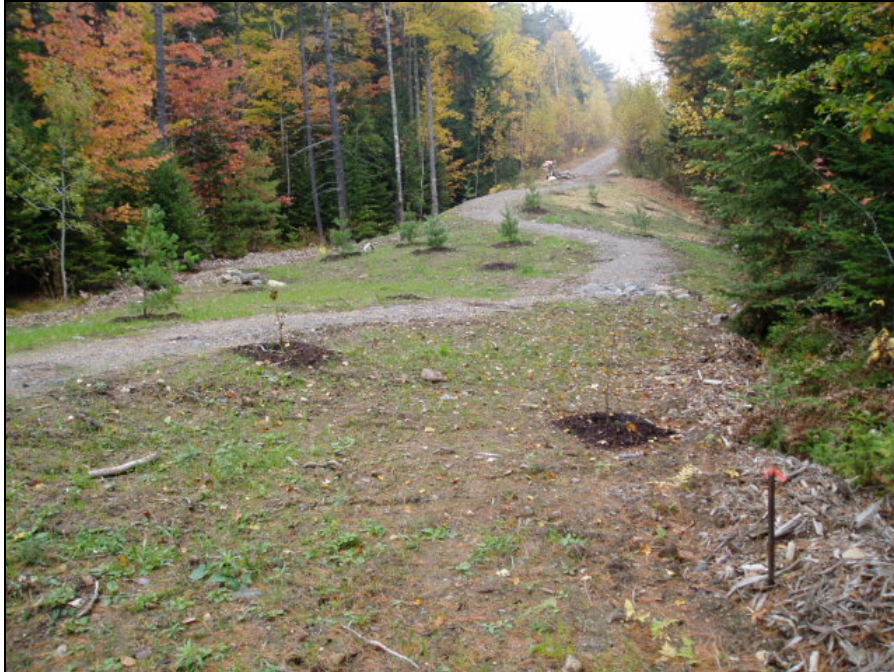
Photo 7. Looking at eastern end of restored upland after seeding and planting. Stantec, October 19, 2007.

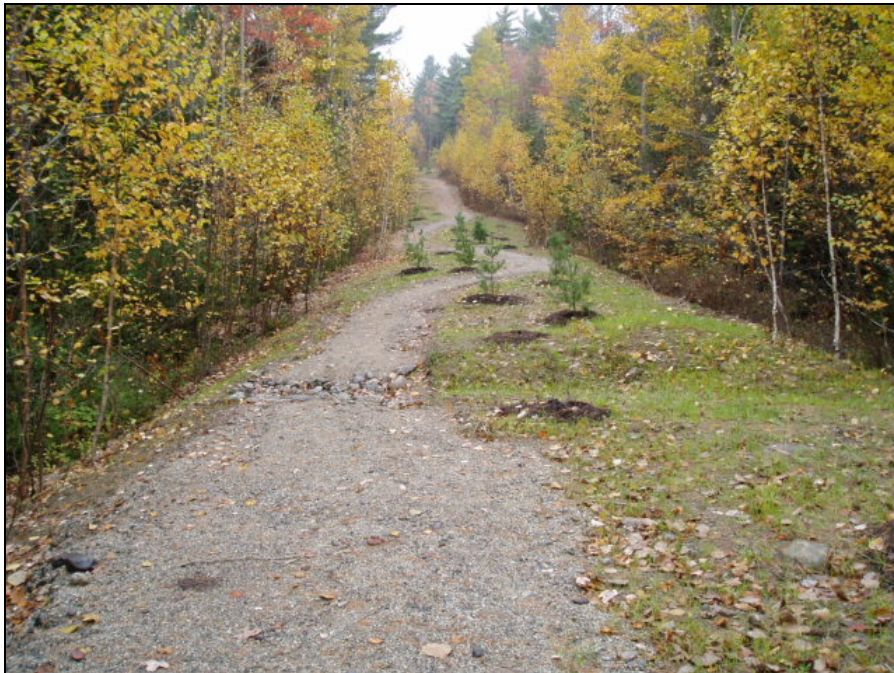
Photo 8. Water bar on sloped section of restored road. Also note trees already established along edges of old road. Stantec, October 19, 2007.

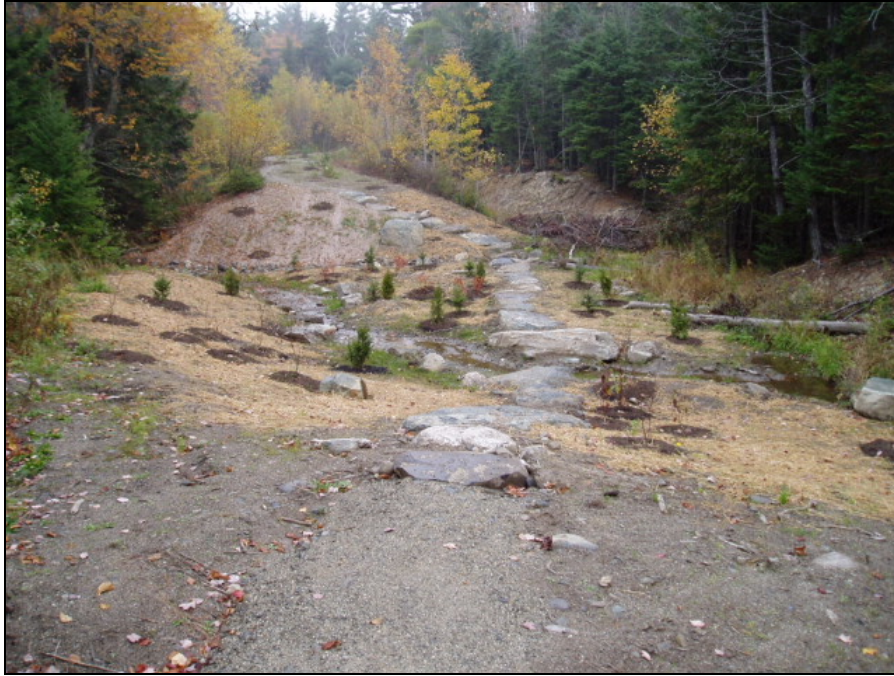
Photo 9. Wetland/stream restoration area, looking north. Stantec, October 19, 2007.

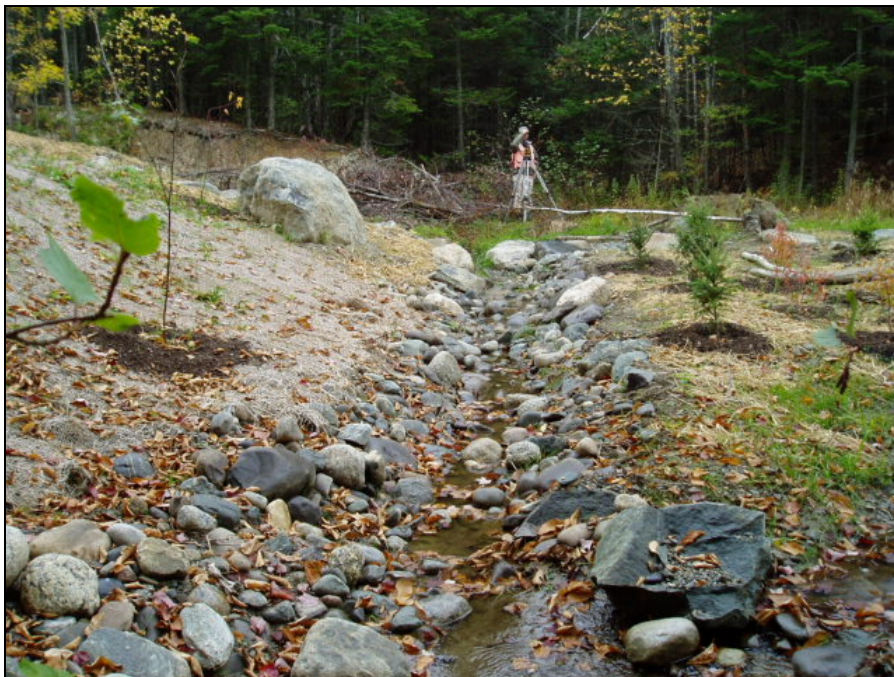
Photo 10. Restored stream channel at culvert removal location, looking upstream (east).
Stantec, October 19, 2007.

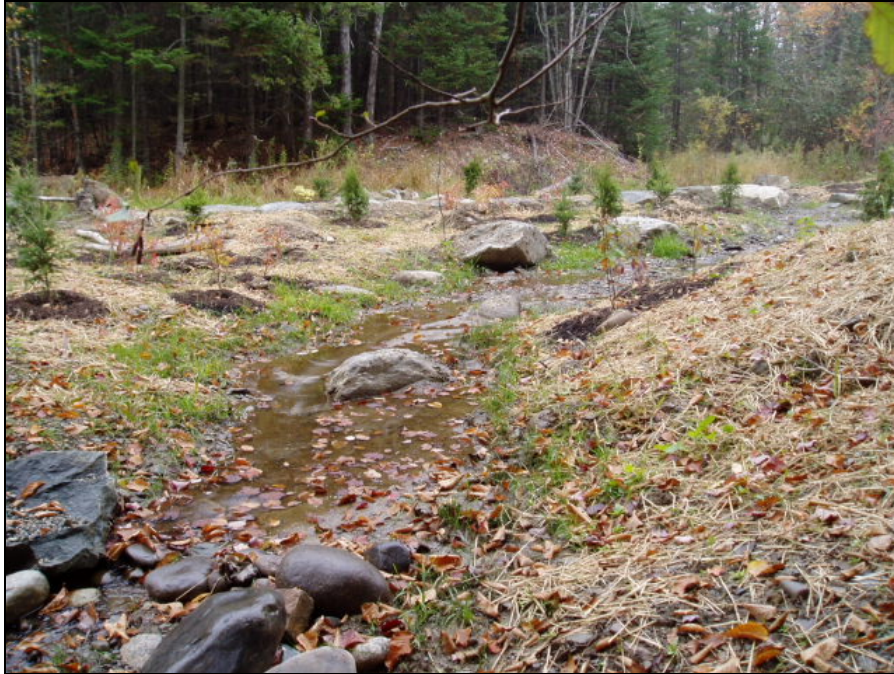
Photo 11. Second restored stream channel, looking upstream (southeast).
Stantec, October 19, 2007.

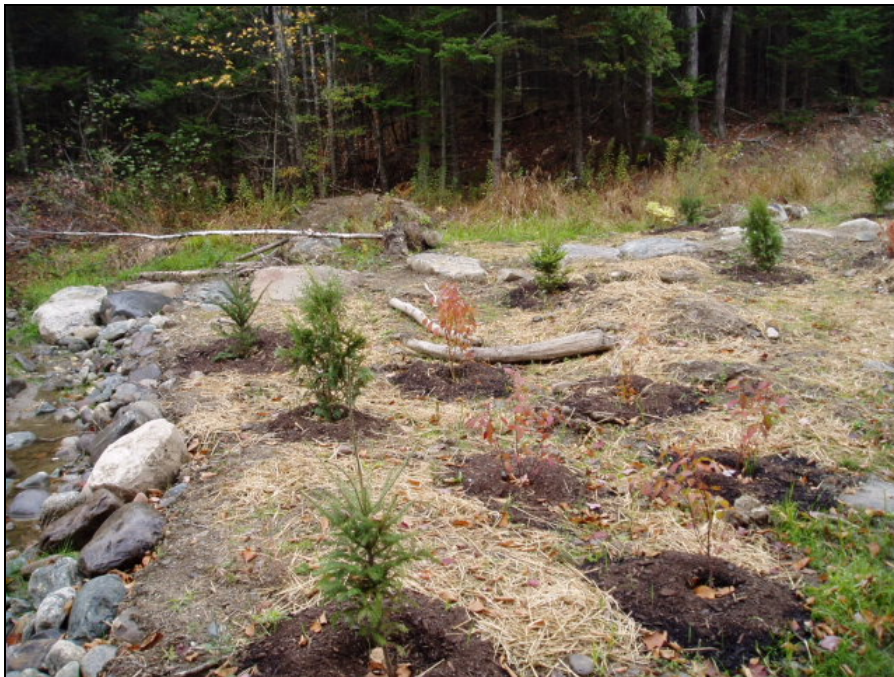
Photo 12. Plantings within wetland restoration area.
Stantec, October 19, 2007.
