**PRELIMINARY JURISDICTIONAL
DETERMINATION FORM**

New England District, Seabrook Development, NAE-2017-00395

Drawing Name: **WETLAND IMPACT PLAN OVERALL**
 Project: **COMMERCIAL DEVELOPMENT**
603 LAFAYETTE ROAD, SEABROOK, NH
 Owner of Record: **SEABROOK DEVELOPMENT ASSOCIATES, LLC**
 322 RESERVOIR STREET, NEEDHAM, MA 02494

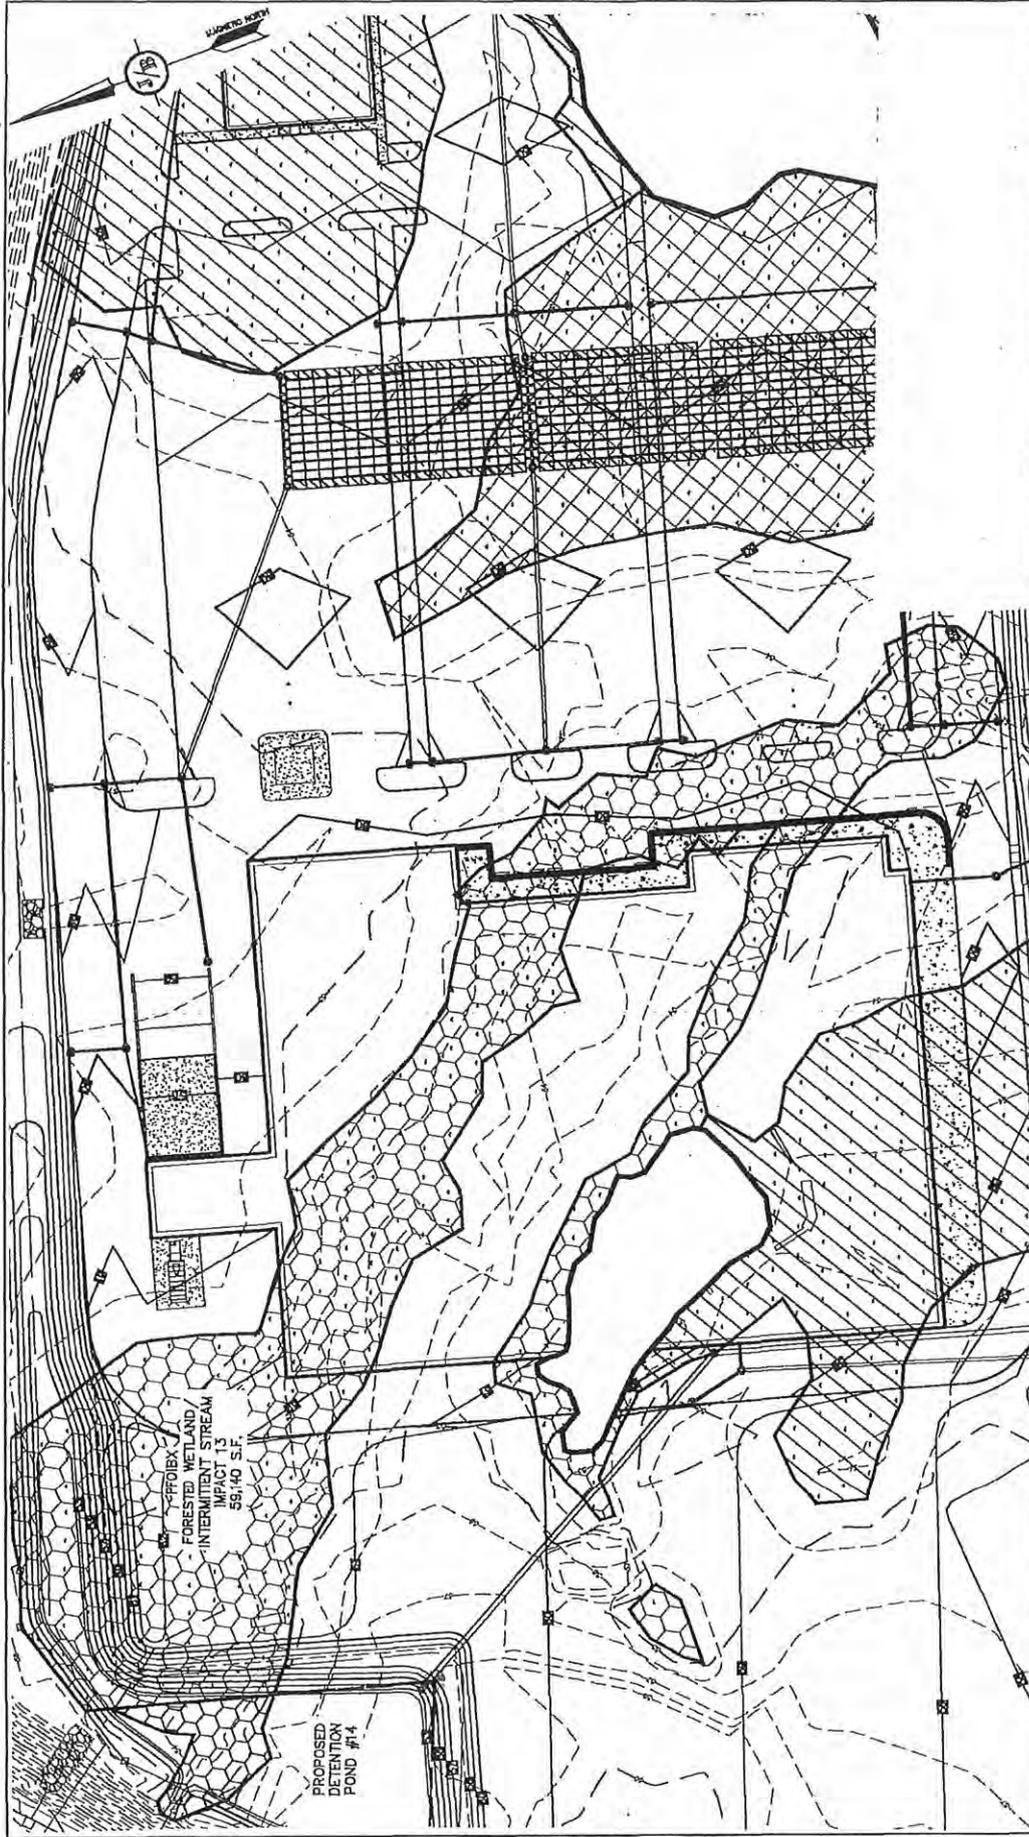
FORECLOSED WETLAND
INTERMITTENT STREAM
IMPACT 1,3
59,140 S.F.
