**Massachusetts Coastal
Zone Management**

Summary Report of
Independent Observations
Phase 1 - Boston Harbor
Navigation Improvement
Project

October 1997

Document Number 4479-001-150

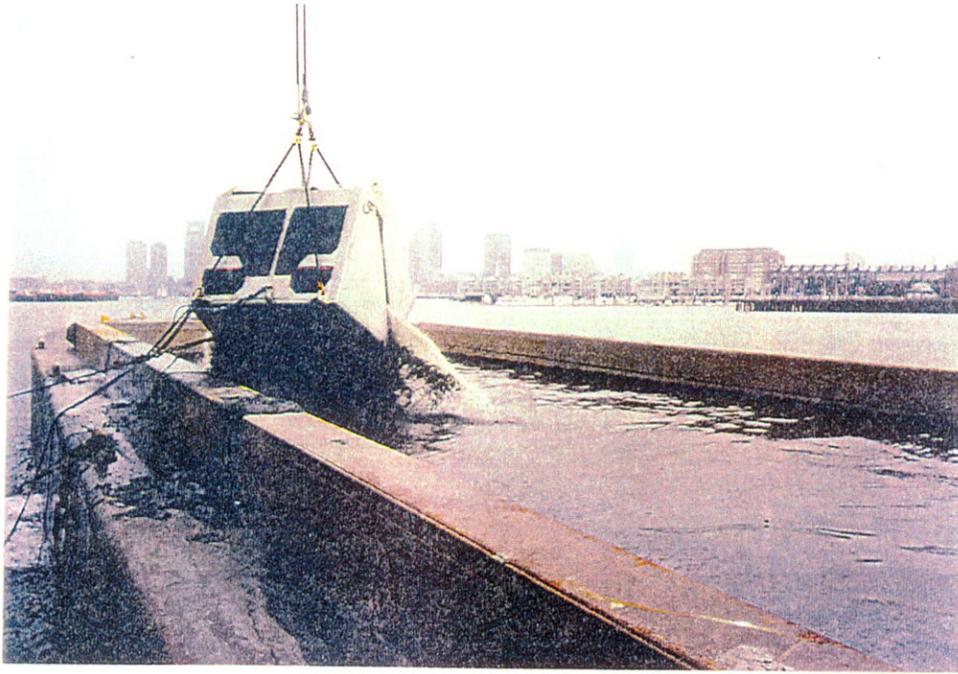
FIGURE 4
Dredging Surface Silts at the Inner Confluence Cell
with the Environmental Bucket

The dredging of contaminated silt materials was performed with the use of a Level Cut/ Environmental Clamshell Bucket manufactured by Cable Arm Inc. (Figure 4, Figure 14). The bucket is outfitted with overlapping jaws and rubber seals and is specifically designed to limit the loss of fine sediment material during bucket closure and while the bucket is drawn up through the water column and hoisted over the dump scow. When fully opened, the bucket yields a 22 by 14 foot footprint on the bottom. The bucket is lightweight and is designed to only remove soft surficial sediments from the bottom, i.e., it did not have the capability to dig into the dense underlying parent materials. The depth of each cut was limited to a 6 inch maximum to minimize the loss of materials during hoisting of the bucket out of the water.

The dredging of the surficial silts began in the evening on 16 June using the environmental bucket with sediments being stockpiled in a large dump scow tied adjacent to the dredge (Figure 4). Dredging of surficial silts over the entire cell footprint was completed within 24 hours (see Table 2-3). The loaded scow was tied up at Mystic Terminal, awaiting disposal after cell construction was completed. Dredging of the underlying parent material (clay) began late on 17 June using a

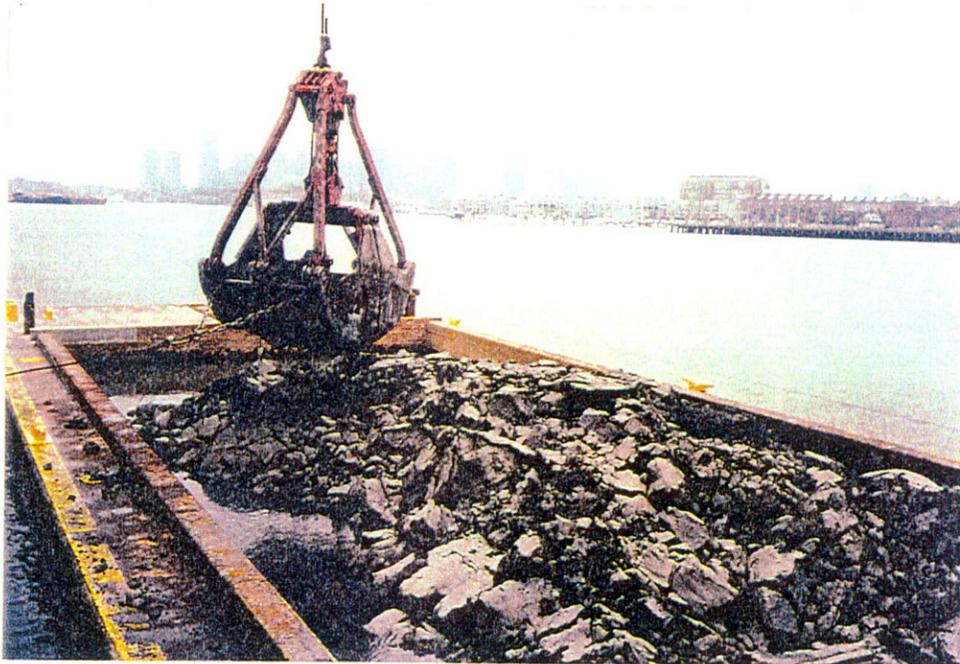
FIGURE 5
Dredging of Parent Material (Clay) at the Inner Confluence Cell
with the Open Toothed Bucket

standard open-toothed bucket (Figure 5). The dredged clay was loaded into a dump scow secured to the dredge. Once filled the dump scow was towed to the MBDS for disposal. The use of two dump scows allowed for 24 hour dredging operations.

Because of the open configuration of the toothed clamshell bucket used for dredging the parent material, suspended solids in the water column were visible for a greater distance from the dredging. *In-situ* turbidity measurements ranged from 3 to 7 NTU at the reference station (1000 feet upcurrent of the dredging), while 300 feet downcurrent of the dredging turbidity ranged from 8 to 56 NTU. TSS ranged from 8 to 60 mg/l at the reference station and from 19 to 48 mg/l at the downcurrent station. All values were well below the 200 mg/l performance standard set in the Water Quality Certification for a point 500 feet downcurrent of the dredging.

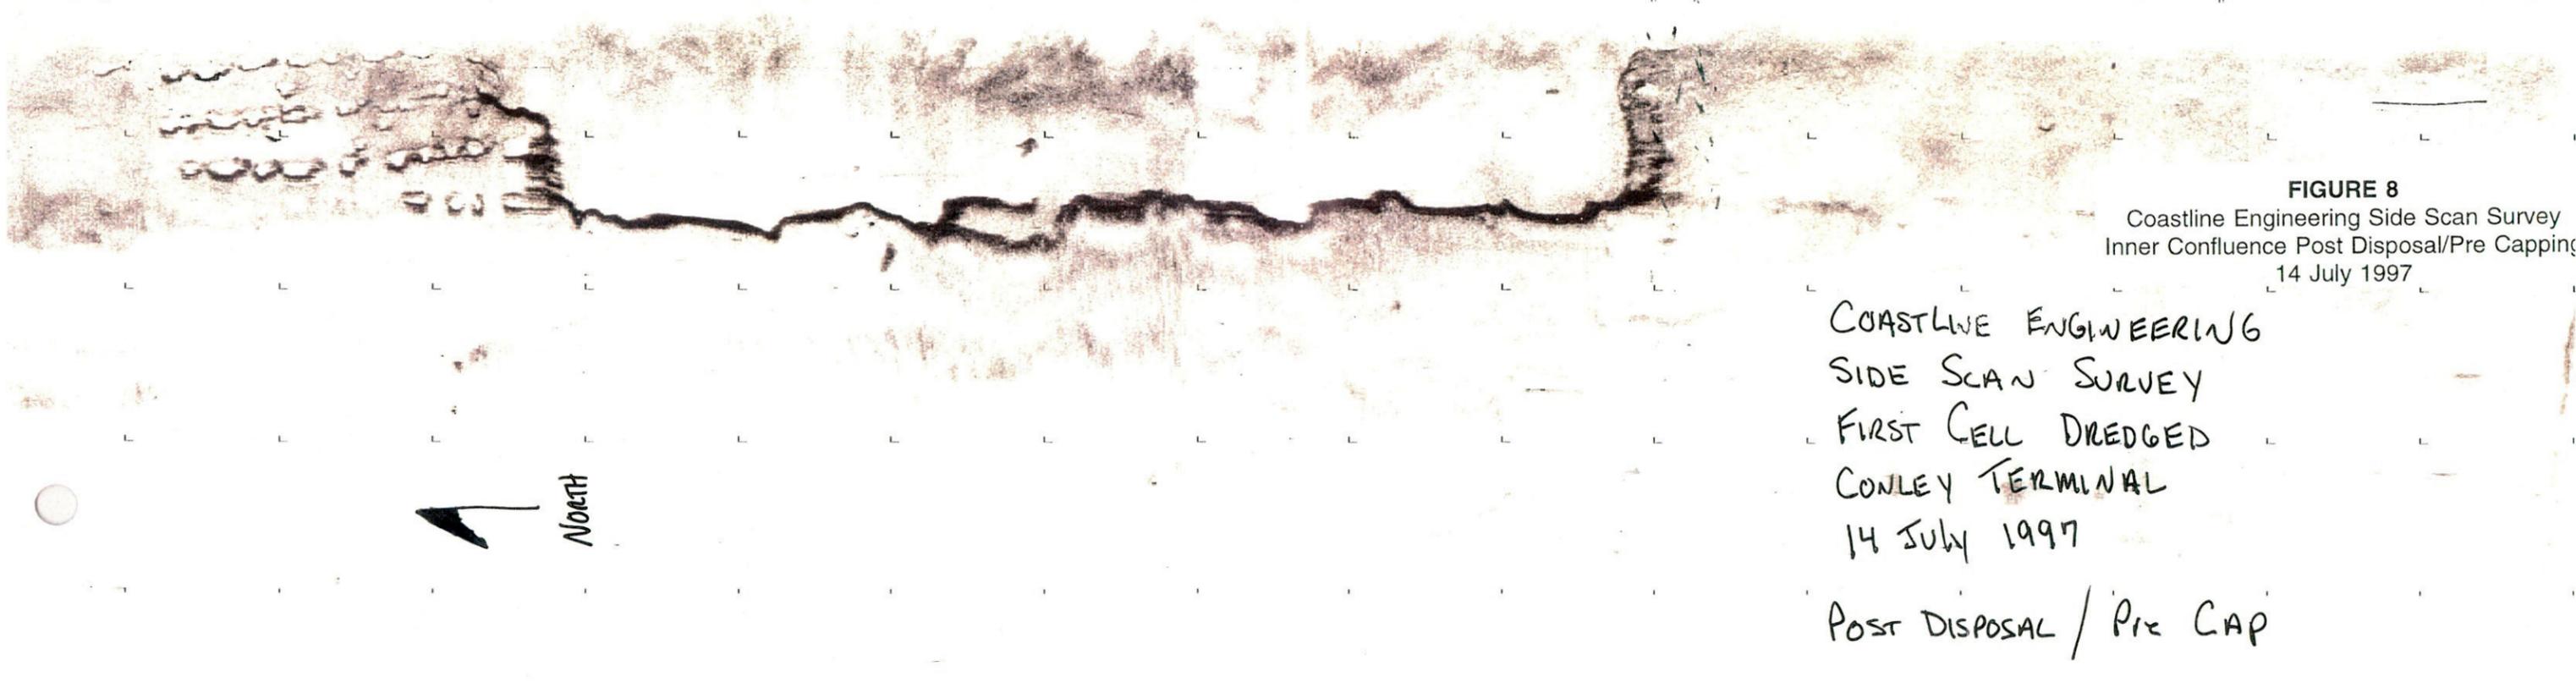
COASTLINE ENGINEERING
 SIDE SCAN SURVEY
 FIRST CELL DREDGED
 CONLEY TERMINAL
 14 JULY 1997

The disposal cell in the Inner Confluence remained open until the dredging was completed and certified at Conley Terminal. A bathymetric survey of the disposal cell and the collection of core samples prior to capping was completed by the USACE on 11 July 1997 (see Appendix C). A conceptualized cross section of the cell with disposed silt based on this bathymetry is presented in Figure 7. A side scan sonar survey of the cell was performed on 14 July (Figure 8).

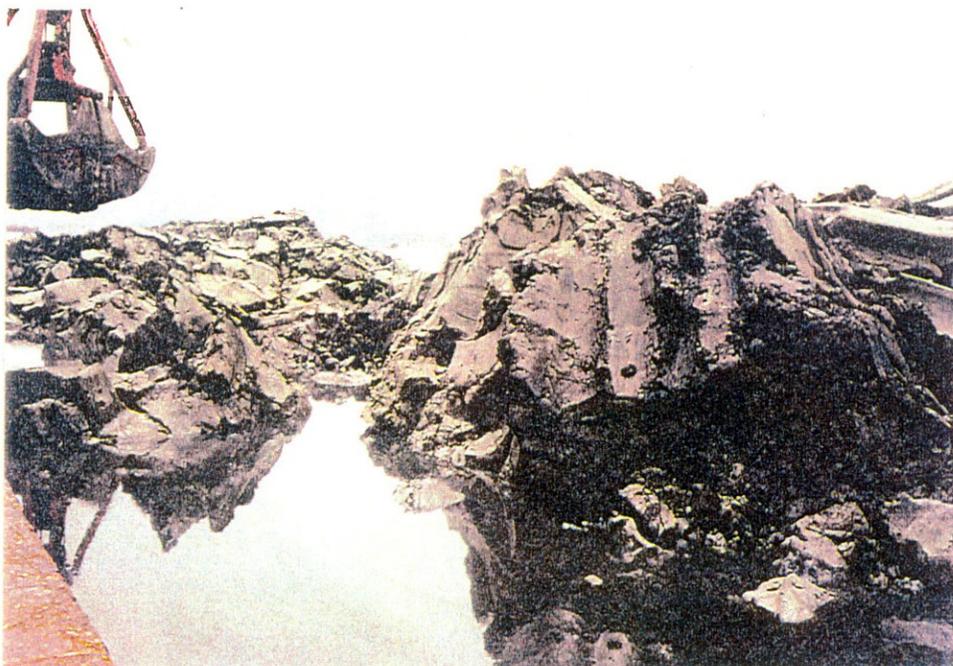
FIGURE 15
Parent Material (Clay) Removed from the Inner Confluence Cell
with Traces of Surface Silts

Increasing amounts of silty sediments were noted in the dredged clay on 19 June (see Section 5 for a discussion of this issue). As a result, Weeks Marine switched back to the environmental bucket, and dredged the cell footprint again. The additional silty sediments that were removed were stockpiled in the dump scow and in an additional storage barge. The dredging with the environmental bucket was completed early on 20 June, and the dump scow and storage barge were tied up at Mystic Terminal. Approximately 3,500 cubic yards of surface sediments were estimated to have been removed from the footprint of the disposal cell during the two rounds of dredging with the environmental bucket.

Residual Silt on Dredged Parent Material - As described in Section 2.1, construction of the disposal cell began with the removal of surface silts over the entire cell footprint with the environmental bucket. After the silts were removed, the contractor switched to an open clamshell bucket to deepen the cell by removing the parent material (clay). Dredging of the parent material began along the mid channel (western) side of the cell and progressed toward shore. As clay was discharged to the scow, traces of surface silts were noted in some of the lifts of clay (Figure 15). Initially, the surface silts were estimated at less than 1 % of the fully loaded scow. The percentage of surface silts in the clay increased as the dredge moved closer toward the shore. The dredging contractor attributed these silts to the following sources:
