Whittenton Branch Solid Waste Concern and Dana Street Station Memos

**FEIS/FEIR Technical Report
Whittenton Alternative**

Re: Whittenton Branch Solid Waste Concern,
Taunton and Raynham, Massachusetts

Re: MassDEP File Review for Proposed Dana
 Street Station in Taunton, Massachusetts

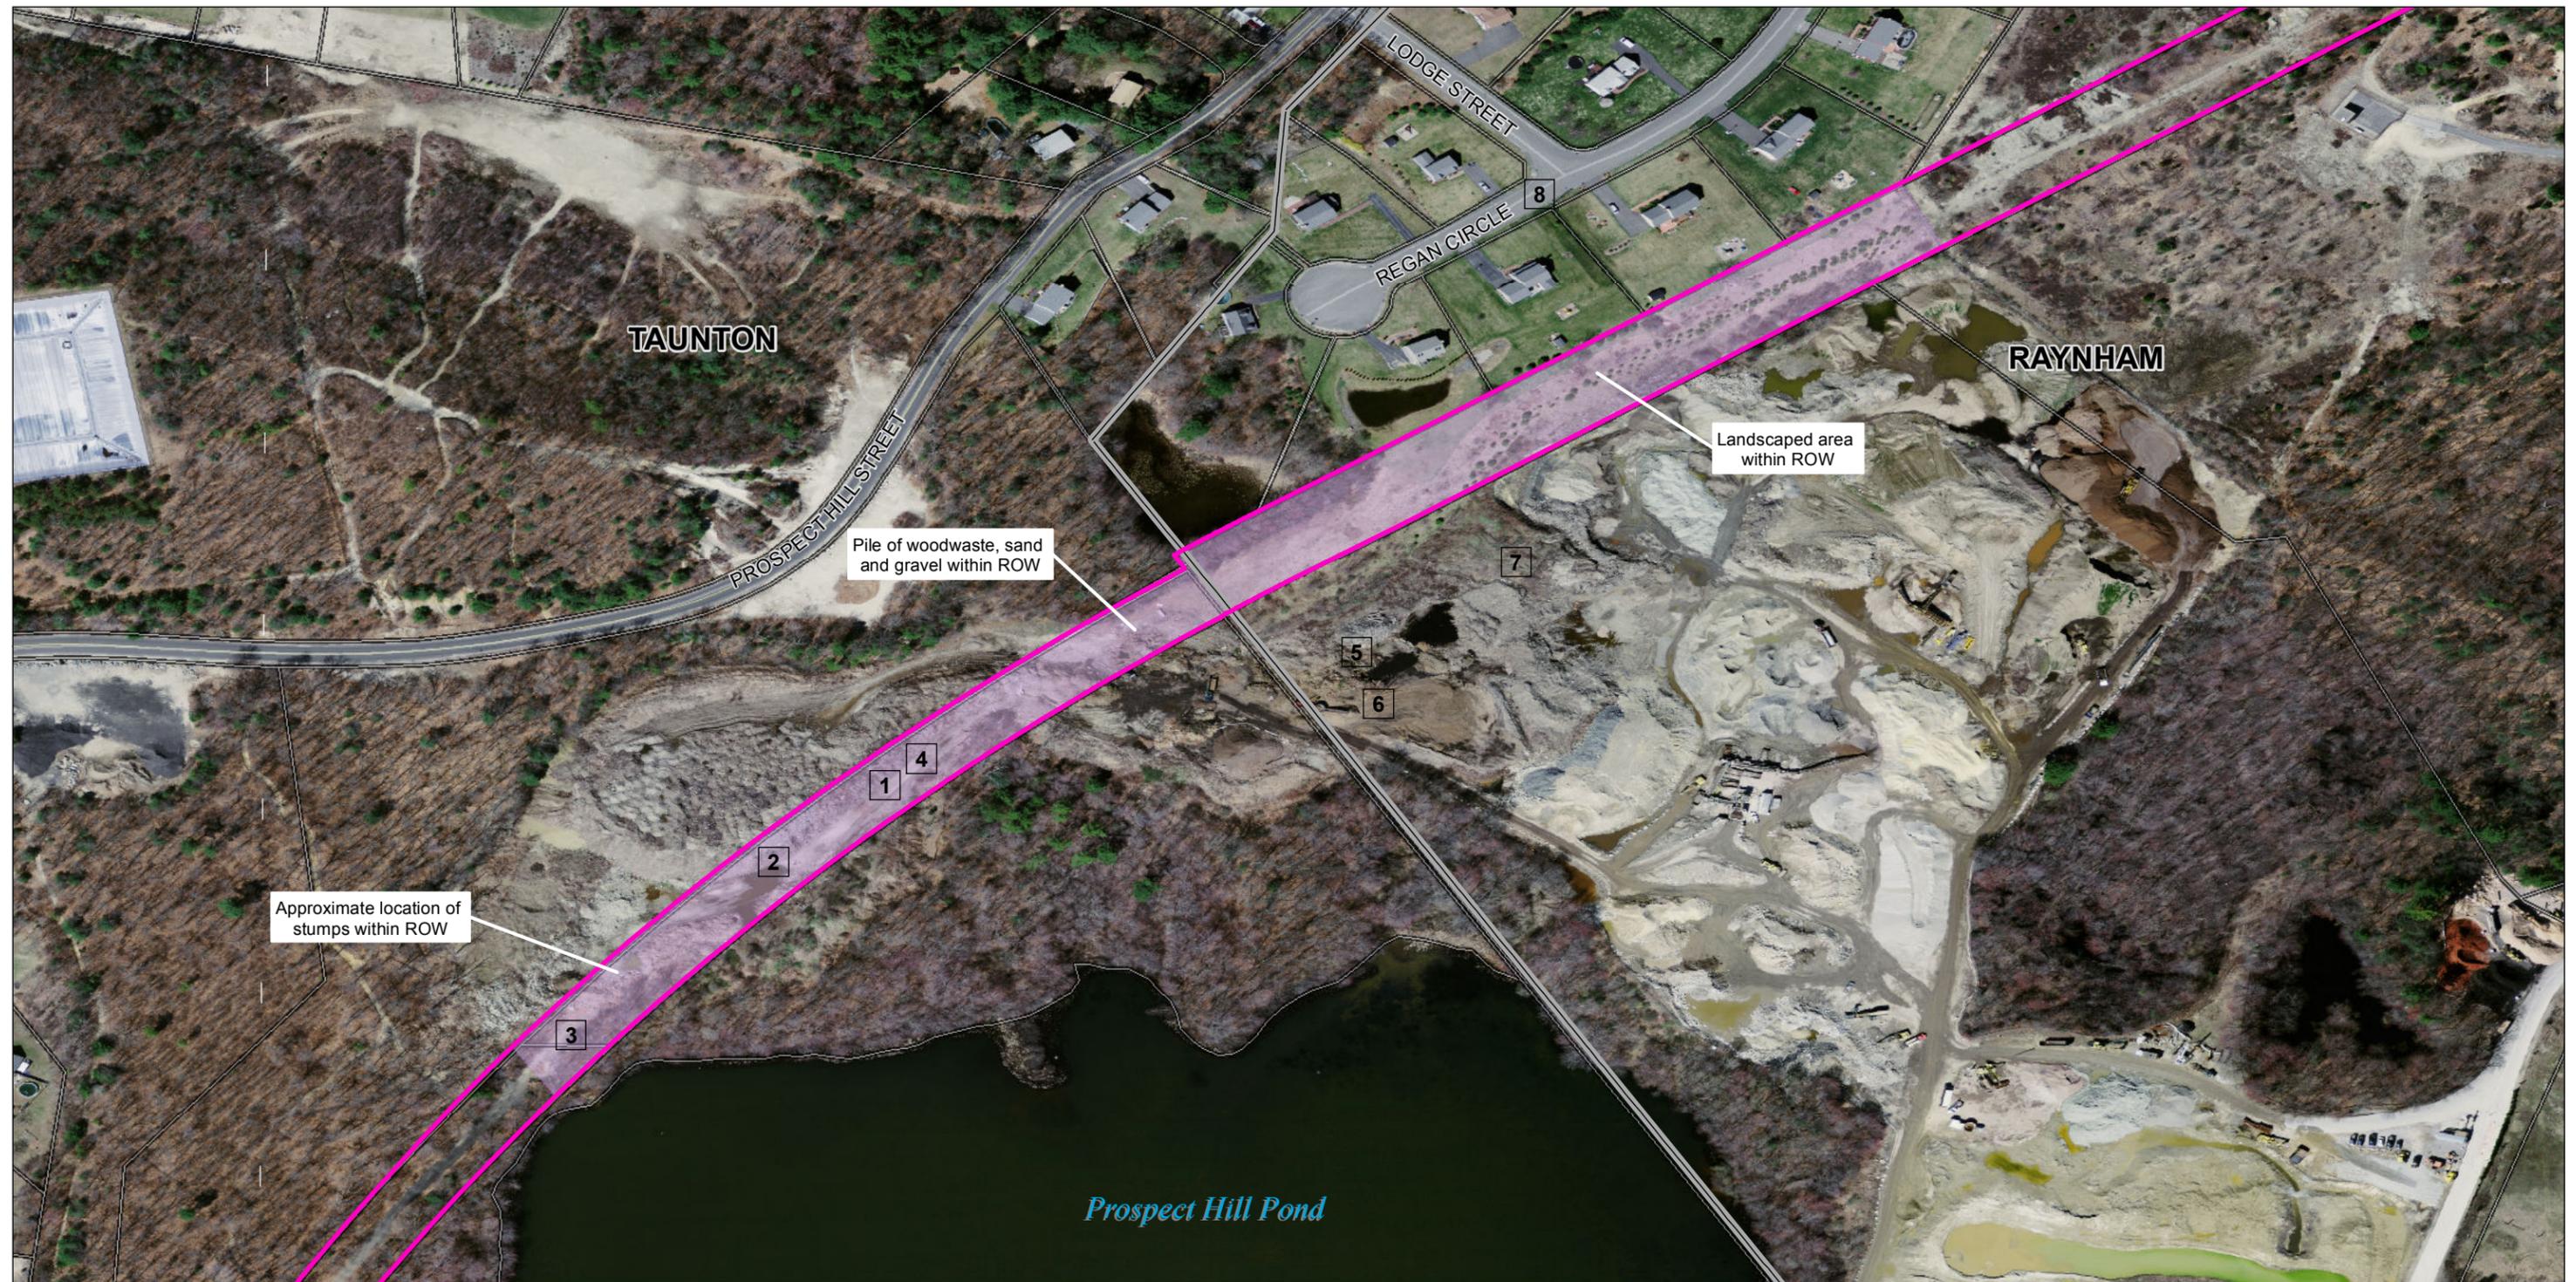
FIGURE 2
Site Plan
Railroad Right-of-Way
Raynham and Taunton, Massachusetts

On behalf of the Massachusetts Department of Transportation (MassDOT), VHB has conducted a limited review of the current use of a portion of the inactive Whittenton Branch railroad right-of-way (ROW) that lies between Prospect Hill Street, Regan Circle, and the property at 184 Broadway in Raynham, Massachusetts (the Site). This limited review was conducted to evaluate fill material reportedly present on the ROW, specifically for the presence of Oil and/or Hazardous Material (OHM) which could have the potential to impact the future development of the Site for the South Coast Rail Whittenton Alternative (the Project). New England Recycling, Inc. (NER), having a primary address at 565 Winthrop Street in Taunton, Massachusetts (Taunton Facility), stores their material at 138 (Rear) Broadway in Raynham, Massachusetts (Raynham Facility), partially within the Site boundary as an unauthorized use. It should be noted that NER is also affiliated with G. Lopes Construction Company of Taunton, Massachusetts. A Site location map showing the vicinity of the Site is provided as **Figure 1**. An aerial photograph depicting relevant Site features and adjacent areas is provided as **Figure 2**.

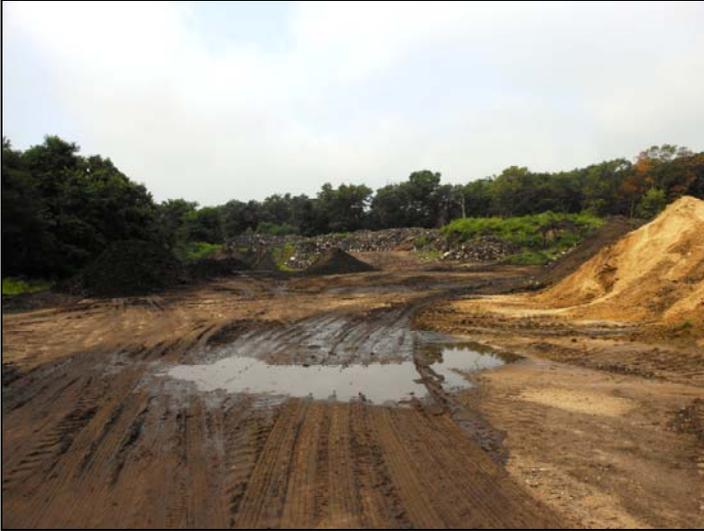
Photo #1: View of southwestern end of Site taken facing southwest. Railroad right-of-way (ROW) in center.

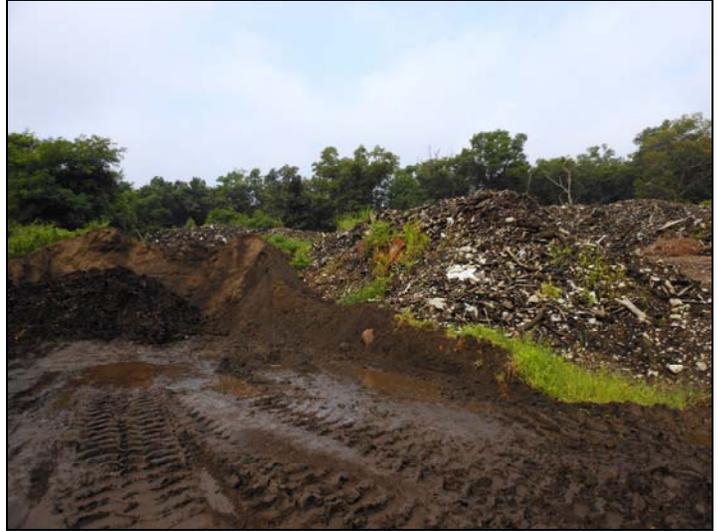
The western end of the ROW closest to Prospect Hill Pond was noted to abut a large pile of stumps and tree limbs that was encroaching upon the ROW. The pile was associated with the NER stump composting process whereby the stumps are initially stored until soft enough to be machine ground and then stored until composted for resale. In addition to the stumps, minor amounts of domestic waste and

Photo #2: View of southwestern end of Site taken southwest depicting piles of wood waste.

The ROW is currently occupied by what appears to be material containing stumps, compost, sand, gravel, boulders, and minor amounts of solid waste and debris. NER has indicated that this material is frequently relocated and new material brought into the Site and as such, could likely be relocated. Once the ROW has been restored and/or material has been permanently re-located, laboratory data could be obtained to assess for the presence of OHM.

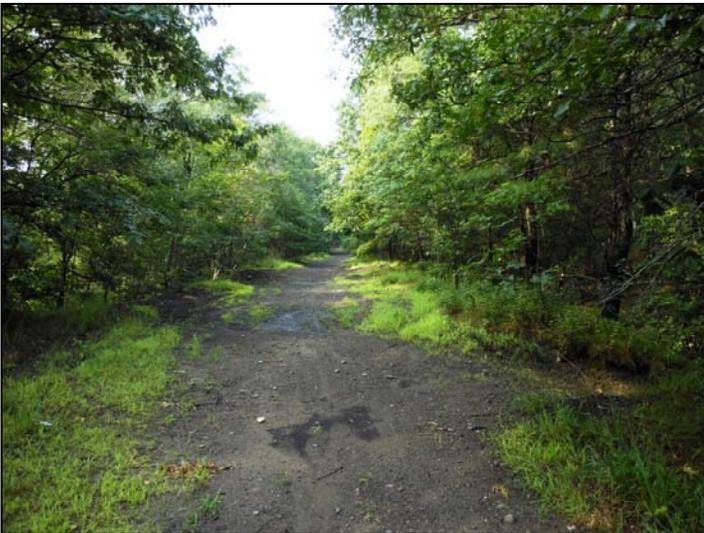
Photo #3: View of ROW at closest point to Prospect Hill Pond, taken facing southwest.

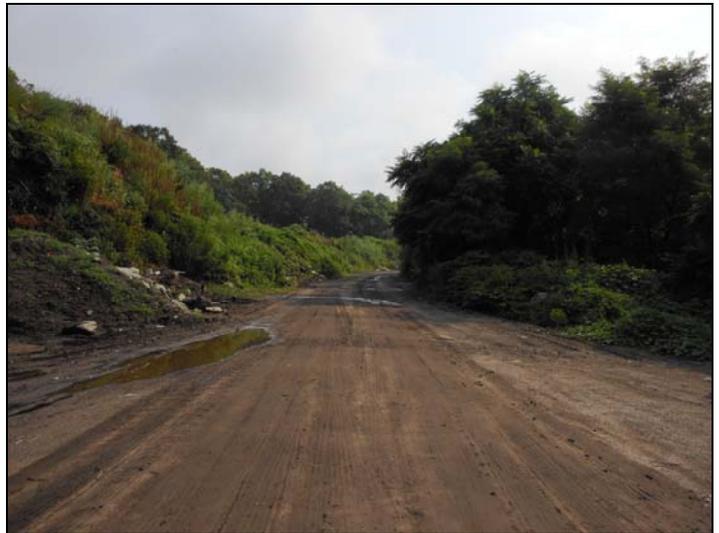
Photo #4: View of central portion of Site taken facing northeast.

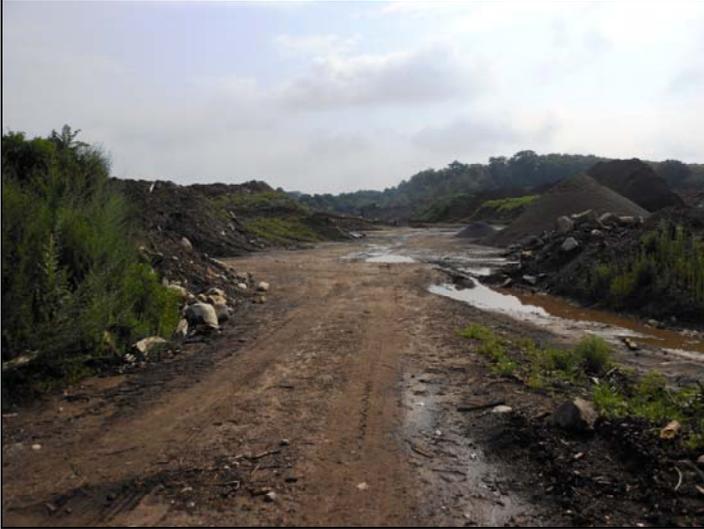
boulders were observed in the pile. A second large pile containing sand, gravel, stumps, and minor debris was noted on another portion of the ROW located within NER's area of operation. According to Mr. Crowley, the piles on the Site are constantly changing as NER imports and exports the materials and no testing is performed for material processed at the Raynham Facility. Mr. Crowley stated that the Raynham Facility does not currently process asphalt shingles and they do not accept painted concrete. In addition, he stated that any material that contains undesirable items such as railroad ties is segregated and shipped to another facility. VHB did not note any significant stressed vegetation, staining, or odors at the time of the Site visit.

Photo #5: Photo taken northeast showing abutting piles of sand and gravel. ROW at center of photo.

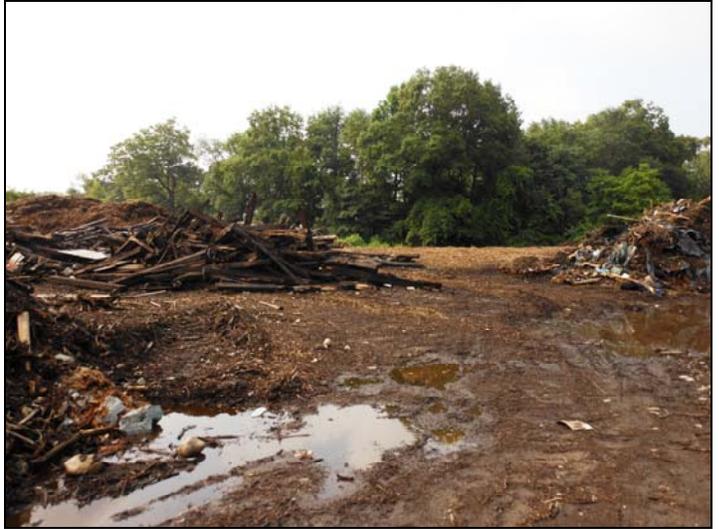
Photo #6: Example of undesirable debris segregated from material by NER for disposal at alternate facility.

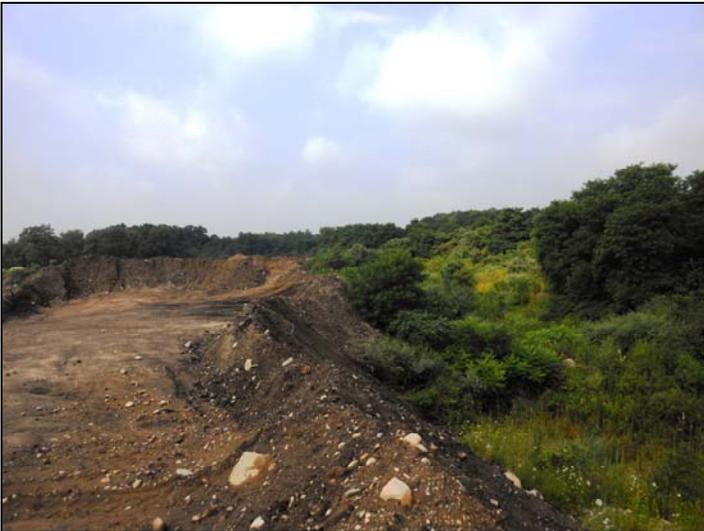
The remainder of the ROW in the vicinity of Regan Circle was observed to be densely vegetated. Landscaped trees and shrubs were noted in the ROW behind four properties on Regan Circle. Site photographs taken by VHB are attached to this memo.

Photo #7: View of ROW, taken facing northwest. ROW is located in vegetated area on right side of picture.

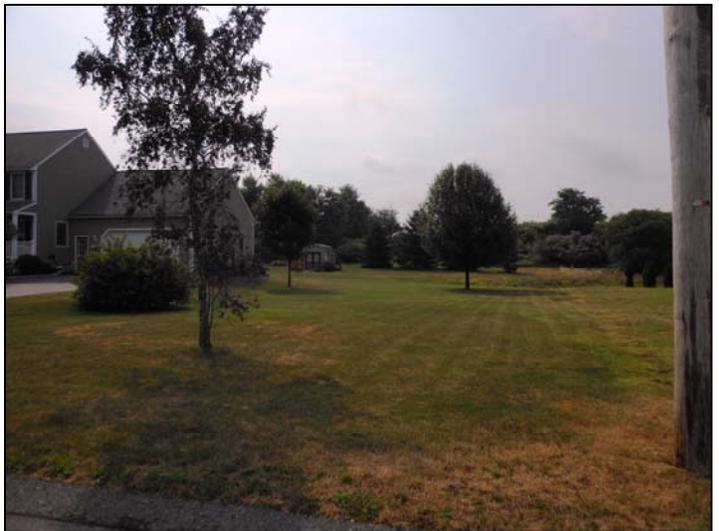
Photo #8: View of portion of ROW abutting residential development on Regan Circle. ROW is located behind landscaped trees behind shed.

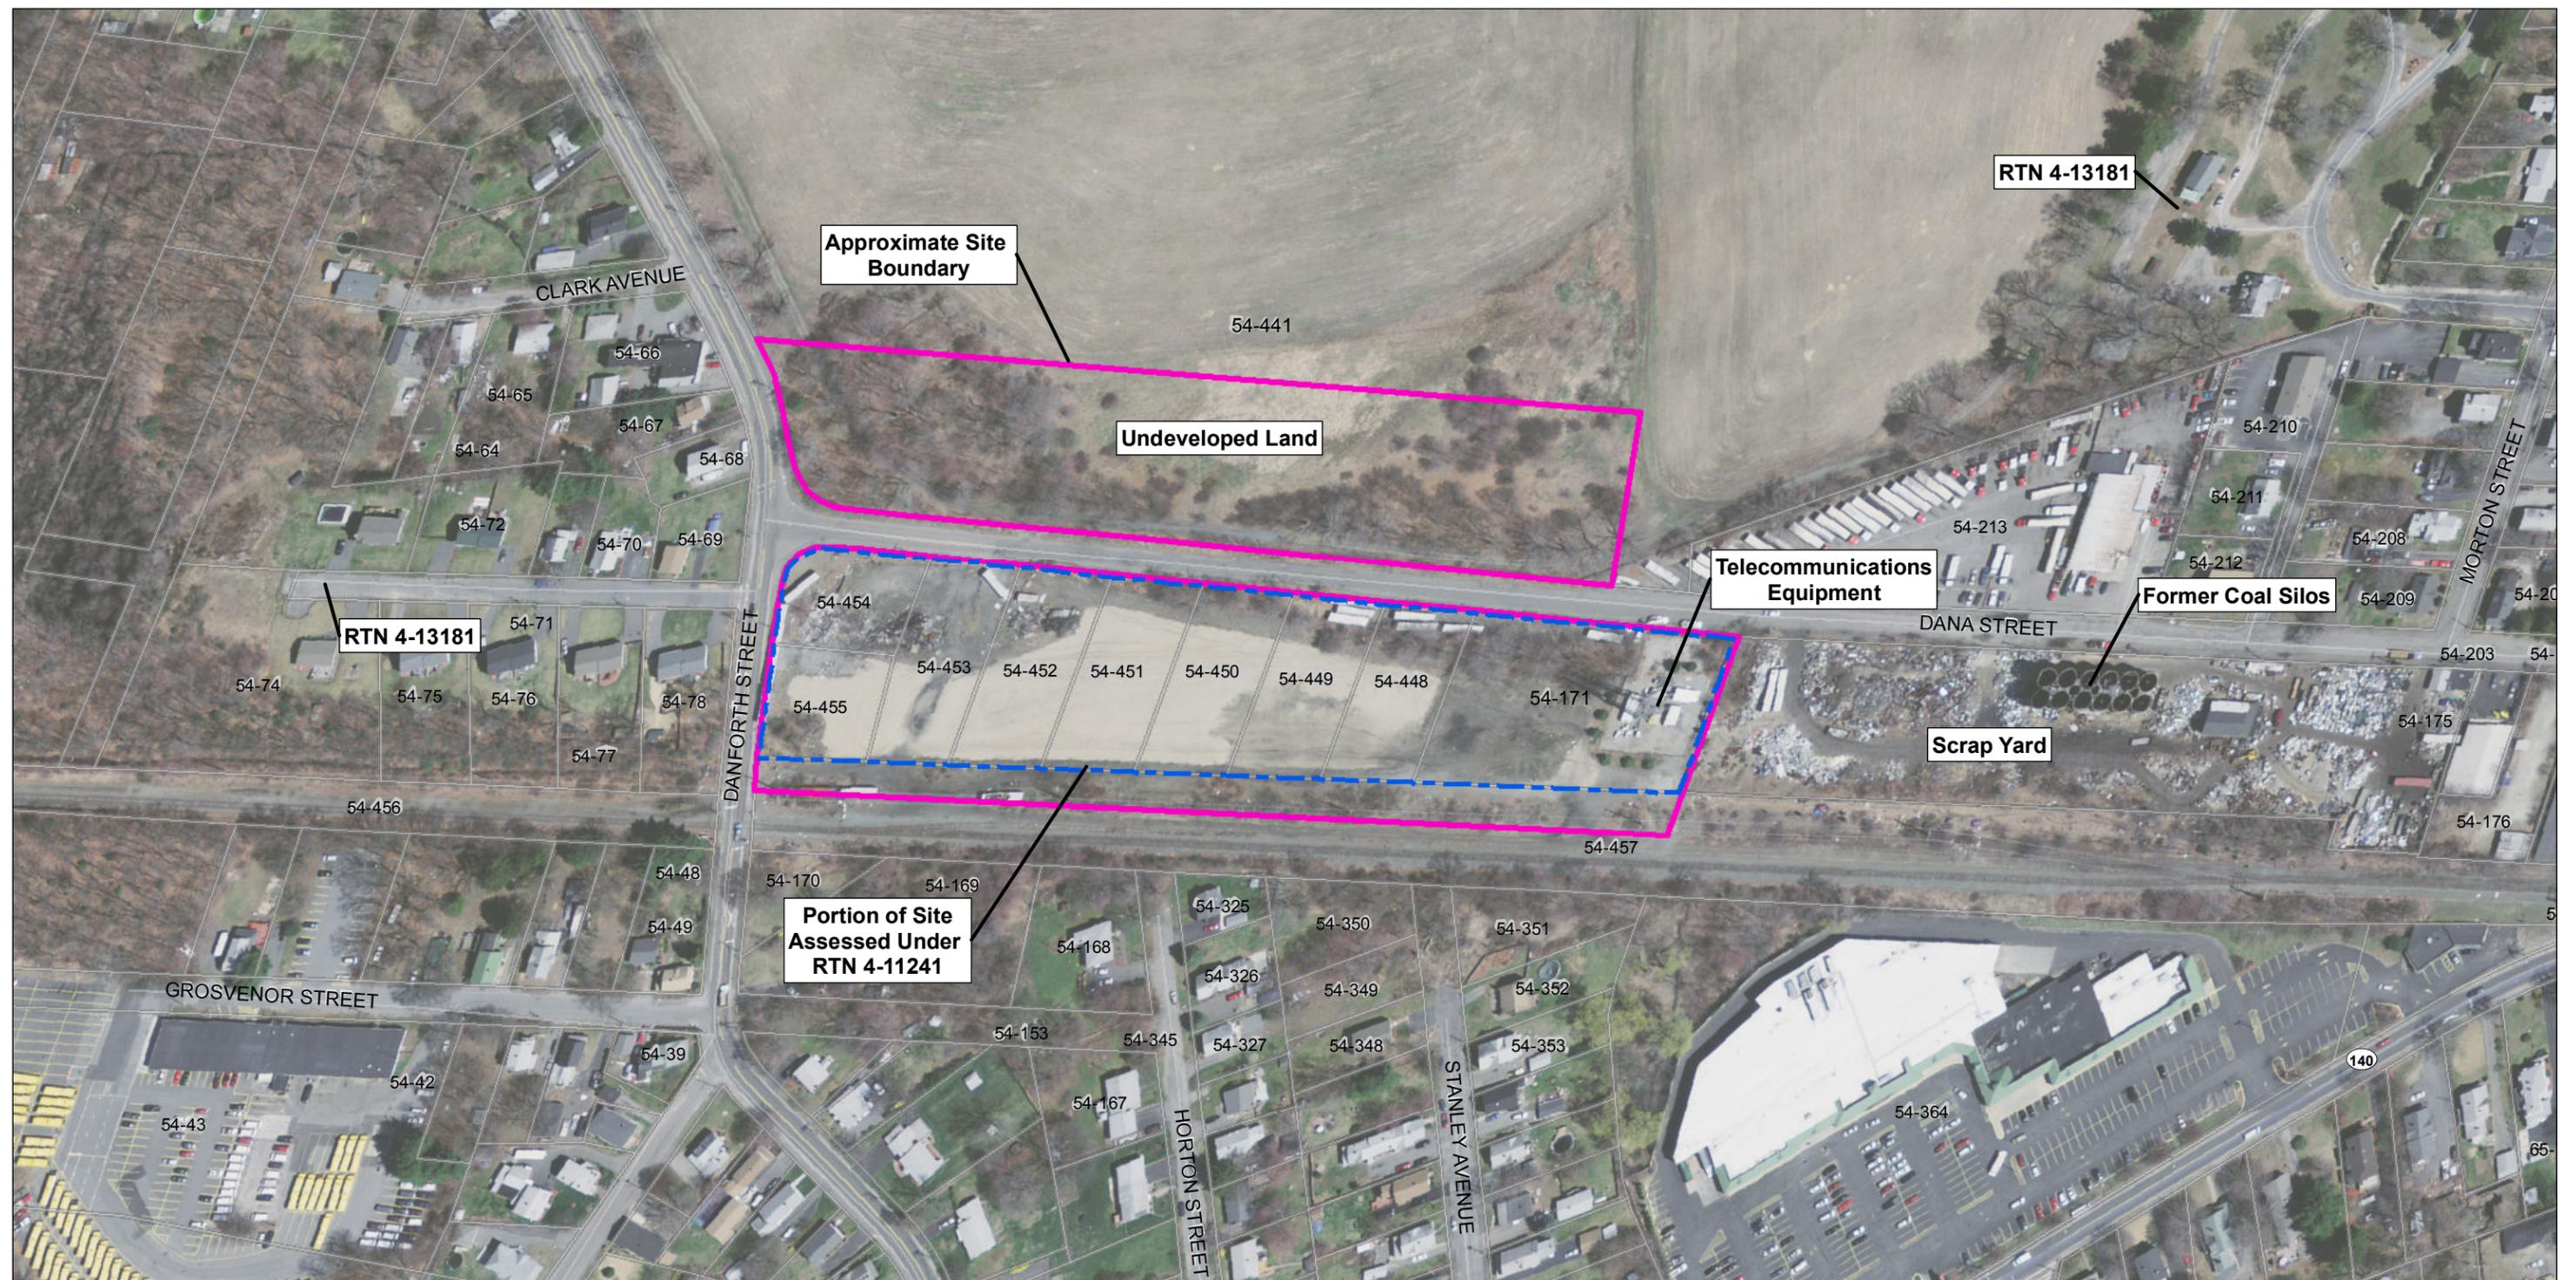
FIGURE 2
Site Plan
Dana Street Station
Taunton, Massachusetts

A release of fuel oil at 140 Dana Street from an underground storage tank (UST) was reported to MassDEP in March 1995 and assigned RTN 4-11241. Based on a review of available reports, the properties (and portion of the Site) assessed under RTN 4-11241 appears to encompass the City of Taunton Assessor's parcels Map 54, Lots 448 through 455 and Map 54, Lot 171 as displayed on **Figure 2**.

telecommunications facility, including equipment and a metal tower is located in a fenced enclosure on the southernmost portion of the Site (see Figure 2).
