**MONITORING SURVEY OVER  
BOSTON HARBOR CAD CELL M19**

**CONTRIBUTION #148**

October 2003

Report No.  
SAIC-605

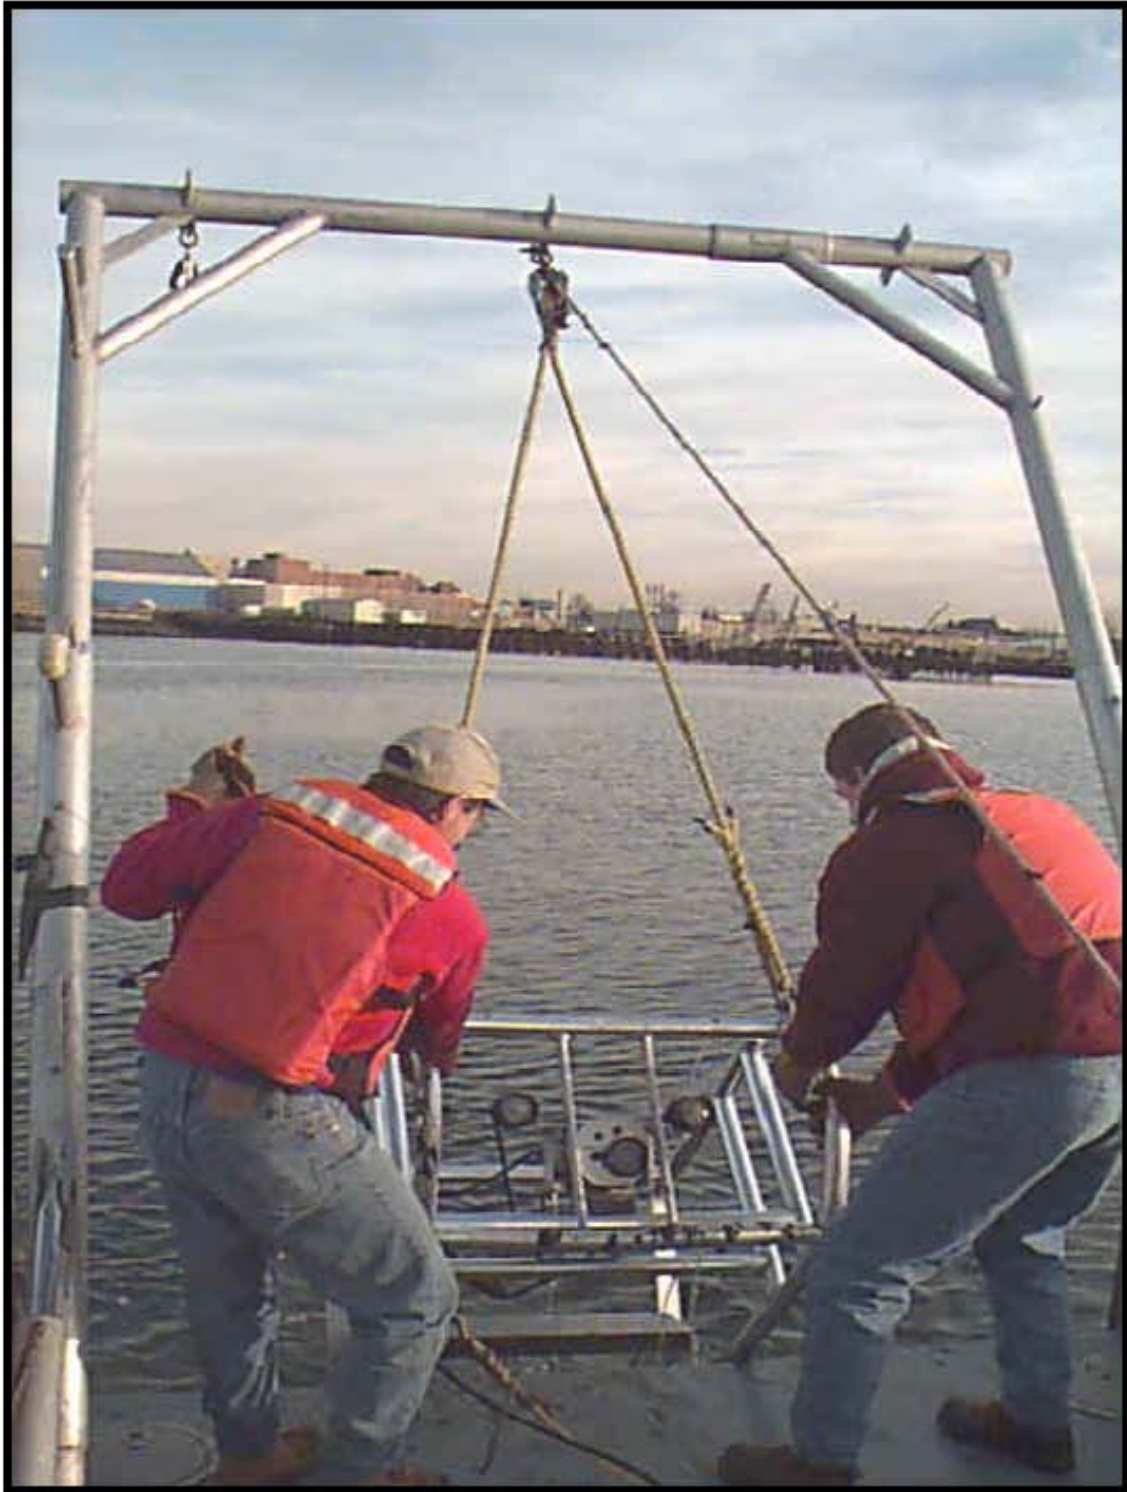
**Figure 2-4.** Photograph of the CR Environmental towed video sled upon deployment

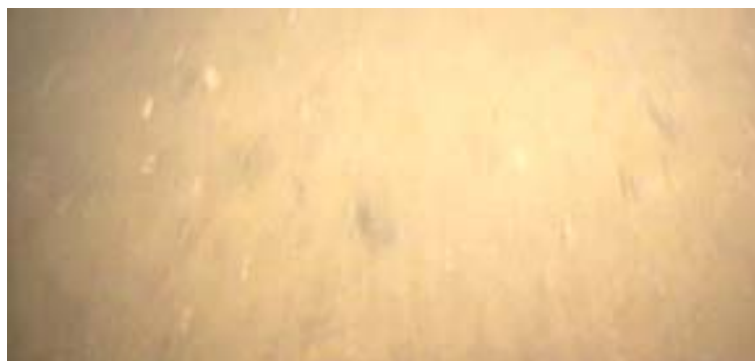
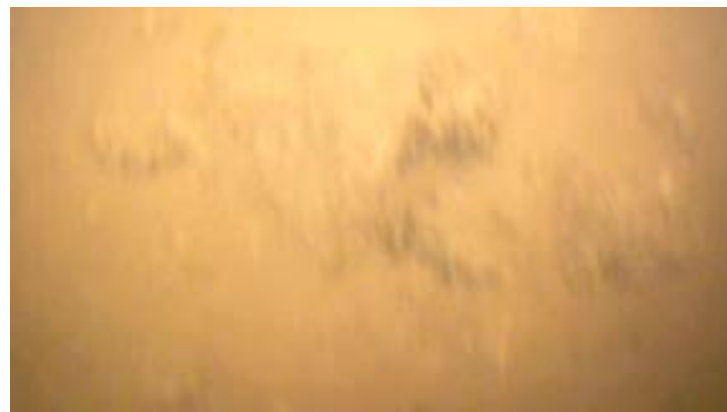
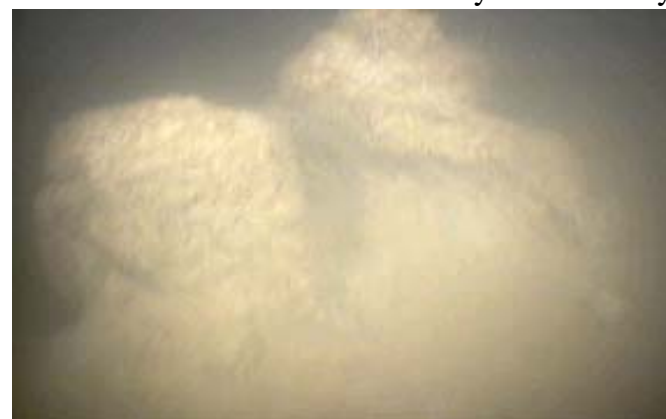
- 1) Oxidized Silty Clay—soft surface sediments with limited or no shell fragments apparent. Frequently this surface condition was viewed as a small cloud of sediment at the leading edge of the video camera (Figure 3-9A).

**A.** Soft bottom covered in oxidized silty clay

**B.** Oxidized silty clay with some shell fragments

**C.** Small nodules of BBC surrounded by oxidized silty clay

**D.** BBC nodules surrounded by oxidized silty clay

**Figure 3-9.** Example images obtained from the towed video footage showing the various non-cap sediment types encountered during the July 2002 survey

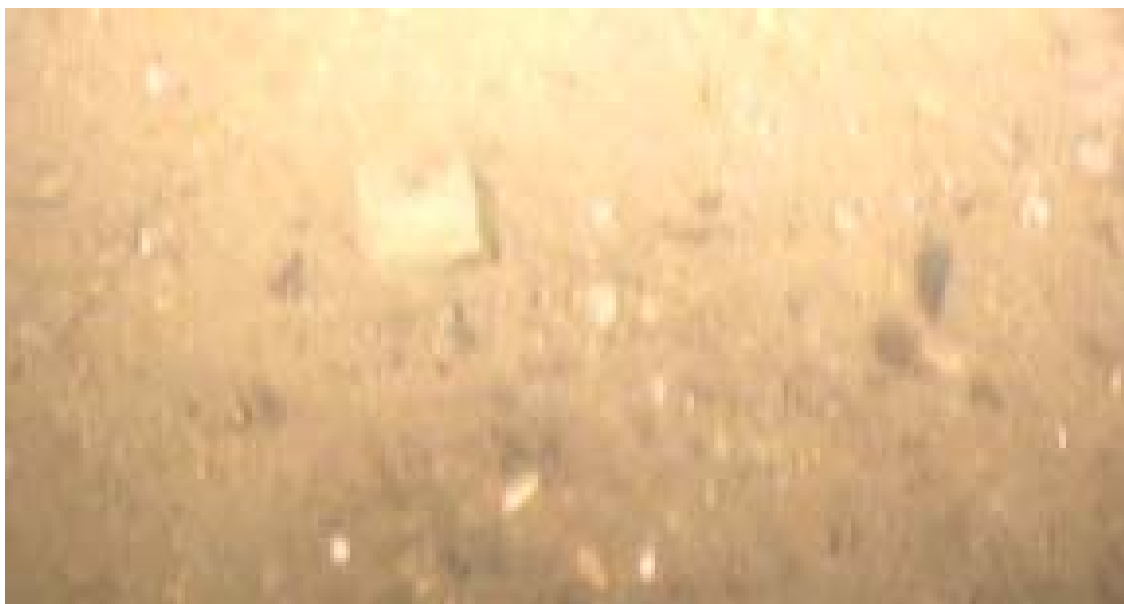
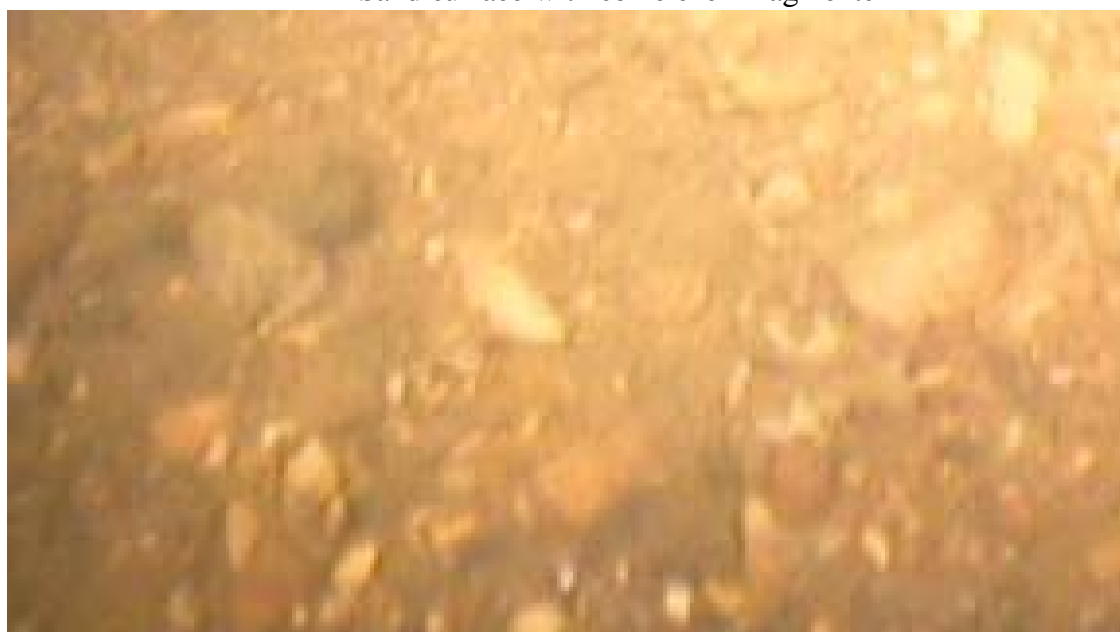
**A.** Sand surface with some shell fragments

**B.** Shell fragments

**Figure 3-10.** Example images obtained from the towed video footage showing the various sediment types defined as cap material encountered during the July 2002 survey

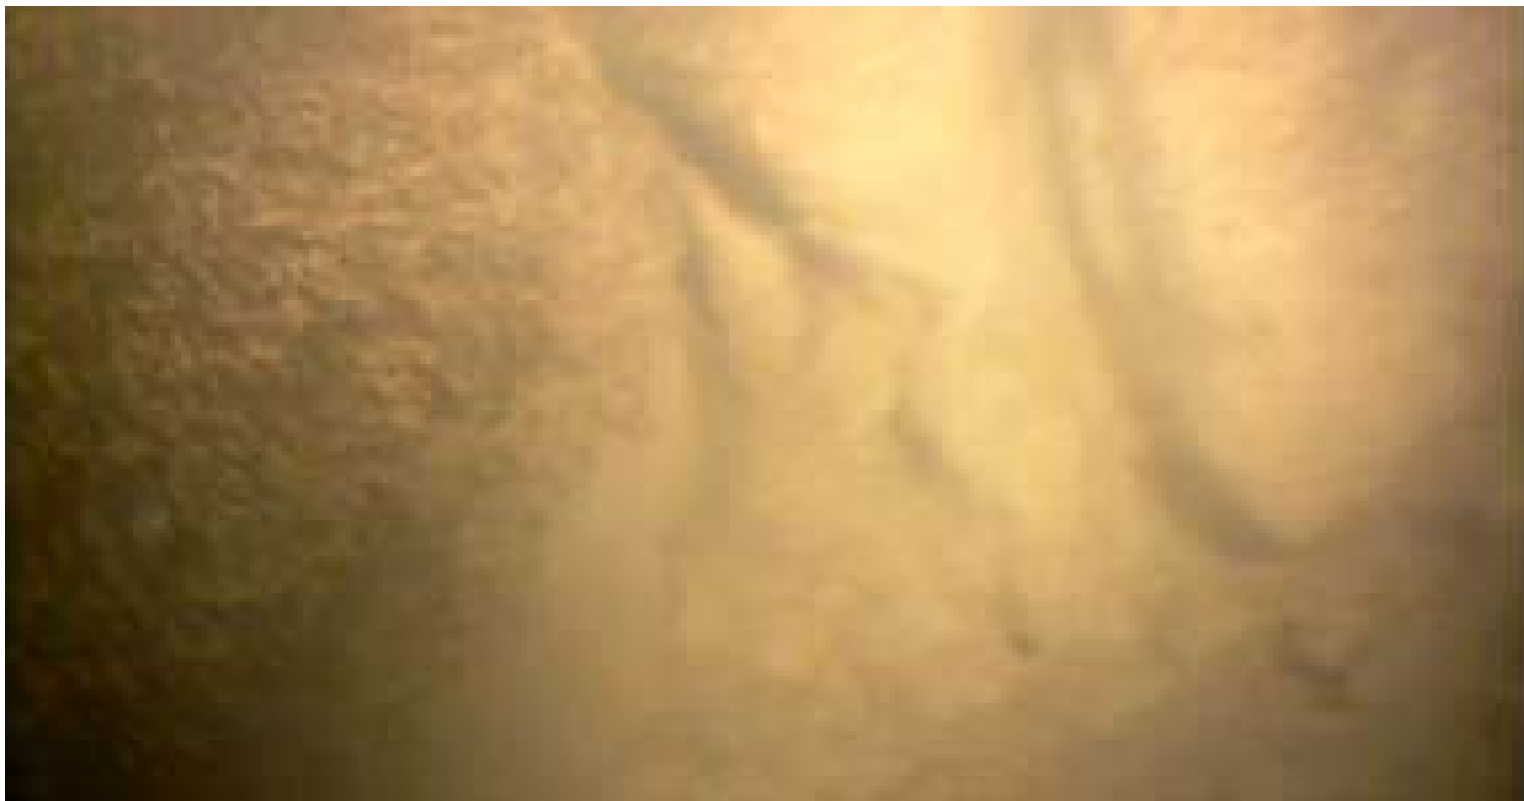
- 6) Boston Blue Clay (BBC)—the basement material of Boston Harbor as well as the sidewalls of the CAD cell. The additional dredging placed BBC in the southern portion of the CAD frequently resulted in pinnacles of BBC (Figure 3-11).

**Figure 3-11.** Pinnacle of BBC located at the margin of Cell M19. The surface of the cohesive clay clumps have been heavily colonized by tubicolous polychaete worms, which filter feed from the water column
