# Monitoring Survey at the Massachusetts Bay Rock Reef Site Summer 2002

# Disposal Area Monitoring System DAMOS

Contribution 151  
March 2004

Report No.  
SAIC-607

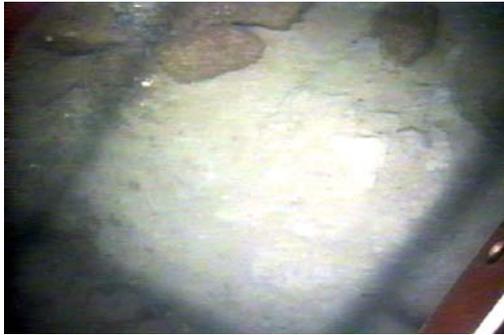
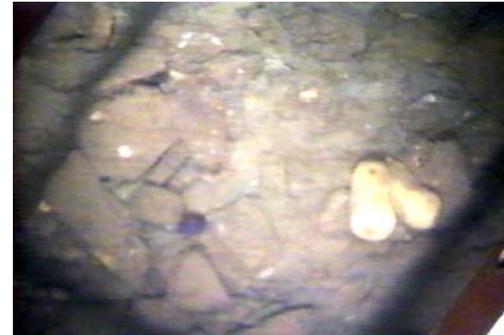
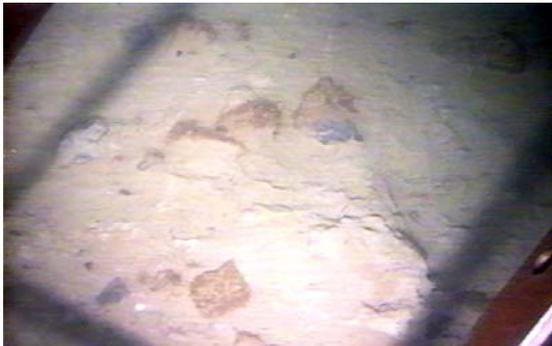
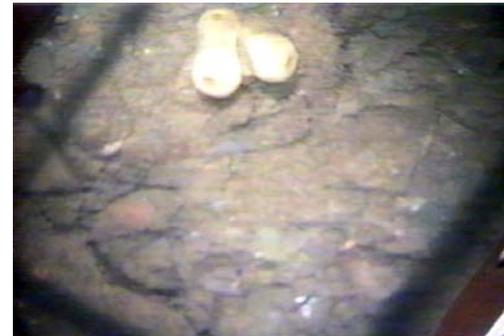
Area coverage of encrusting organisms ranged from 5 to 25 percent cover in the cobble areas dominated by the palmate sponge to 1 to 5 percent cover in the boulder areas. Generally, encrusting organisms accounted for less than 5 percent cover. Part of the reason why these small percentages of encrusting organisms were observed may be related to the moderate layer of soft sediment and flocculent material seen on many of the rock

**Figure 3-10.** Example images obtained from the drop video footage collected over MBRRS showing the various sediment types encountered during the 2002 monitoring survey. The images above depict the following: Sandy, coarse-grained sediment overlain to varying degrees by cobbles, boulders, and gravel (A); greater than 50 percent sediment interrupted by patches of gravel and cobbles (B); and hard substrate with cobble and boulders dominating (C and D).

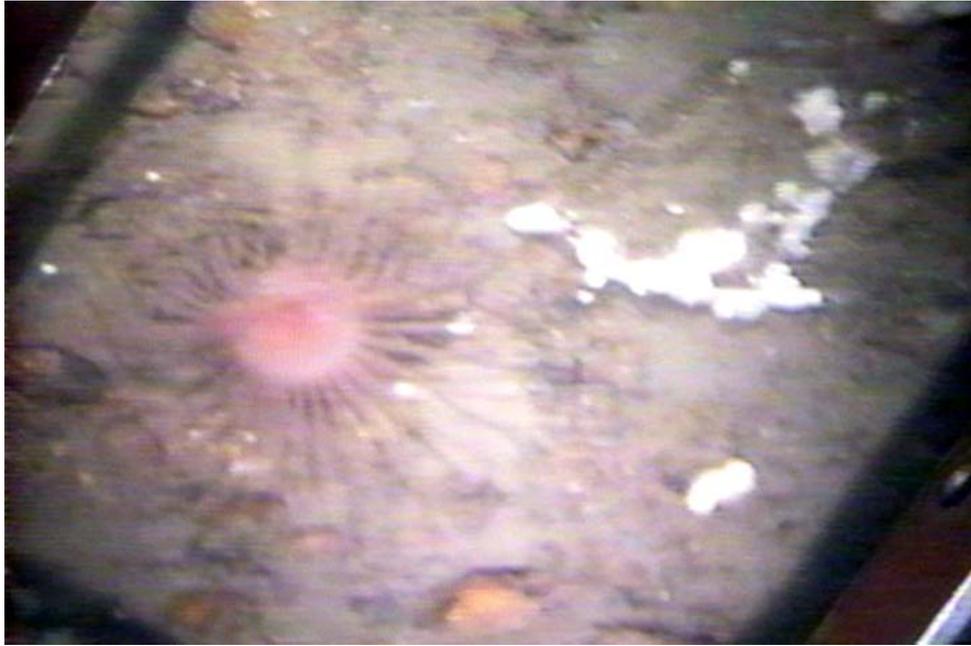
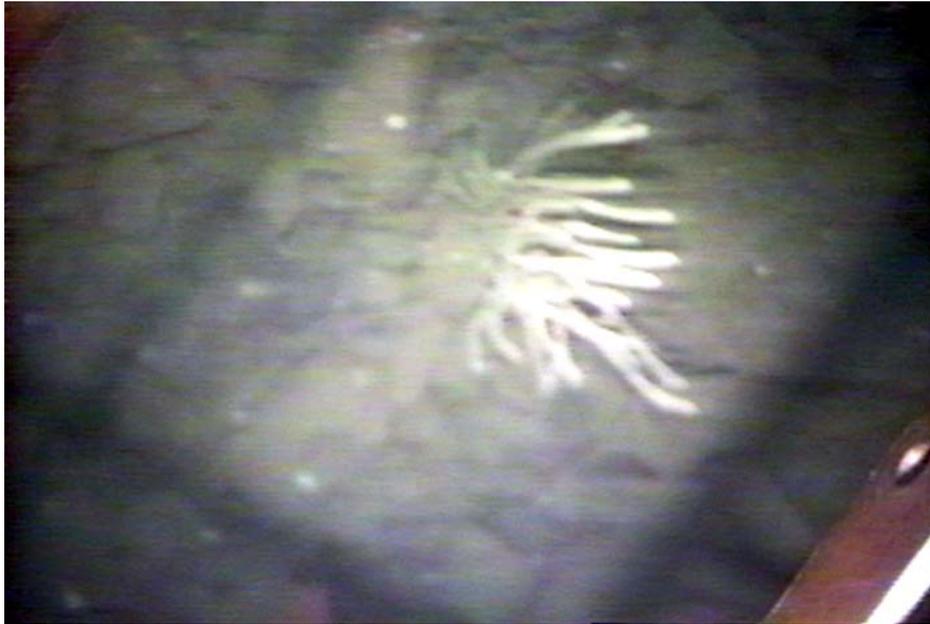
**Figure 3-11.** Example images obtained from the towed video footage showing a mud anemone (*Cerianthus borealis*; A) and a finger sponge (*Haliclona oculata*; B) detected on the seafloor within MBRRS

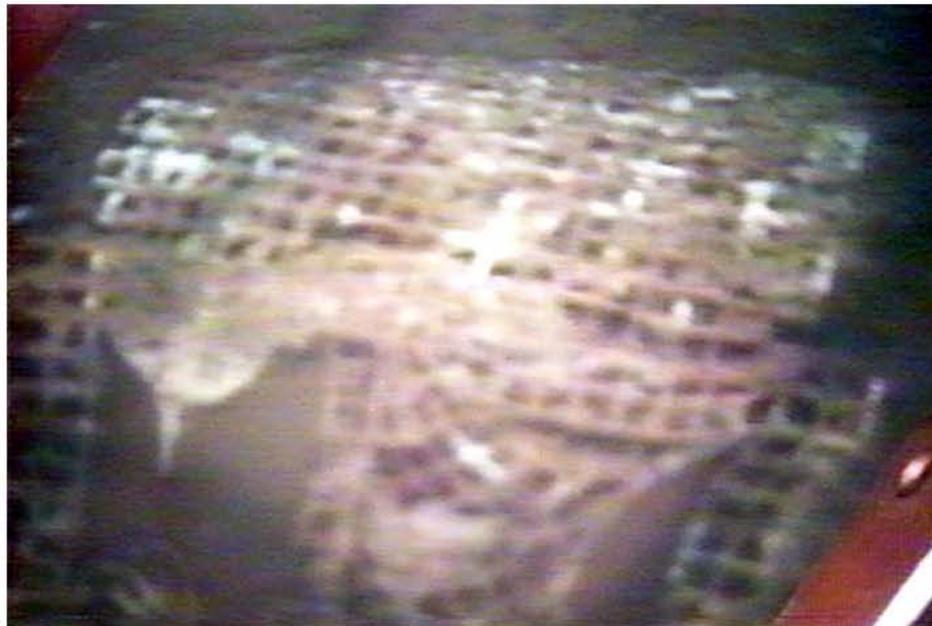
Several other species of invertebrates, *Corymorpha pendula* (a stalked solitary hydroid), *Neptunea decemcostat* (the ten-ridged whelk), and *Homarus americanus* (the northern lobster) were only seen once during the survey (Table 3-1). Although abundance of lobster was low based on the drop video data, several sets of lobster fishing gear were documented on site (Figure 3-5). The video imagery revealed the presence of both actively fished and abandoned lobster gear, suggesting this area may have developed into a relatively productive lobster fishing area over the past ten years (Figure 3-12).

**Figure 3-12.** Example images obtained from the towed video footage showing actively fished (A) and abandoned (B) lobster traps within MBRRS

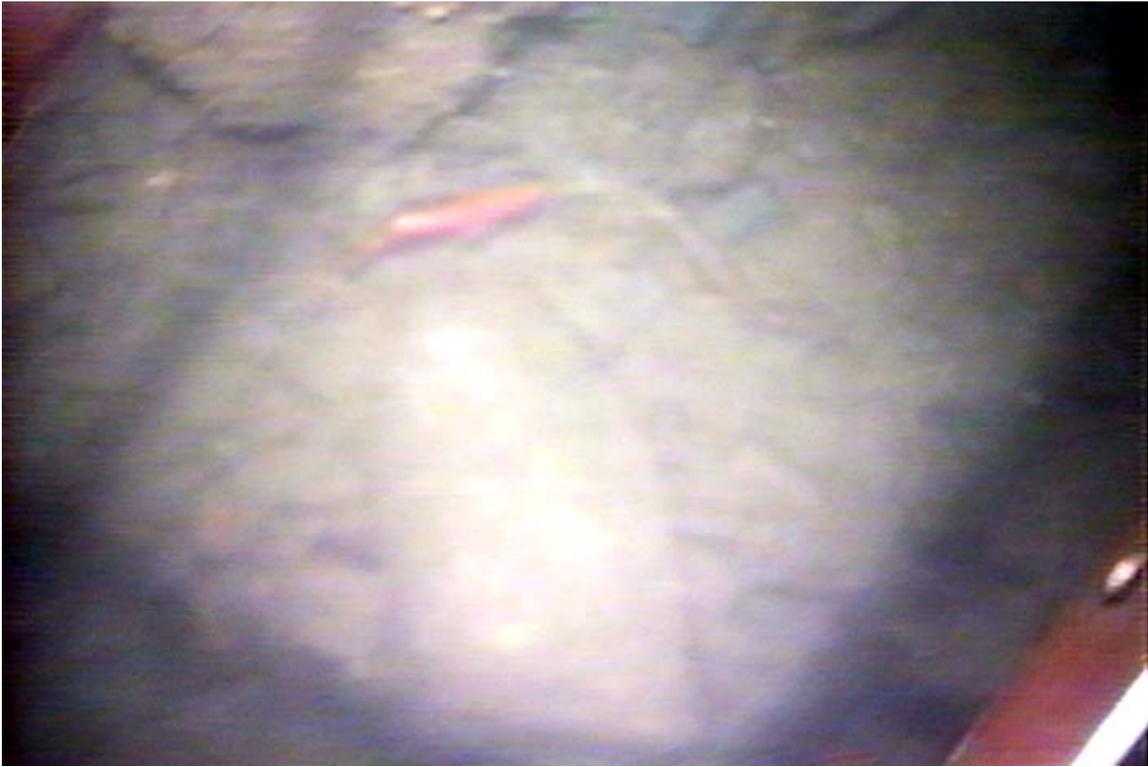
The most common finfish observed was the cunner, *Tautoglabrus adspersus*, which was only seen in the vicinity of boulders (Figure 3-13). The second most common fish seen were sculpin (*Myoxocephalus* spp.), which were usually seen in areas of sediment and cobbles. Other fish seen included several flounder, several ocean pout (*Macrozoarces americanus*), two cod (*Gadus morhua*), two hake, a skate, one possible sea raven (*Hemitripteris americanus*), and eight other unidentified fish.

**Figure 3-13.** Example image obtained from the towed video footage showing small cunner (*Tautogolabrus adspersus*) in the upper left quadrant of the image inhabiting the rock reef structure
