# Monitoring Survey at the Boston Harbor CAD Cells August 2004

# Disposal Area Monitoring System DAMOS

Contribution 168  
January 2007

Report No.  
ENSR-9000-361-330

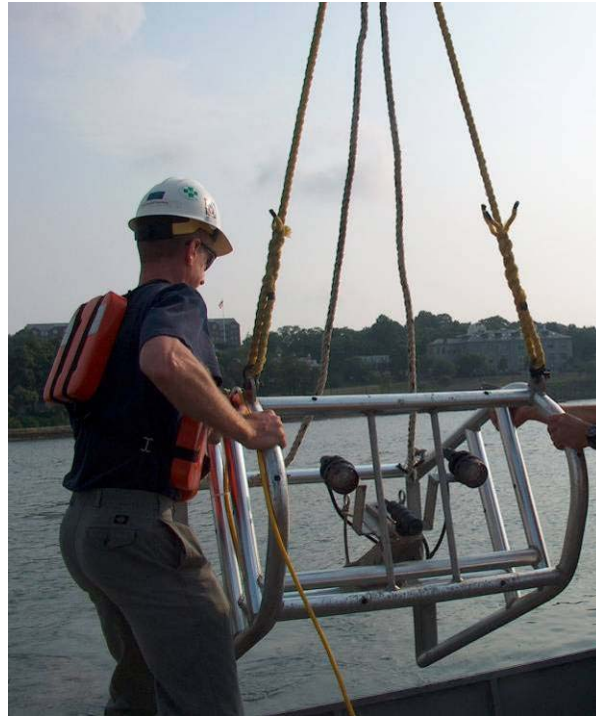
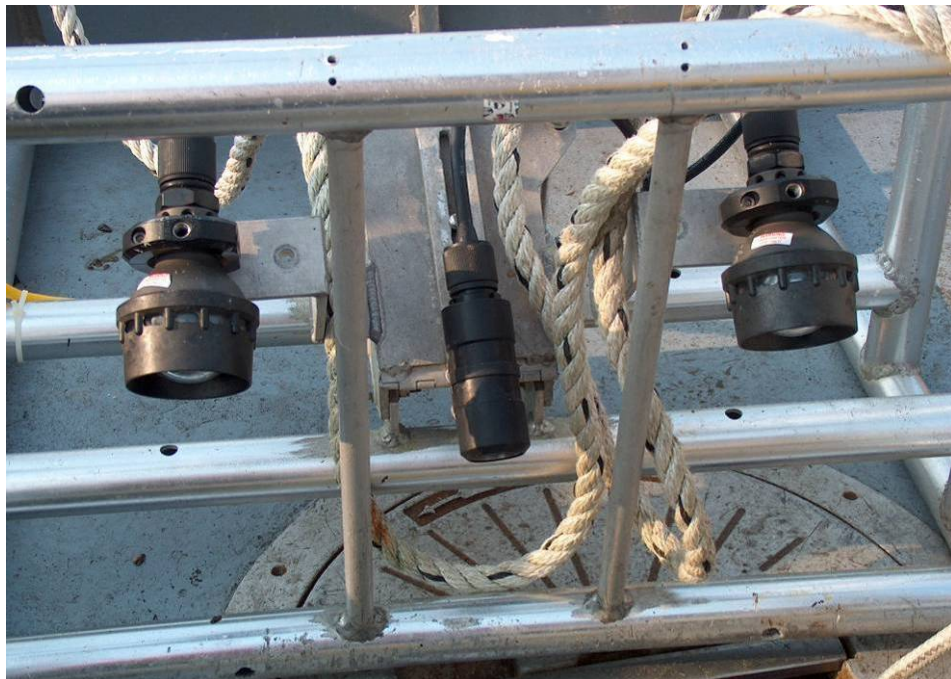
**Figure 2-4.** Towed video sled and camera setup

The 2004 video sled survey focused on Mystic River cell M19, with additional coverage of cells Supercell, M8-11, M12, M4, and IC2 (Figure 2-3). The survey was performed on 12 August 2004 aboard the R/V *Cyprinodon*. Video imagery was recorded using a Deep Sea Power and Light Multi-Sea Cam (Figure 2-4). This high resolution color video camera was mounted to a lightweight aluminum frame equipped with two 250 watt underwater flood lights. The frame was lowered to the bottom and slowly dragged along the full length of the survey transect. Real-time imagery from the frame was displayed topside on a color computer monitor while simultaneously being recorded. The viewing area of the sled in the towed configuration is approximately one square meter. Vessel position during the survey was recorded using the HYPACK® software.

Position data were imported into GIS-based software for plotting of track lines (Figure 2-4). The underwater video footage was reviewed and representative sequences illustrating some of the most interesting features were selected for creation of short clips or screen captures. In addition, the complete clips were reviewed and annotated, with references to sediment characteristics, observed fauna and debris.

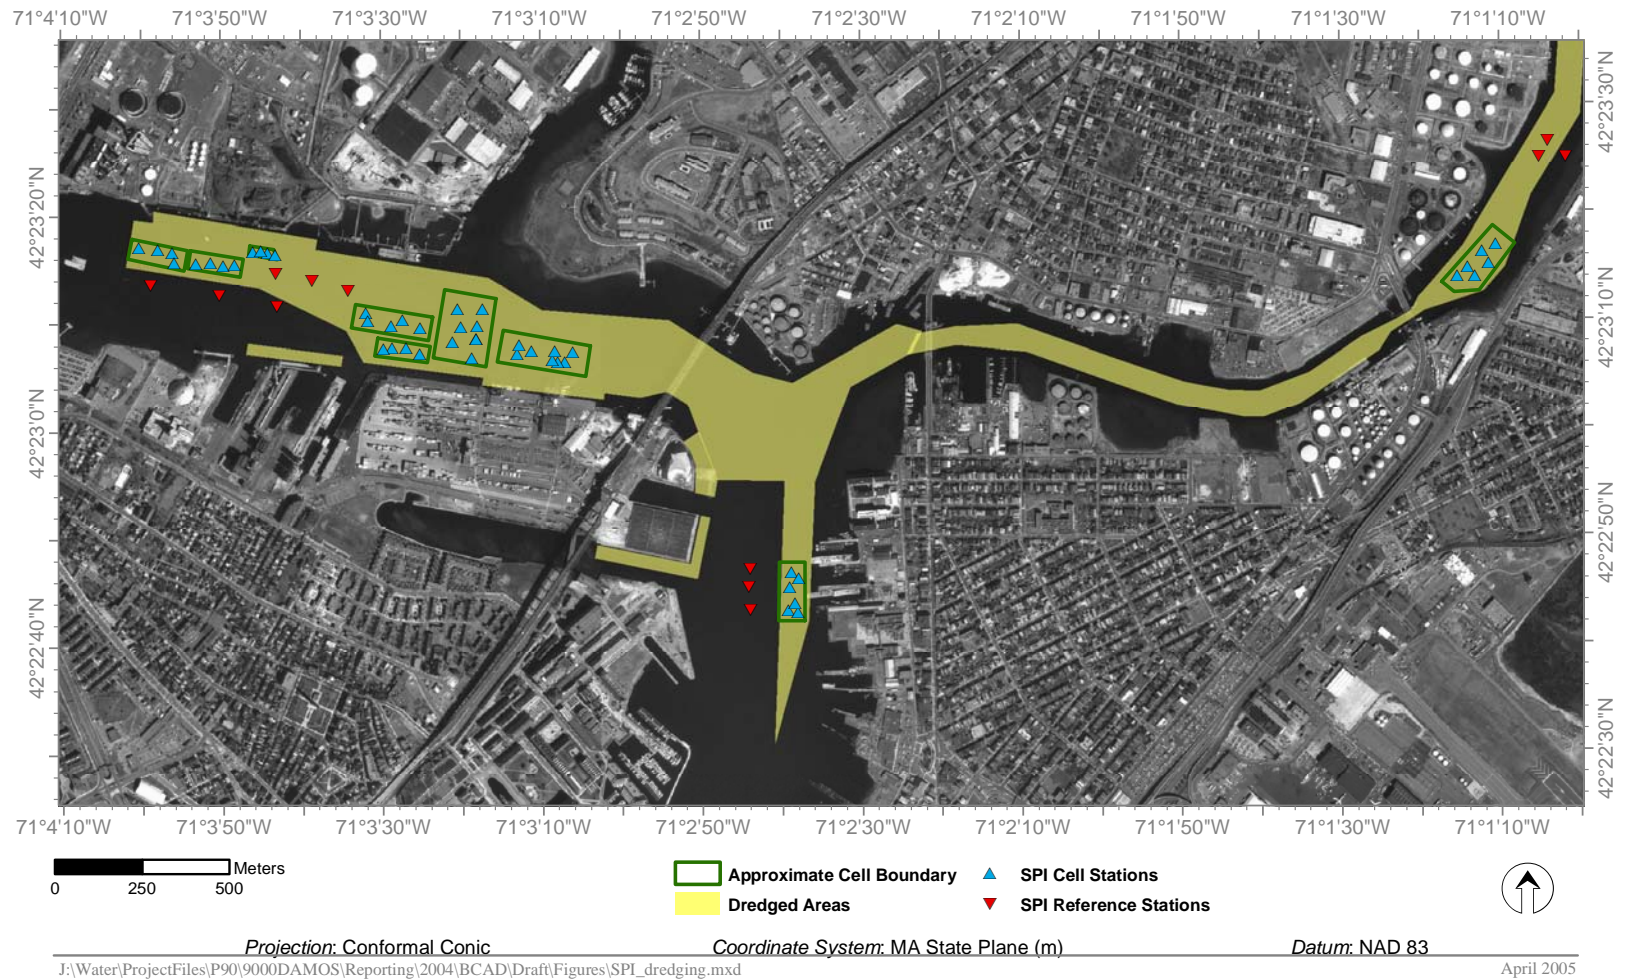
**Figure 2-7.** Target SPI sampling stations relative to areas dredged during the BHNIP

The 2004 BHCAD sediment-profile imaging (SPI) survey design included 60 stations distributed among the nine CAD cells and three associated reference areas (Table 2-2; Figures 2-5 and 2-6). Four stations each were located within CAD cells M2, M4, M5, and M12. CAD cell M8-11 contained five stations, C12 and IC2 each had six stations, the Supercell had seven stations, and M19 had eight stations. The reference areas were located adjacent to the cells and within the channel boundaries to provide characterization of ambient conditions in the active channel areas. Reference areas were selected to represent ambient conditions in both dredged and undredged channel areas. (Figure 2-7). Reference stations included six stations in the Mystic River (MREF), three stations in the Chelsea River upstream from CAD cell C12 (CREF), and three stations west of Inner Confluence CAD cell IC2 (ICREF). Target locations for all stations except C12-6 and SC-7 were determined prior to the survey. Stations C12-6 and SC-7 were selected while on site.
