Monitoring Survey at the Muscongus Bay Disposal Site
Lincoln County, Maine
July/September 2005

Disposal Area Monitoring System DAMOS

Contribution 171
June 2007

MONITORING SURVEY AT THE
MUSCONGUS BAY DISPOSAL SITE
LINCOLN COUNTY, MAINE
JULY/SEPTEMBER 2005

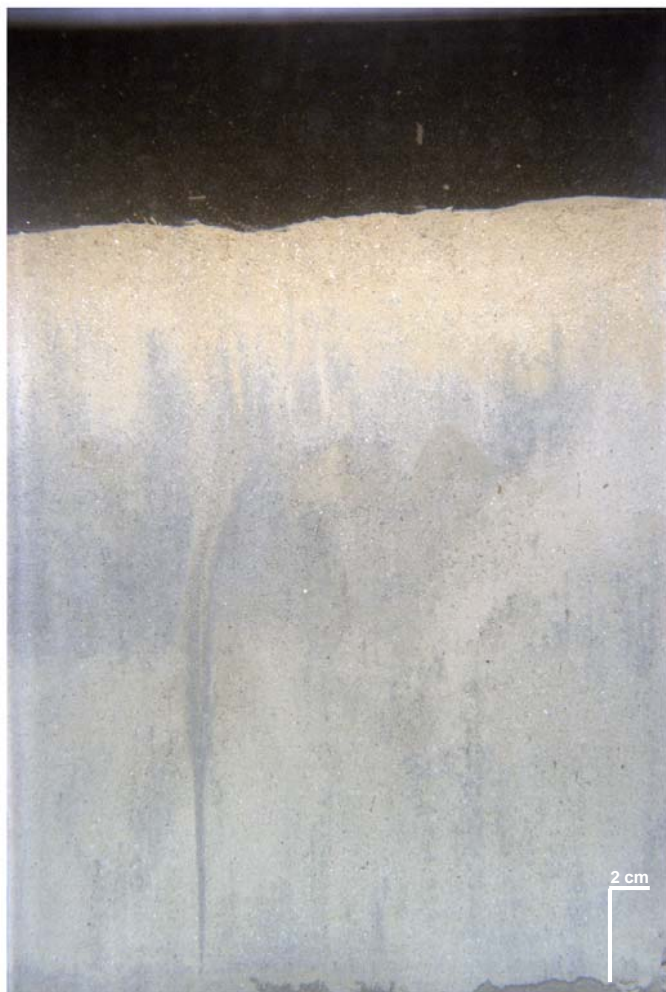
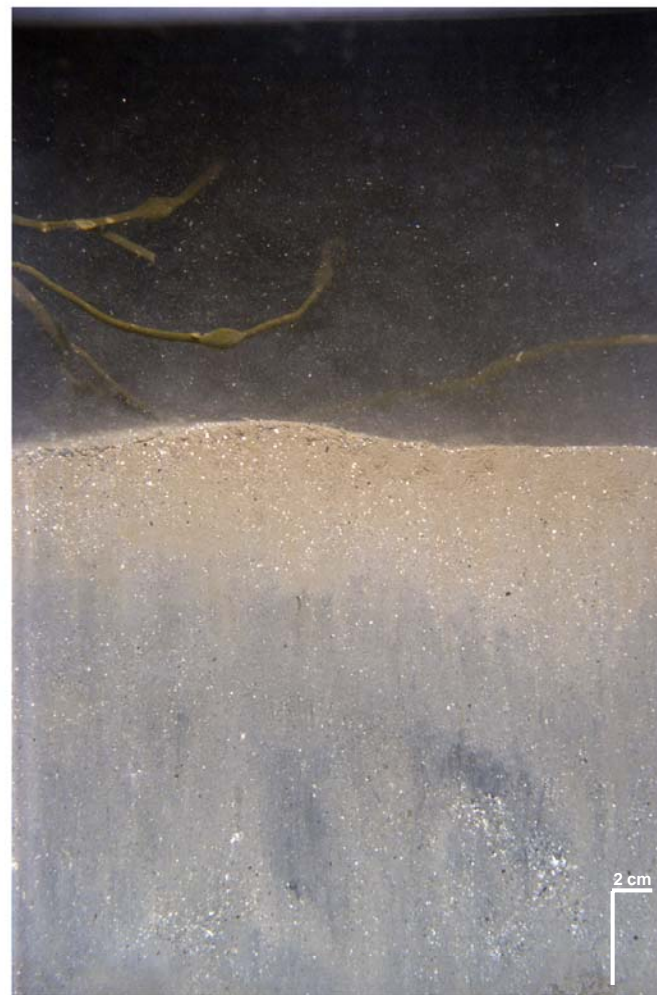
Figure 3-3. The sediment grain-size major mode at Station 26 (left) was > 4 phi, representative of most of the stations at the disposal site. A small handful of stations had a higher fine sand component, as can be seen in this image from Station 27 (right).

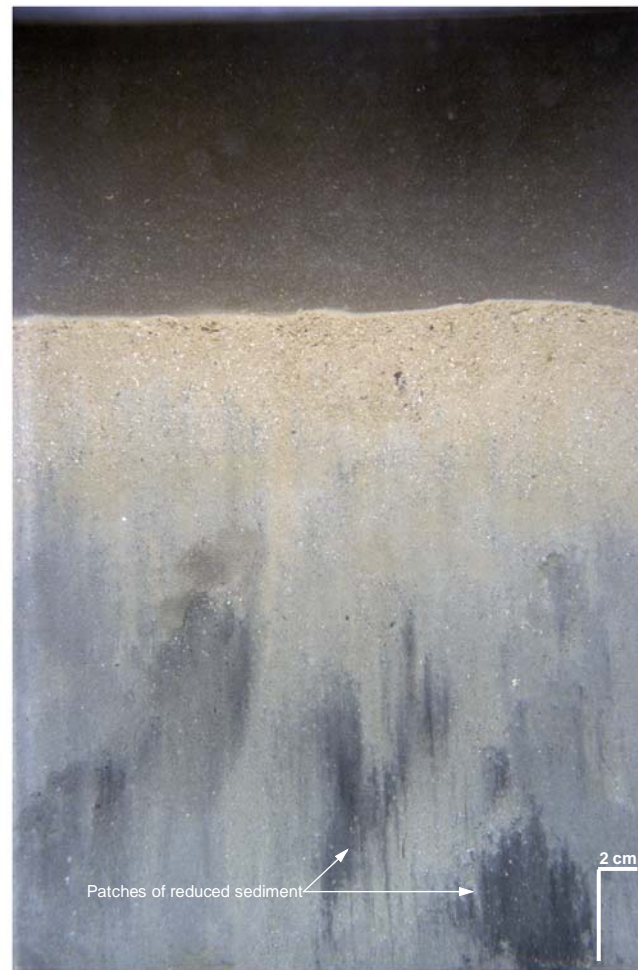
Figure 3-4. The layers of reduced subsurface sediment in this profile image from Station 6 (left) have an optical signature typical of historical dredged material deposits, but similar subsurface sediments are also found at the reference stations, as seen in this image from SWREF 04 (right)

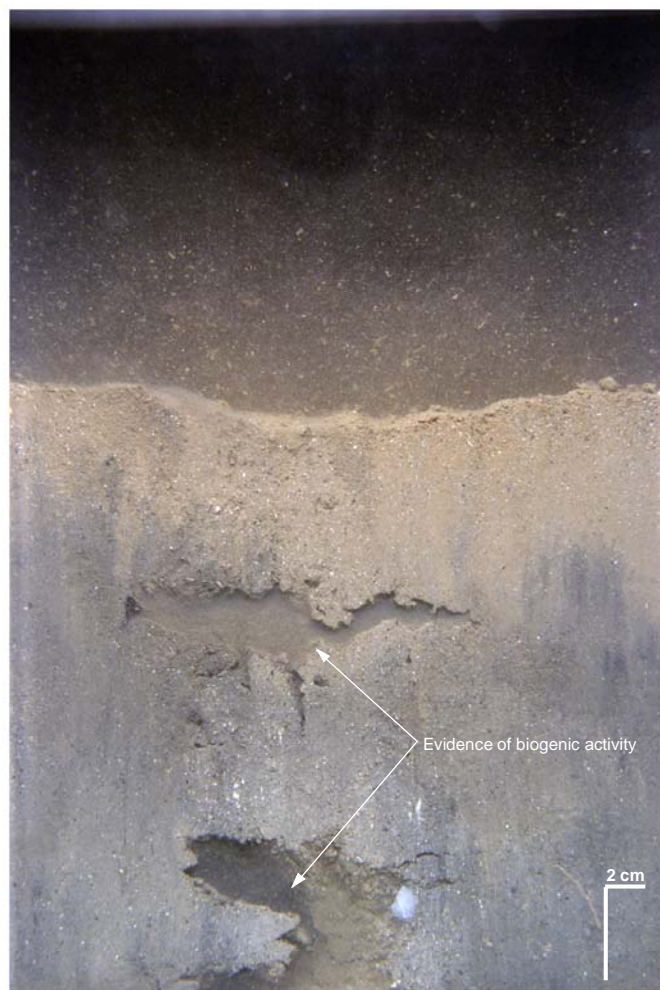
Figure 3-9. The deep biogenic reworking seen in these profile images from Station 29 (left) and Station 2 (right) are excellent examples of why any evidence of past depositional events has been obliterated more than 40 years after the last disposal event

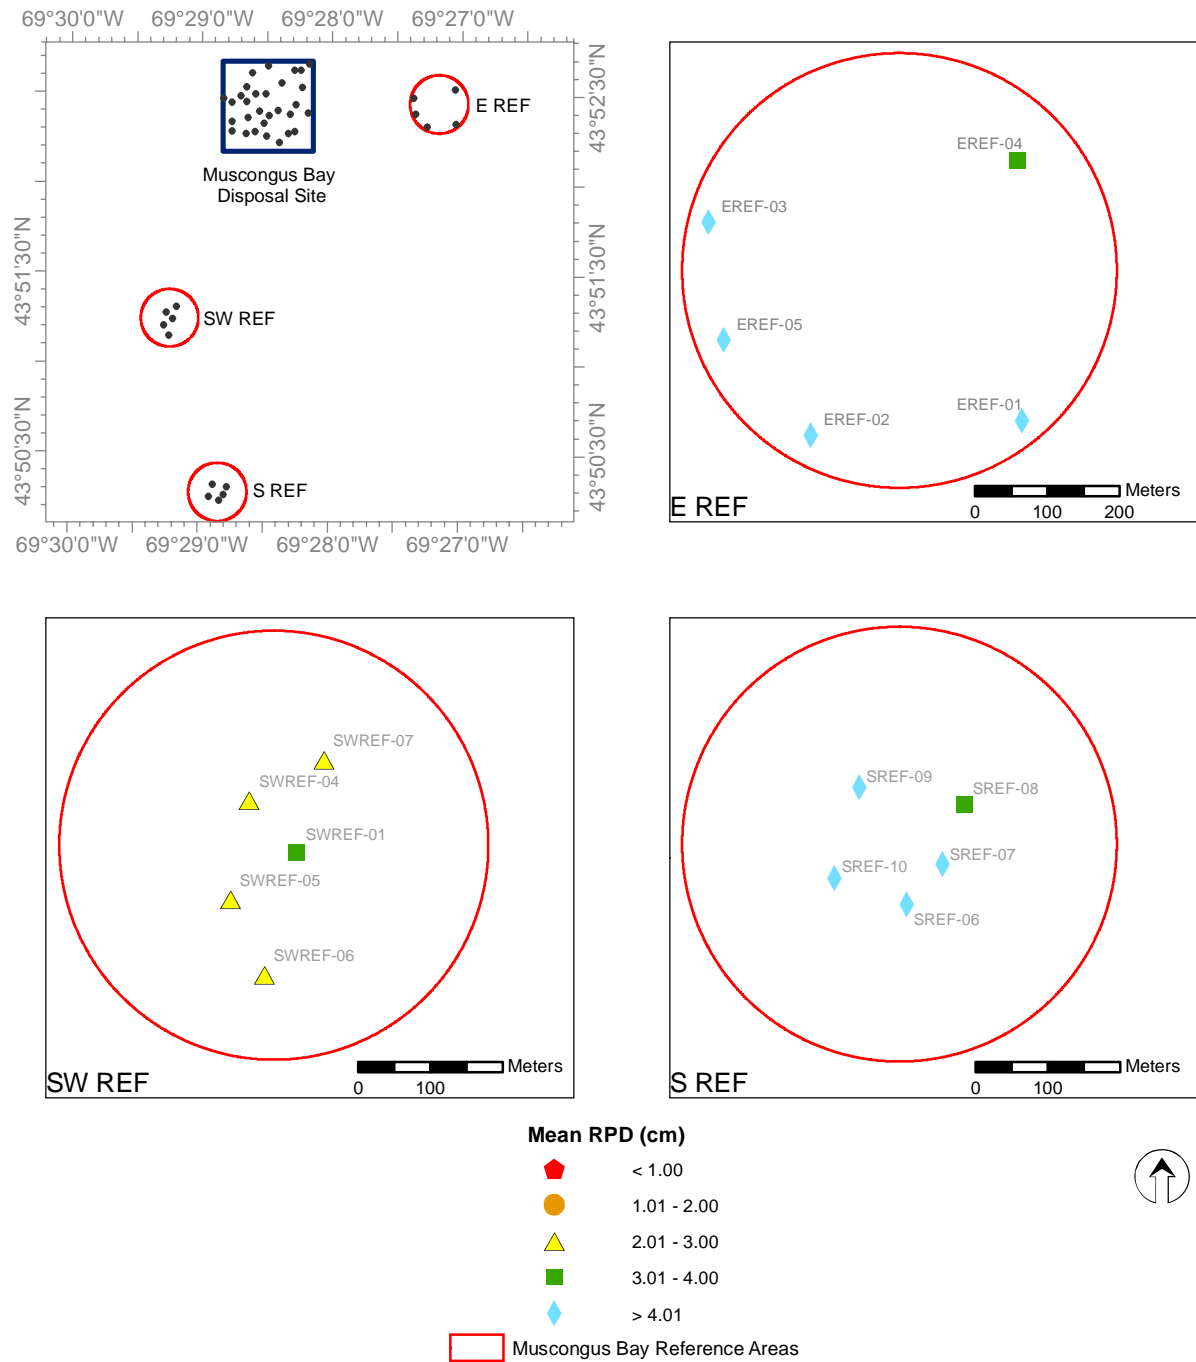
Figure 3-12. Distribution of mean apparent RPD depths (cm) at the Muscongus Bay reference sites

The average apparent RPD among stations at the reference areas ranged from 2.3 to 5.2 cm (Figure 3-12), with an overall ambient seafloor or reference area average of 4.0 cm (Table 3-2). Similar to all the stations sampled within the disposal area, all replicate images from the reference areas showed evidence of Stage 3 taxa, with maximum biological mixing depth ranging from 7.5 to 19.2 cm (Table 3-2; Appendix B). Evidence of intense subsurface particle advection from resident infauna was also seen in images from the reference stations (Figure 3-13).

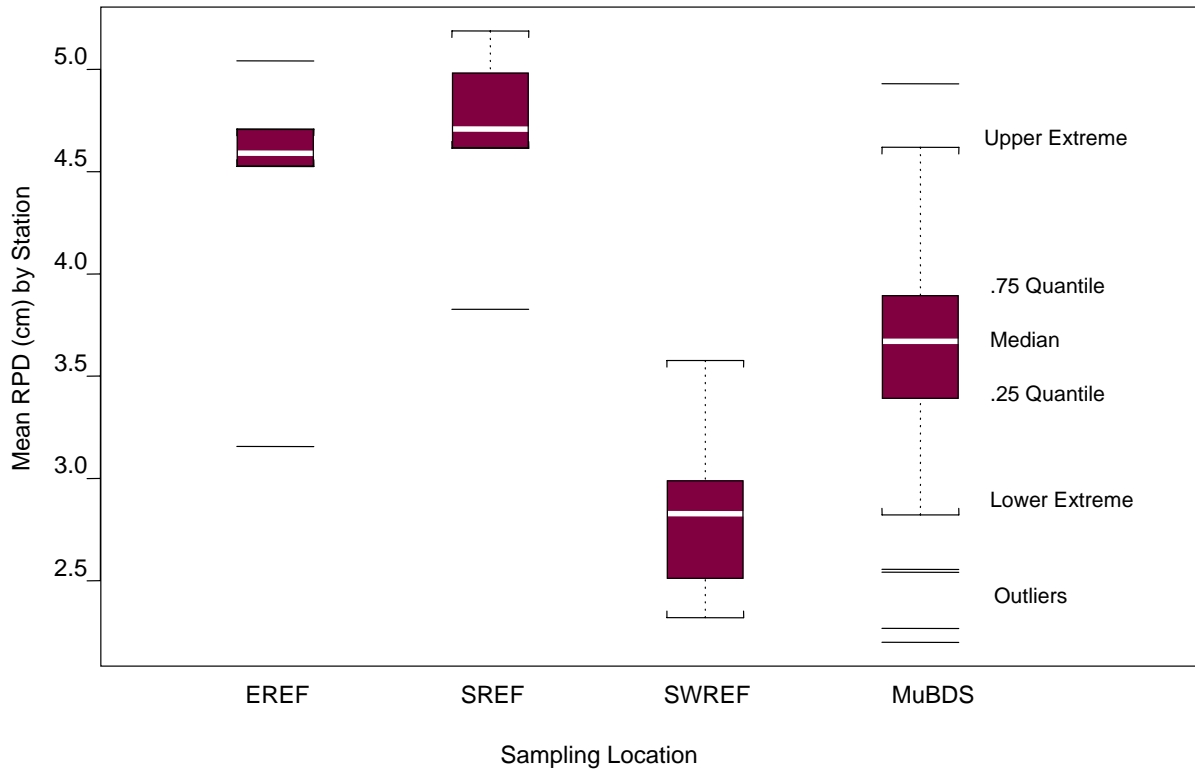
The three reference areas were different (Table 3-3; Figure 3-14) in both RPD means and variances. This is depicted in Figure 3-14 the box and whisker plot which shows the RPD median surrounded by a box confined by the upper and lower quantile (75 and 25 percentile respectively). The whisker lengths are the upper and lower extreme values and then any outliers are plotted. Consequently, the three reference areas were treated as separate groups to compare the disposal site to reference area conditions.

Figure 3-14. Box and whisker plot of mean apparent RPD values at the Muscongus Bay reference and disposal areas. The box contains the RPD mean confined by the upper and lower quantiles (75 and 25 percentile values respectively). The whisker lengths are the upper and lower extreme values

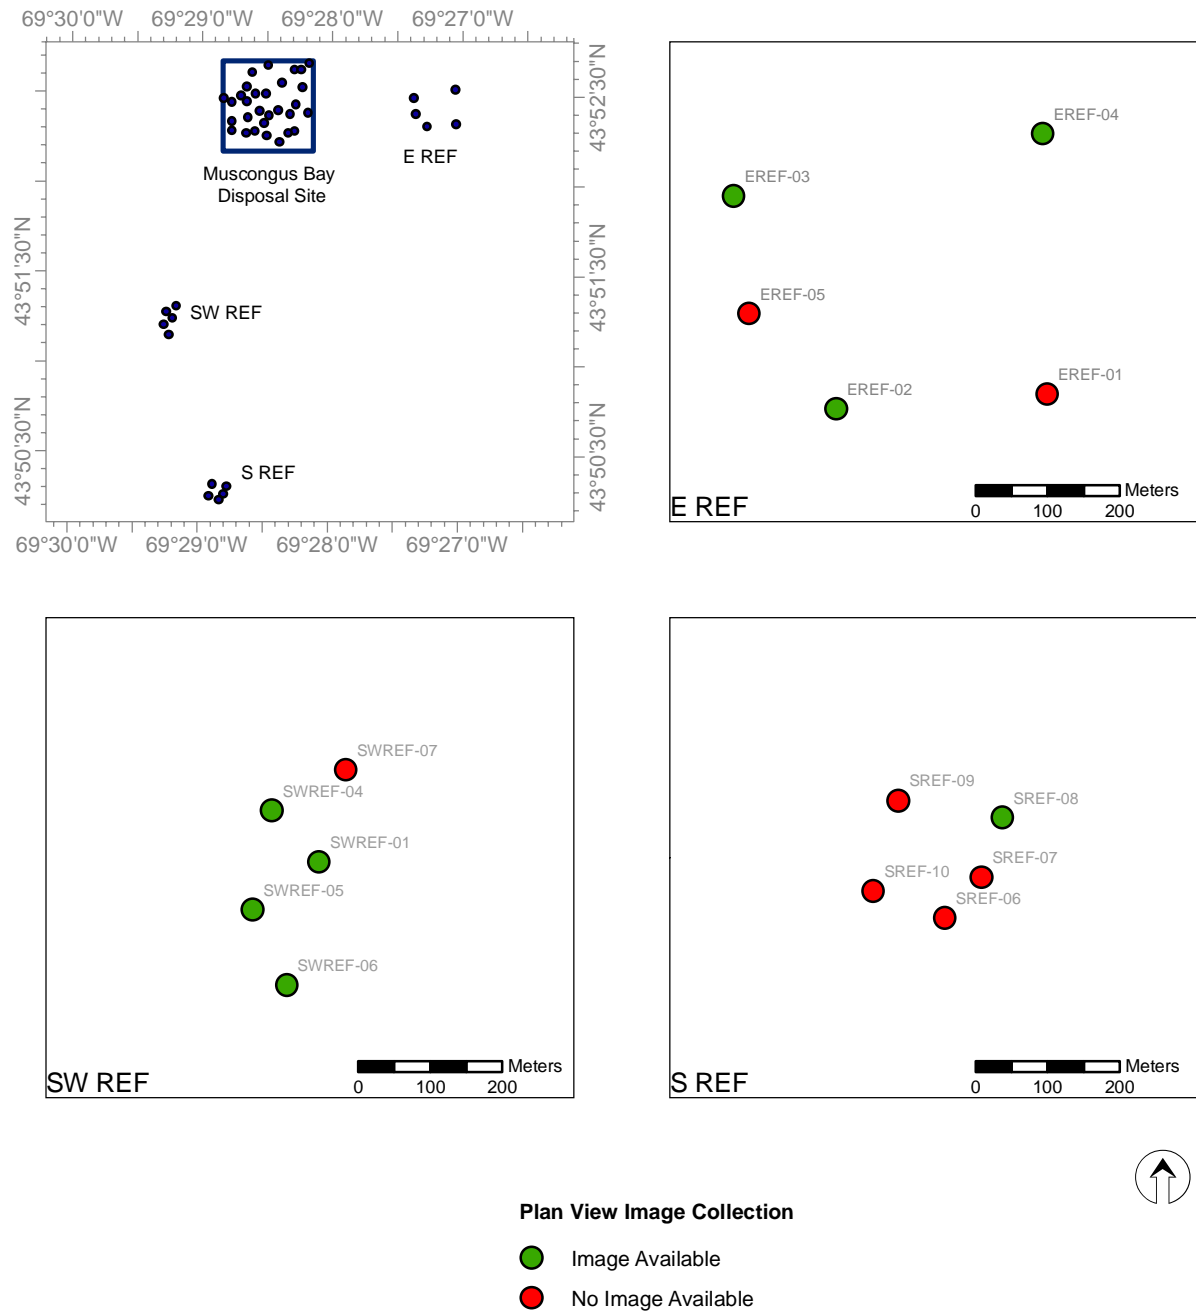
Figure 3-16. Plan view image availability at the Muscongus Bay reference sites

Most of the plan view images taken at the Muscongus Bay Disposal Site and the reference areas were unusable because of extremely high turbidity levels in the water column; of the 135 images collected, only 18 images had discernible features (Appendix C). Maps depicting which stations had plan view images that had discernible features can be found in Figure 3-16 for the reference sites and Figure 3-17 for the disposal site. The features common to all the visible images were rippled bedforms on the sediment surface with evidence of large openings from burrowing invertebrates (Figure 3-18). Occasional fish and shrimp could be seen in a few of the images, and one station had what appeared to be juvenile squid swimming just above the bottom (Figure 3-19).

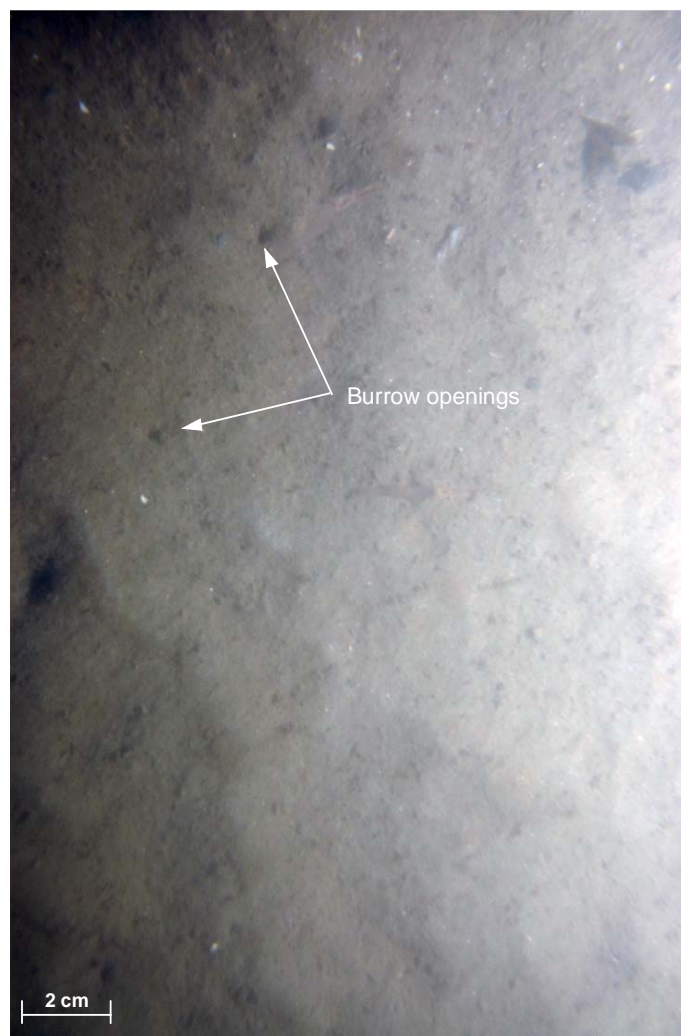
Figure 3-18. Plan view images from Station 15 (left) and EREF 03 (right) showing rippled silty sands with burrow openings on the sediment surface

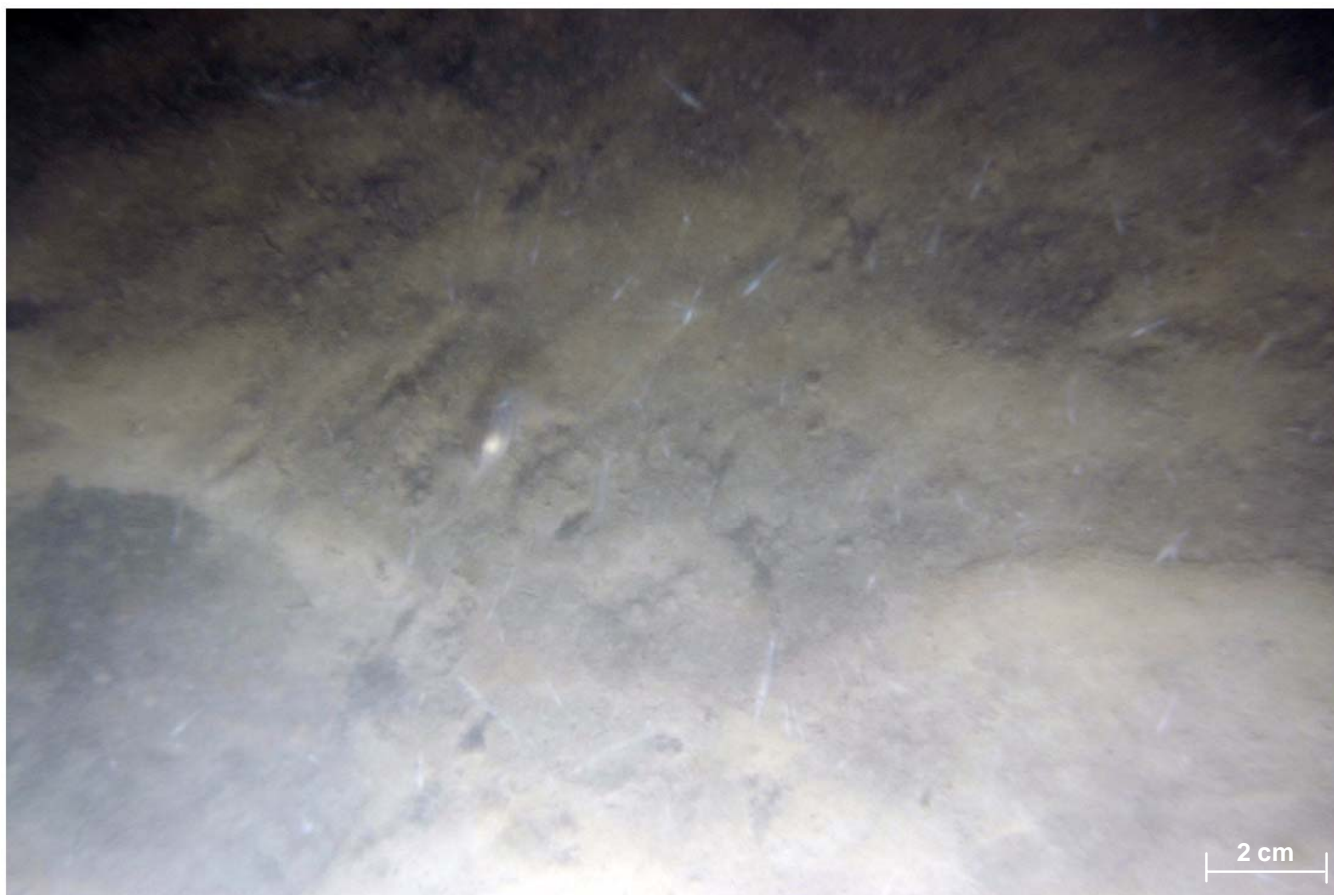
Figure 3-19. The hummocked muddy sands seen in this image from EREF 02 has numerous burrows and tubes on the sediment surface as well as a collection of what appear to be juvenile squid in the overlying water
