Monitoring Survey at the Tupper Ledge Disposal Site  
Union River Bay, Maine  
July/September 2005

# Disposal Area Monitoring System DAMOS

MONITORING SURVEY AT THE  
TUPPER LEDGE DISPOSAL SITE  
UNION RIVER, MAINE  
JULY/SEPTEMBER 2005

Report No.  
ENSR-9000-383-300

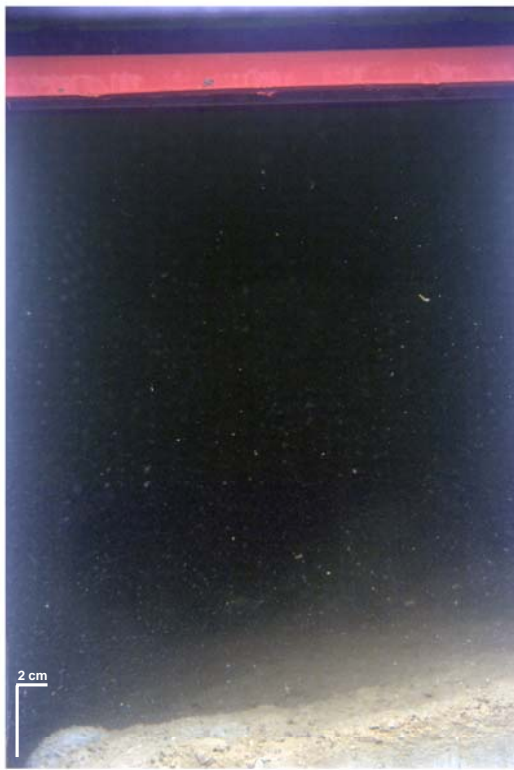
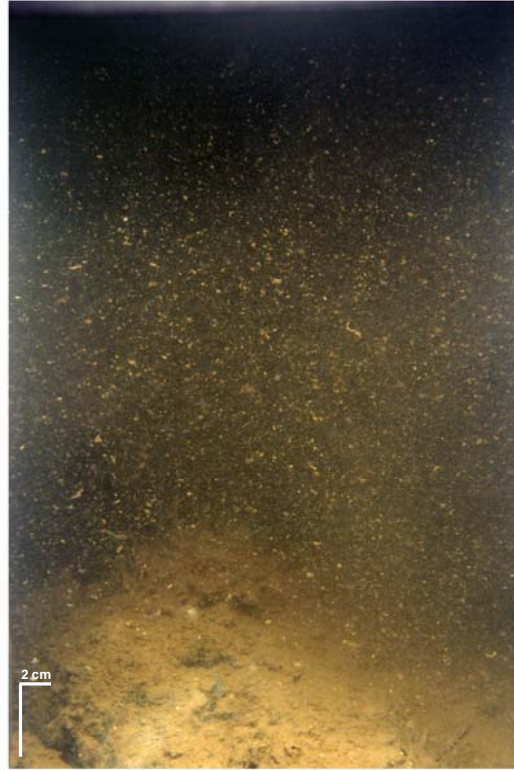
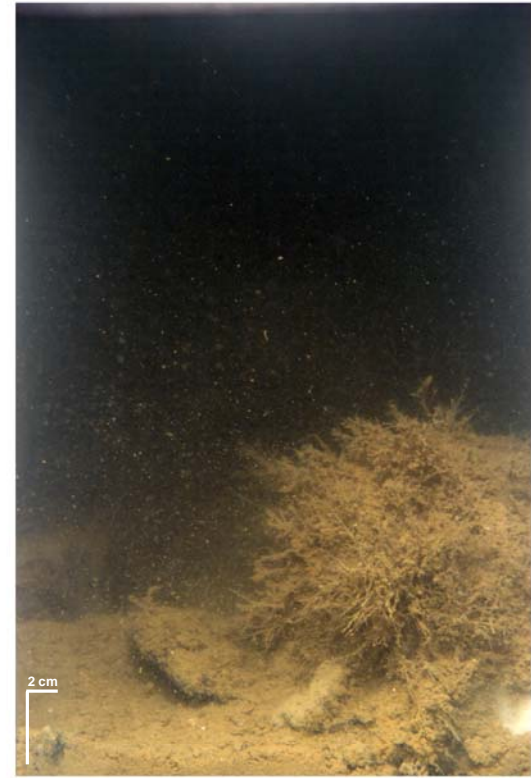
**Figure 3-5.** Despite the appearance of fine-grained sediments at Station I17, the silt-clay particles are mantling an underlying foundation of cobbles and rocks

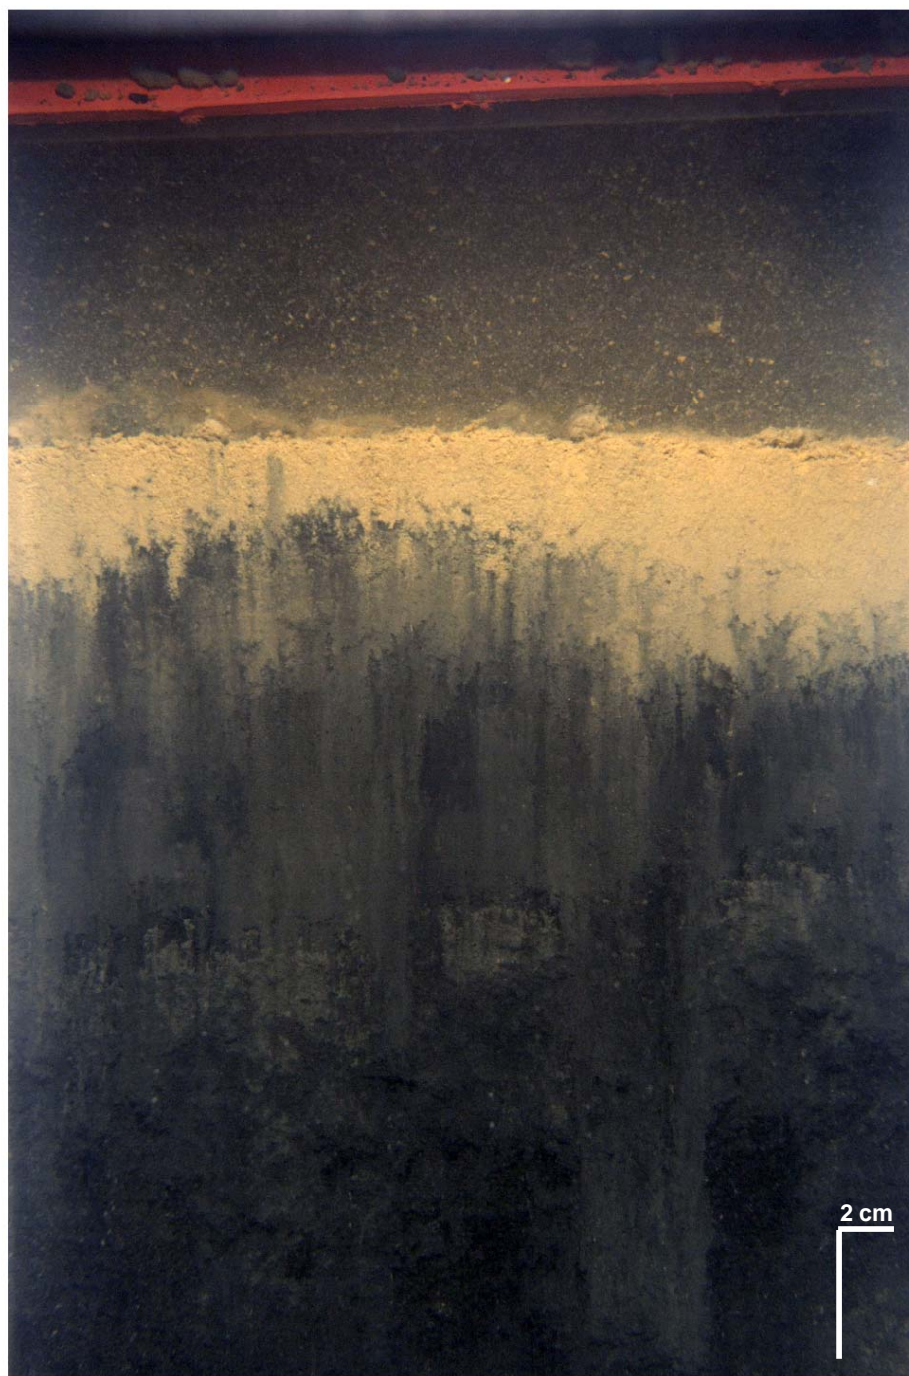
The dredged material present at all stations within the disposal site boundary was characterized by the presence of either high water-content reduced mud (Figure 3-8), a chaotic cross-sectional fabric with consolidated blue clay (Figure 3-9), the presence of wood chips (Figure 3-10), or disposed rock and cobble (Figure 3-5). While there was no evidence of low dissolved oxygen in the overlying water at the time of the survey, or subsurface methane generation, subsurface laminations indicative of past hypoxic or anoxic events observed in the previous survey could still be detected at many of the stations in 2005 (Figure 3-11).

**Figure 3-8.** The dredged material in this profile image from Station I02 is readily recognized by the highly-reduced nature of the subsurface sediments, reflecting the high organic content of the disposed mud

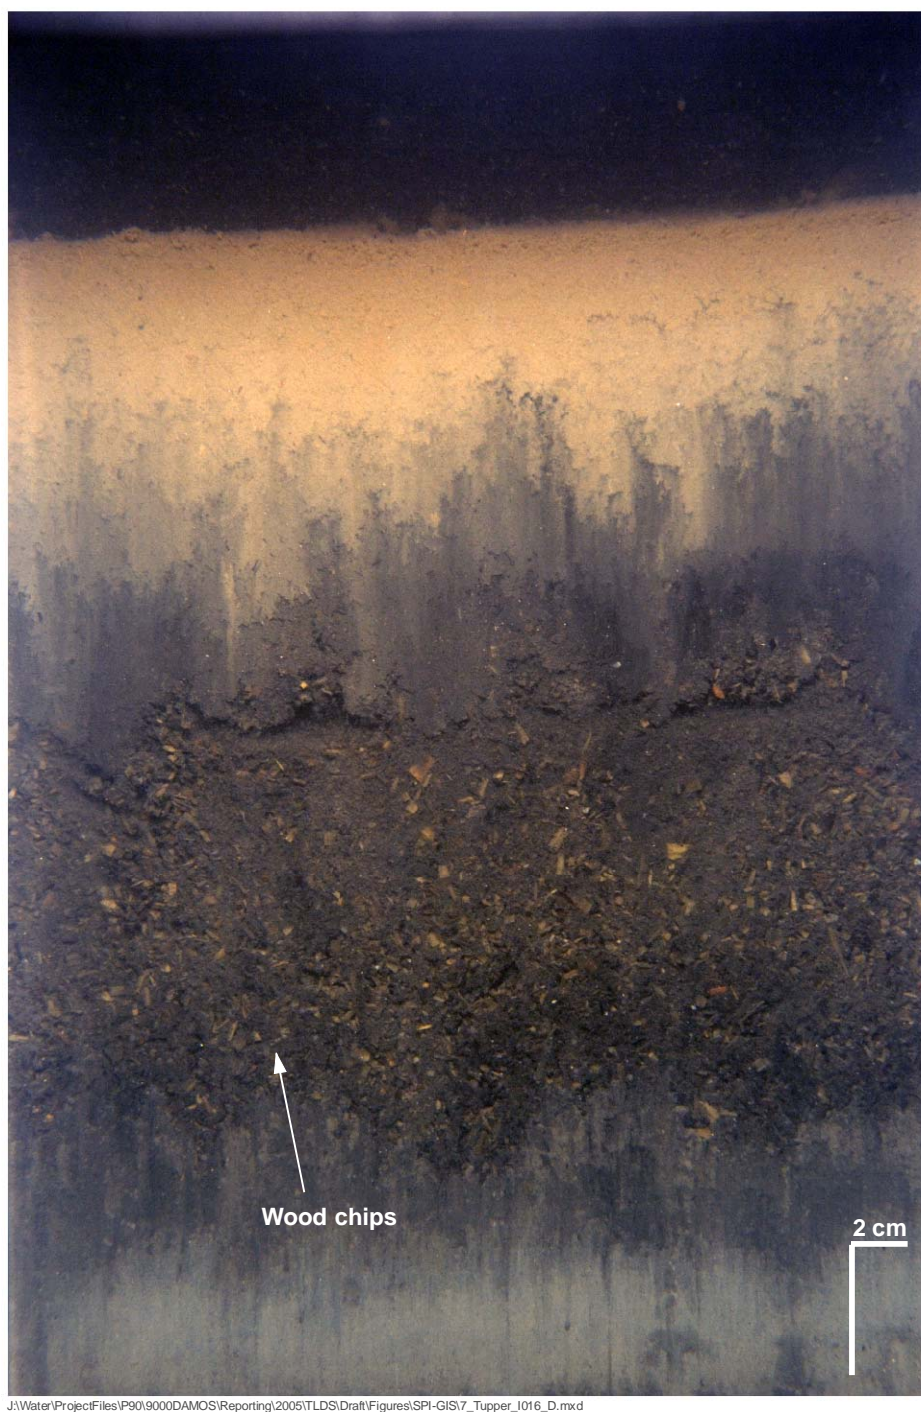
**Figure 3-10.** One quite common diagnostic feature of disposed sediment at the Tupper Ledge Disposal Site was the presence of wood chips and fibers, as can be seen in this profile image from Station I16

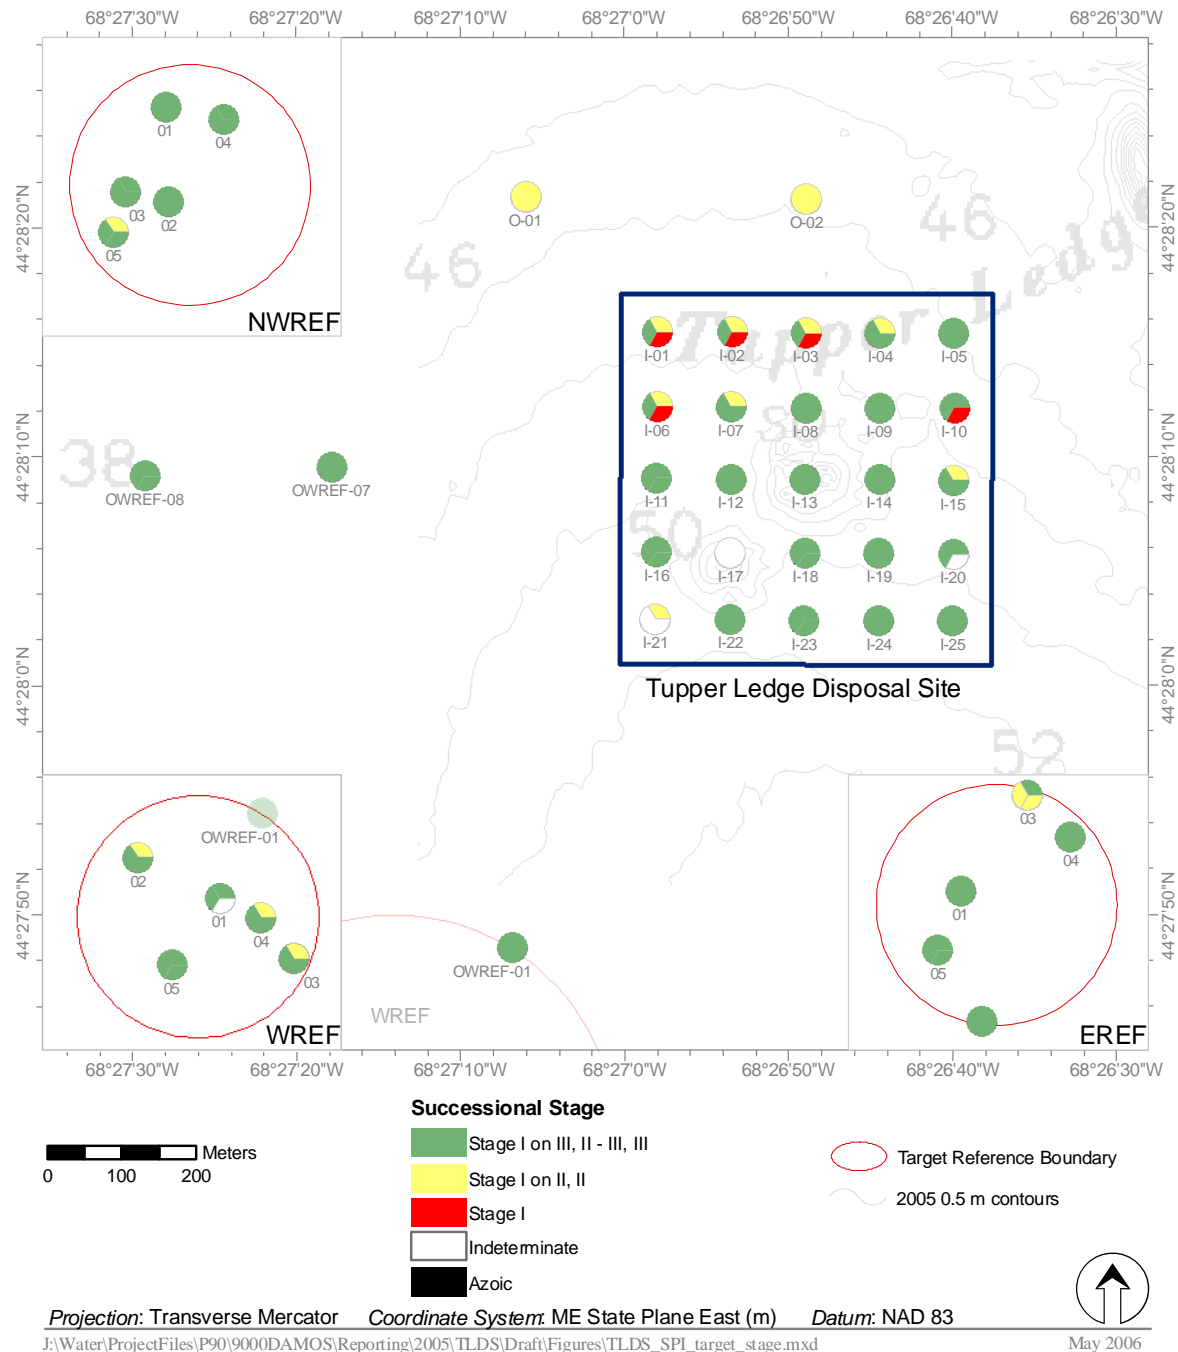
Of the stations with dredged material present, there were only 4 (Stations O-01, O-02, I17, and I21) that had no evidence of any Stage 3 taxa (Table 3-1, Figure 3-13). No determination of infaunal successional stage could be made at Station I17 because of the poor camera penetration at this particular location. Evidence of infaunal deposit feeding activities to depths greater than 10 cm was found at approximately half of the stations surveyed within the disposal site (Figure 3-14), with structures ranging from subsurface megafaunal burrows (Figure 3-15) to feeding voids and vertical burrow structures (Figure 3-16).

**Figure 3-13.** Distribution of infaunal successional stages at the Tupper Ledge Disposal Site

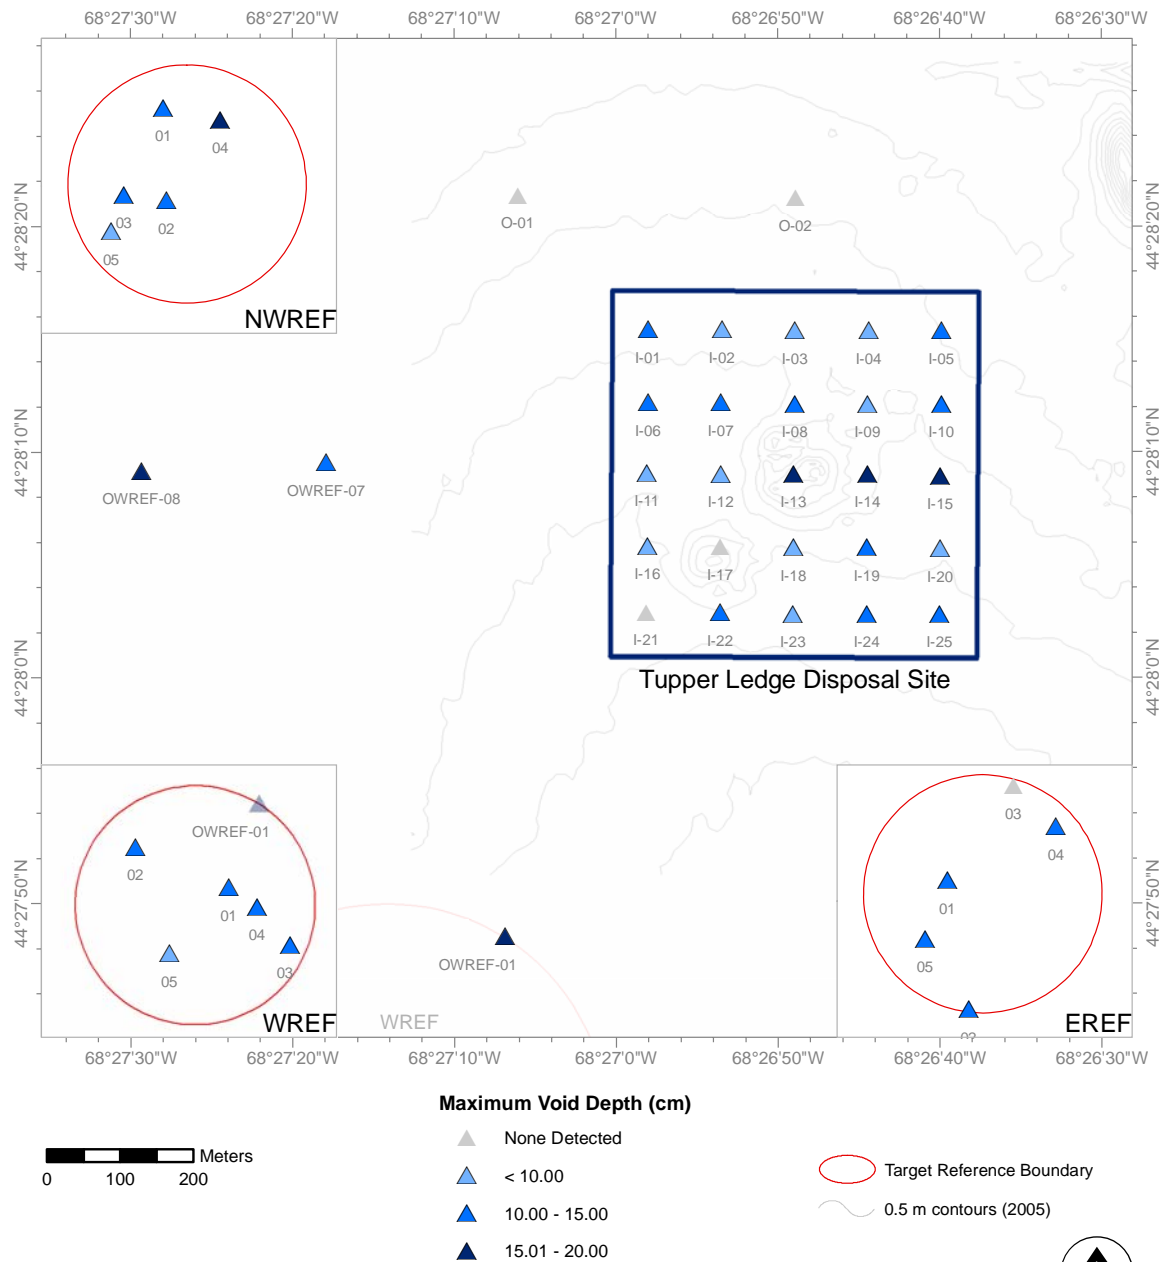
**Figure 3-14.** Distribution of maximum infaunal feeding void/burrow depth (cm) at the Tupper Ledge Disposal Site

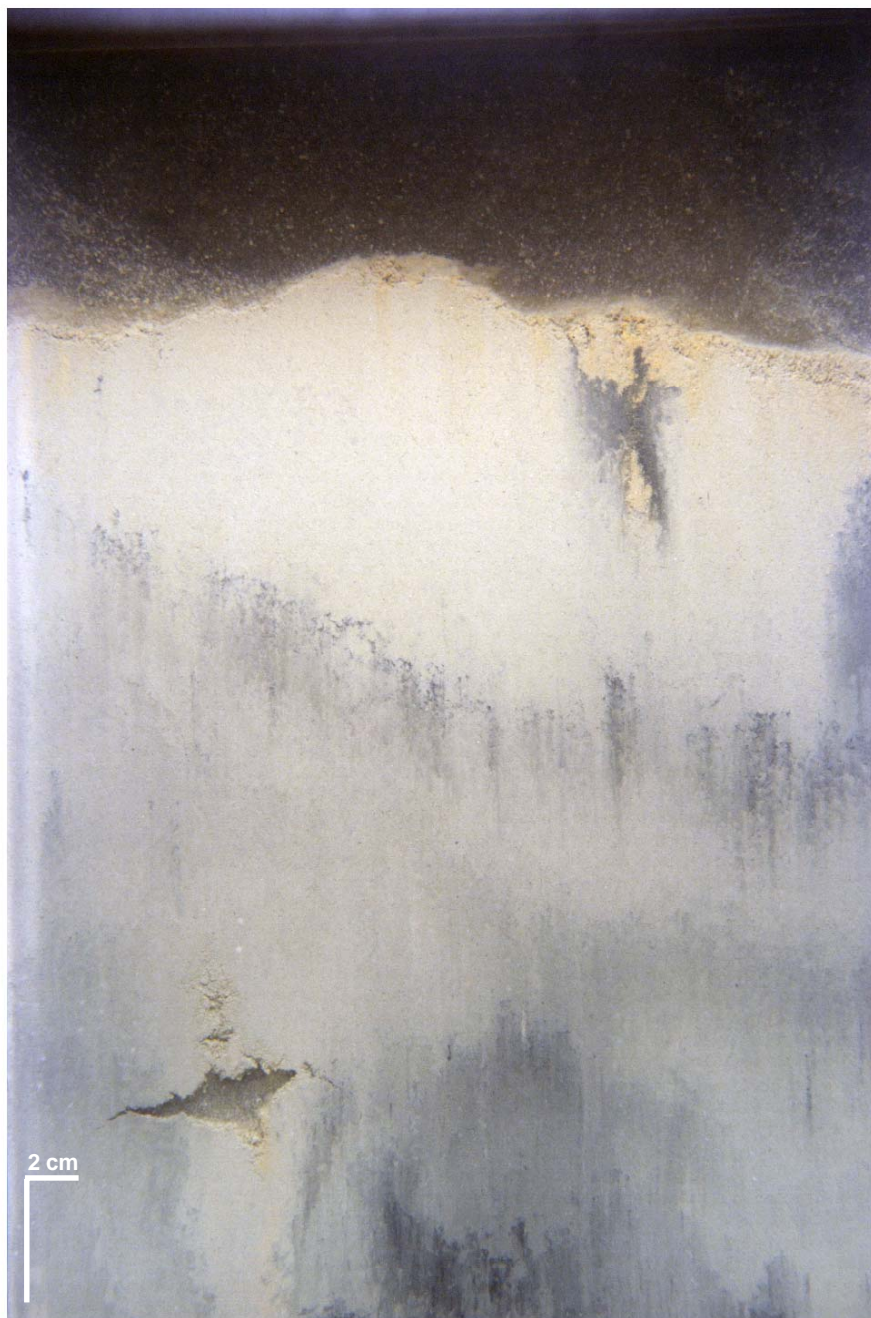
stations in each of the three reference areas (Figure 3-14); the particle advection by bioturbating infauna at many of the reference stations was responsible for homogenizing and disrupting the sub-surface laminations caused by past seasonal hypoxic/anoxic events (Figure 3-18).

**Figure 3-18.** The bioturbational activities of Stage 3 infauna as seen in this example profile image from Station WREF03 were responsible for homogenizing the sub-surface anoxic strata at many of the reference stations

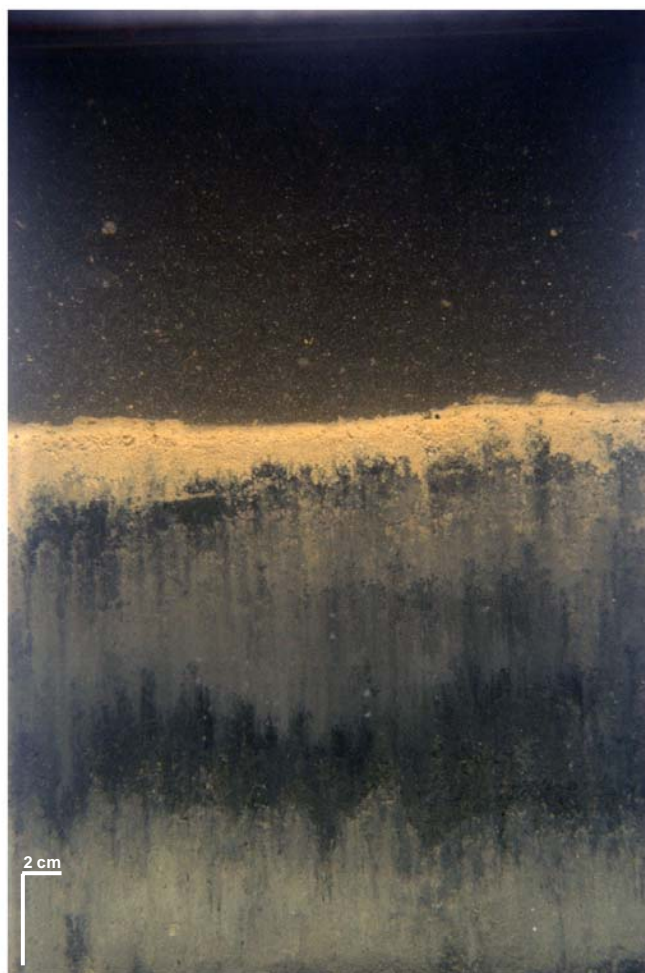
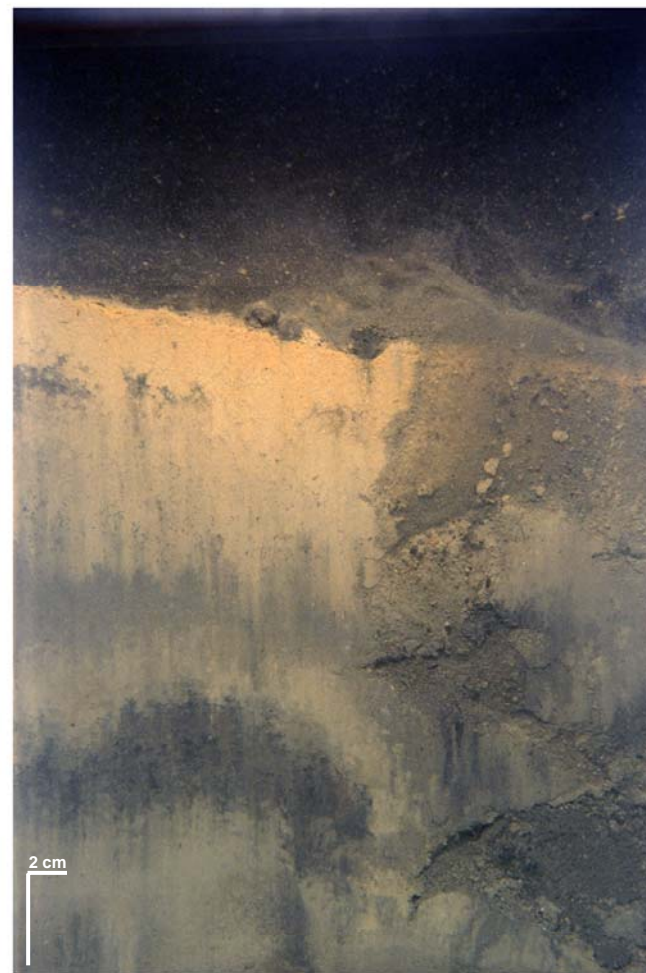
**Figure 4-1.** These two replicate images from Station I06 show preserved strata of anoxic events in the recent past (left) as well as the effects of bioturbational activities on disrupting this preserved signature
