Monitoring Survey at the Eastern Passage Disposal Site October 2012

Disposal Area Monitoring System DAMOS

Contribution 194
June 2013

**MONITORING SURVEY AT THE
EASTERN PASSAGE DISPOSAL SITE
OCTOBER 2012**

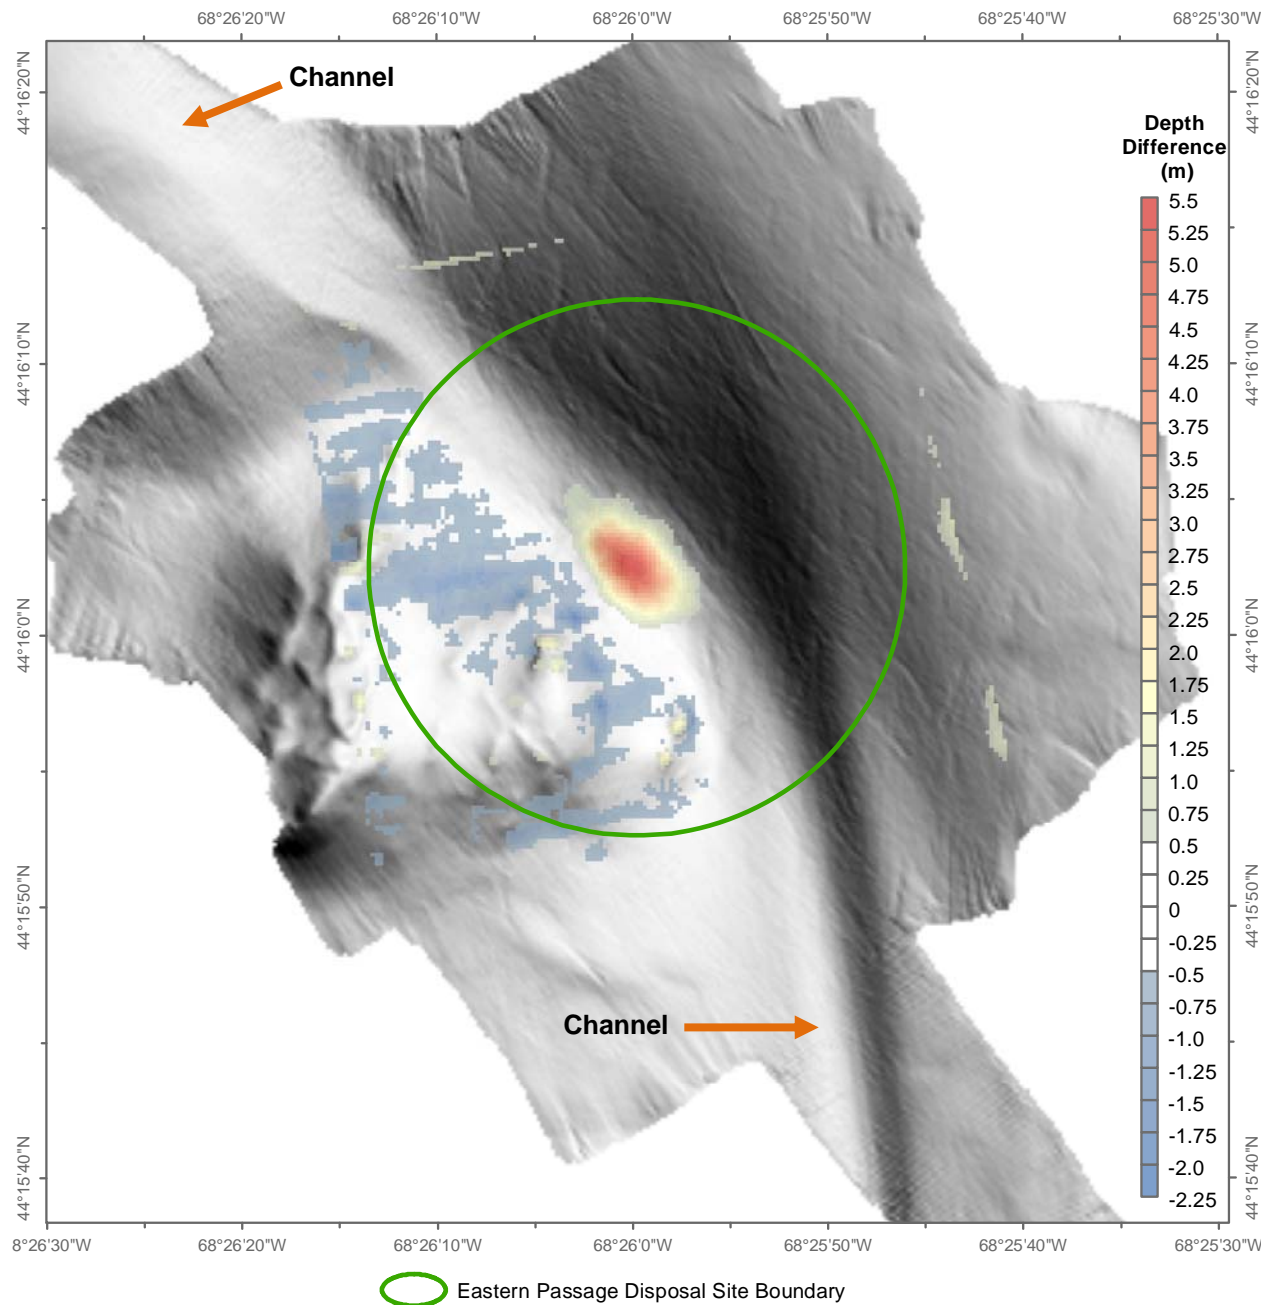
Figure 3-7. Depth difference contour map of EPDS: December 2009 vs. October 2012
Monitoring Survey at the Eastern Passage Disposal Site October 2012

1. Data: Depth difference (2009-2012) over 2012 acoustic relief model 5x vertical exaggeration.
2. Positive values (green through red shading) indicate a decrease in depth.
Negative values (blue shading) indicate an increase in depth.
3. Differences from + 0.5 to - 0.5 m fall within the estimated combined uncertainty between the 2012 and 2009 surveys and are not depicted.

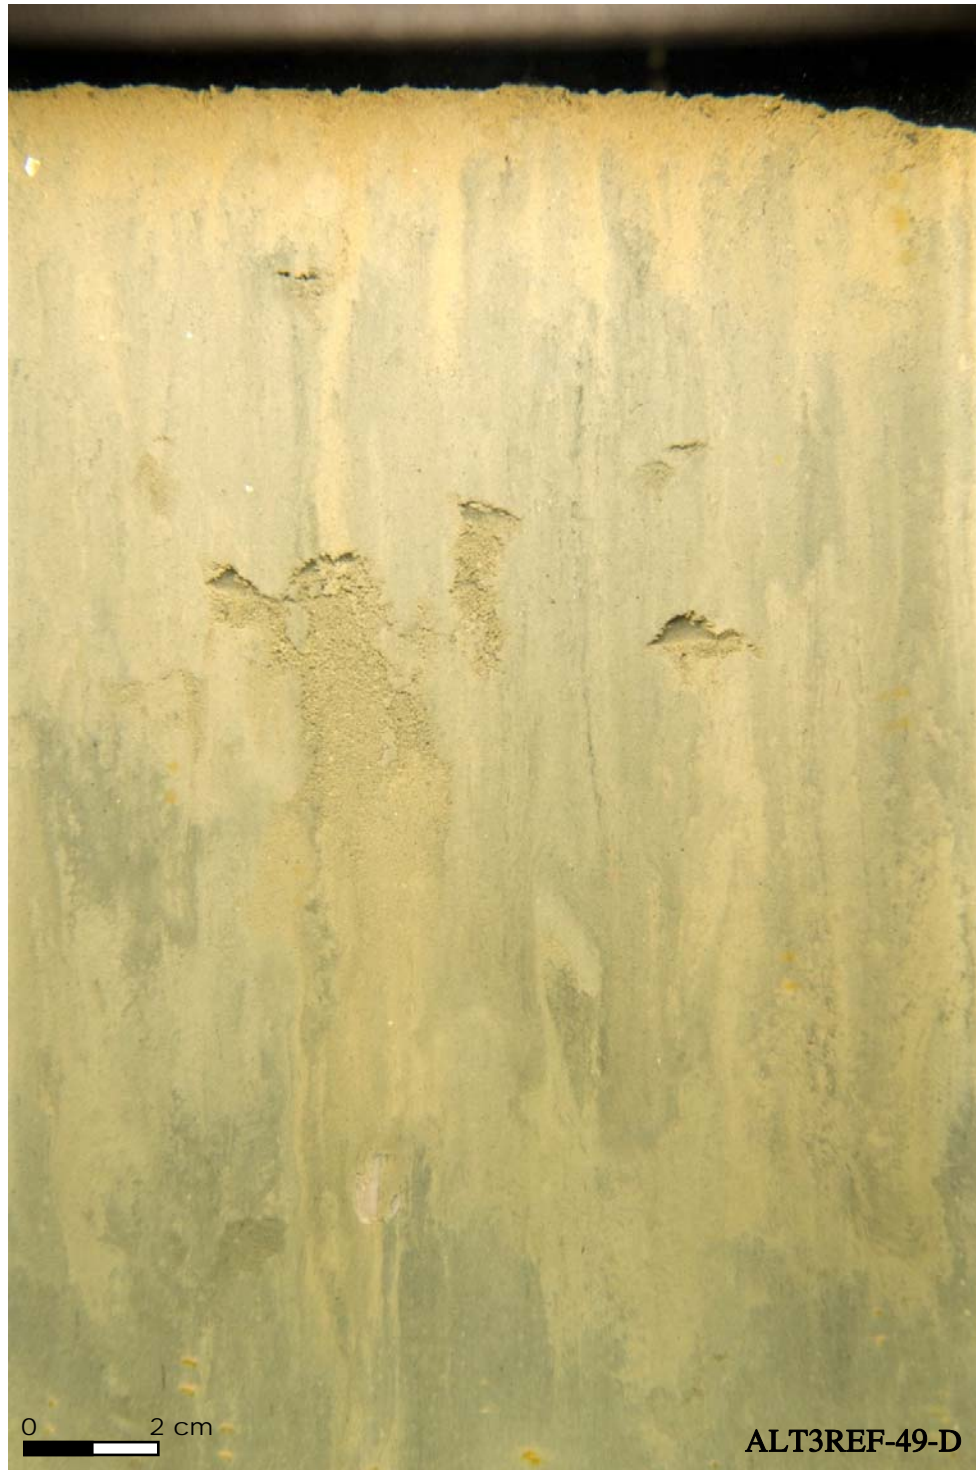
Figure 3-9. Sediment-profile image from Station 49 was typical of sediment particle size found at all stations surveyed in the northernmost reference area ALT3REF.

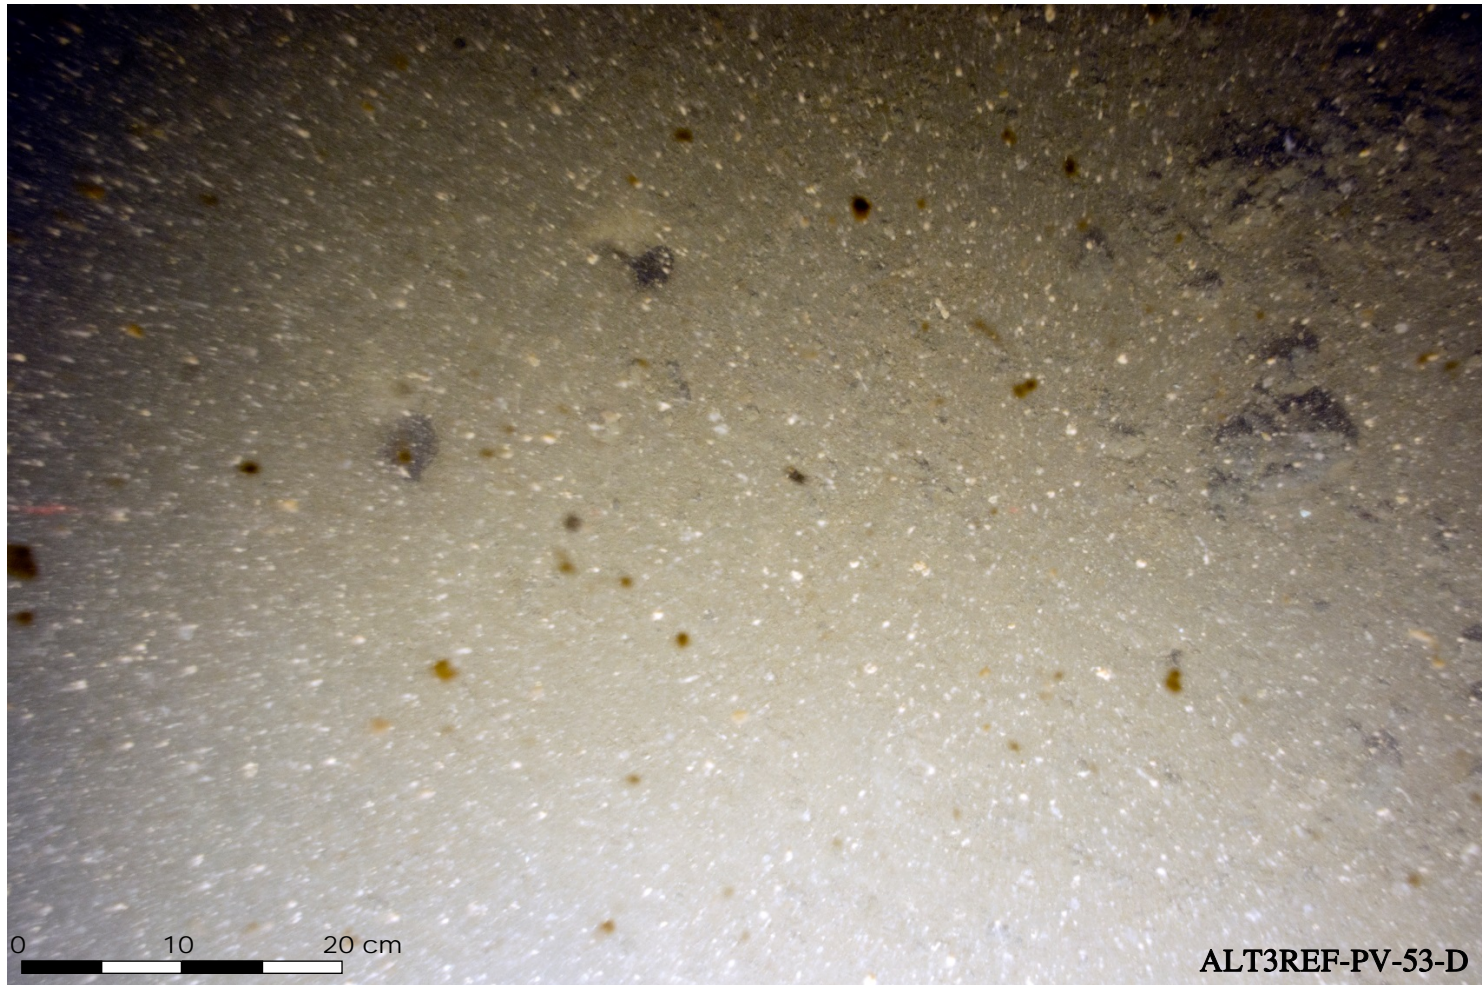
Figure 3-10. Plan-view image from Station 53 was a good example of the seafloor surface at ALT3REF; aside from the mud clast artifacts on the surface assumed to have fallen off the camera base sled, the only features visible on the silt/clay bottom were a few large burrow openings in the upper left quadrant of the image.

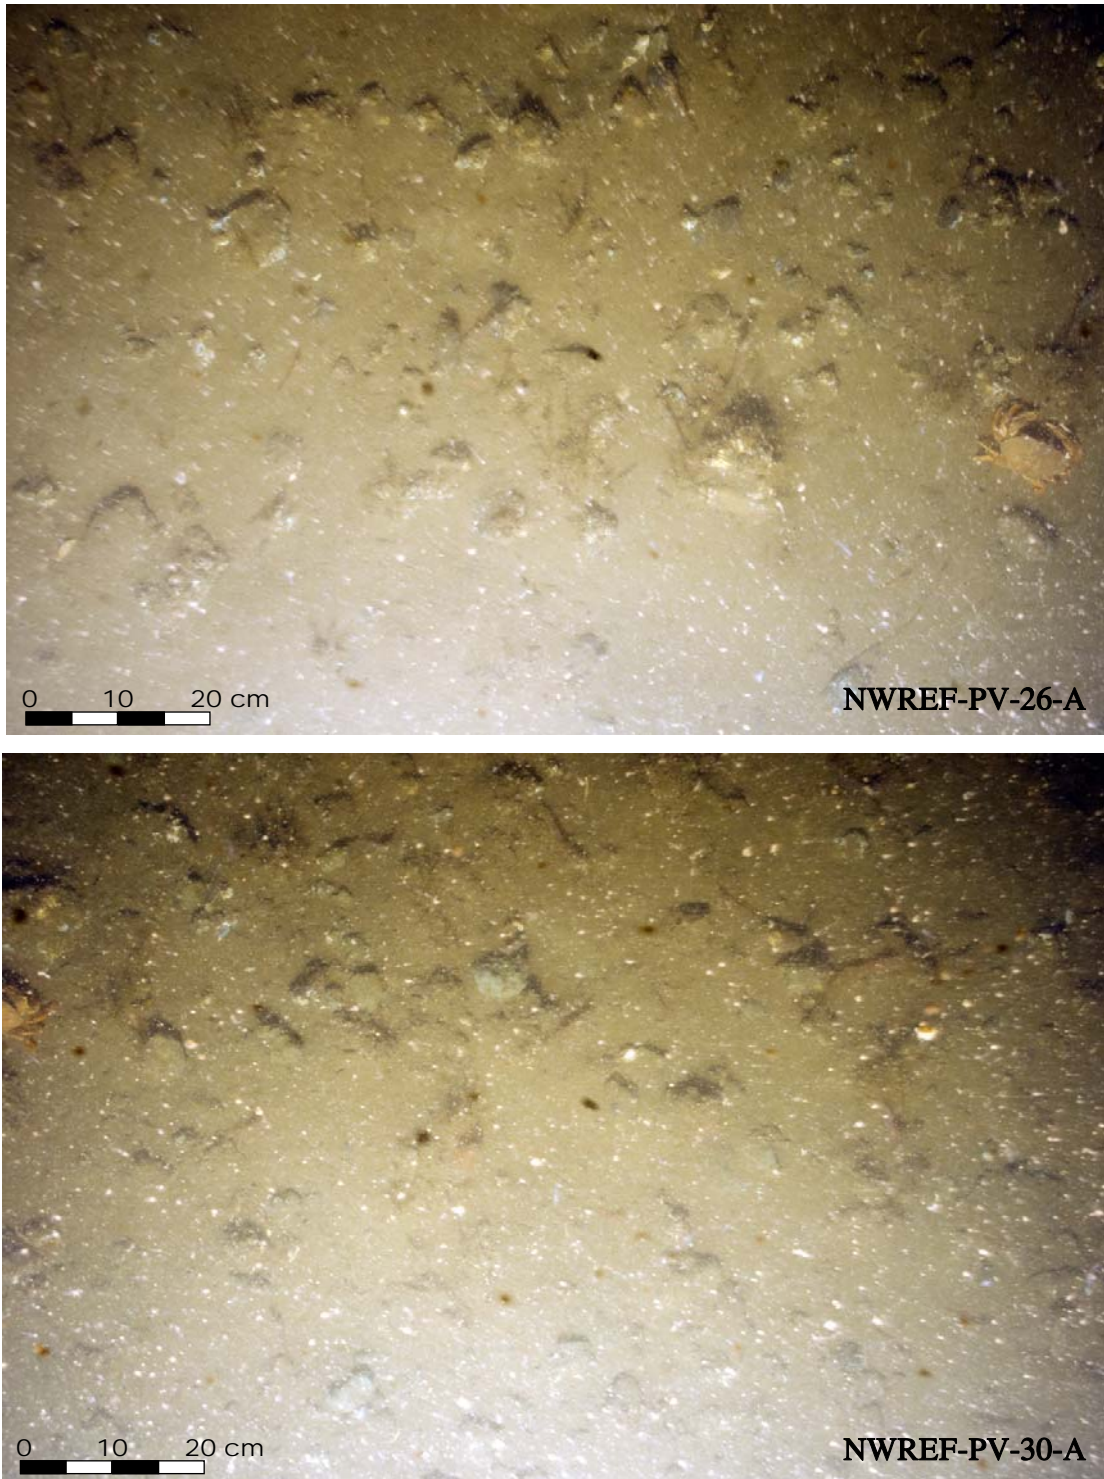
Figure 3-11. Plan-view images from NWREF Stations 26 (top) and 30 (bottom) showed a sandy silt bottom with varying densities of larger cobble and rocks on the sediment surface.

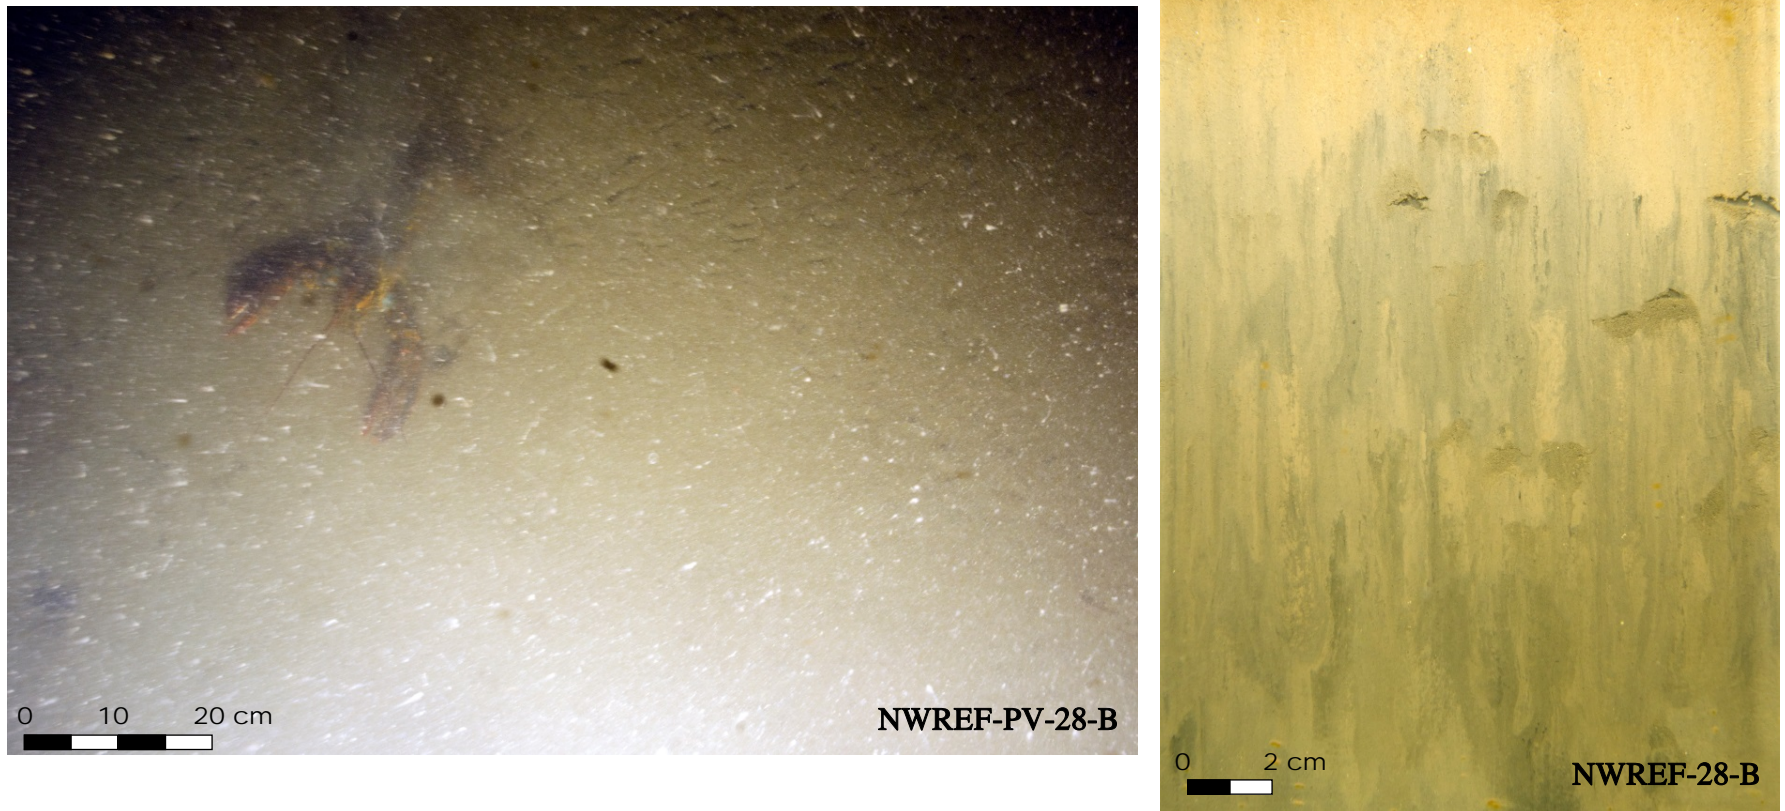
Figure 3-12. The silt/clay bottom in these plan-view and profile images from NWREF Station 28 showed a relatively narrow range of sediment particle sizes in contrast to those found in the previous image.

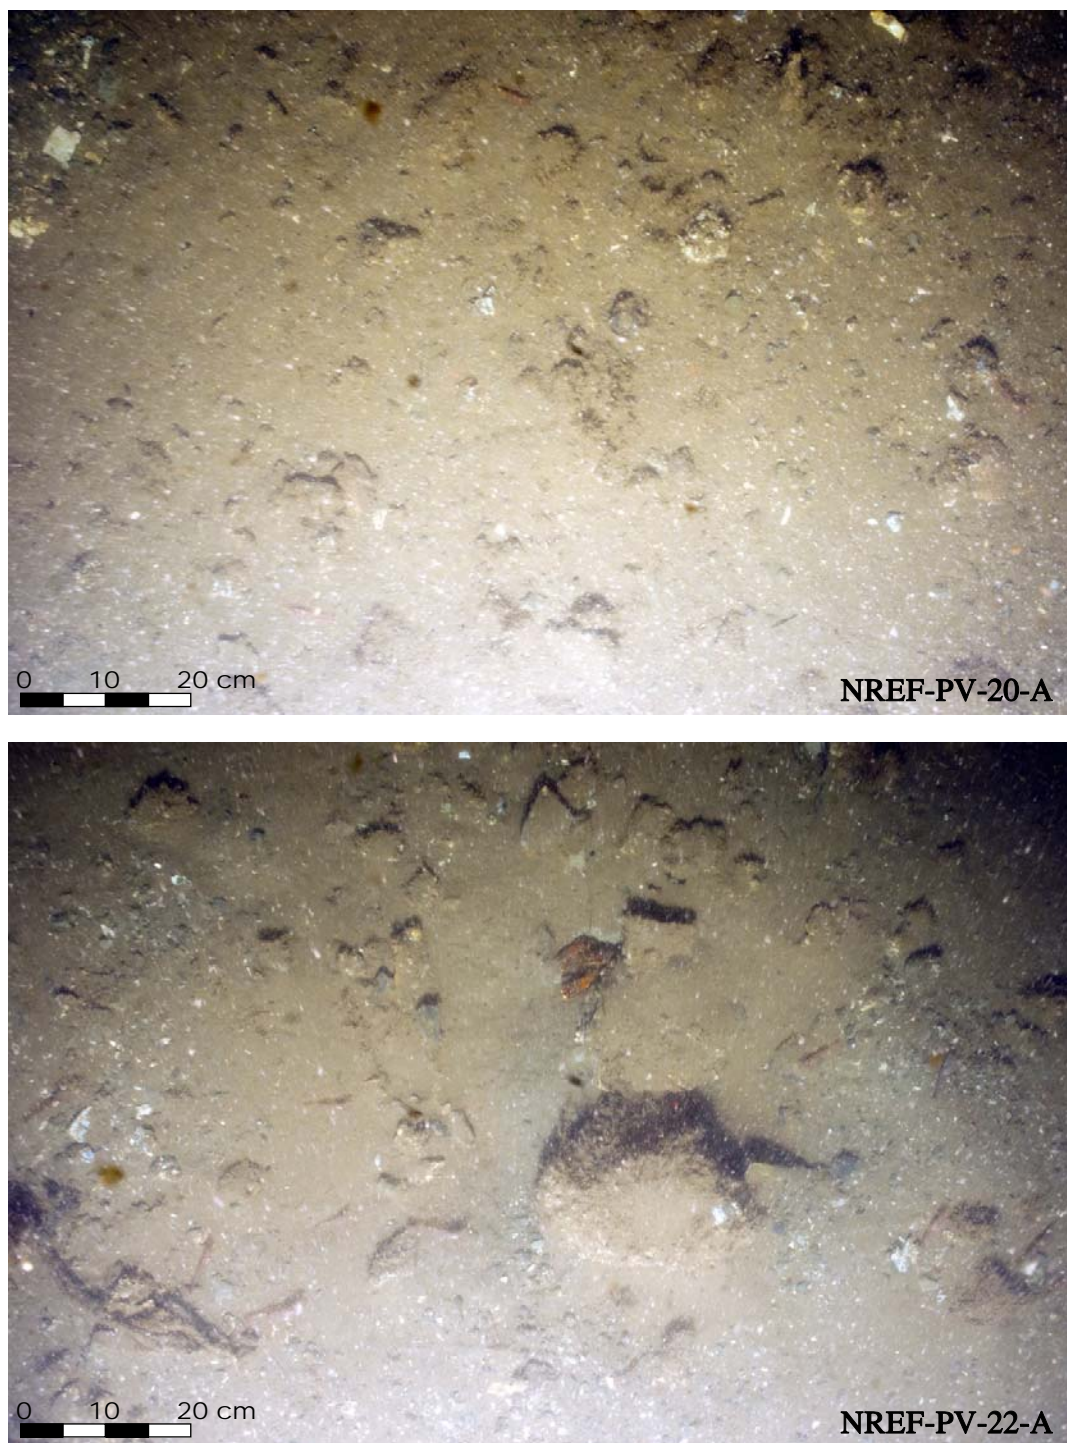
Figure 3-13. Plan-view images from NREF Stations 20 (top) and 22 (bottom) showed a mixture of fine and coarse-grained sediments which provided surfaces for sessile fouling organisms as well as attractive structures for larger motile epifaunal foragers.

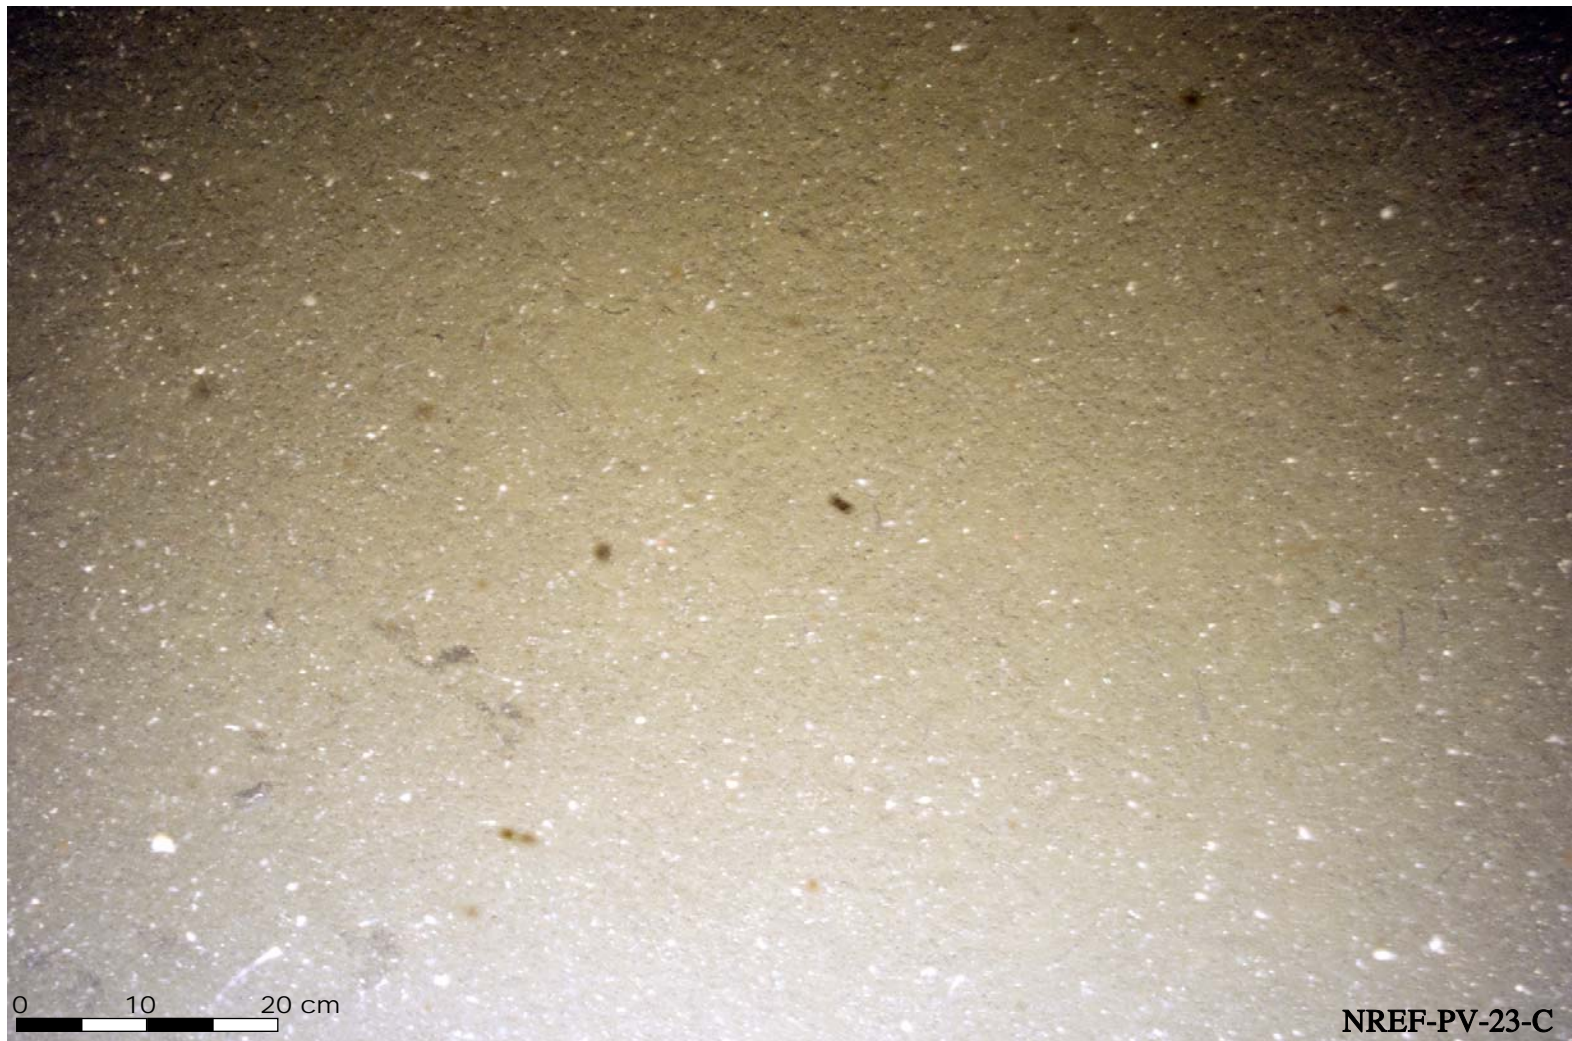
Figure 3-14. Plan-view image from NREF Station 23 showed a dense covering of tiny tubicolous fauna as well as small burrow openings.

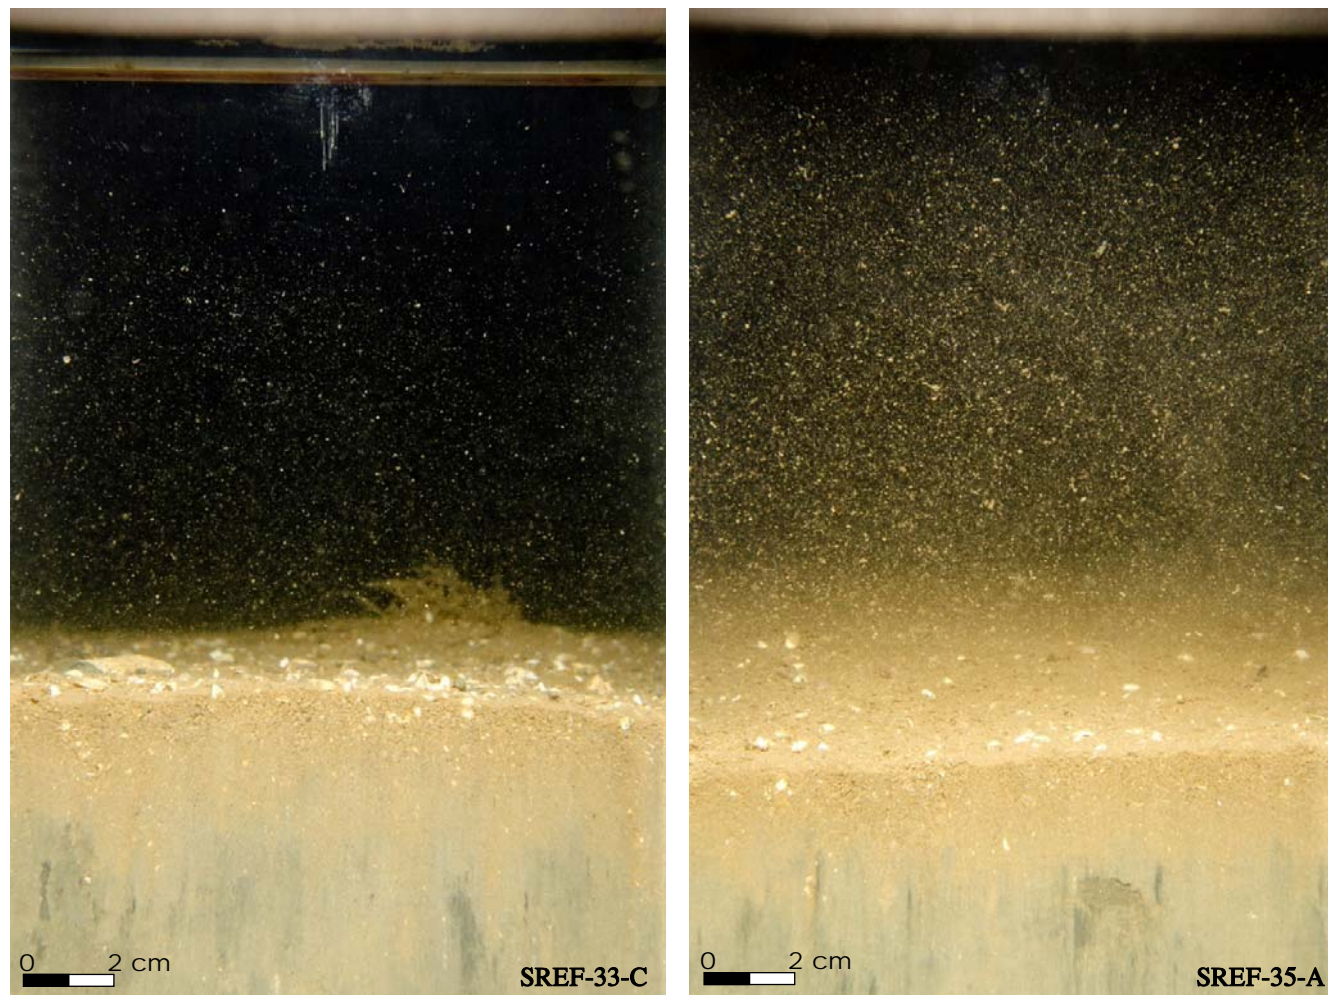
Figure 3-15. Sediment-profile images from SREF Stations 33 (left) and 35 (right) typified the sediment grain size major mode and range found at the majority of the south reference locations surveyed; note the varying degree of shell fragments on the sediment surface.

SREF was located approximately 5 km southeast of EPDS. Five SREF stations had a silty, very fine to fine-sand surface layer overlying a silt/clay foundation with varying degrees of shell armoring on the sediment surface (Figure 3-15). At one location (Station 36) the sediment surface was armored with shell hash (Figure 3-16).

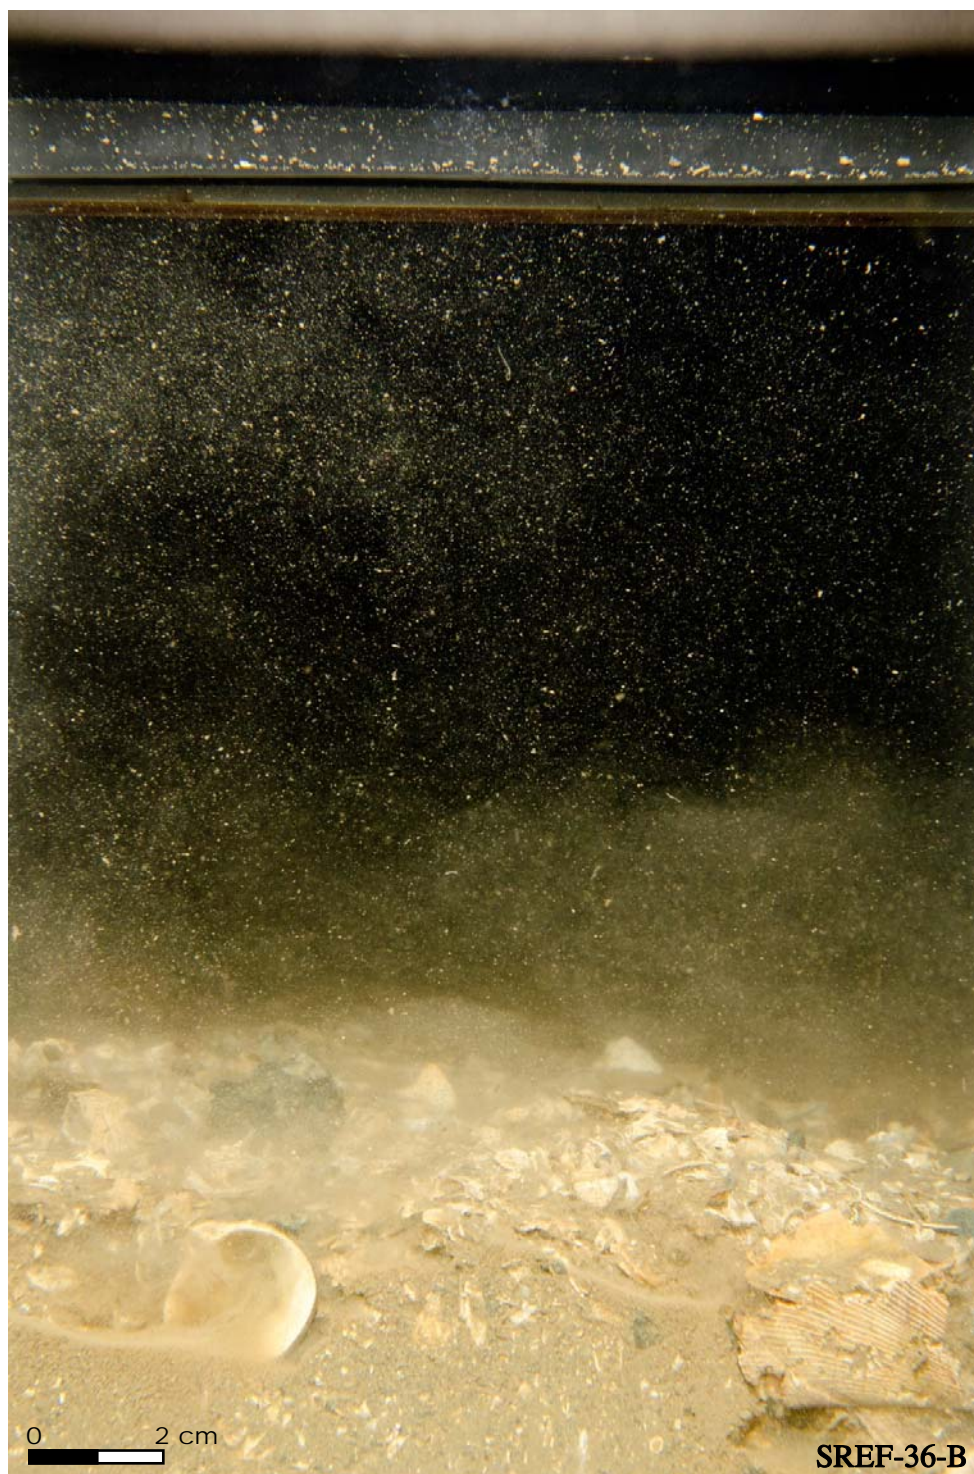
Figure 3-16. Sediment-profile image from SREF Station 36 showed the sediment surface armored with shell fragments which was an effective barrier to the camera prism penetration.

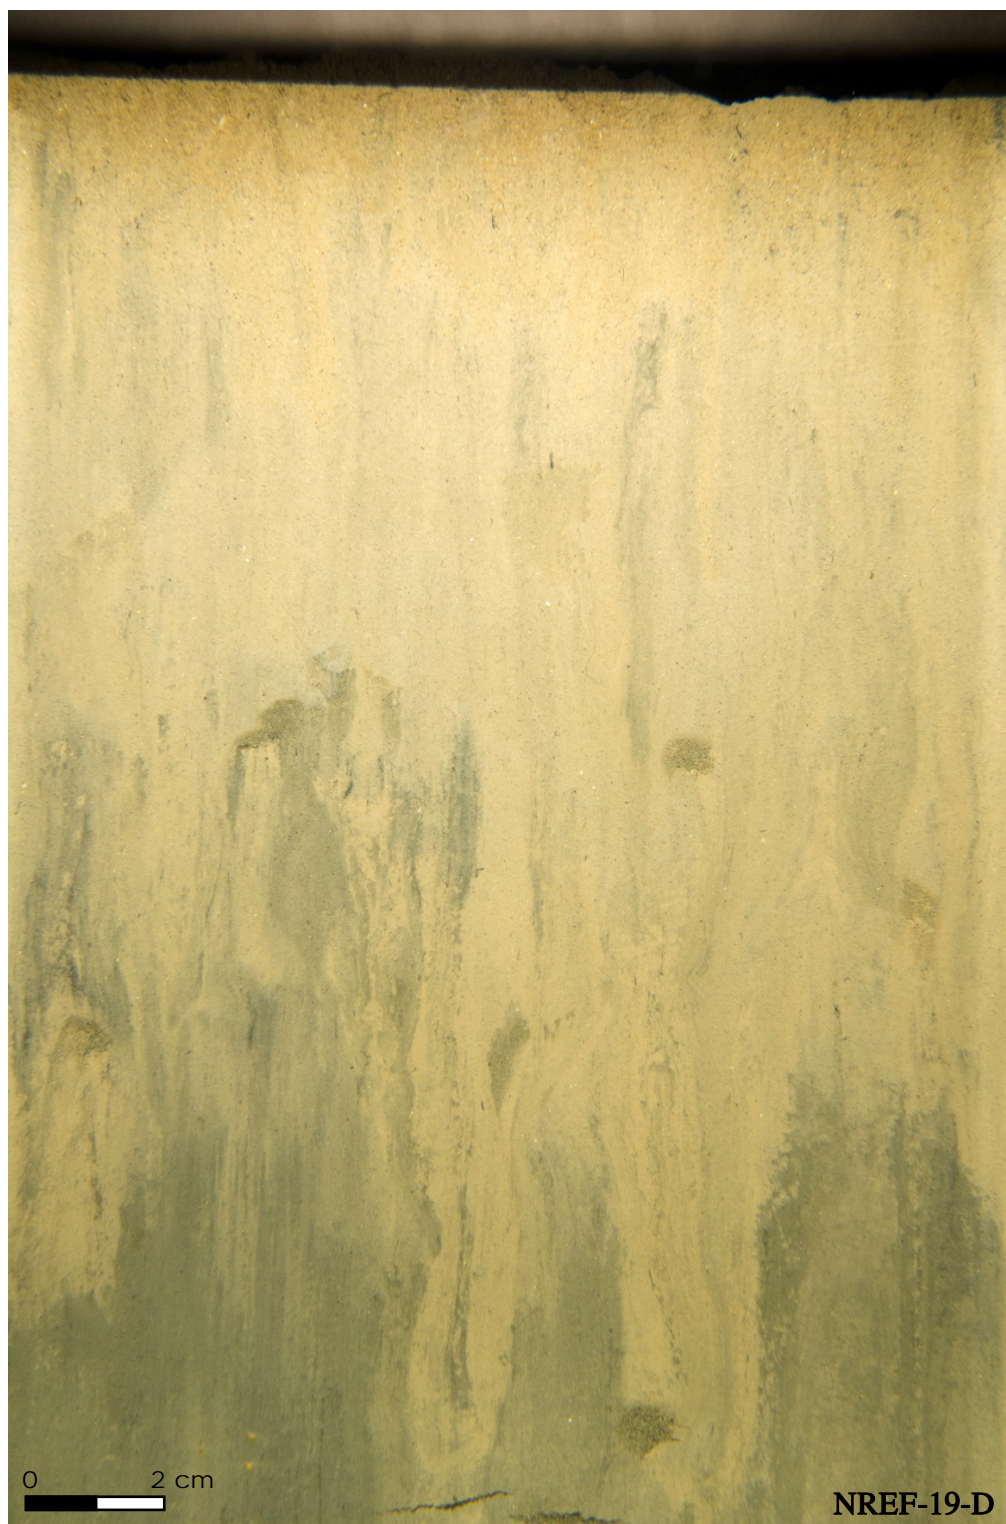
Figure 3-19. Sediment-profile image from NREF Station 19 showed evidence of infaunal activity to the full depth of the imaged cross-sectional area.

Biological Conditions and Benthic Recolonization: Station values for the mean aRPD depths at the reference stations ranged from 0.8 to 5.2 cm (Table 3-1, Figure 3-17). Evidence of Stage 3 infaunal deposit feeders was found at all the reference stations (Figure 3-18), with bioturbation depths extending to the full depth of prism penetration at some of the locations (Figure 3-19, Appendix A).

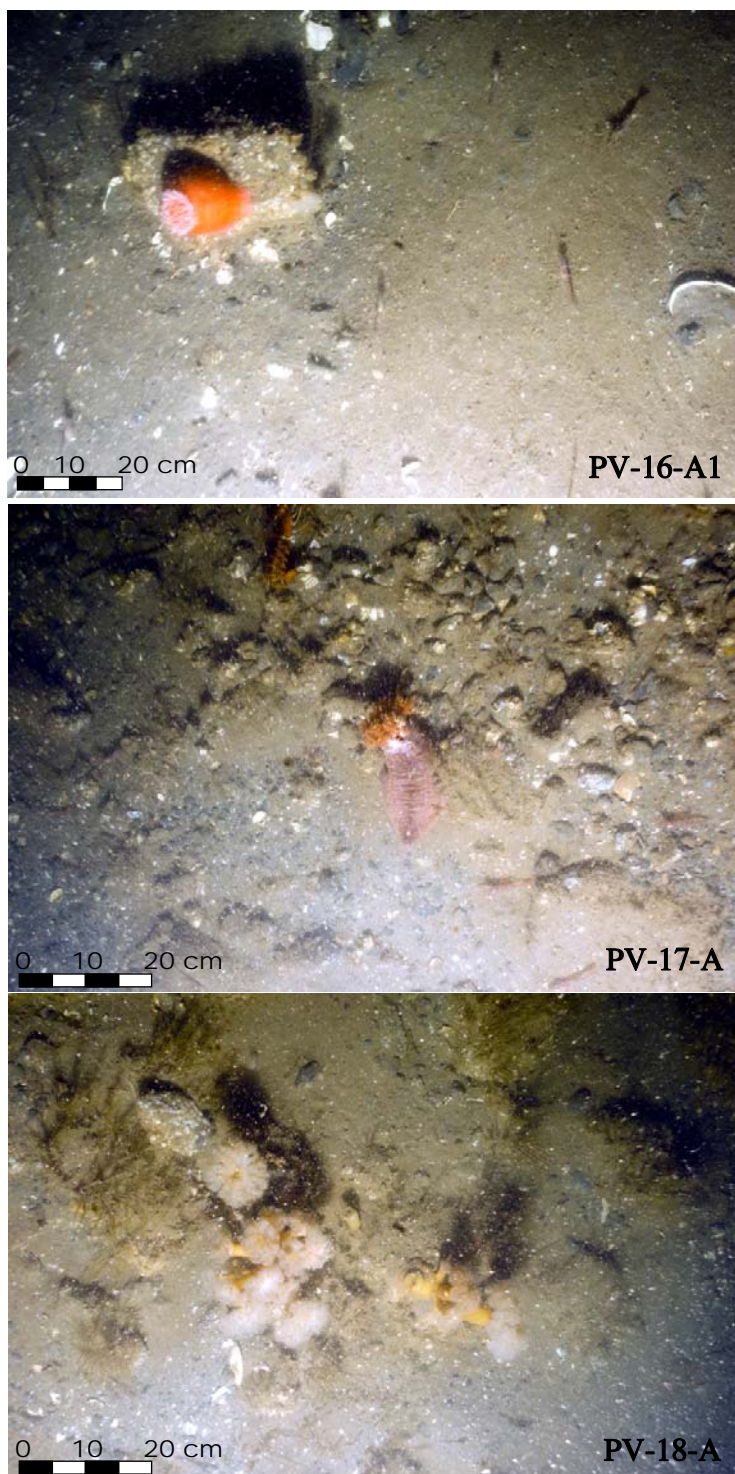
Figure 3-22. Plan-view images from Stations 16 (top), 17 (center) and 18 (bottom) on the western slope had rocky bottoms with complex topography that attracted larger, mobile epifauna.

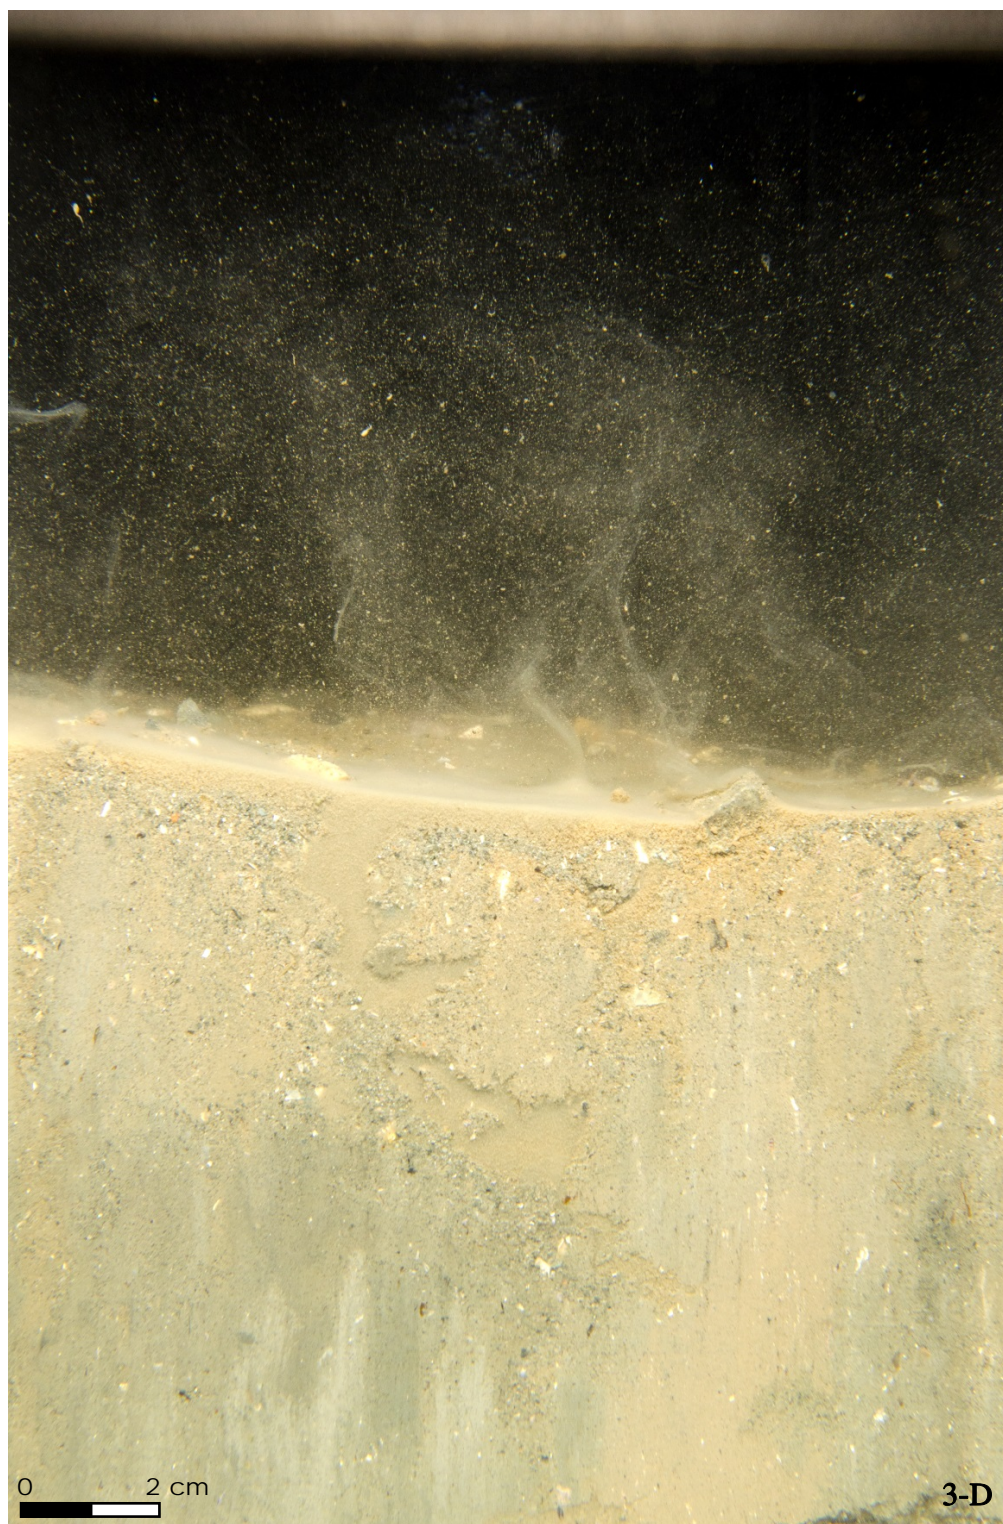
Figure 3-23. Sediment-profile image from Station 3 located on disposed material had silty, very-fine sands as a sediment grain size major mode (4-3 phi).

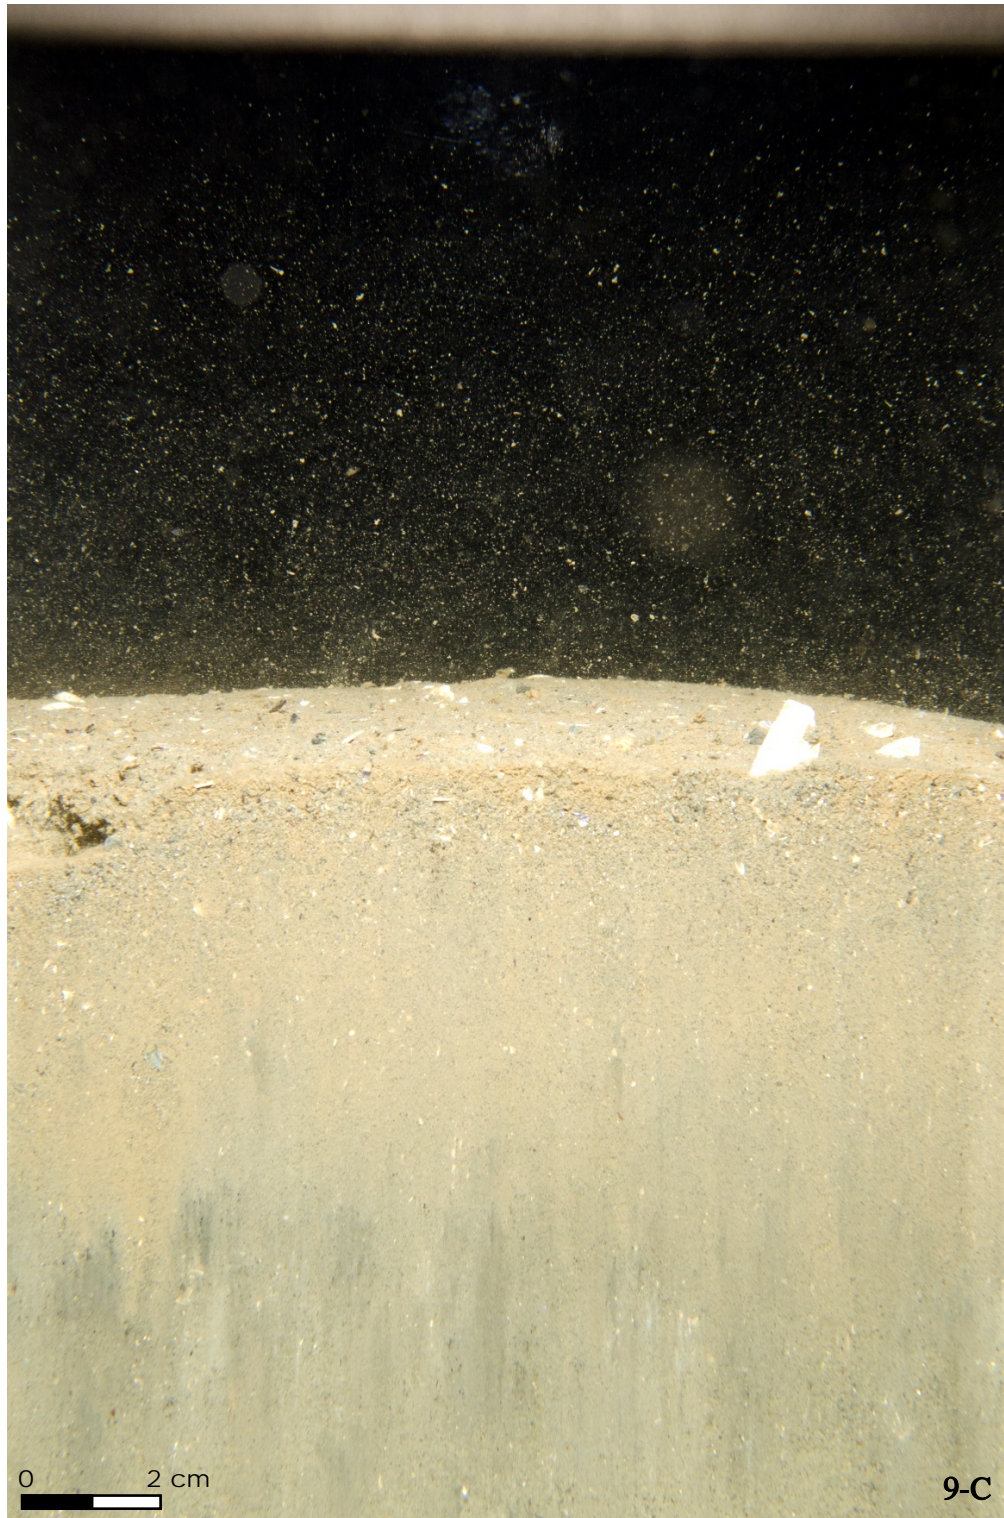
Figure 3-24. Sediment-profile image from Station 9 located on disposed material had a surface layer of silty fine sand overlying a basement foundation of silt/clay.

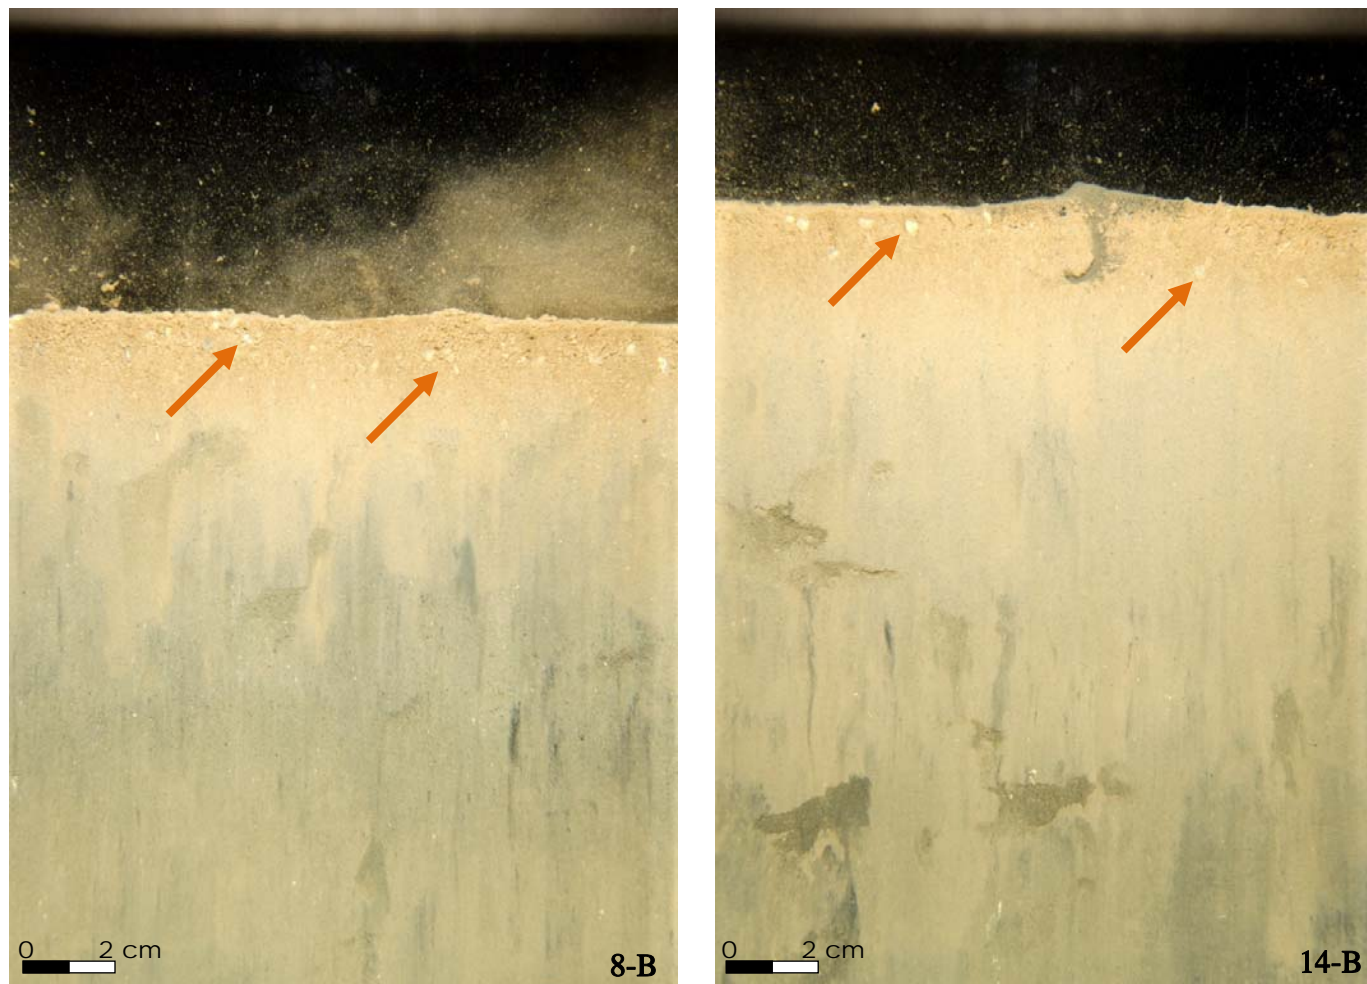
Figure 3-25. Sediment-profile images from Station 8 (left) located on disposed material and Station 14 (right) had a sediment grain size major mode of silt/clay (≥ 4 phi); arrows note the high densities of the coot clam, *Mulinia lateralis*, in the top 2 cm of the oxidized surface layer.

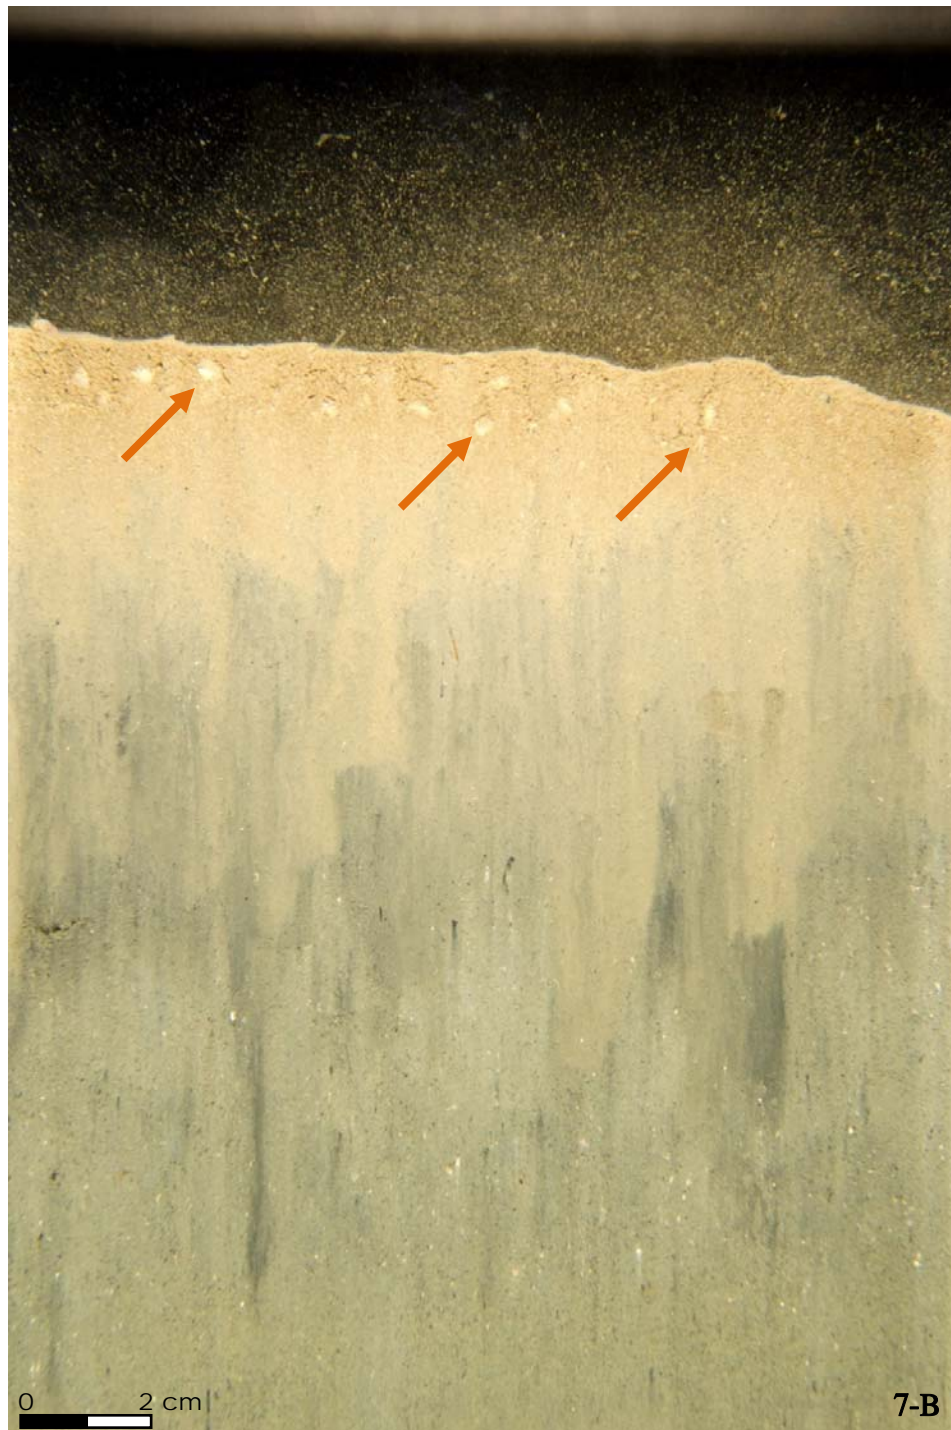
Figure 3-26. Sediment-profile image from Station 7 showed a dredged material layer exceeding prism penetration depth, yet there was a healthy oxidized surface layer of sediment (aRPD = 2.8 cm) with a relatively high density of *Mulinia* (arrows) near the sediment-water interface.

Biological Conditions and Benthic Recolonization: Station mean values for the aRPD depth at the disposal site ranged from 1.7 to 3.5 cm with an overall disposal site mean aRPD depth of 2.7 cm (Table 3-2, Figure 3-26). Evidence of mature, deposit-feeding assemblages (Stage 3 taxa) was found at all stations where the camera was able to get adequate penetration (Figure 3-27). The maximum depth of feeding void structures
