Monitoring Survey at the Eastern Passage Disposal Site October 2012

Disposal Area Monitoring System DAMOS

Contribution 194
June 2013

**MONITORING SURVEY AT THE
EASTERN PASSAGE DISPOSAL SITE
OCTOBER 2012**

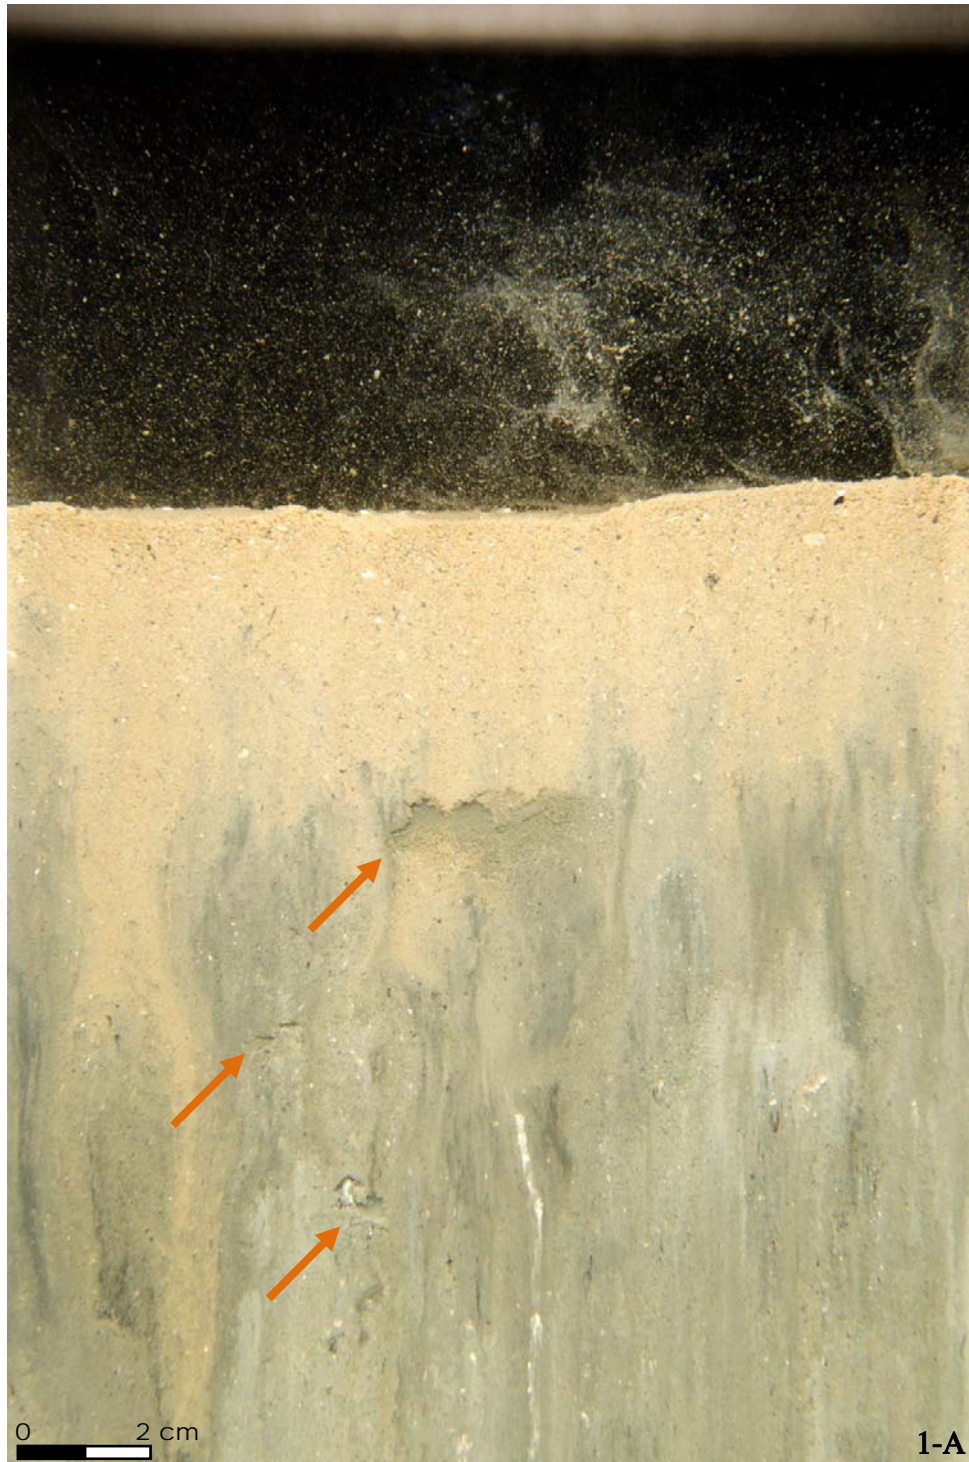
Figure 3-28. Sediment-profile image from Station 1, located in the deeper areas of the disposal site where the majority of the dredged material accumulated, showed active feeding voids (arrows) at depth.

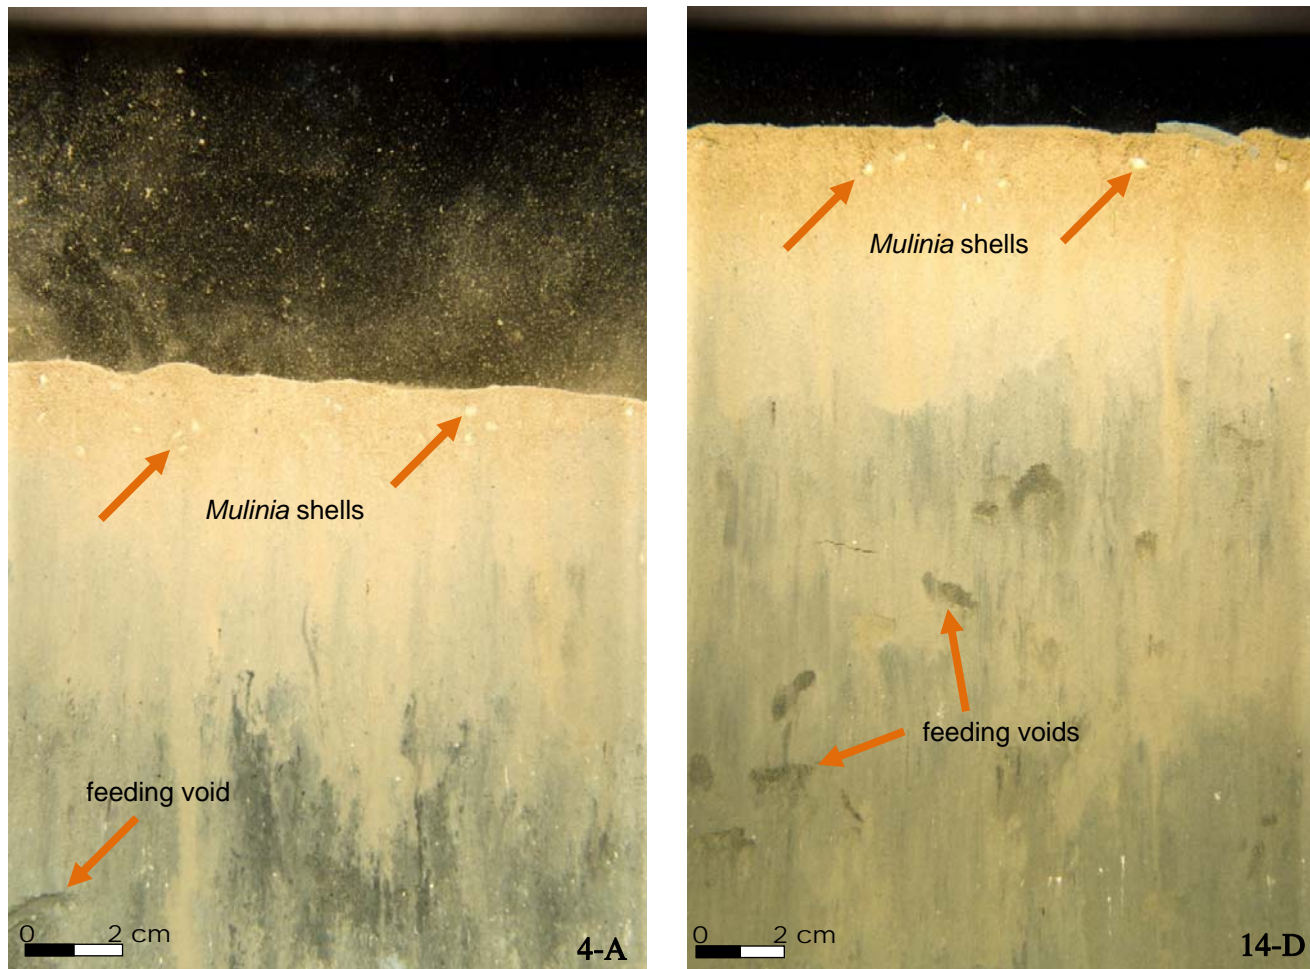
Figure 4-2. Sediment-profile images from Station 4 (left) located on the dredged material in the bathymetric trough within the disposal site and Station 14 (right) located in the shallower northeast corner of the site showed similar sediment type, aRPD depth, and successional assemblages (arrows note both the subsurface feeding voids as well as the presence of *Mulinia* shells in the upper oxidized layer).

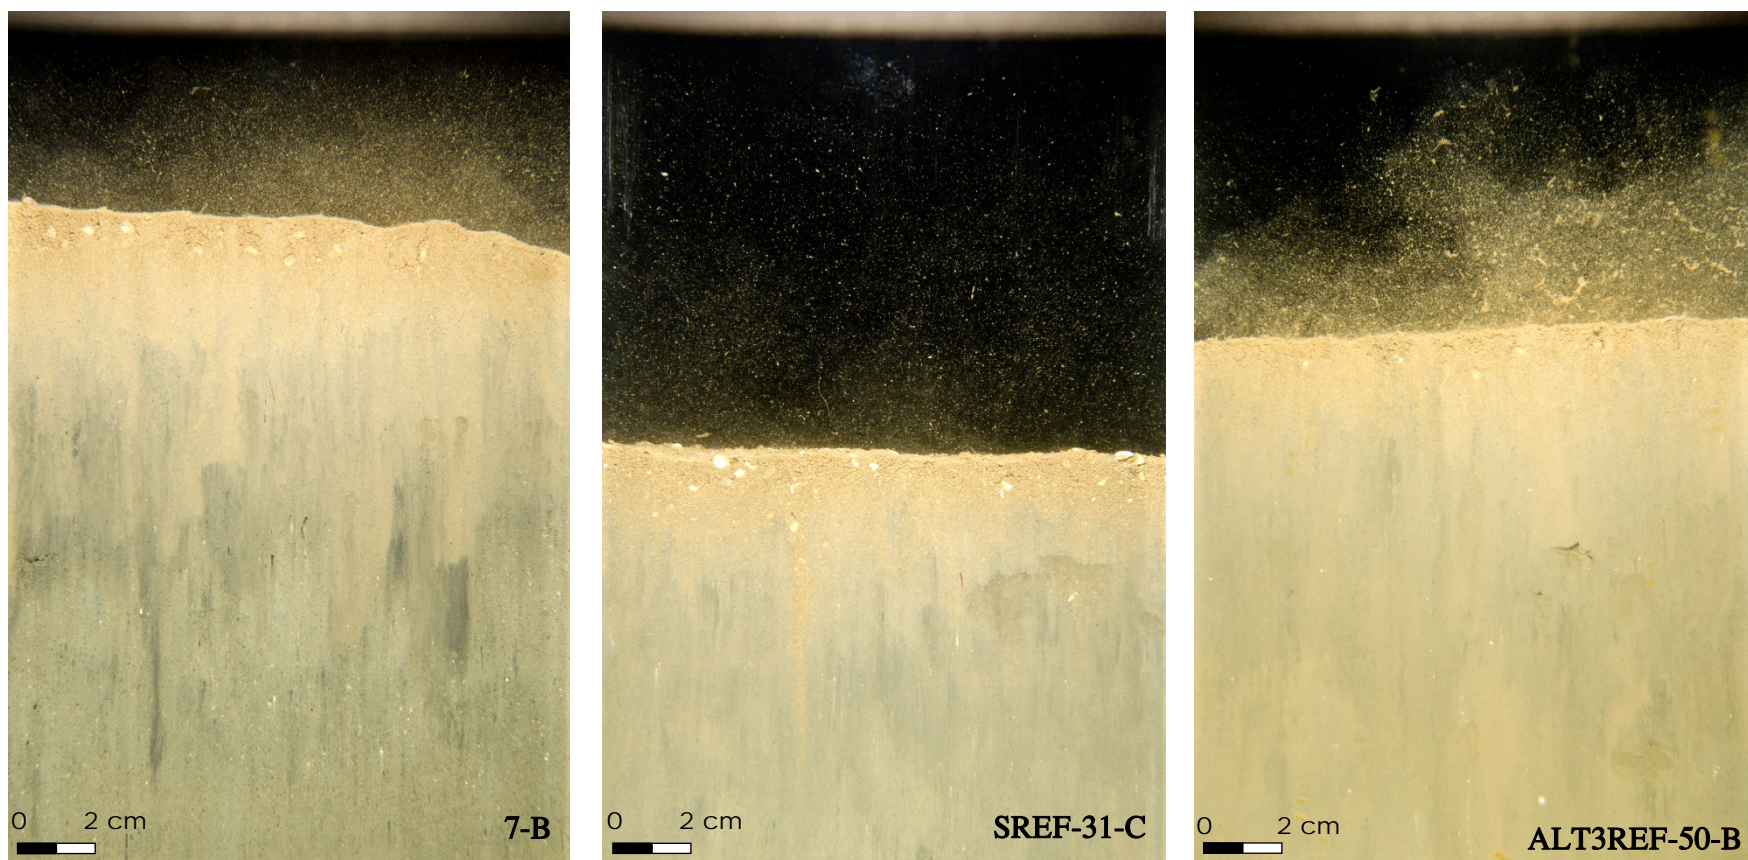
Figure 4-7. Sediment-profile images from Station 7 (left) located within EPDS, Station 31 (center) from SREF, and Station 50 (right) from the ALT3REF showed similar sediment type, aRPD depth, and successional assemblages (note both the sediment grain size as well as the presence of *Mulinia* shells in the upper oxidized layer).

To support selection of suitable reference areas, substrata at each of the four reference areas were classified as hard or soft based on camera penetration (Figure 4-6), and the two distinct sedimentary habitats within the disposal site were classified (Figure 4-3). SREF and ALT3REF were found to be most representative of pre-impact EPDS central trough area conditions and are recommended as suitable reference areas (Figure 4-7).

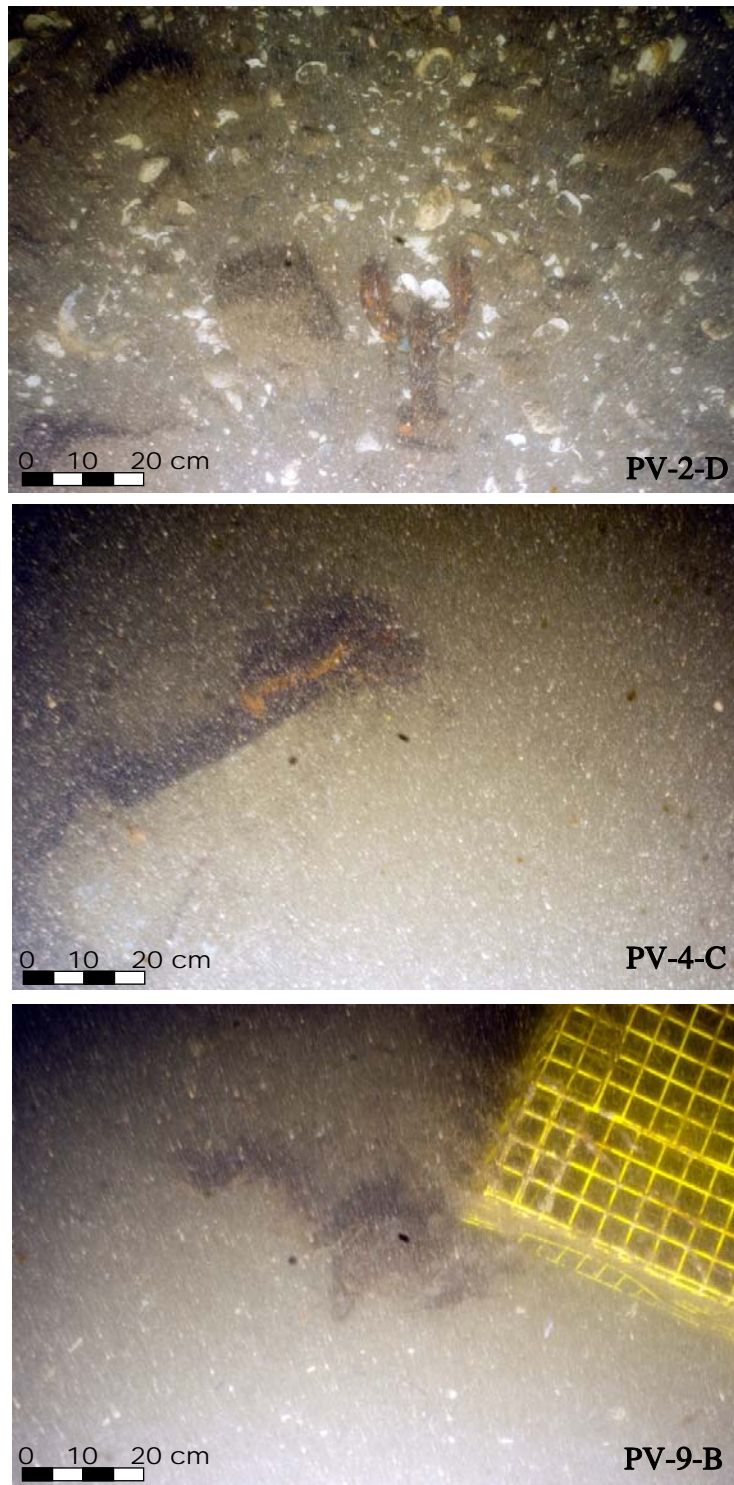
Figure 4-8. Plan-view images from Station 2 (top), Station 4 (center) and Station 9 (bottom) showed evidence of an active lobster/lobstering area had not been hampered by the disposal operation.
