Baseline Seafloor Assessment Survey for the Proposed Expansion  
of the Massachusetts Bay Disposal Site September/October 2015

# Disposal Area Monitoring System - DAMOS

Contribution 201  
January 2017

**BASELINE SEAFLOOR ASSESSMENT SURVEY FOR THE PROPOSED  
EXPANSION OF THE MASSACHUSETTS BAY DISPOSAL SITE  
SEPTEMBER/OCTOBER 2015**

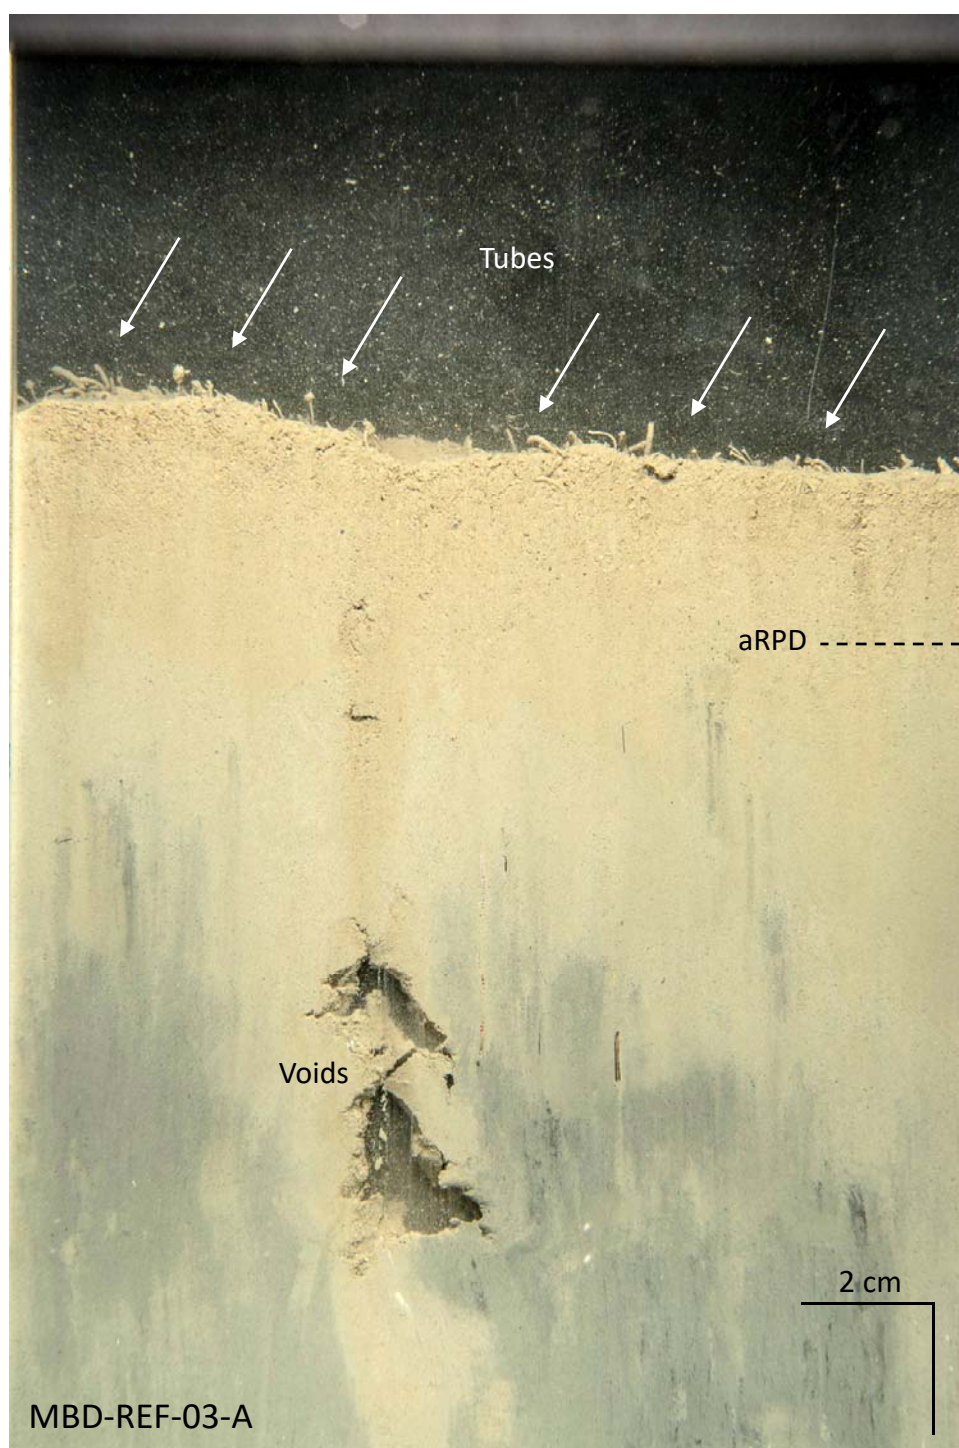
**Figure 3-17.** Sediment-profile image from Station MBD-REF-03 is representative of Stage 1 on 3 infauna; surface tubes at the sediment-water interface (white arrows) with large feeding voids observed in the sediment column below the aRPD

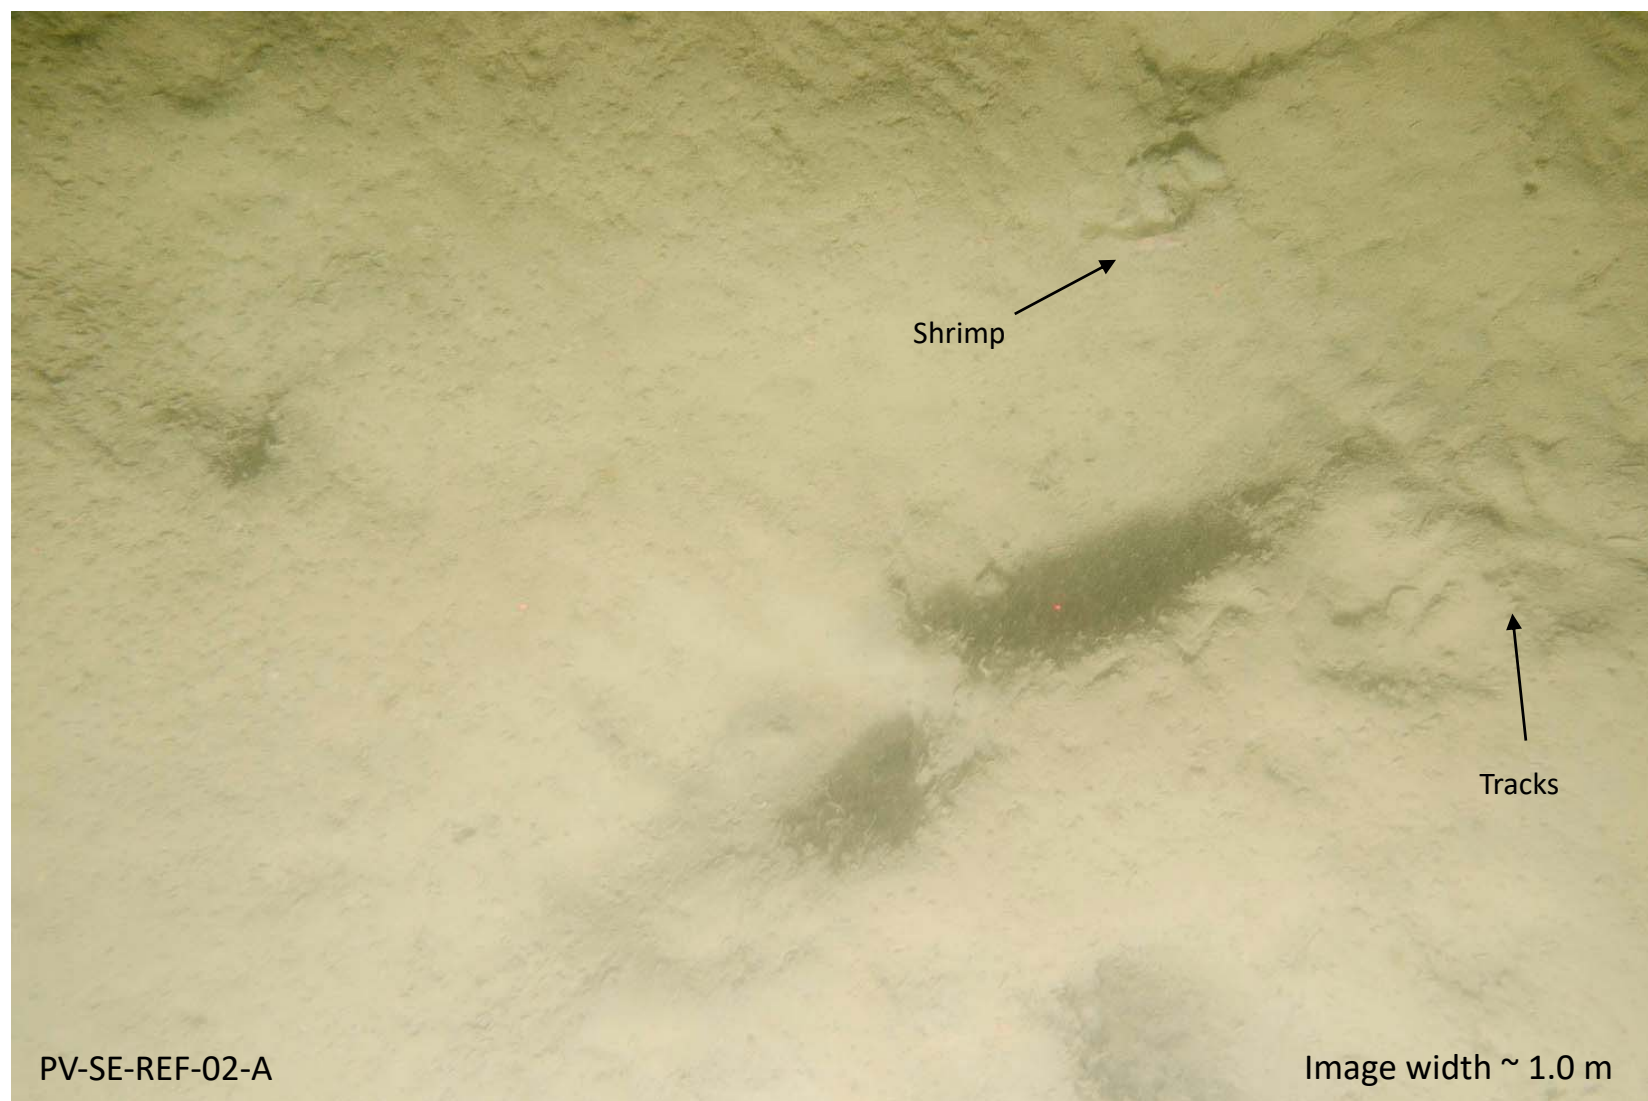
**Figure 3-21.** Plan-view image from Station SE-REF-02 depicting tracks and a shrimp on the seafloor

(10% to 25% coverage; Figure 3-19). The presence of tubes, indications of Stage 1 taxa, ranged from present at reference area MBD-REF, to dense (>75% coverage) at reference area SE-REF (Figure 3-20). Tracks across the seafloor, often created by epifauna (decapods, gastropods), were seen at all three reference areas (Figure 3-21, Appendix D). The seafloor of the reference areas was free of debris, excluding a replicate at one station (PV\_SE-REF-05-B) where small shell fragments were observed in PV images (Figure 3-20). No fish or flora were present in the PV images across reference areas (Appendix D). Due to bottom water turbidity determination of a number of biogenic features (tubes, bedforms, burrows) was not possible in PV images captured at reference area FG-23 (Appendix D).

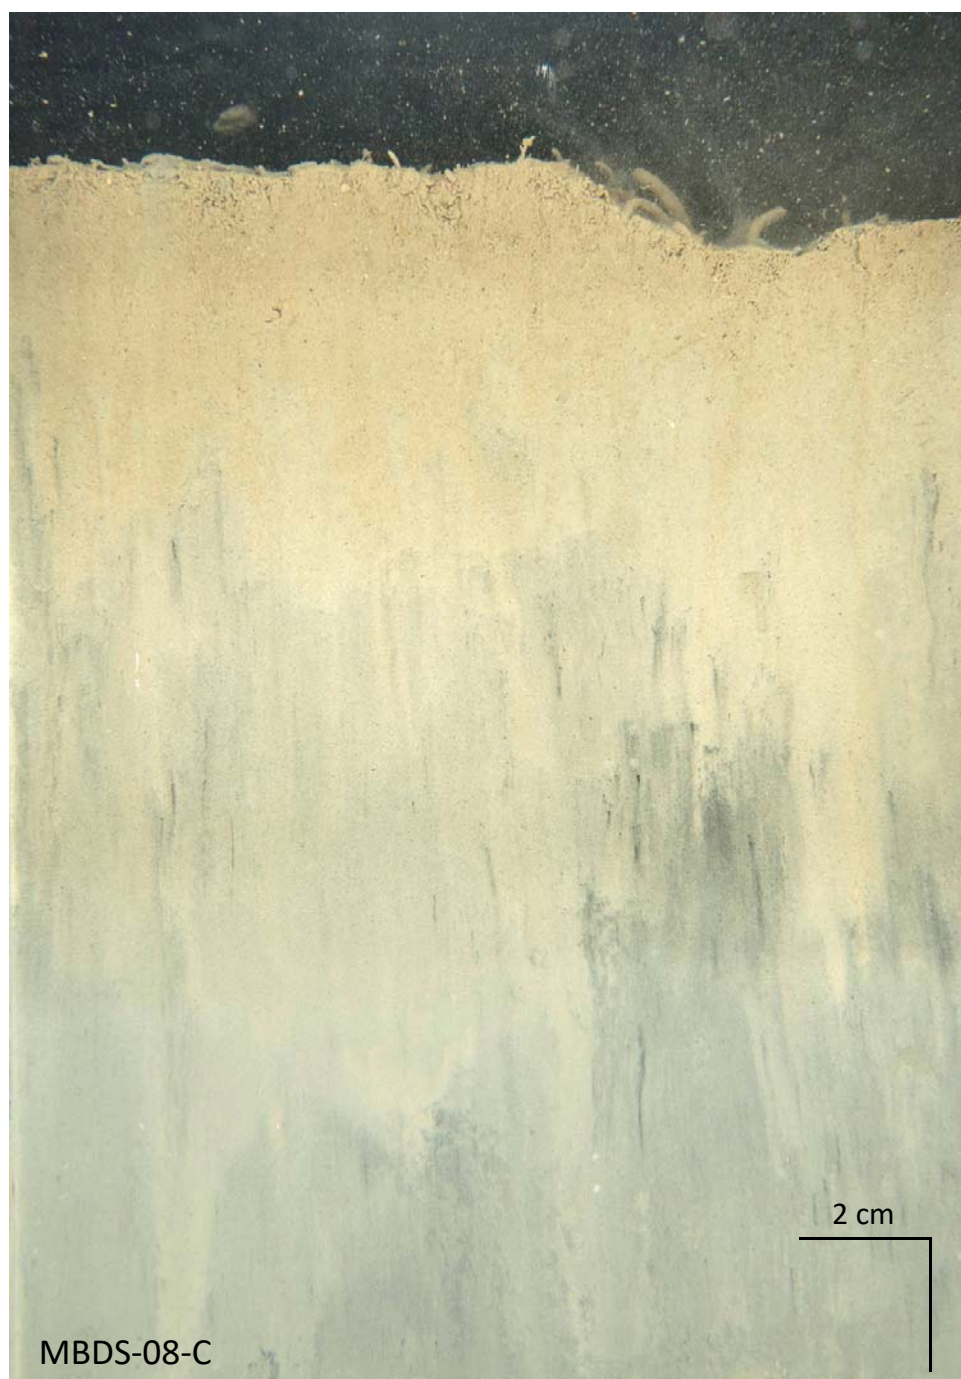
**Figure 3-23.** Sediment-profile image from Station MBDS-08 is representative of the  $>4$  phi (silt-clay) grain size major mode, and pelletized sediment-water interface, present at the majority of stations in the MBDS survey area

The sediments at stations in the MBDS survey area were mostly spatially homogenous, consisting of uniform light brown over light gray silt-clay, with a grain size major mode of >4 phi (Figures 3-22 and 3-23). Three stations varied from this description, Station MBDS-11 had light brown silt-clay with a depositional layer of white glacial clay dredged material (Figure 3-24), and Stations MBDS-24 and MBDS-26 had light brown over a darker grayish black silt-clay (Figure 3-25). Grains at the sediment-water interface were generally larger, pelletized silt-clay particles (Figure 3-23), and the sediment column was extensively reworked historical dredged material (addressed in detail in Section 3.2.2.2). Historical dredged material was present at the majority of stations (Figure 3-26) and extended below the penetration maximum of the prism at all stations where it was observed (Figure 3-27A). For these stations the dredged material thickness must be considered a minimum thickness based on prism penetration. The mean of measured dredged material thickness ranged from 7.4 to 21.1 cm, with an overall MBDS station mean of 17.3 cm (SD±2.5). Most stations contained a dredged material layer that was greater than 15 cm in thickness (Table 3-2, Figure 3-28). The one exception, Station MBDS-29, had a smaller documented thickness of dredged material that was largely due to the low prism penetration depth at this site (Figure 3-29). A few stations, 7 of the 30, did not contain dredged material (Figure 3-27B). Most of the stations where dredged material was not present were located in the western portion of the MBDS survey area, except for Station MBDS-25 (Figure 3-26). There was no evidence of low dissolved oxygen (DO) or sedimentary methane at any station.

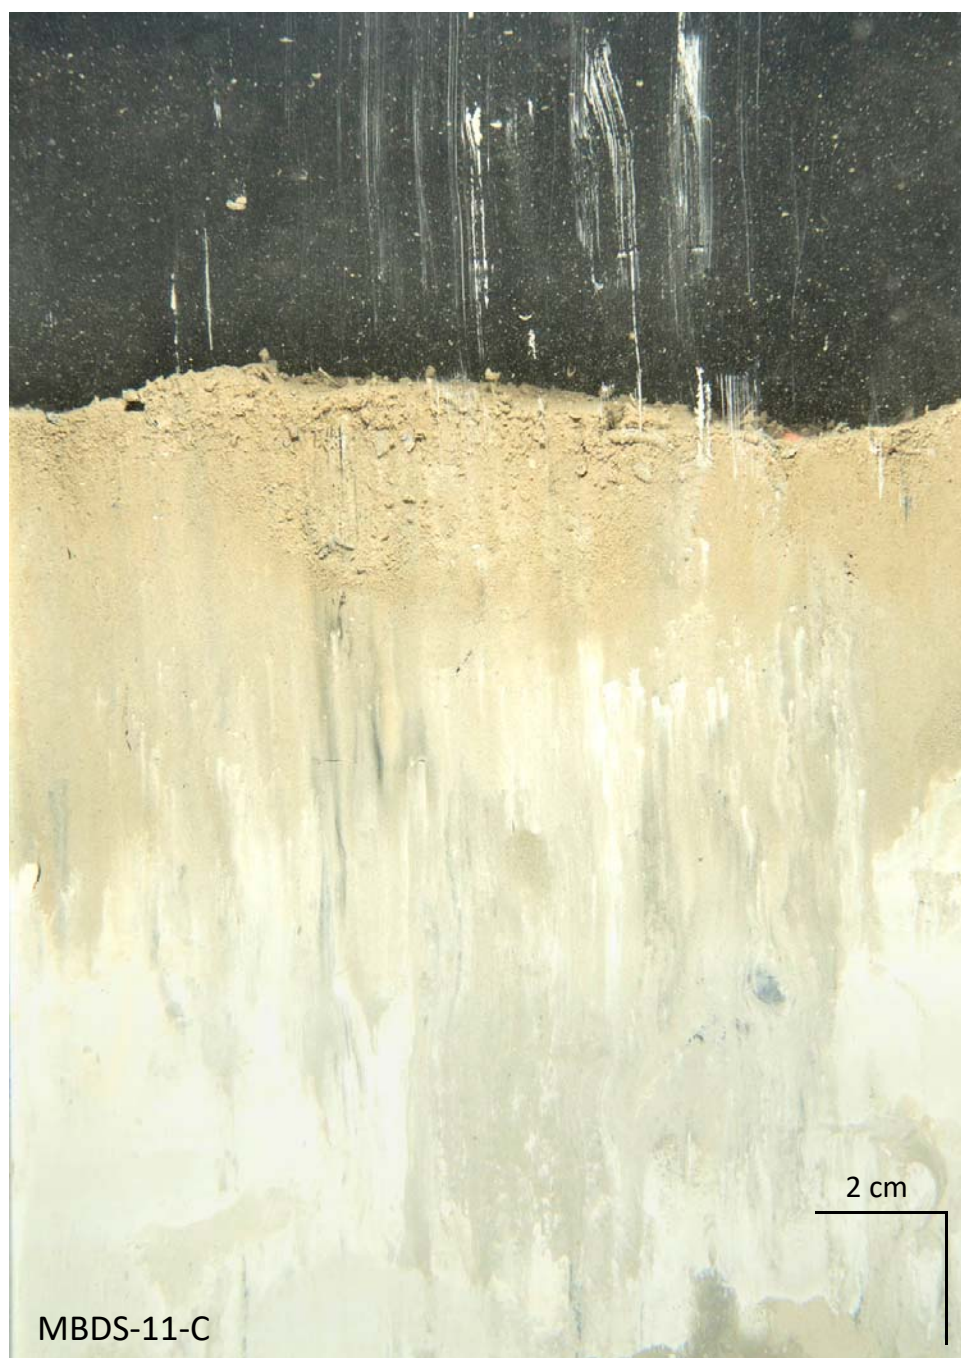
**Figure 3-24.** Sediment-profile image from Station MBDS-11 depicting light brown silt-clay with a depositional layer of white glacial clay dredged material

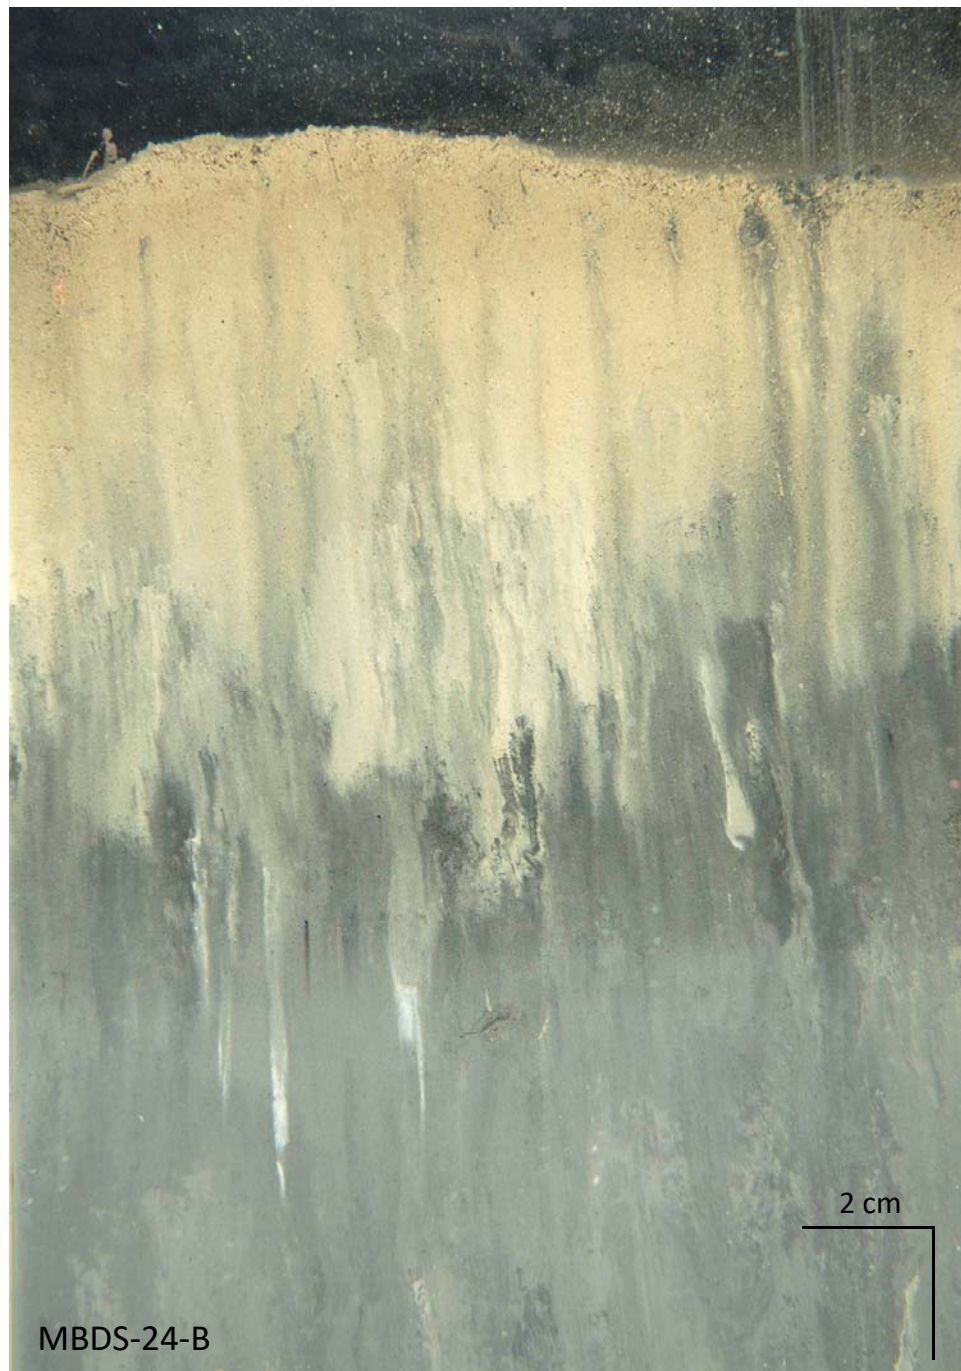
**Figure 3-25.** Sediment-profile image from Station MBDS-24 is representative of a sediment column with light brown silt-clay over a darker silt-clay

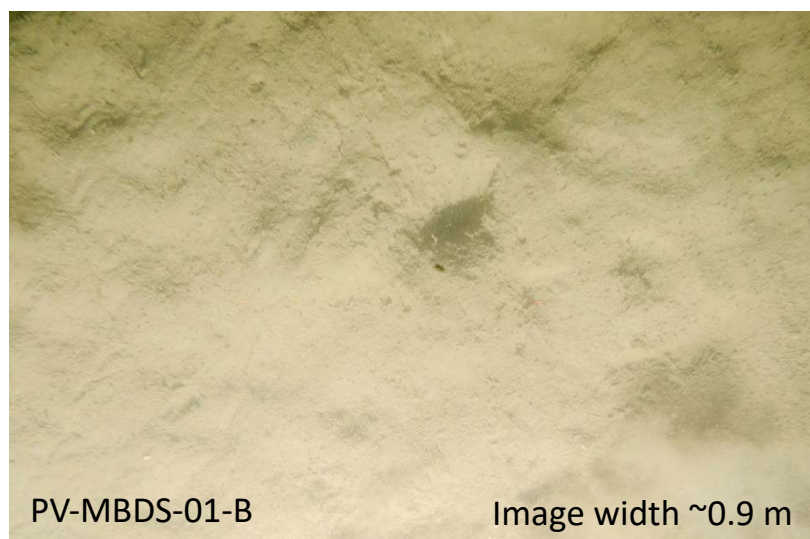
**Figure 3-40.** Plan-view images from (A) Station MBDS-01 representative of <10% burrow coverage, (B) Station MBDS-05 representative of 10-25% burrow coverage, and (C) Station MBDS-18 representative of 25-75% burrow coverage
