Muddy River Flood Risk Management & Environmental Restoration Project
Phase 1 Construction Activities Next 90 Days
May 2016

MUDDY RIVER FLOOD DAMAGE
REDUCTION AND ENVIRONMENTAL
RESTORATION PROJECT
(PHASE 1)
BOSTON AND BROOKLINE, MASSACHUSETTS

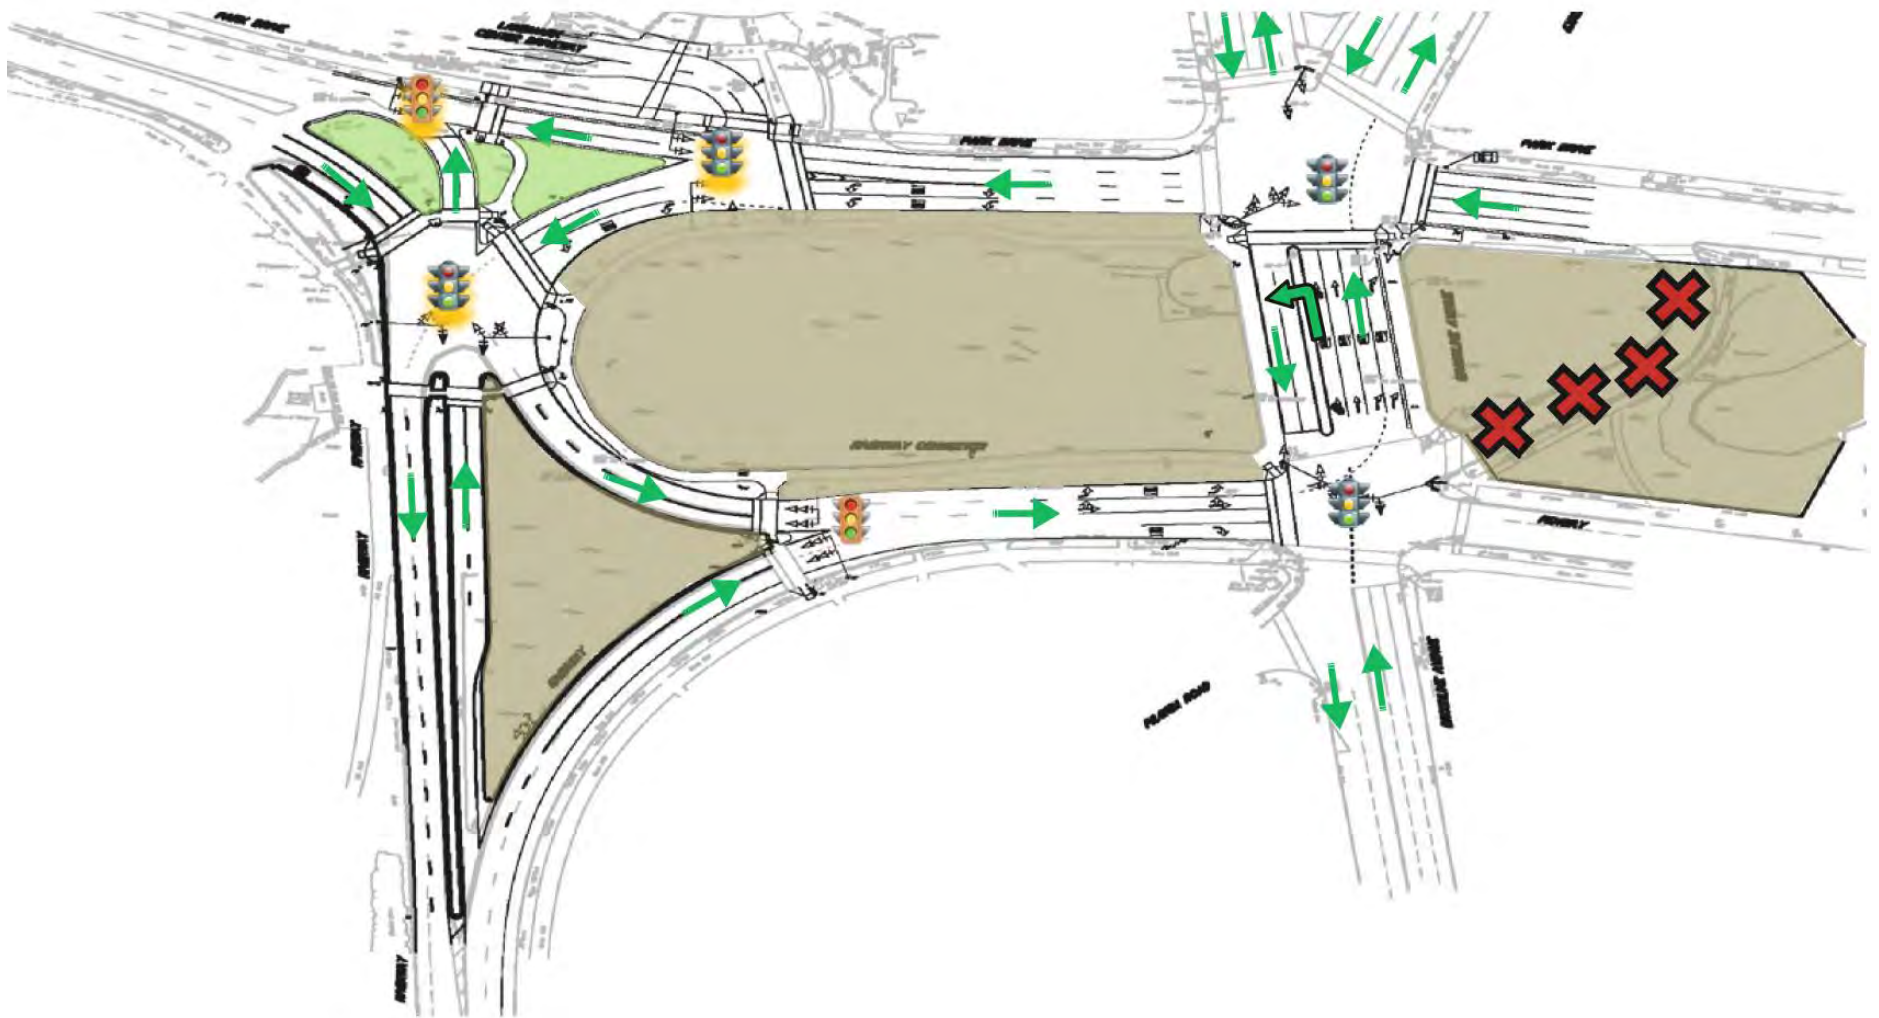
TRAFFIC MANAGEMENT PLAN DURING THE DAYLIGHTING OF THE MUDDY RIVER AT THE JUG HANDLE ROADWAY AND THE FORMER SEARS PARKING LOT

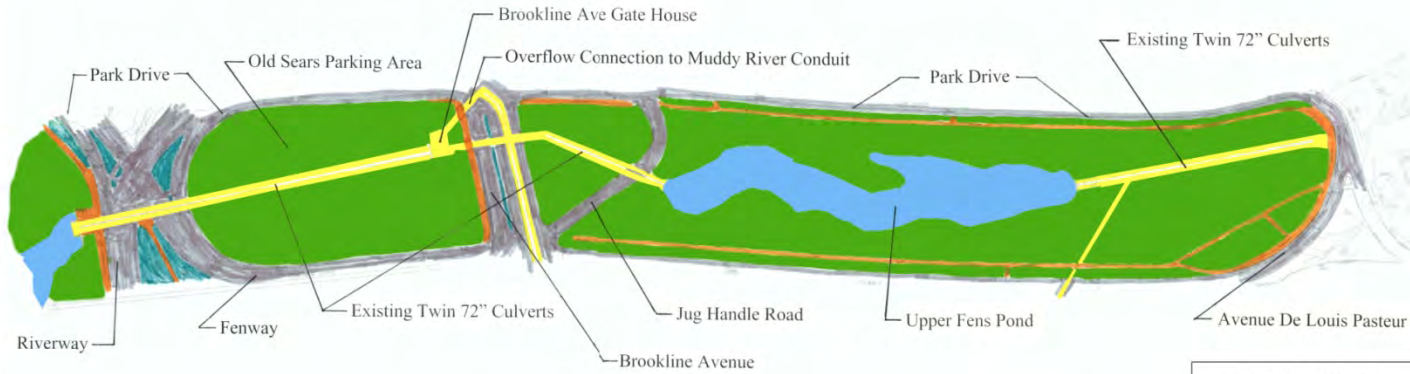
Existing Phase 1 Conditions

MUDDY RIVER FLOOD DAMAGE
REDUCTION AND ENVIRONMENTAL
RESTORATION PROJECT
EXISTING CONDITIONS
BOSTON AND BROOKLINE, MASSACHUSETTS

General: The Muddy River Flood Risk Management (FRM) & Environmental Restoration Phase 1 Construction Project is located in the footprint generally between the Riverway downstream to Avenue Louis Pasteur. The major project components involve the installation of a 10-foot by 24-foot box culvert under the Riverway roadway, the installation of 10-foot by 24-foot box culvert under the Brookline Avenue roadway, daylighting of the area between the Riverway and Brookline Avenue, and daylighting of the area between Brookline Avenue and Avenue Louis Pasteur. Daylighting is the removal of existing twin 72" culverts and excavation of the area to return the waterway to a natural state. This Notice is intended to identify the general construction activities that will be performed in the next 90 days. A figure that shows the existing conditions and the proposed improvements is at the end of this report.

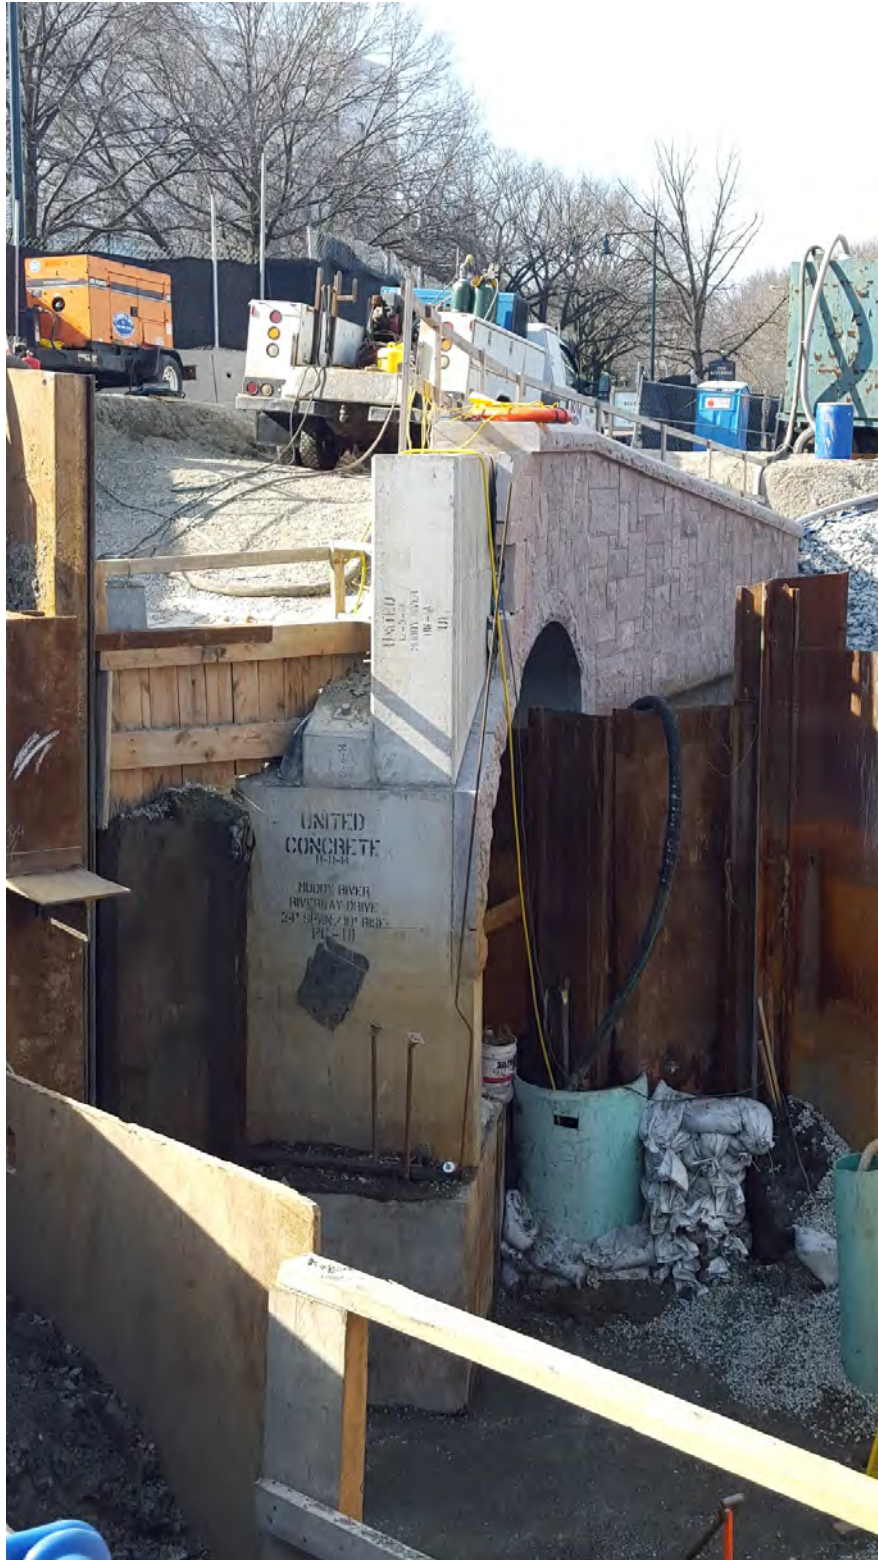
Existing Riverway Intake Structure Removed – Area ready for installation of pipe piles for the upstream northwest wing wall – late March 2016.

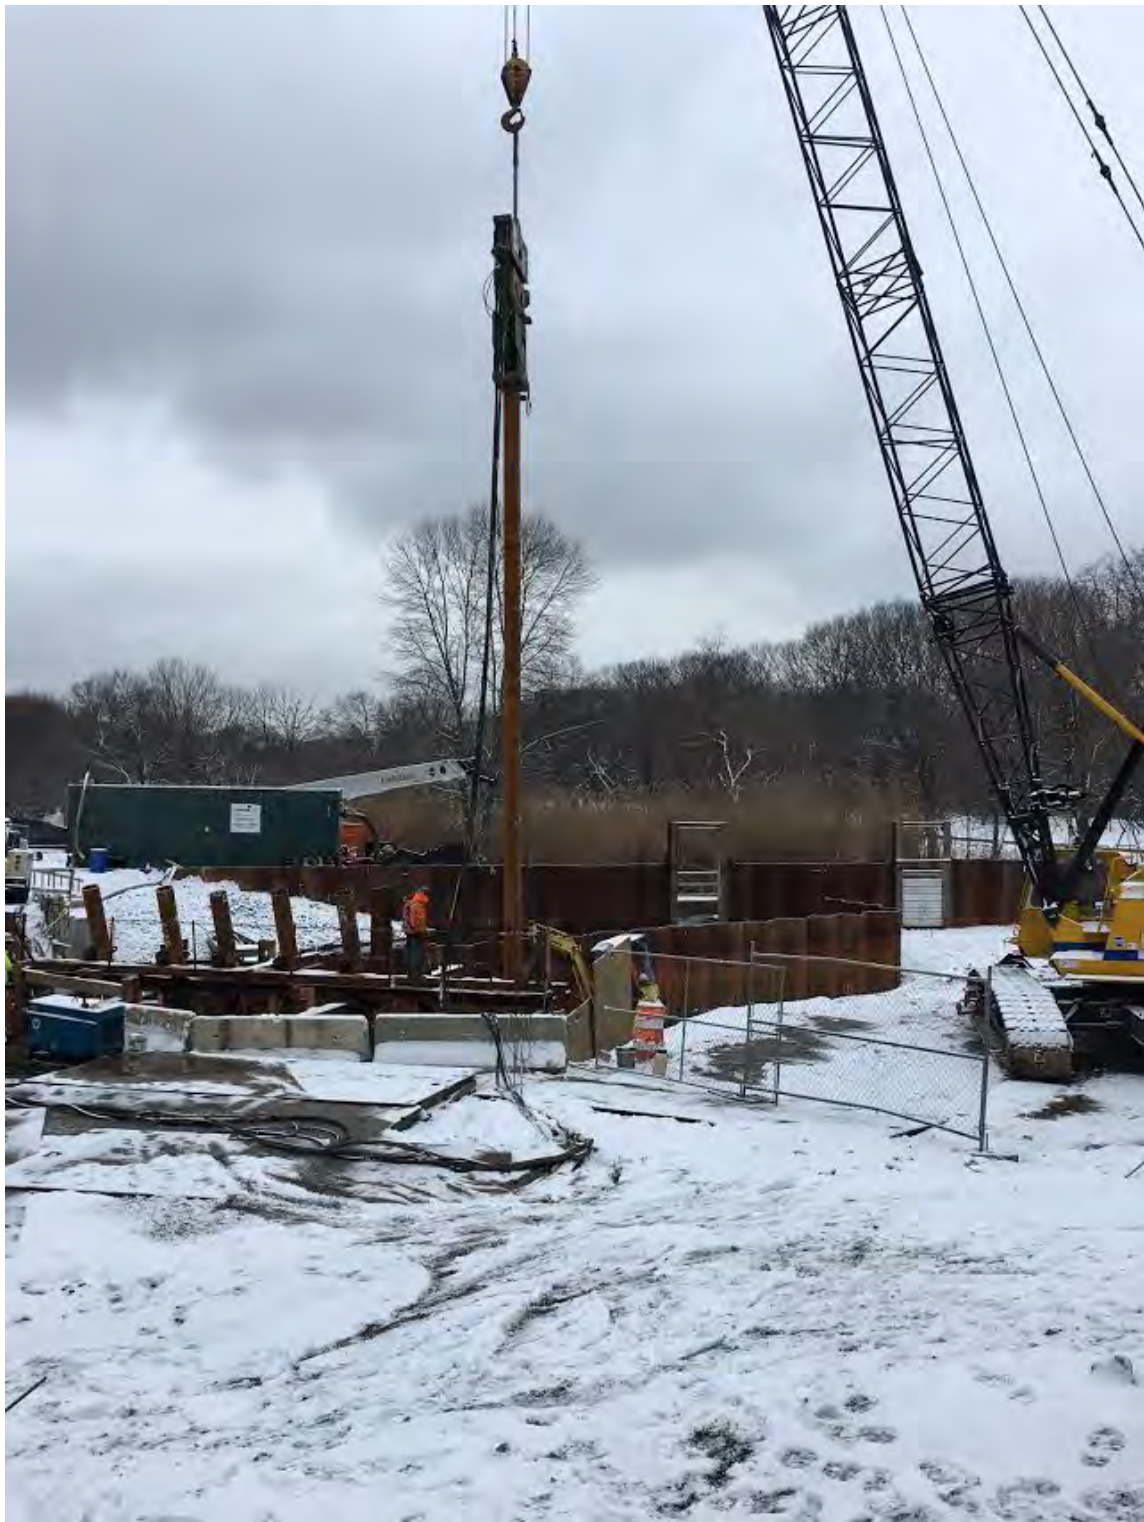
Riverway Culvert Area – Installation of the steel pipe piles for the northwest wing wall – early April 2016.

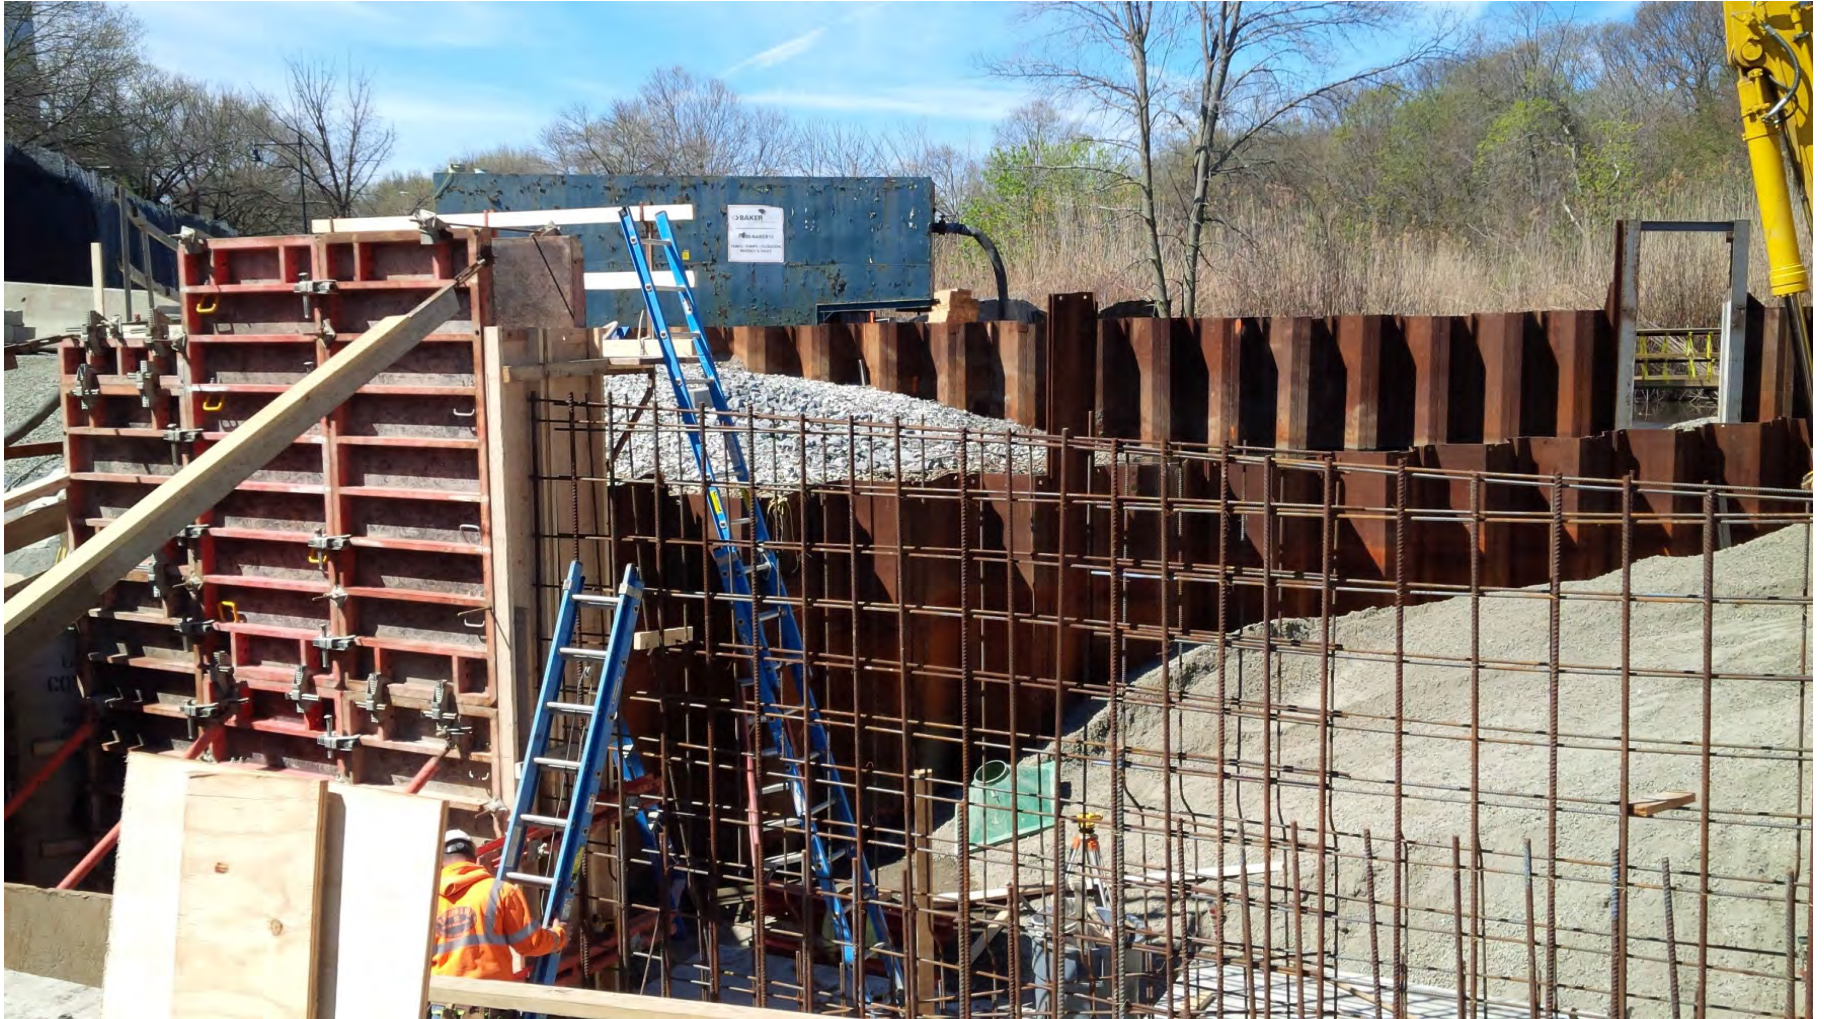
Rebar and formwork for the northwest wing wall at the new Riverway Culvert – late April 2016.

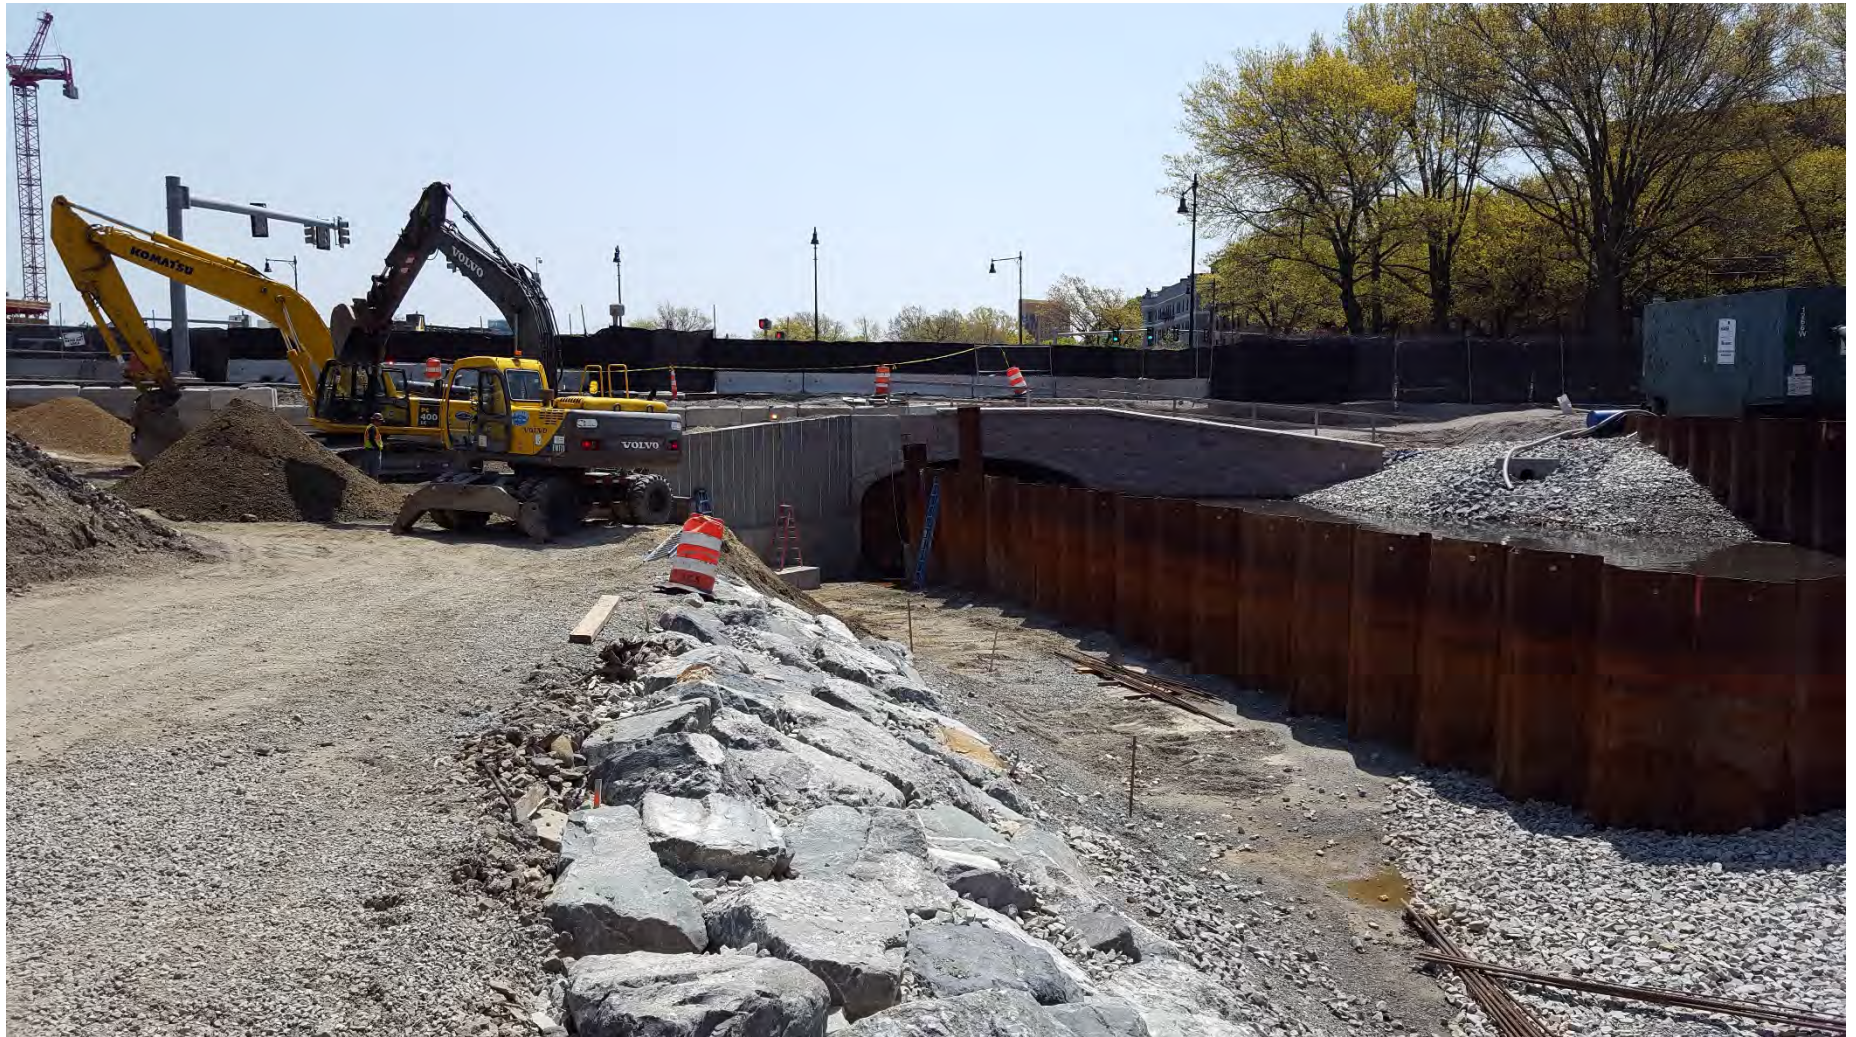
Upstream Riverway Culvert – northwest wing wall cast and ready for granite veneer installation and continued shaping of the flood risk management (FRM) channel – mid-May 2016.

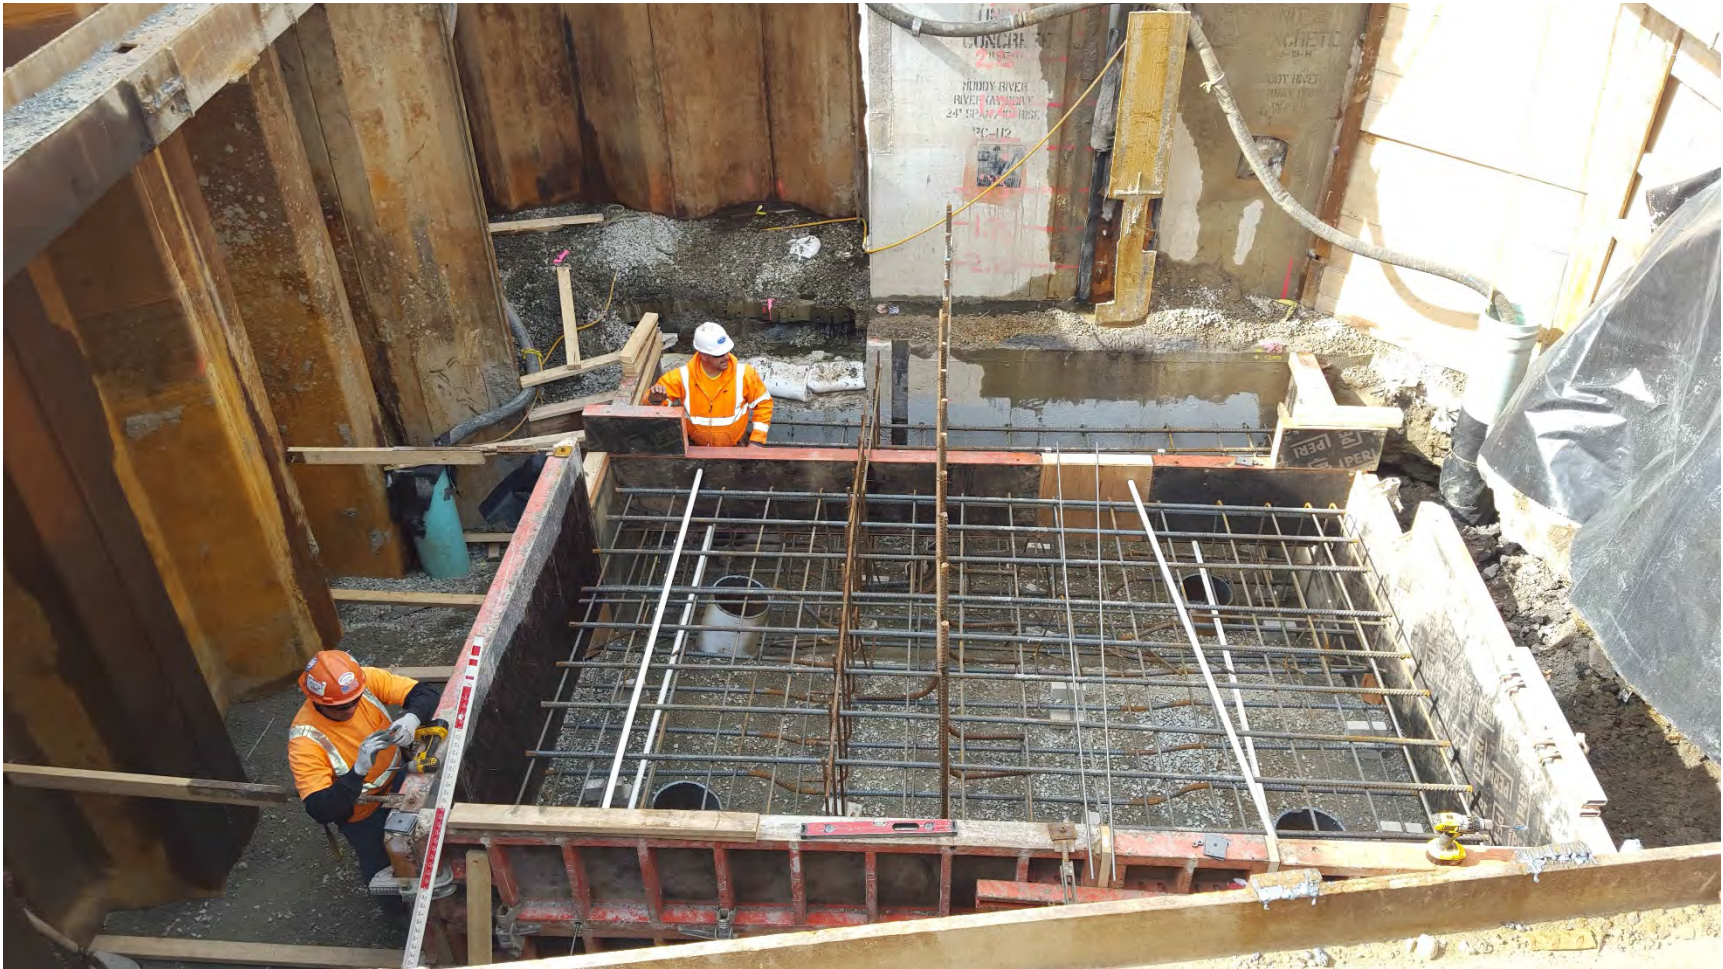
Riverway Culvert – Downstream northeast wing wall – steel pipe piles installed and rebar and formwork installed for the pile cap – late March 2016.

2. At the downstream end of the new Riverway Culvert, a portion of the existing twin 72" culverts was removed to install the steel pipe piles, concrete pile cap and the northeast wing wall. Granite veneer has been installed and back fill behind the wing wall. Upcoming activities include the installation of articulated concrete blocks (ACBs) downstream of the culvert.

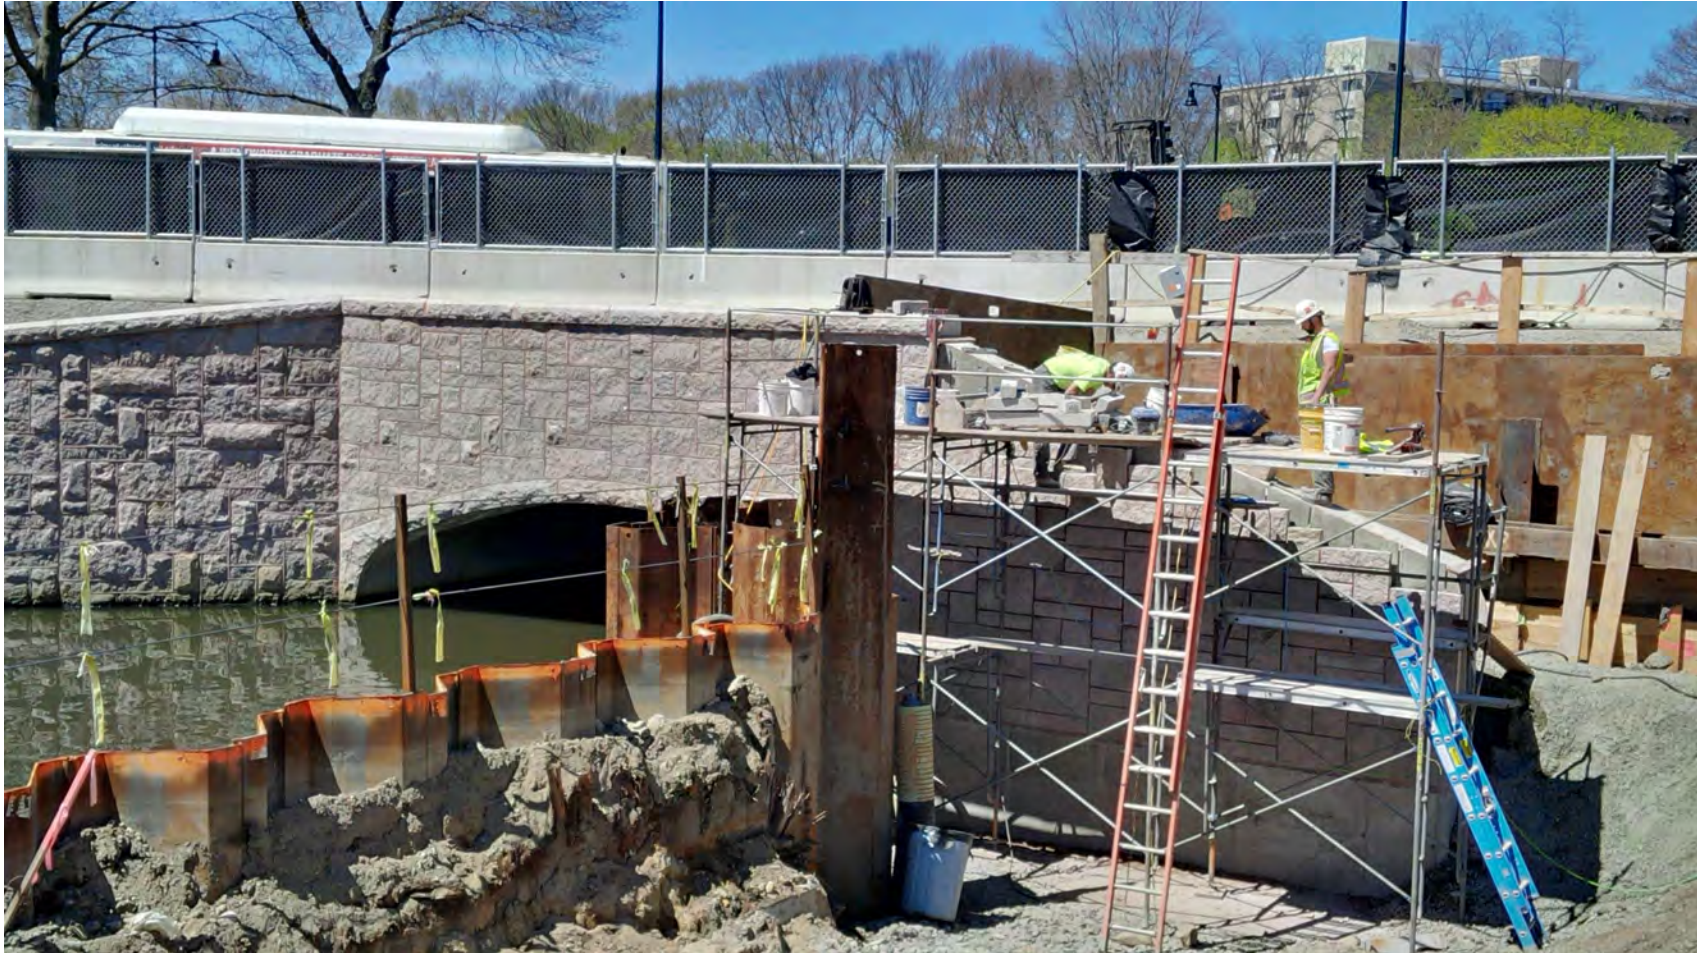
Downstream of Riverway Culvert – granite veneer being installed on the constructed northeast wing wall – late April 2016.

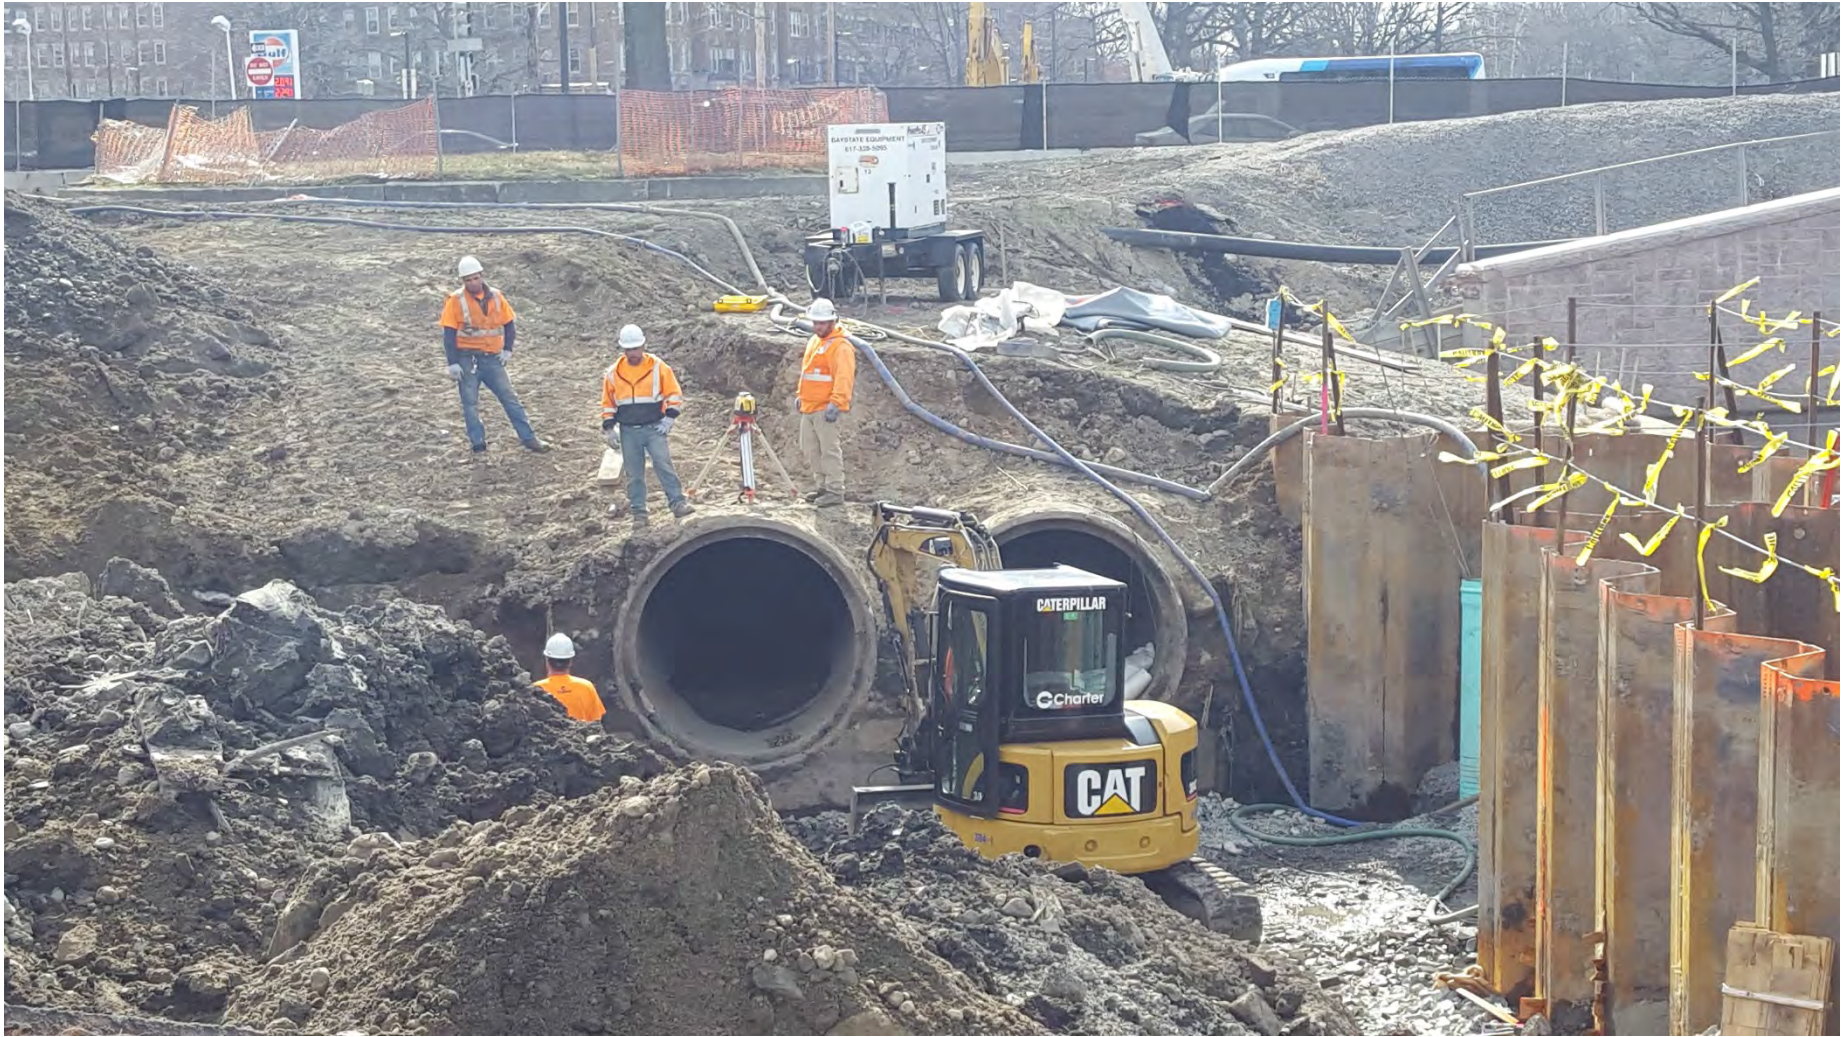
Removal of the existing twin 72" culverts in the former Sears Parking Lot – note the new Brookline Avenue Culvert on the right side – late March 2016.

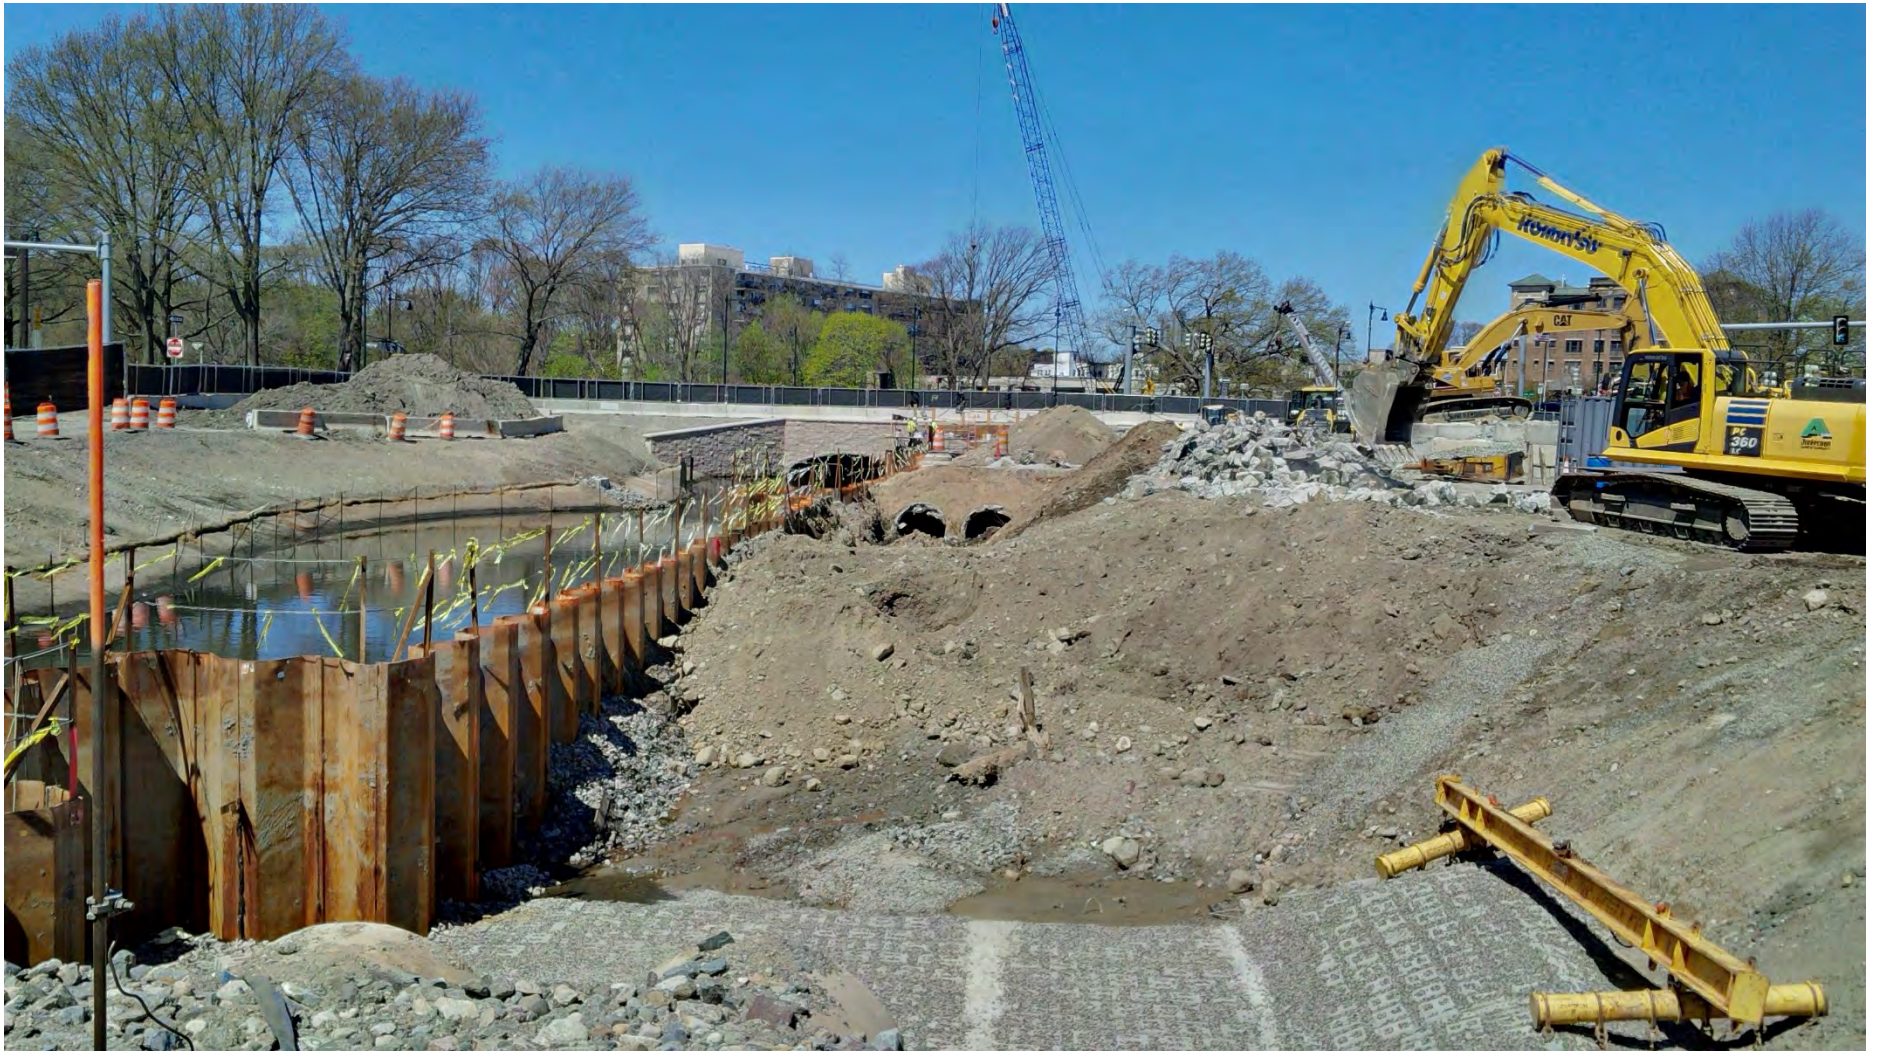
Excavation and removal of the existing twin 72" culverts in the former Sears Parking Lot – looking upstream at the new Riverway Culvert – note the articulated concrete blocks (ACBs) on the constructed channel bottom near Brookline Avenue (nearside) and the existing twin 72" culverts (farside) – late April 2016.

- With the completion of the sewer line work at the upstream end of the new Brookline Avenue Culvert, the excavation and removal of the existing twin 72" culverts in that area began, as well as the construction of the northside of the new river channel. Continuing activities include the grading of the new banks, installation of articulated concrete blocks (ACB) at the upstream of the Brookline Avenue Culvert, and stone protection/bank stabilization for the length of the former Sears Parking Lot, from Brookline Avenue Culvert to Riverway Culvert. Plantings will be installed as the banks are constructed. Once the lower portion of the new channel is constructed to include stone protection, the river diversion steel sheeting will be removed – late May/early June – this will allow the Muddy River to flow fully in the former Sears Parking Lot.

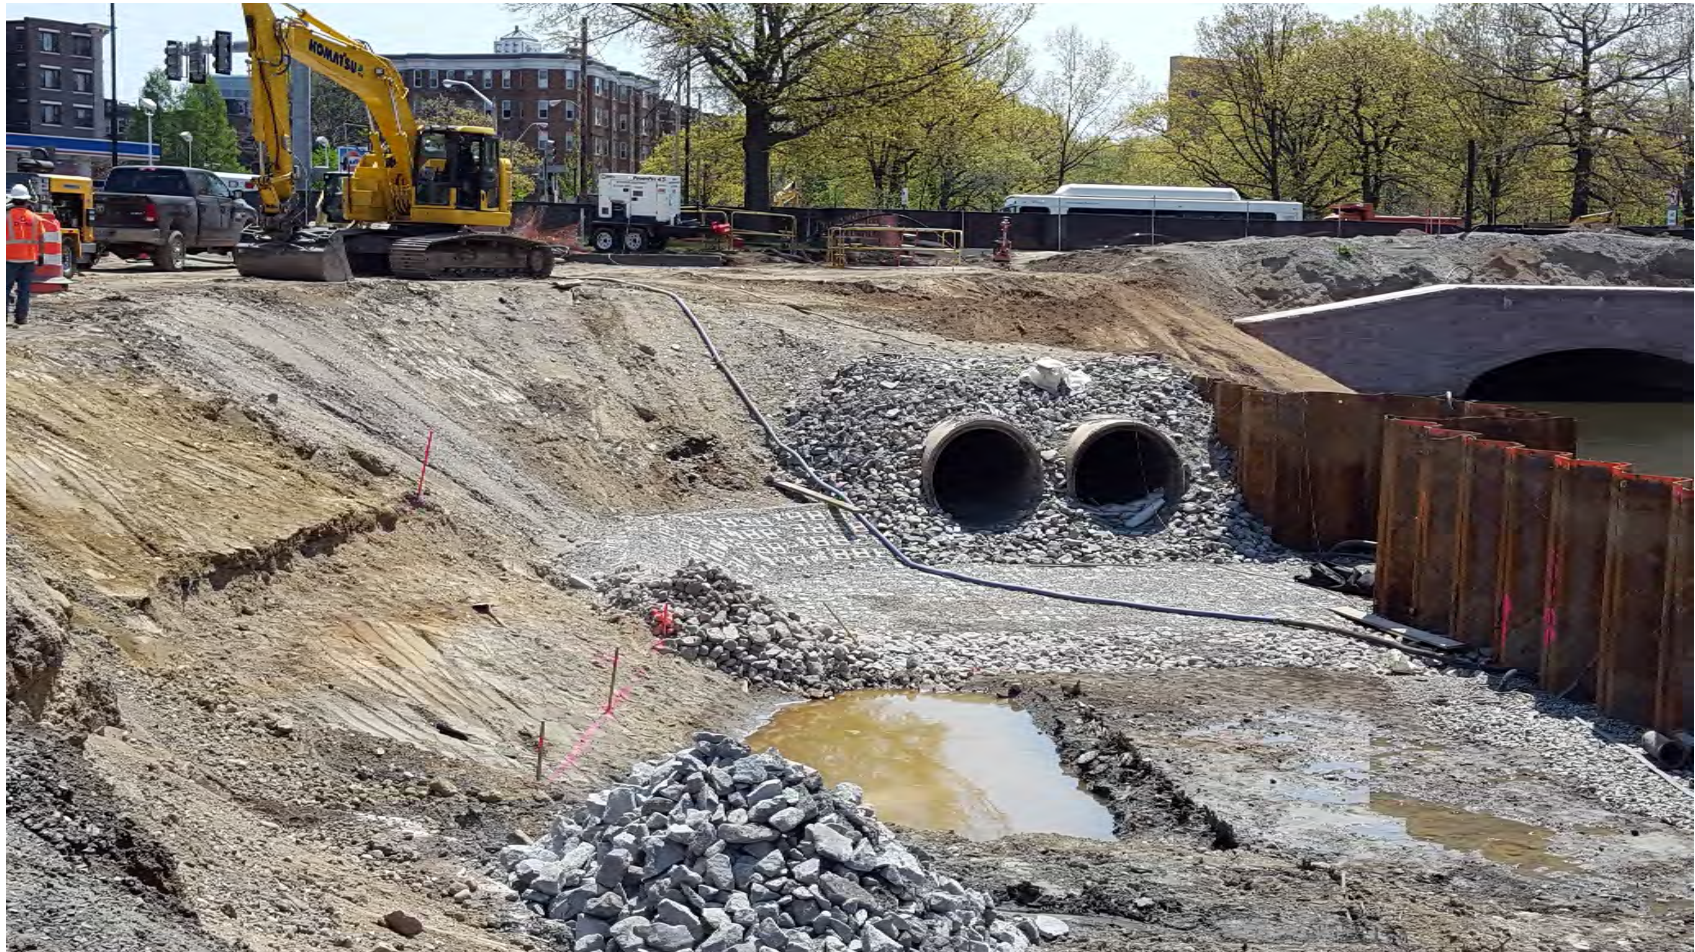
Sections of the existing twin 72" culverts that will remain as part of an overflow connection which ties into the existing underground Brookline Avenue Gatehouse and Conduit – note the new Brookline Avenue Culvert on the right side – mid-May 2016.

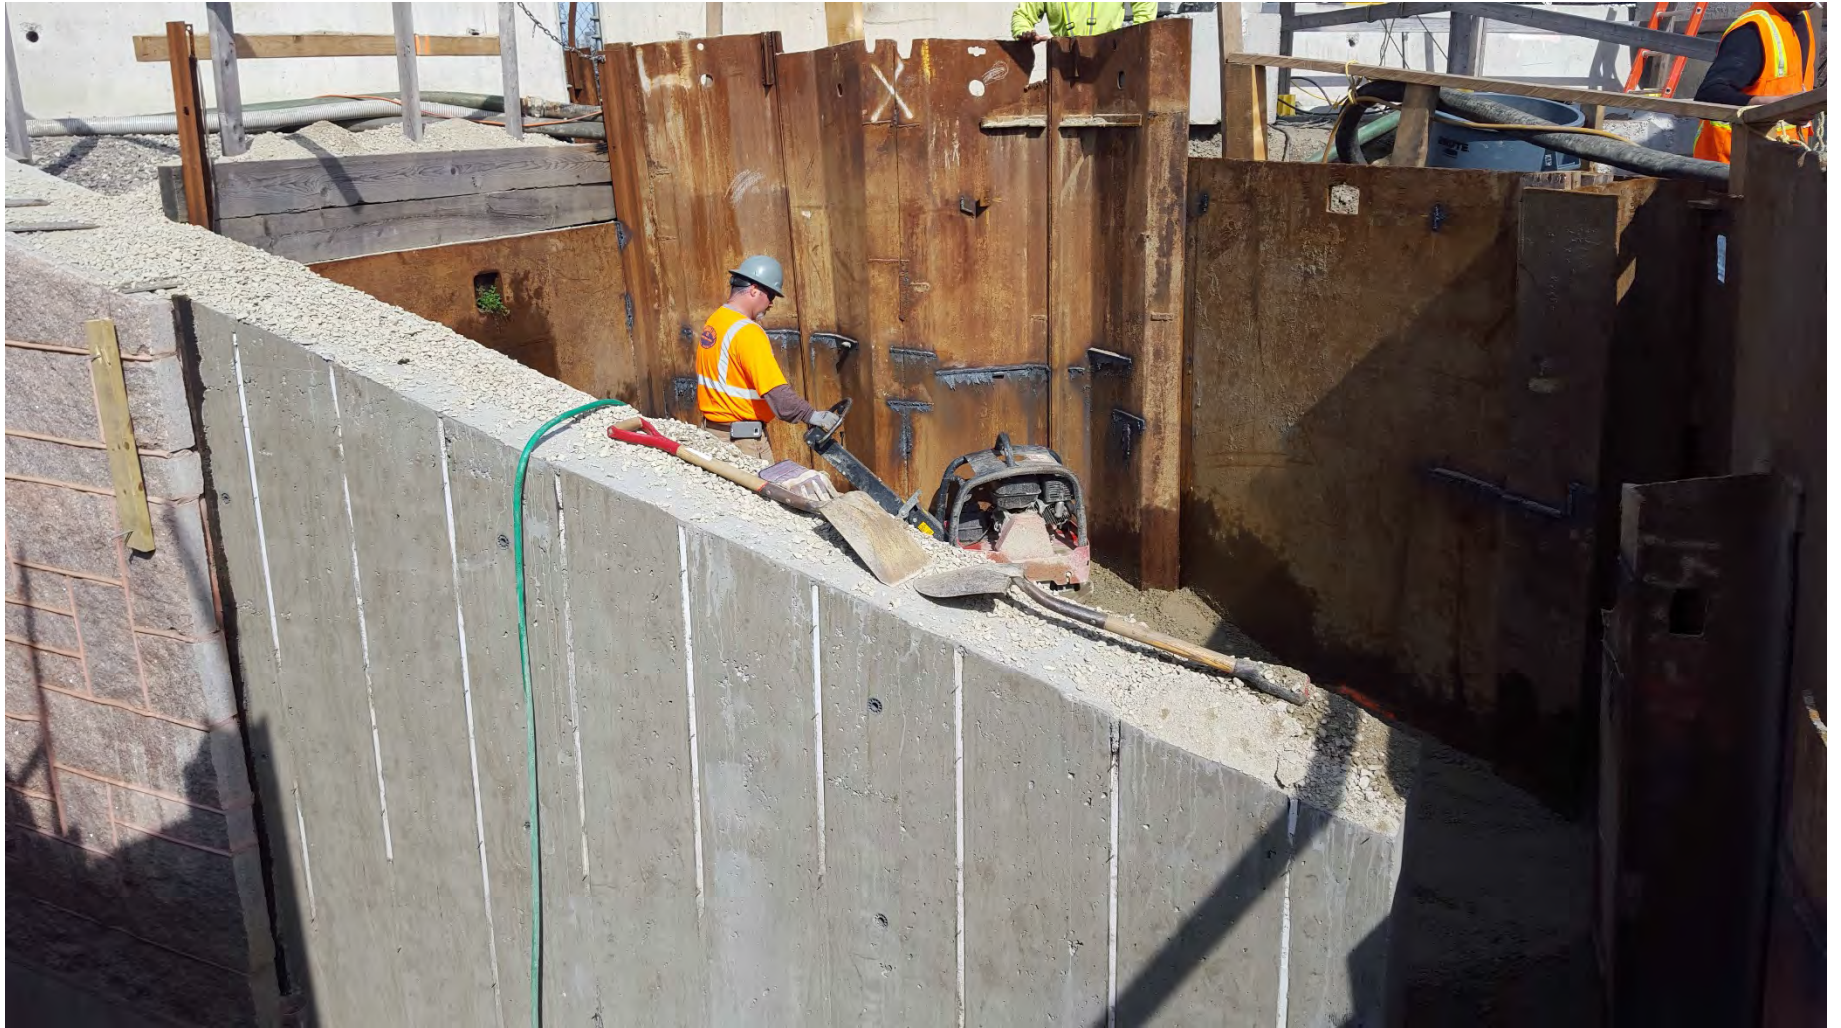
Downstream northeast Brookline Avenue Culvert wing wall – compacting backfill behind the wall – late March 2016.

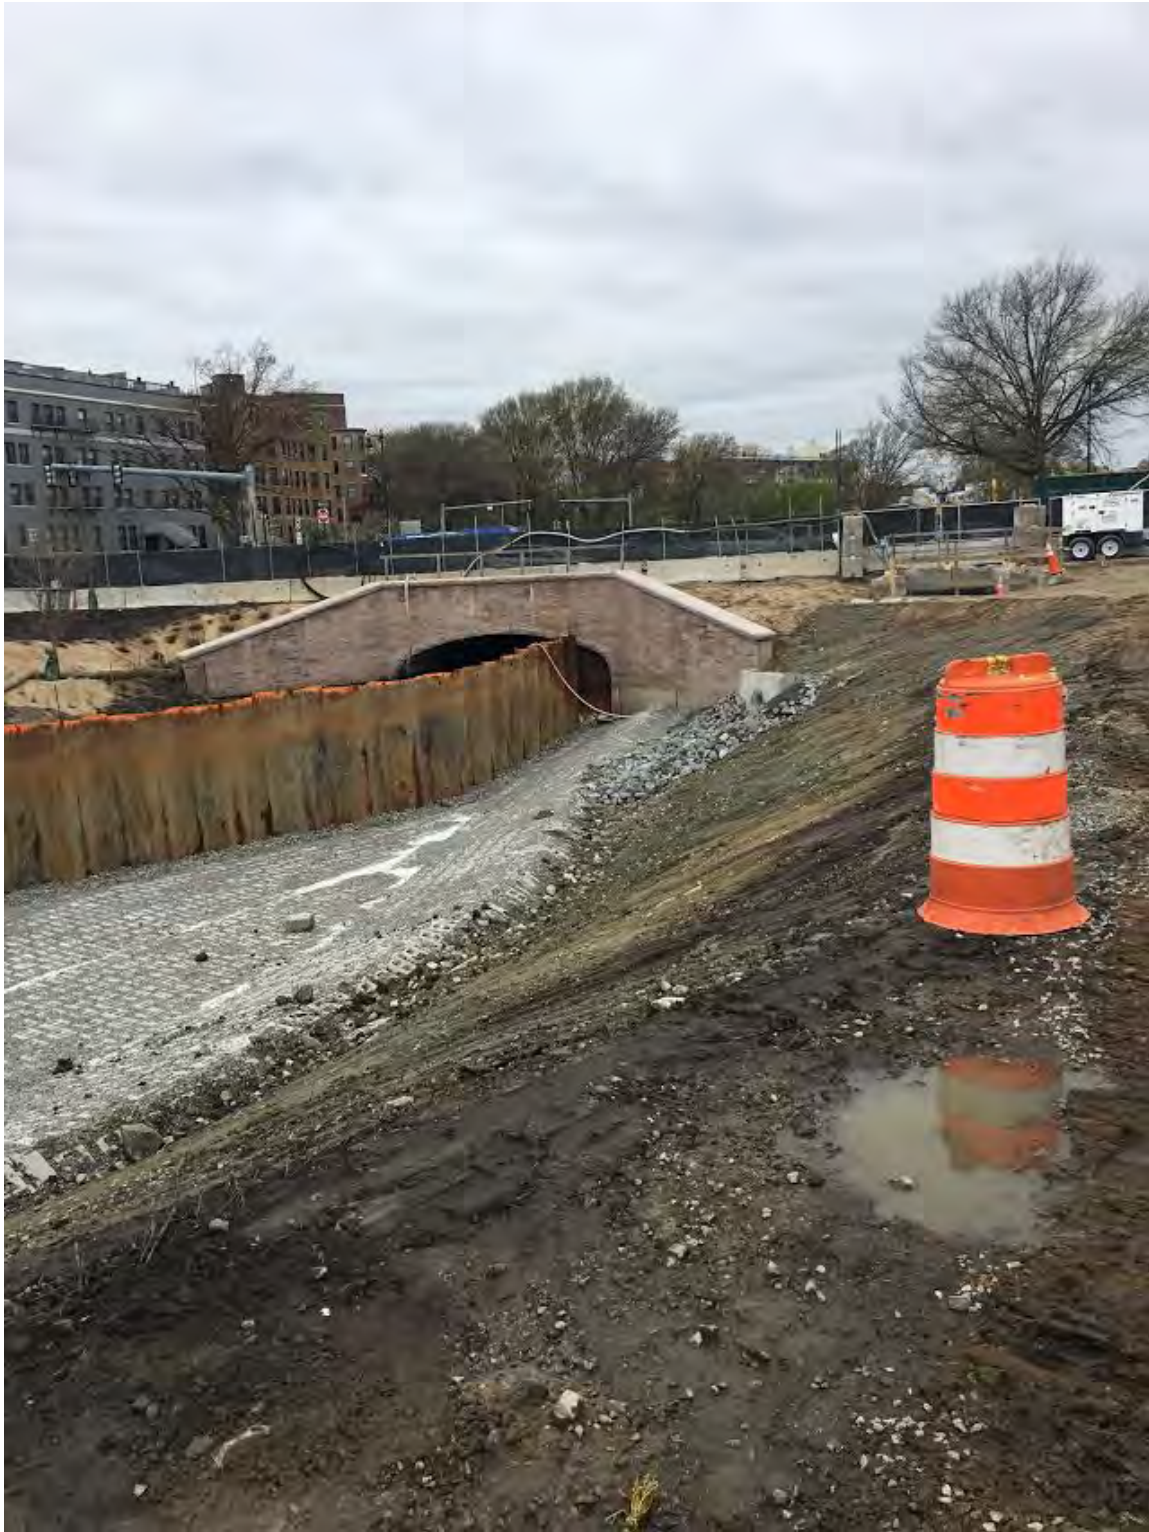
Downstream of new Brookline Avenue Culvert – note the granite veneer on the newly constructed northeast wing wall and the installed articulated concrete blocks (ACBs) on the constructed channel bottom – early May 2016.

- Since the construction of the downstream northeast wing wall of the Brookline Avenue Culvert, sections of the existing twin 72" culverts have been removed; and the grading of the new banks and installation of articulated concrete blocks (ACB) at the downstream of the Brookline Avenue Culvert are completed. Plantings will continue until late May. The river diversion steel sheeting will be removed mid-May, which will complete the daylighting of the former Jug Handle Roadway area.
