Muddy River Flood Risk Management & Environmental Restoration Project
Phase 1 Construction Activities Next 90 Days
May 2016

MUDDY RIVER FLOOD DAMAGE
REDUCTION AND ENVIRONMENTAL
RESTORATION PROJECT
(PHASE 1)
BOSTON AND BROOKLINE, MASSACHUSETTS

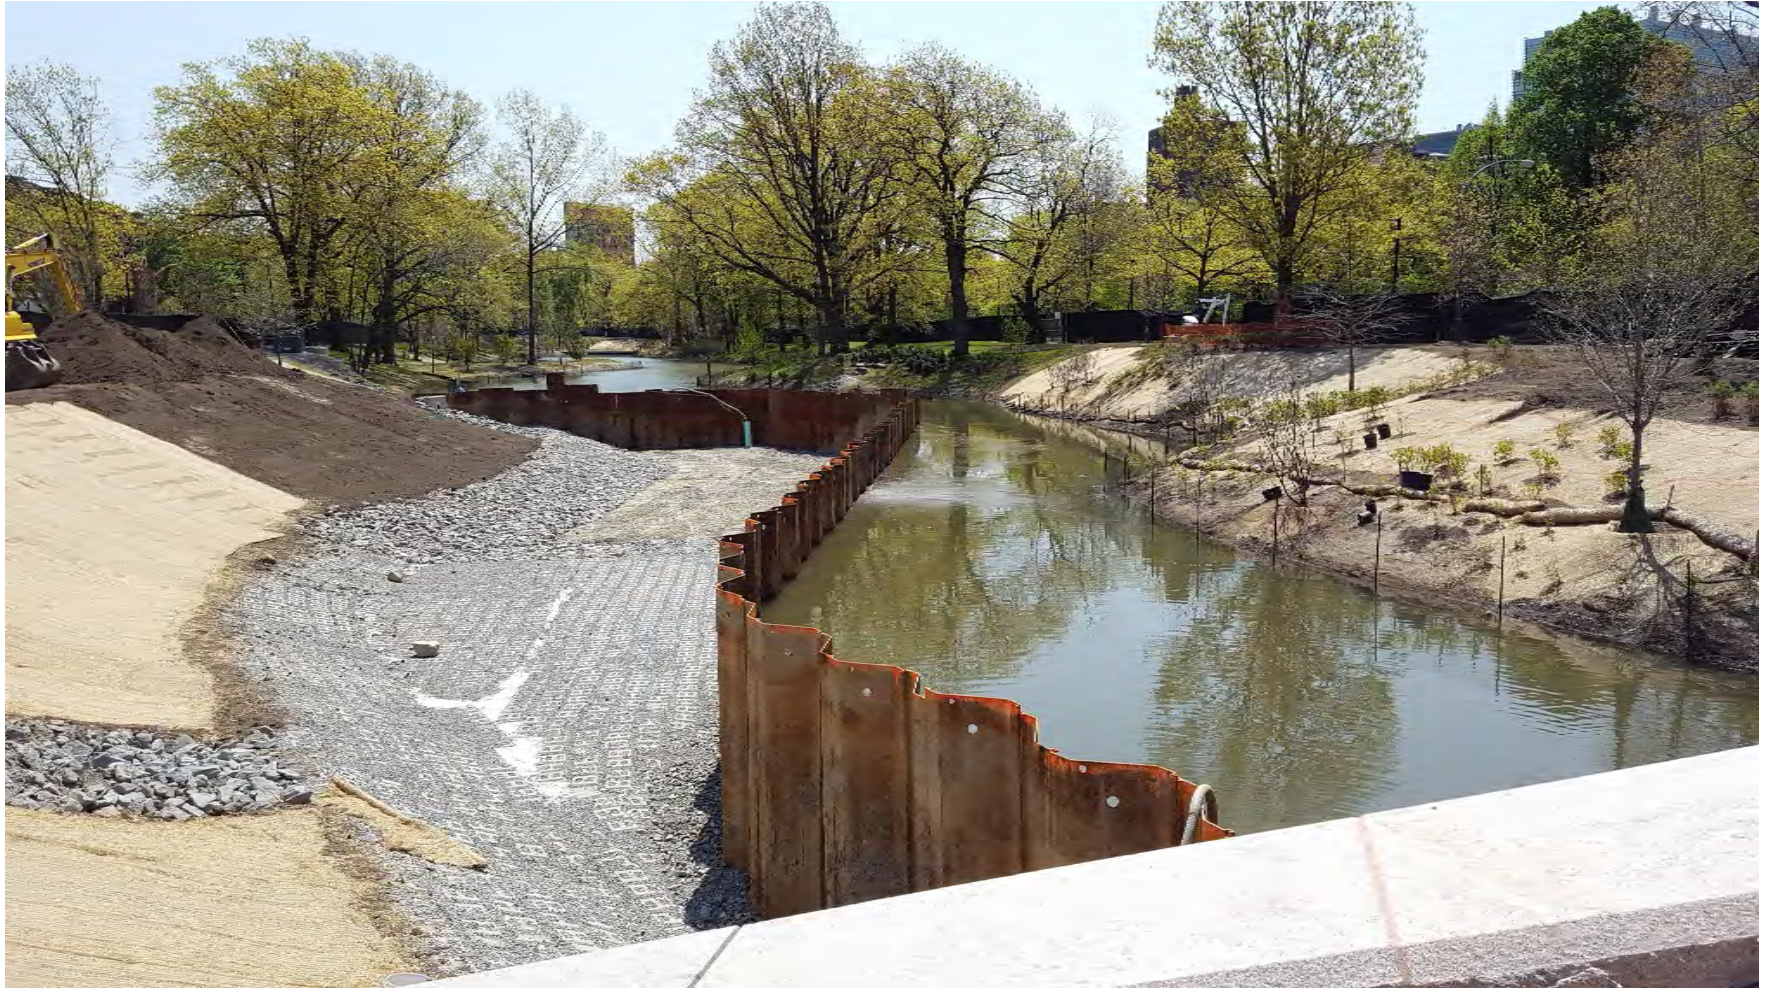
Constructed flood risk management (FRM) channel on the north side of the former Jug Handle Roadway – note the articulated concrete blocks (ACBs) and the loam and turf reinforcement mattress (TRM) on the constructed banks – mid-May 2016.

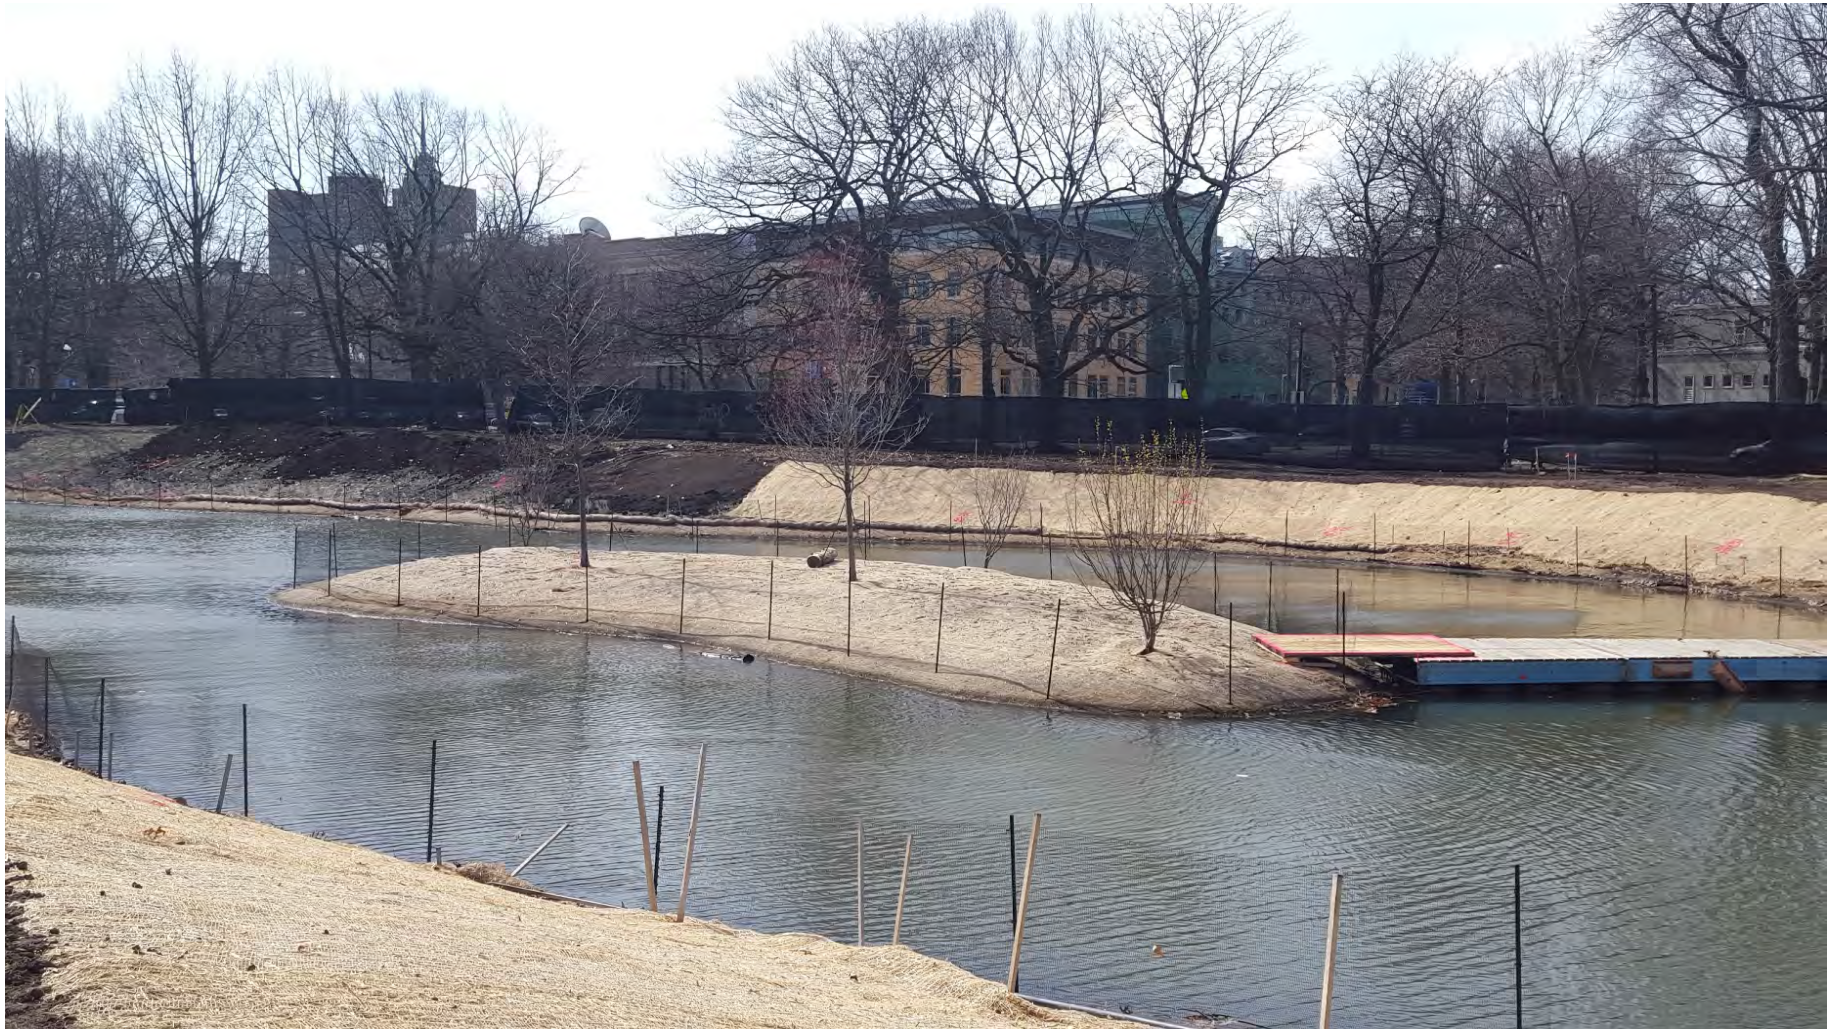
Historic Olmsted Island – note the temporary floating dock leading to the island installed to plant the remaining plants on the island – late March 2016.

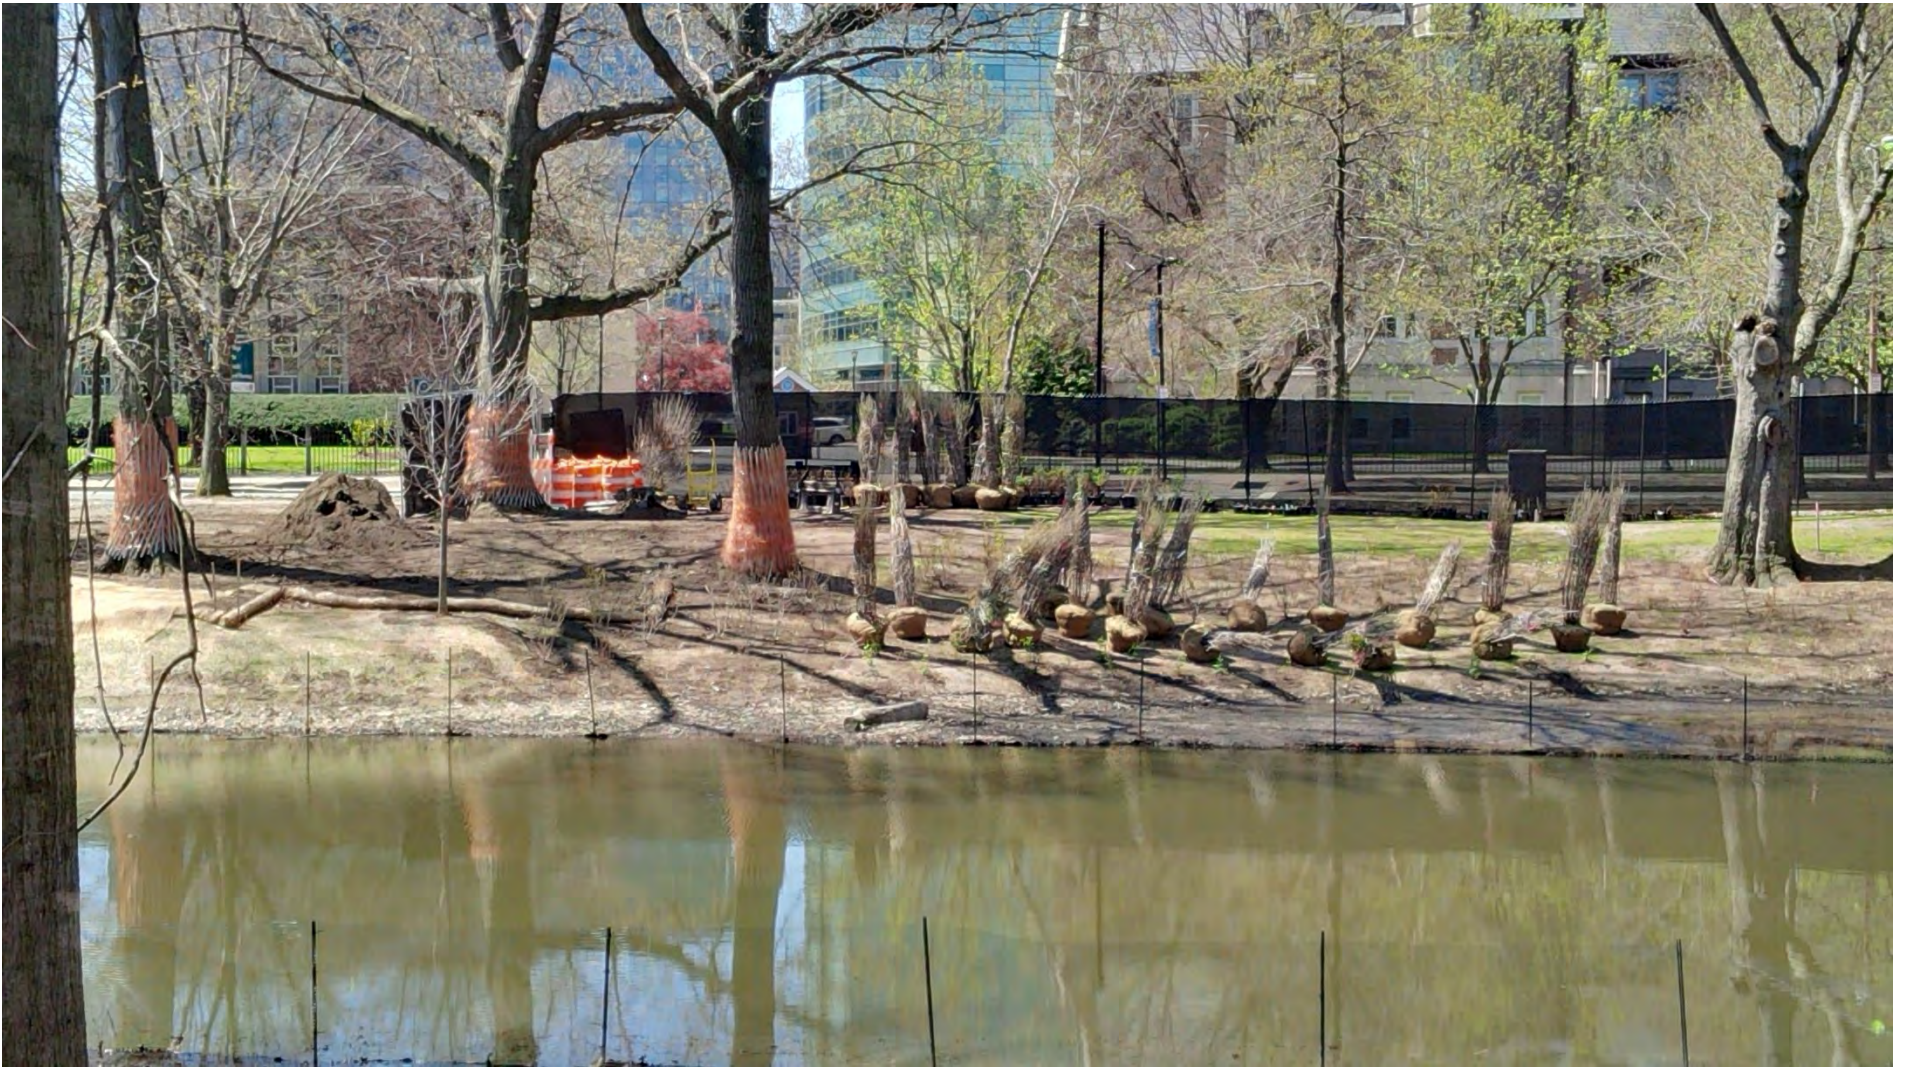
Newly arrived trees staged for planting at the Upper Fens Pond – late April 2016.

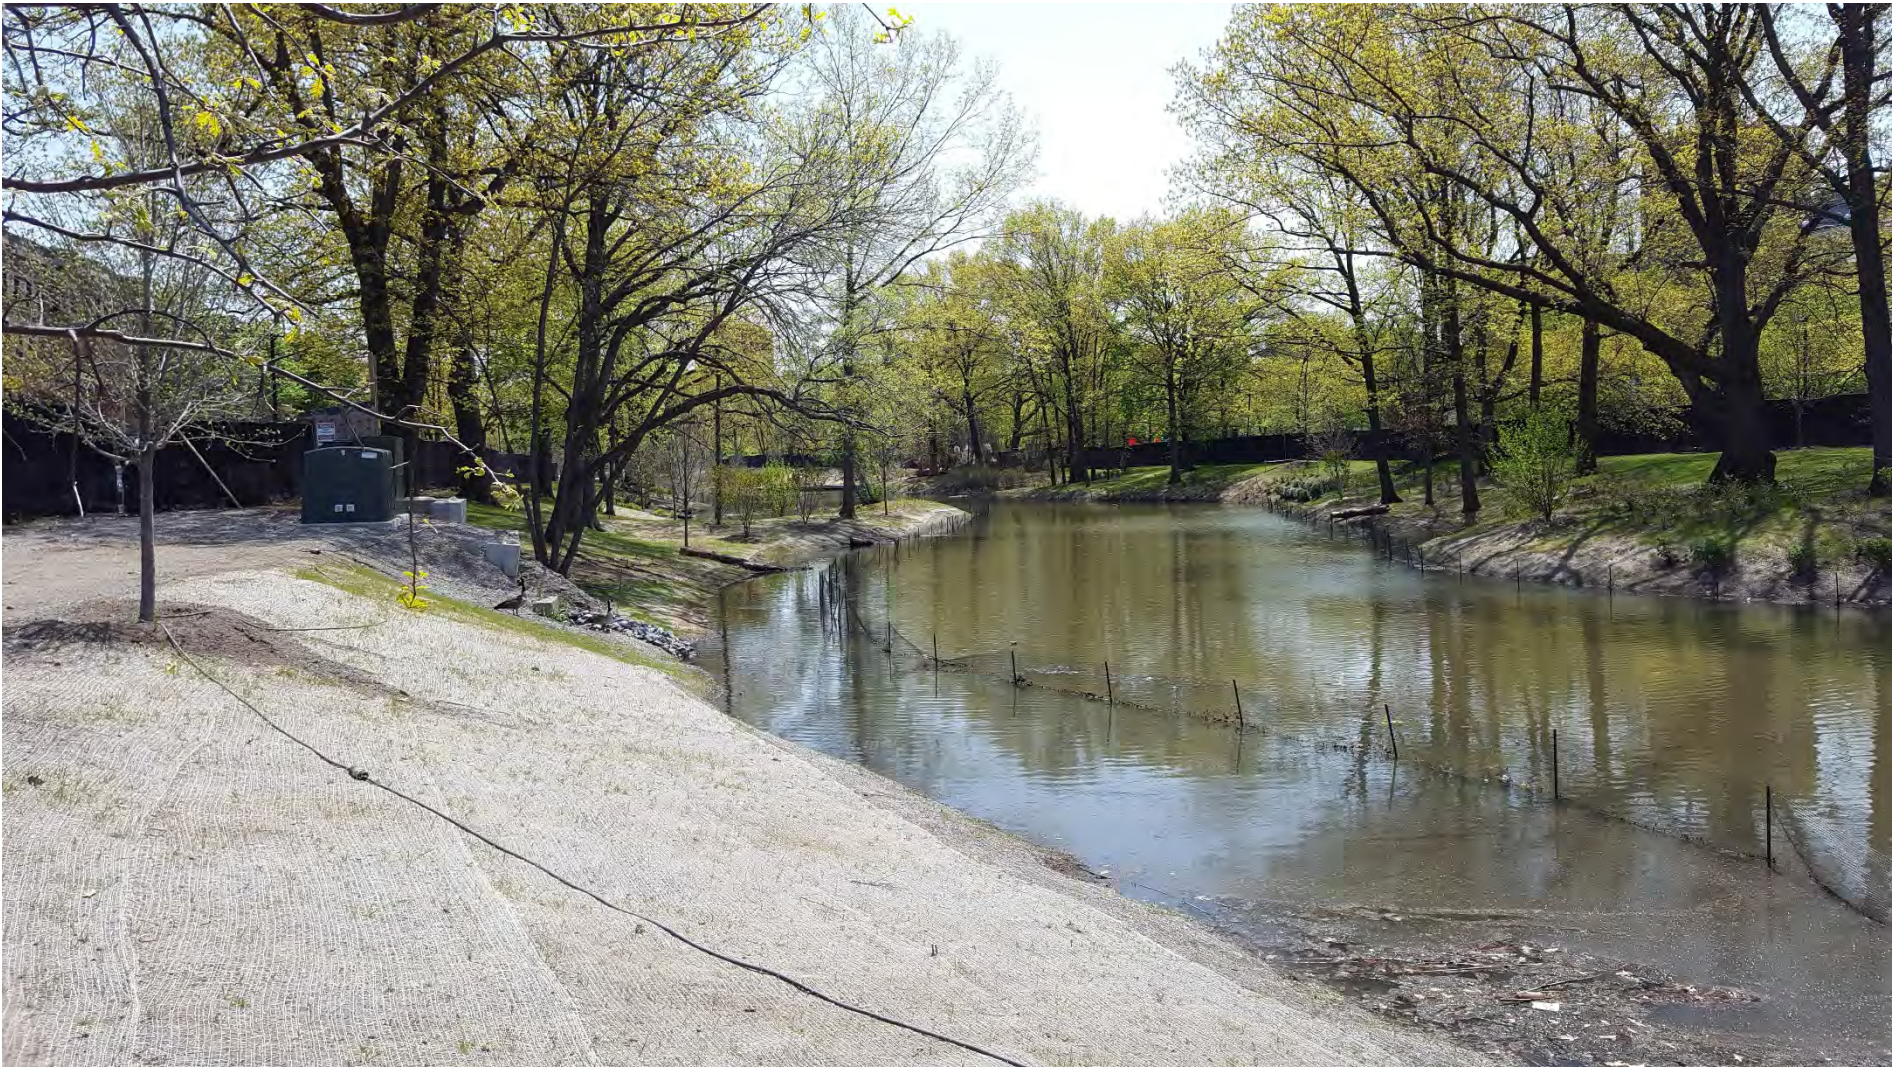
Upper Fens Pond – note new grass growing and new trees and shrubs planted on the constructed banks – mid-May 2016.

- In the Upper Fens Pond area, landscaping activities such as grading the upland area of the banks and plantings and seeding will be complete by end of May. Installation of temporary landscape protection fence and the removal of the construction fencing will begin late May.

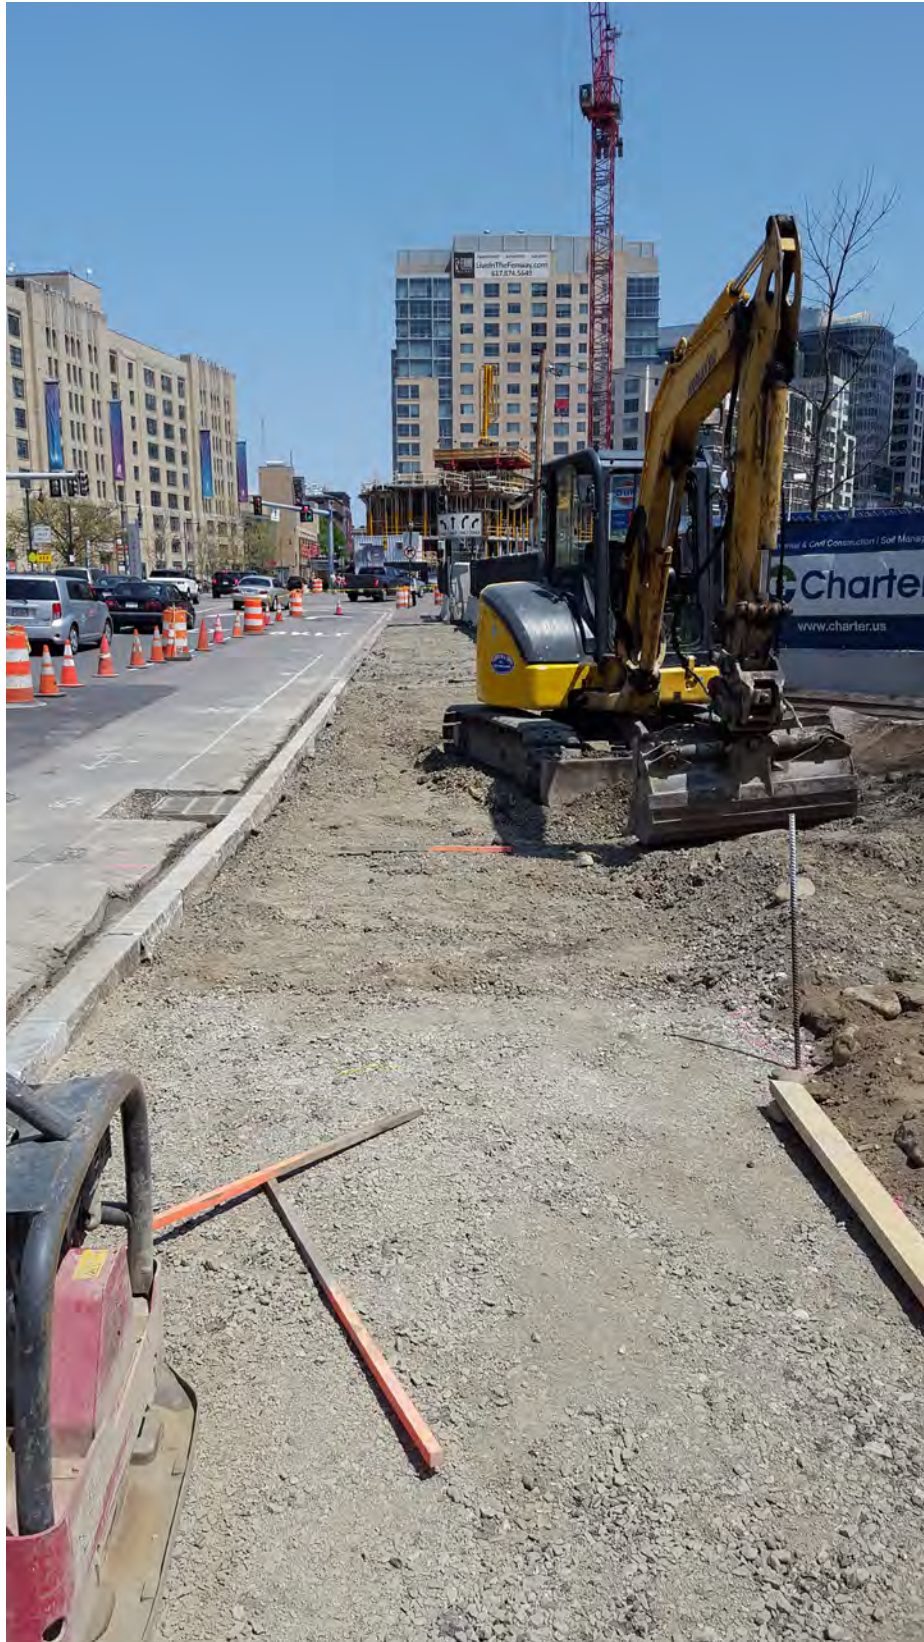
Construction of the end condition concrete sidewalk on Brookline Avenue – late May 2016.

- Site work around the project – permanent sidewalk construction on Brookline Avenue began early May and will continue until late May. Milling of the roadways will begin mid-May, with final paving to occur early June.
