Re: NH DES File #2012-001052 & 2012-1060  
Third Year Monitoring Report

## **Introduction**

## Monitoring Photo log

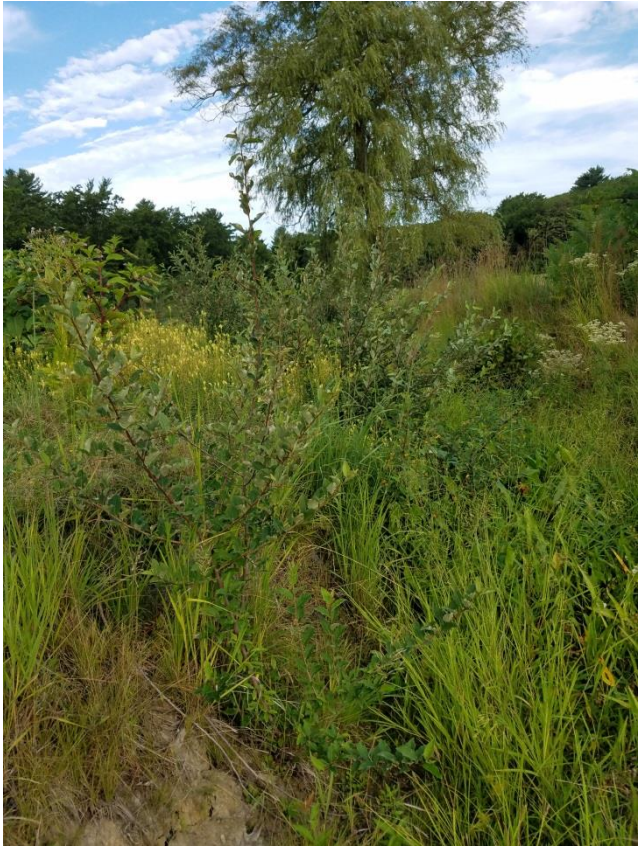
Date: 8-29-16
 		Photographer: Benjamin Griffith
		Comments: Stream bank restoration with dense shrub and herbaceous growth along the bank

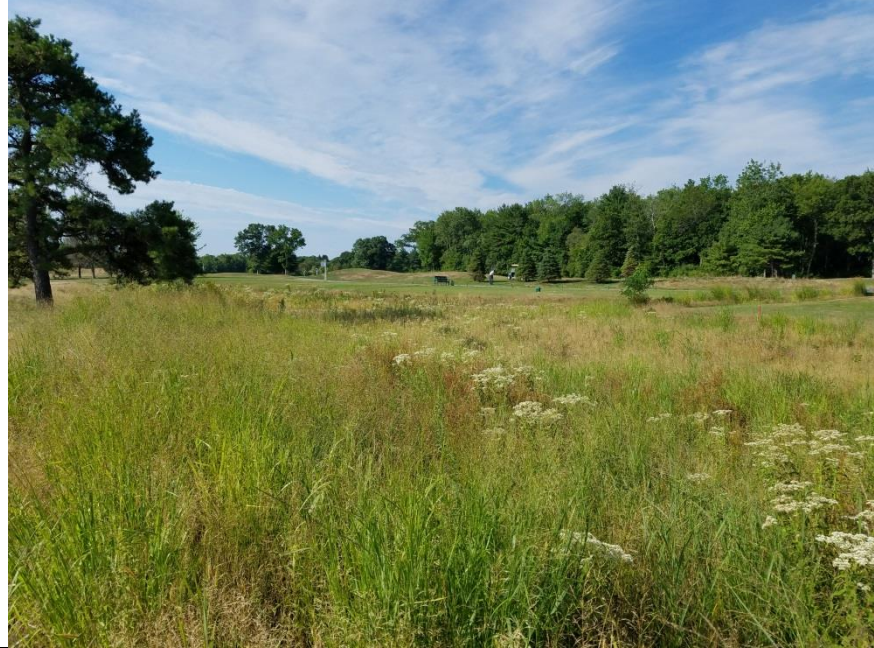
Date: 8-29-15

Photographer: Benjamin Griffith
		Comments: Dense shrub and herbaceous growth along stream buffer

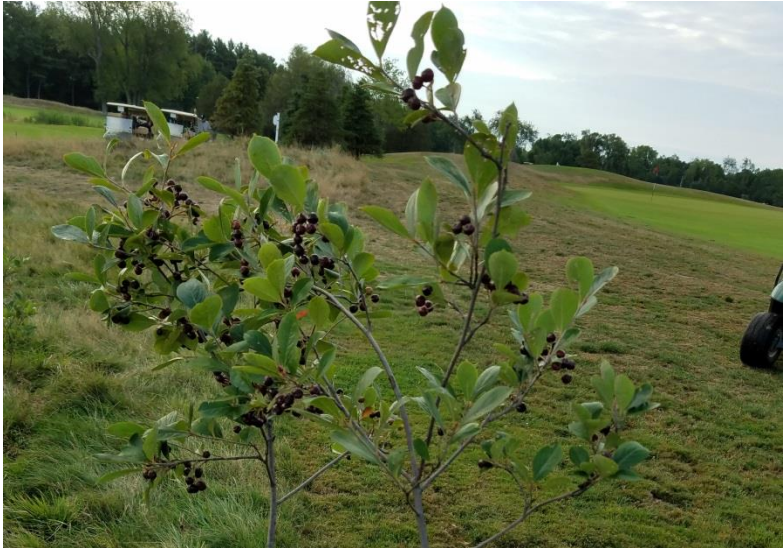
Photographer: Benjamin Griffith
	Comments: Wetland mitigation area with dense herbaceous vegetation
	Date: 9-8-15
