Muddy River Flood Risk Management & Environmental Restoration Project
Phase 1 Construction Activities Next 90 Days
June 2016

Muddy River Flood Damage Reduction & Environmental Restoration Project

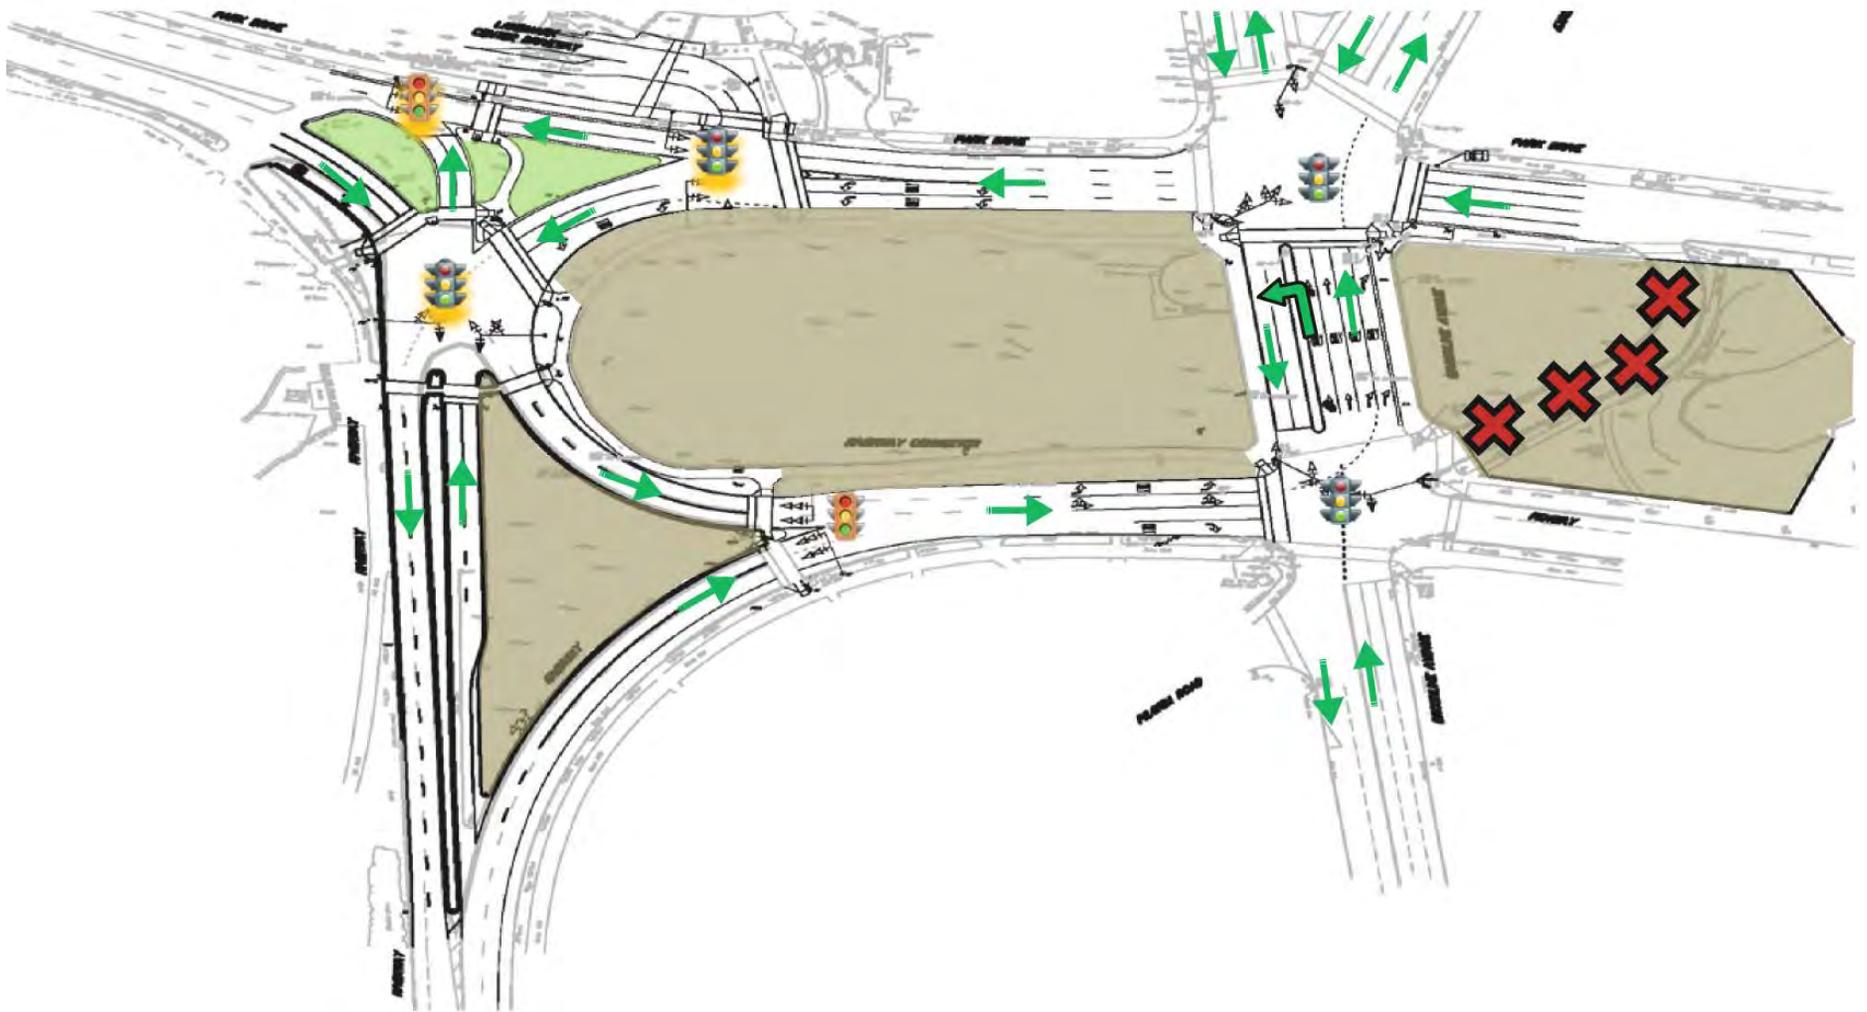
TRAFFIC MANAGEMENT PLAN DURING THE DAYLIGHTING OF THE MUDDY RIVER AT THE JUG HANDLE ROADWAY AND THE FORMER SEARS PARKING LOT

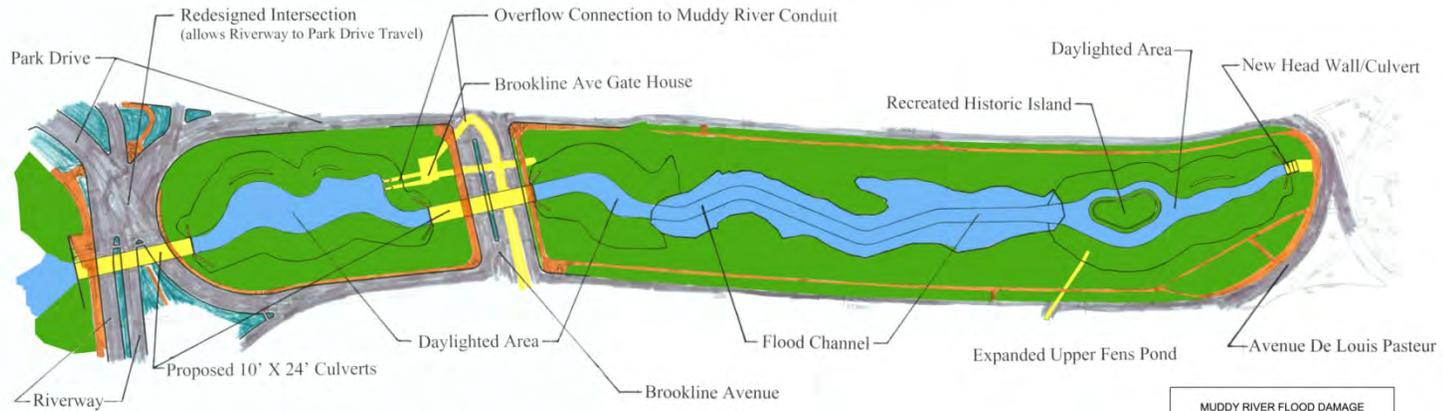
Proposed Phase 1 Improvements

MUDDY RIVER FLOOD DAMAGE
REDUCTION AND ENVIRONMENTAL
RESTORATION PROJECT
(PHASE 1)
BOSTON AND BROOKLINE, MASSACHUSETTS

General: The Muddy River Flood Risk Management (FRM) & Environmental Restoration Phase 1 Construction Project is located in the footprint generally between the Riverway downstream to Avenue Louis Pasteur. The major project components involve the installation of a 10-foot by 24-foot box culvert under the Riverway roadway, the installation of 10-foot by 24-foot box culvert under the Brookline Avenue roadway, daylighting of the area between the Riverway and Brookline Avenue, and daylighting of the area between Brookline Avenue and Avenue Louis Pasteur. Daylighting is the removal of existing twin 72" culverts and excavation of the area to return the waterway to a natural state. This Notice is intended to identify the general construction activities that will be performed in the next 90 days. A figure that shows the existing conditions and the proposed improvements is at the end of this report.

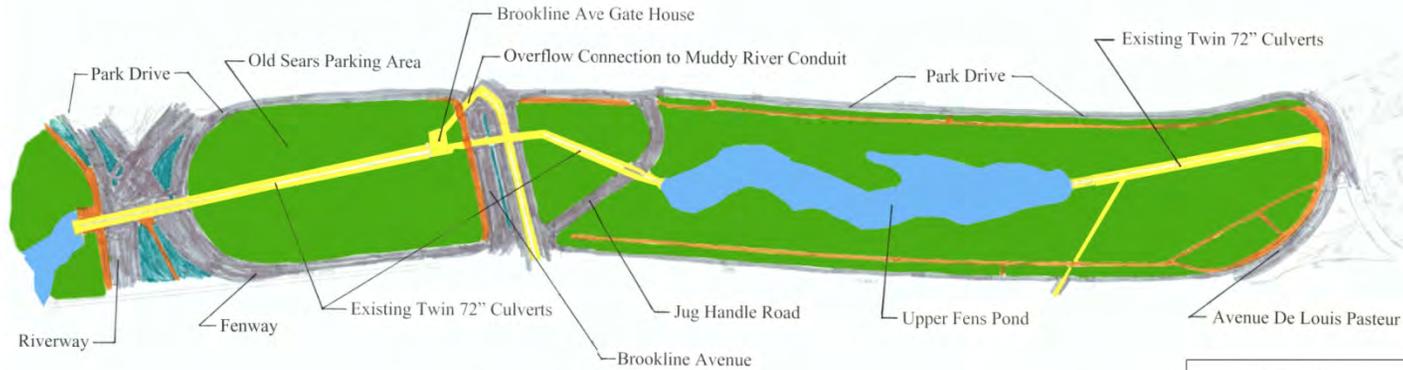
Existing Phase 1 Conditions

MUDDY RIVER FLOOD DAMAGE
REDUCTION AND ENVIRONMENTAL
RESTORATION PROJECT
EXISTING CONDITIONS
BOSTON AND BROOKLINE, MASSACHUSETTS

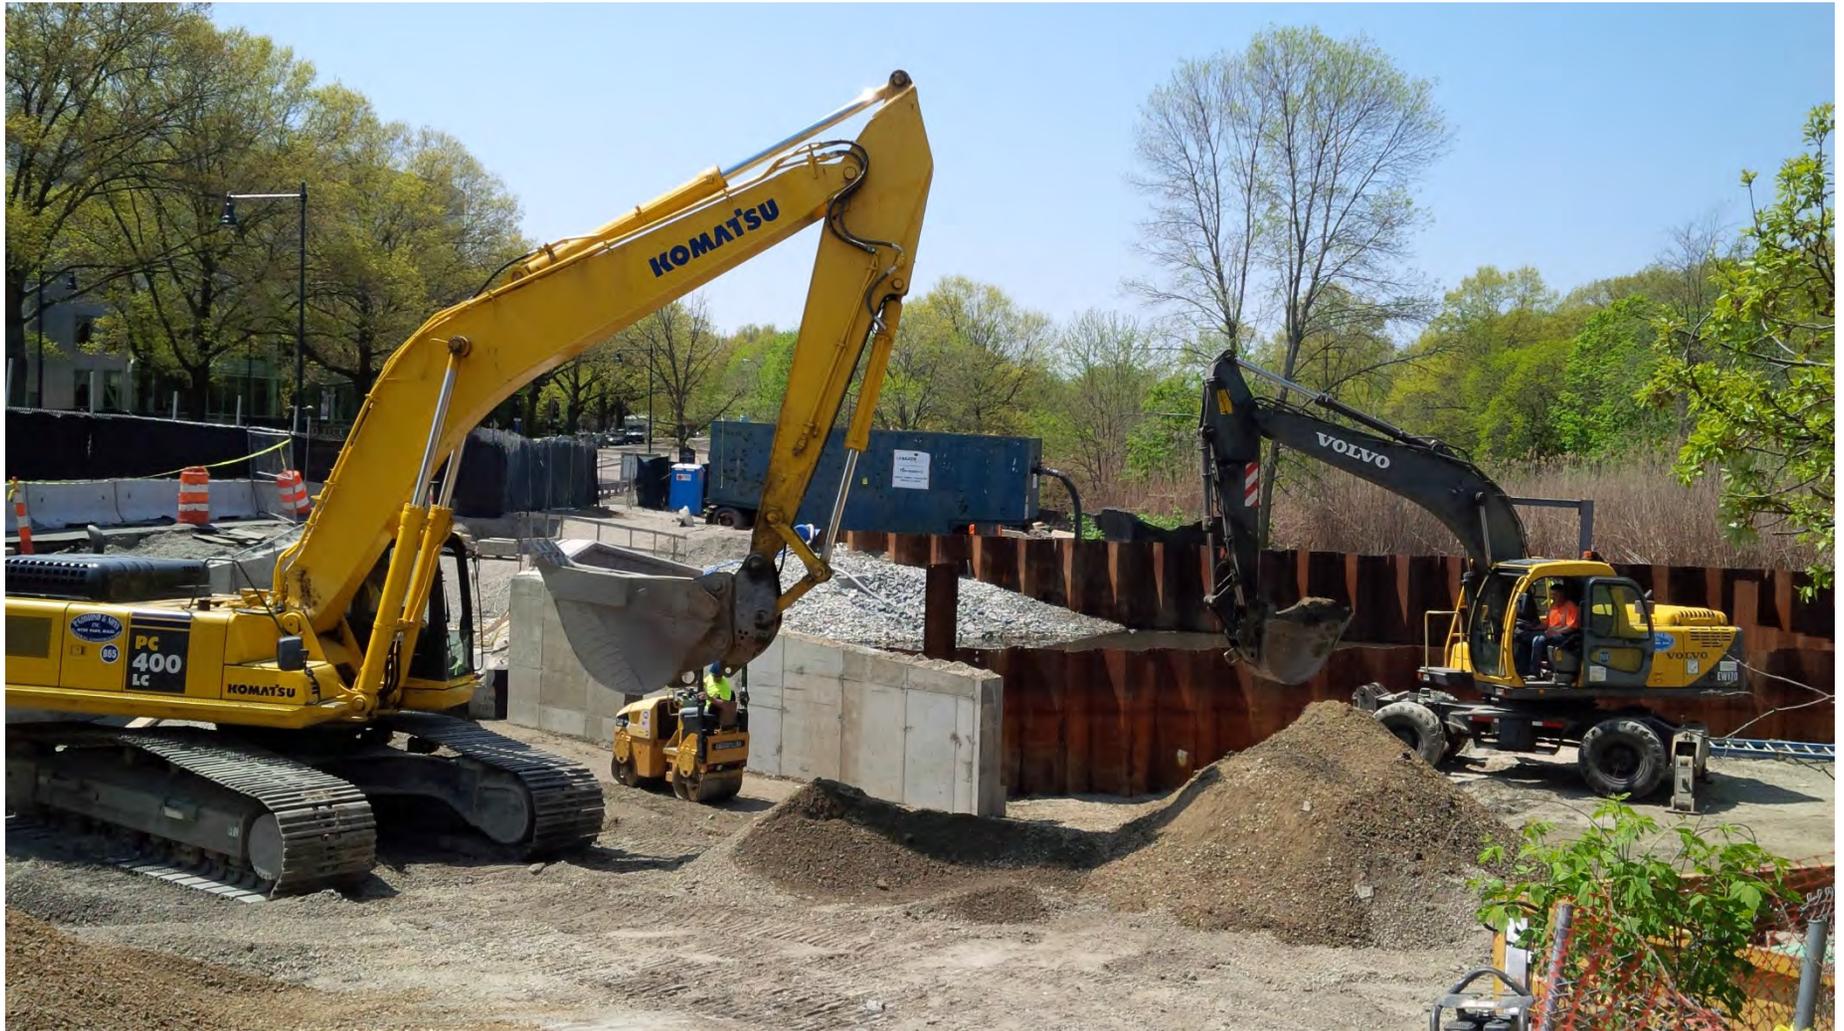
Upstream Riverway Culvert – northwest wing wall cast and backfilling behind the headwall – mid-May 2016.

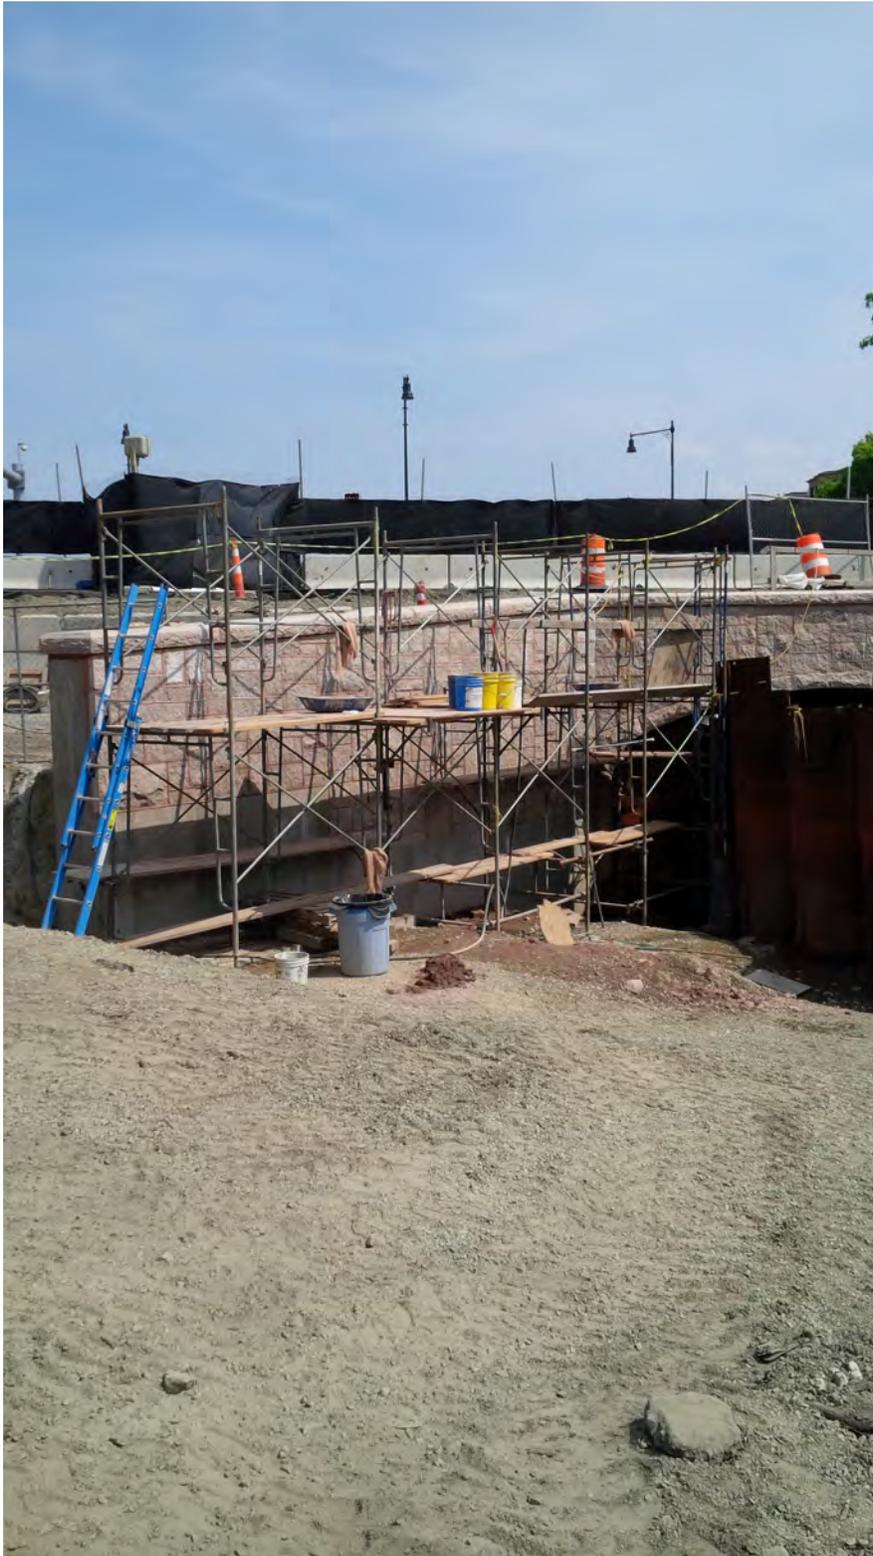
Upstream Riverway Culvert – Installing granite veneer on the northwest wing wall – late May 2016.

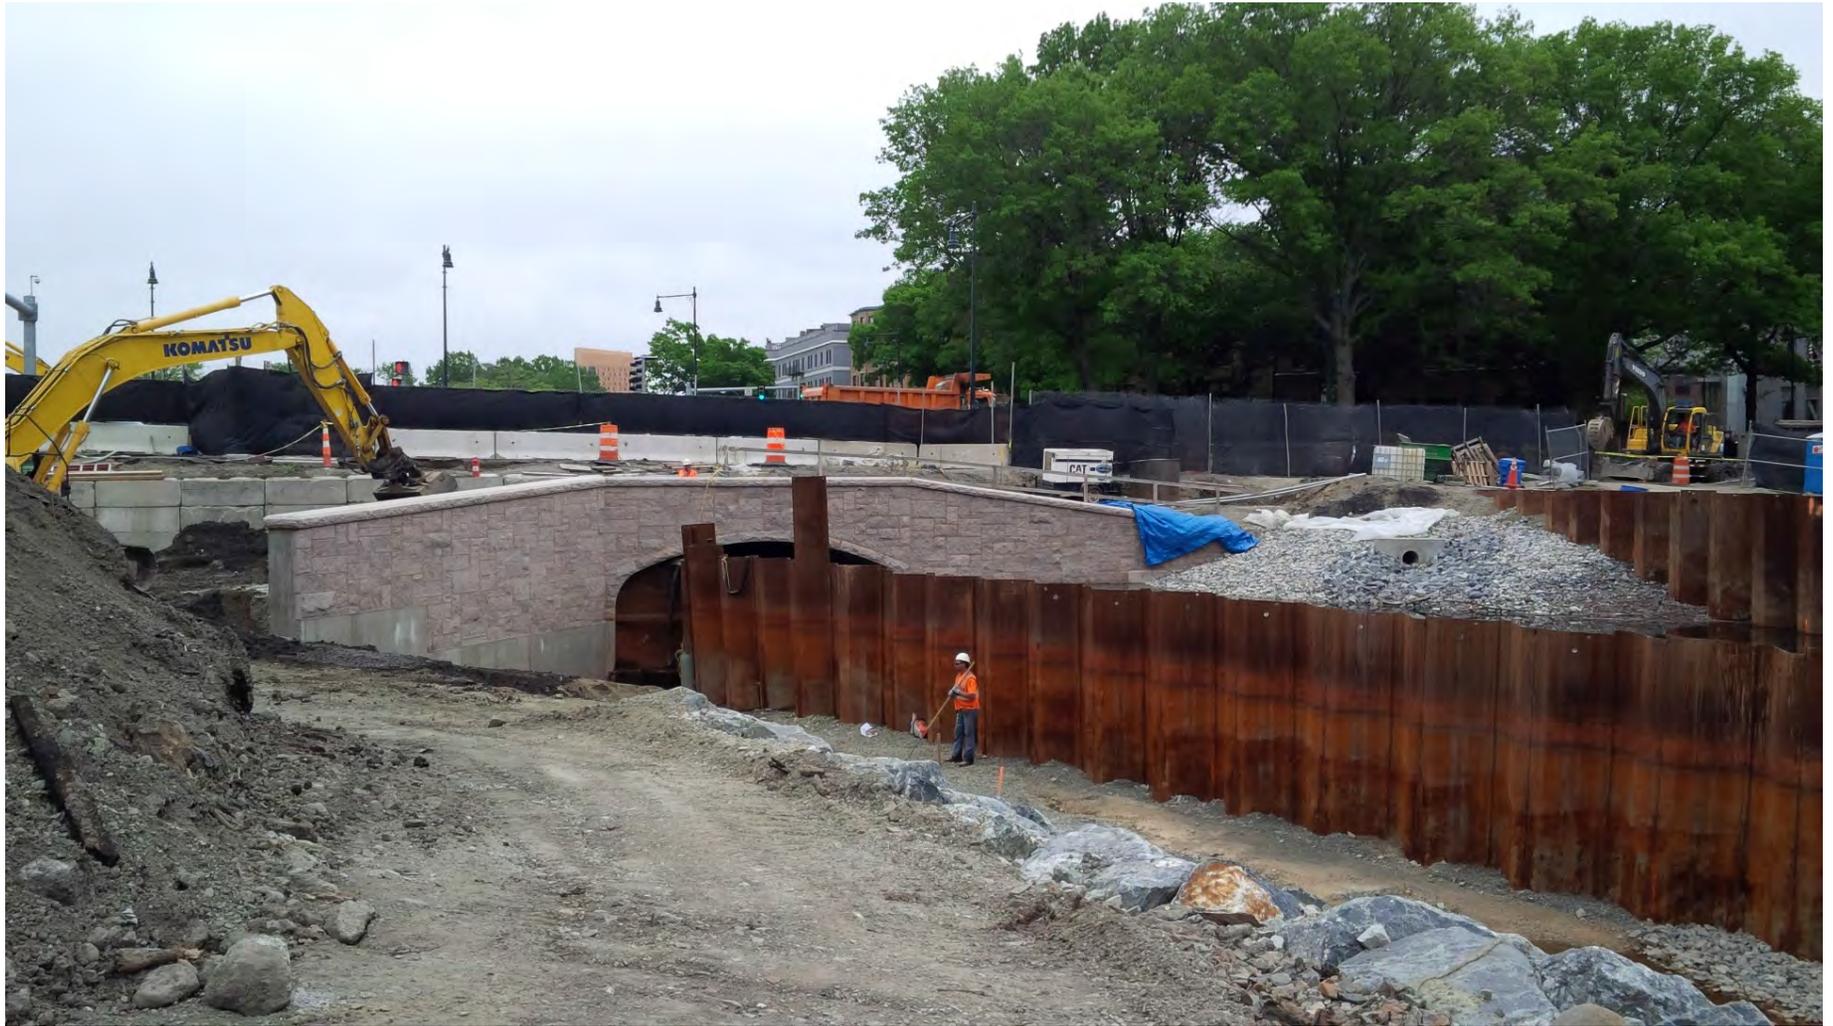
Upstream Riverway Culvert – granite veneer installed and continued backfilling behind the wing wall and shaping of the Flood Risk Management (FRM) channel on the northside – early June 2016.

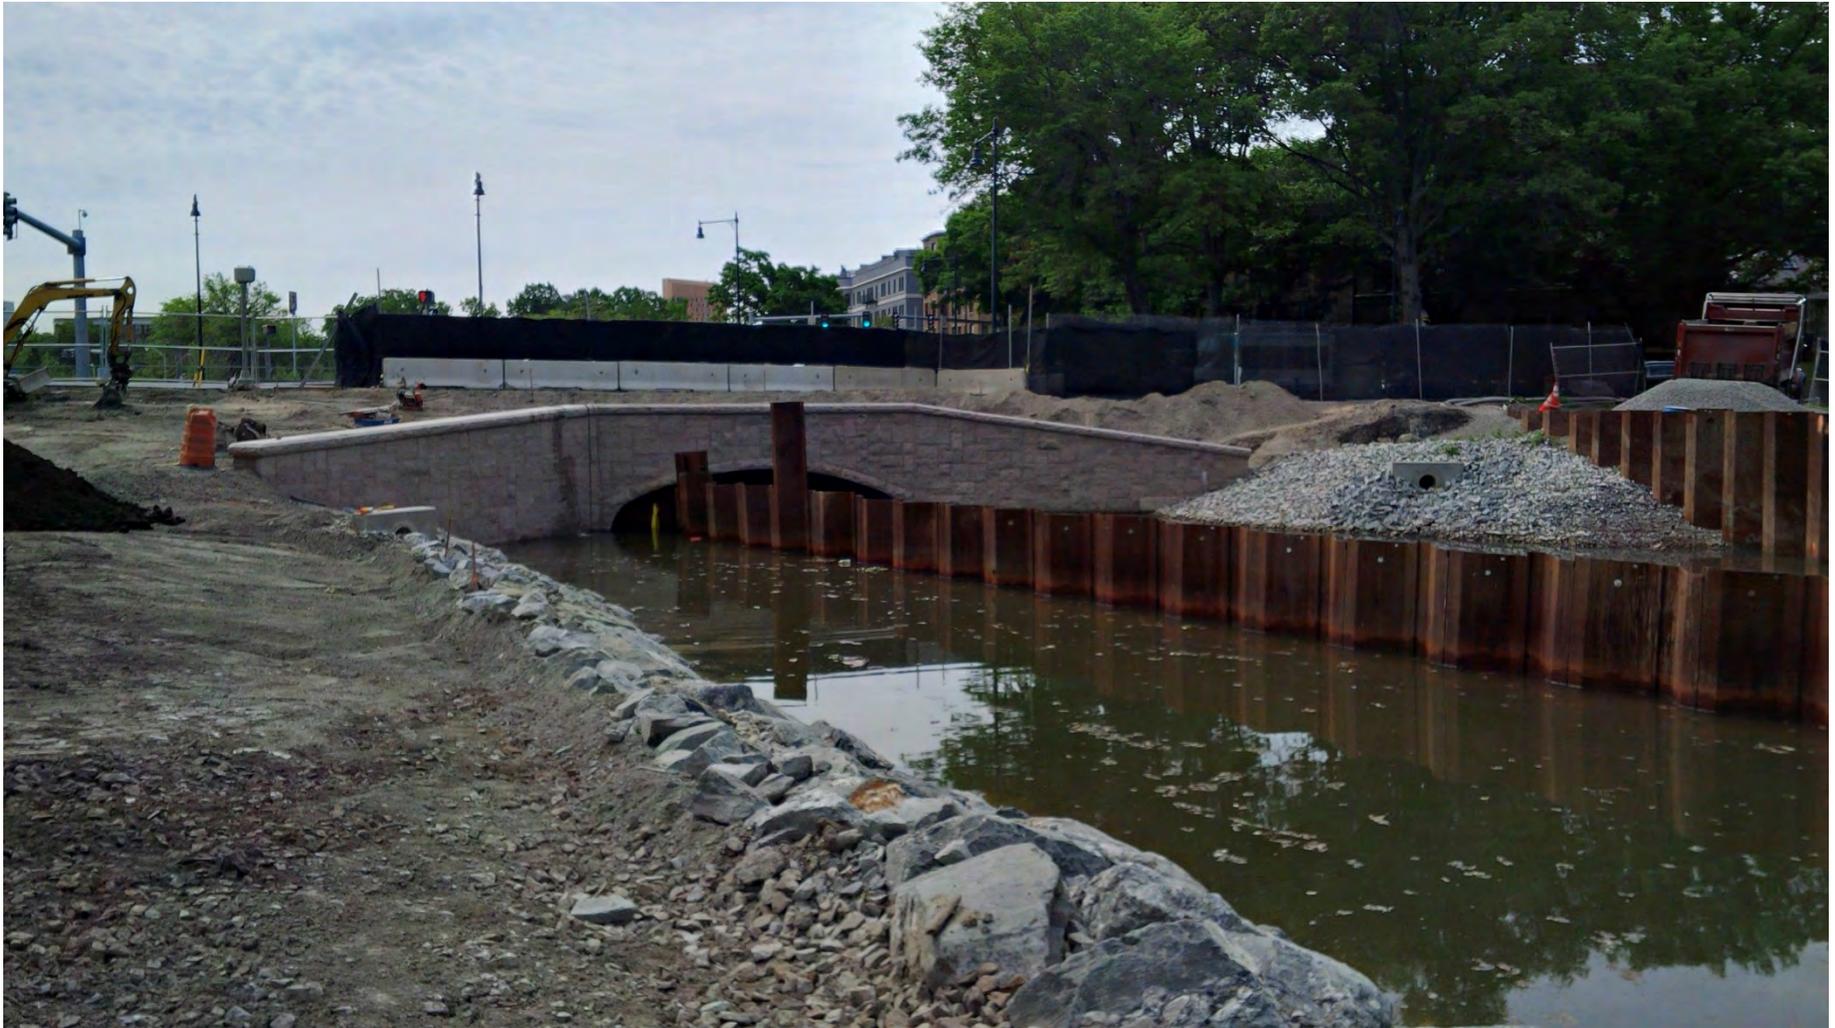
Upstream Riverway Culvert – river pumped into the left side, looking downstream, (northside) of the FRM channel in anticipation of extracting the river diversion steel sheeting; continued backfilling behind the wing wall; and beginning of loam and planting on the upland bank – mid June 2016.

- At the upper end of the project limits, downstream of the Flow Restriction Control Structure (FRCS), the sediment has been removed in order to construct the northside of the flood risk management (FRM) channel, to include stone protection/bank stabilization, at the Riverway. In addition, the existing Riverway Intake Structure was removed mid-March; and the upstream northwest wing wall of the new Riverway culvert was cast and granite veneer installed late May. Upcoming activities include continued final grading and planting of this area; installation of the temporary landscape protection fencing and permanent steel handrail at the culvert headwall; and the extraction of the river diversion steel sheeting which will allow the Muddy River to flow in the newly constructed FRM channel.

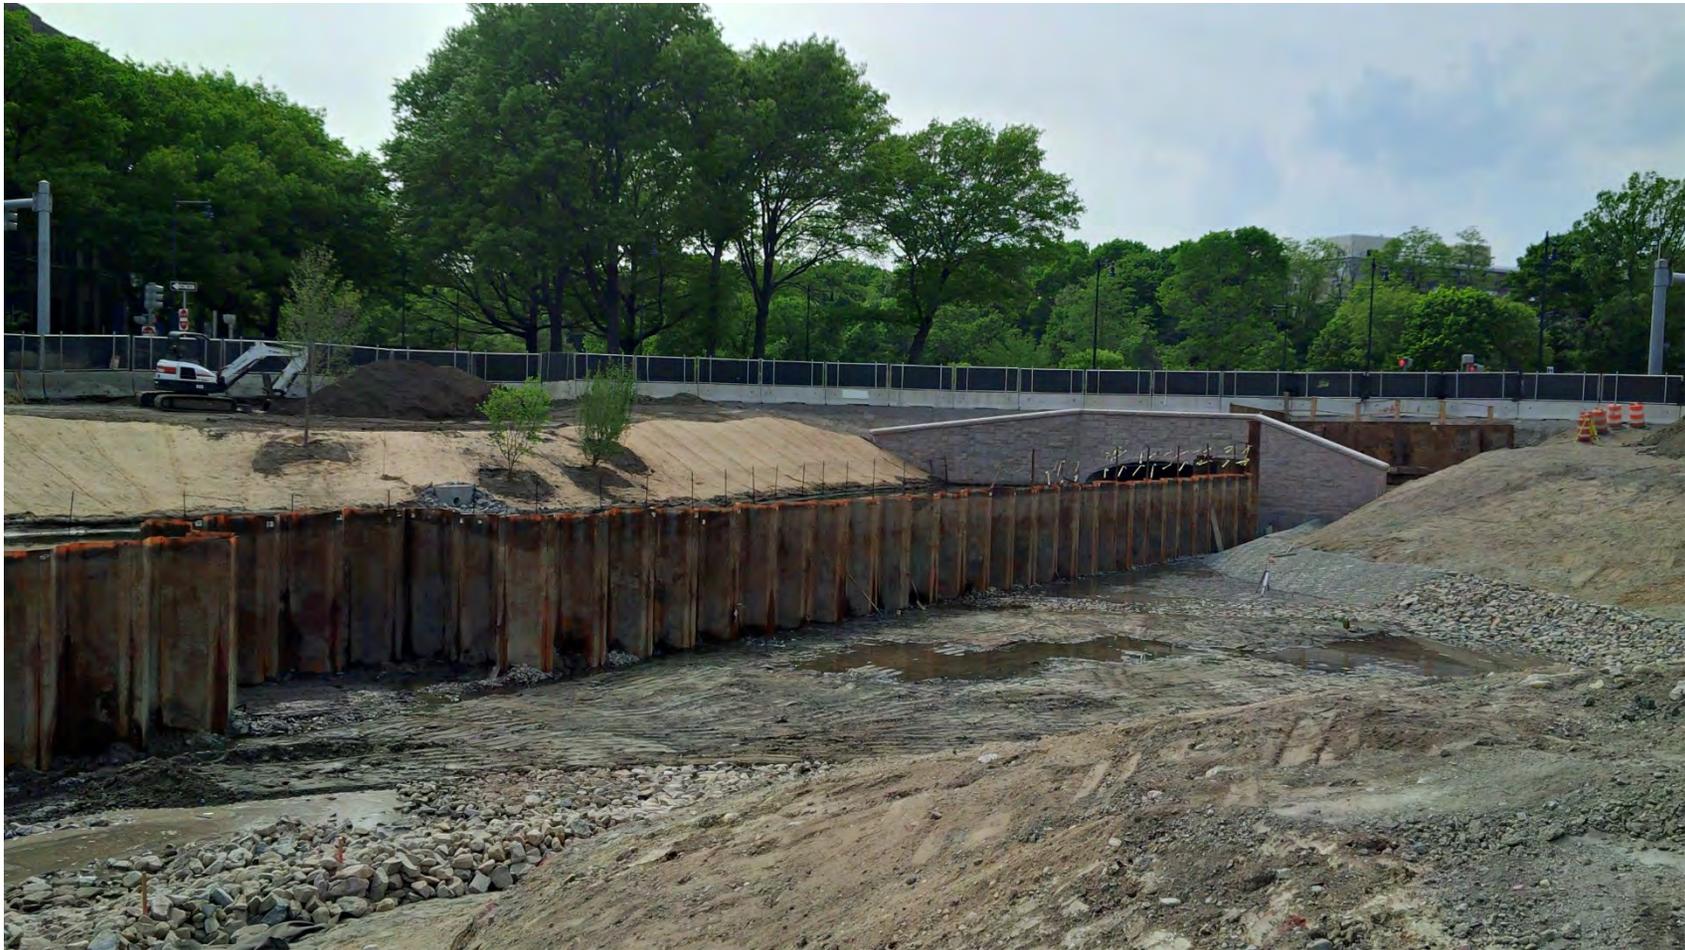
Downstream Riverway Culvert in the former Sears Parking Lot – looking upstream – note the shaping of the bank on the northside to construct the FRM channel and the beginning of planting on the southside of the channel – late May 2016.

- With the construction of the downstream northeast wing wall of the Riverway Culvert; the relocation of the existing 24" sewer line; and the excavation and removal of the existing twin 72" culverts in the former Sears Parking Lot, the lower portion of the FRM channel on the northside was completed at the end of May such that it allowed the filling of the northside with the river. This allowed for the planting of the wetland plants in the last week. Upcoming activities include final grading of the upland banks; continued planting on the upland areas; final construction of the meandering path around the river; installation of the temporary landscape protection fencing and permanent steel handrail at the culvert headwalls; and the extraction of the river diversion steel sheeting which will allow the Muddy River to flow fully in the former Sears Parking Lot.

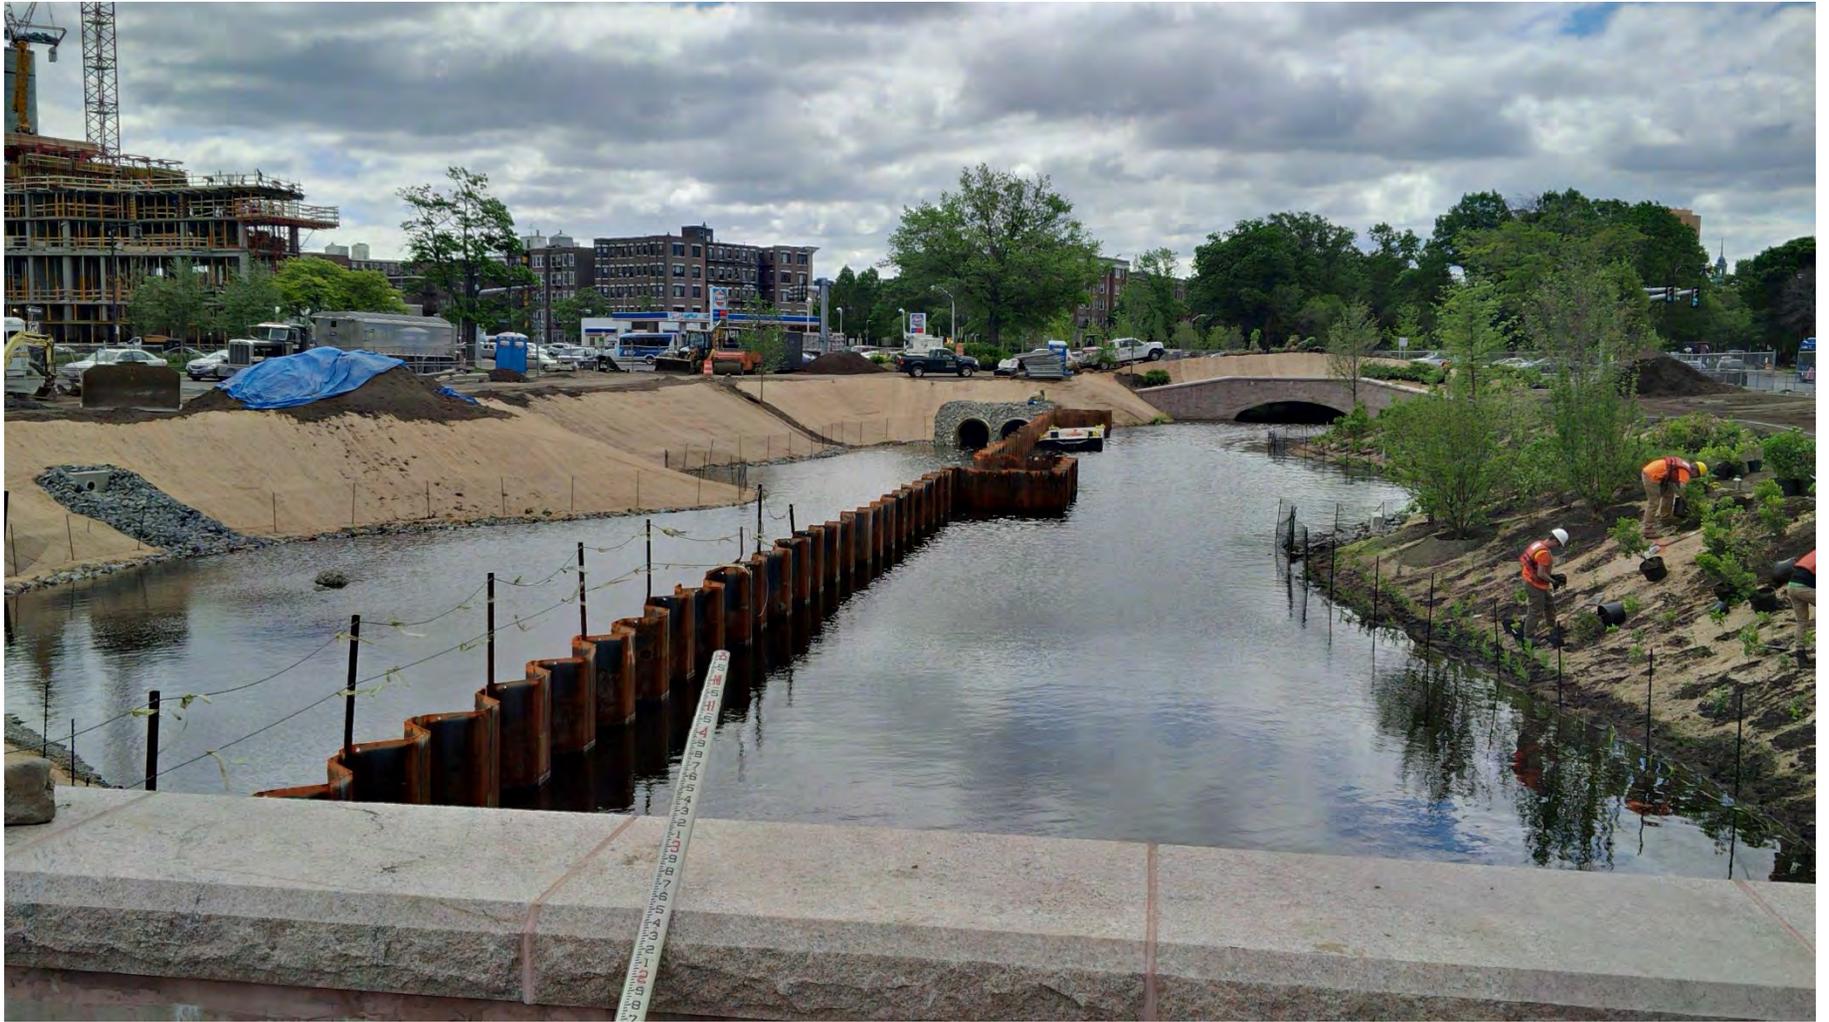
Former Sears Parking Lot – looking downstream at the new Brookline Avenue Culvert – filling of the left side, looking downstream, of the FRM channel once the lower portion of the channel was constructed; note the continued planting on the right side (southside) of the bank of the channel – early June 2016.

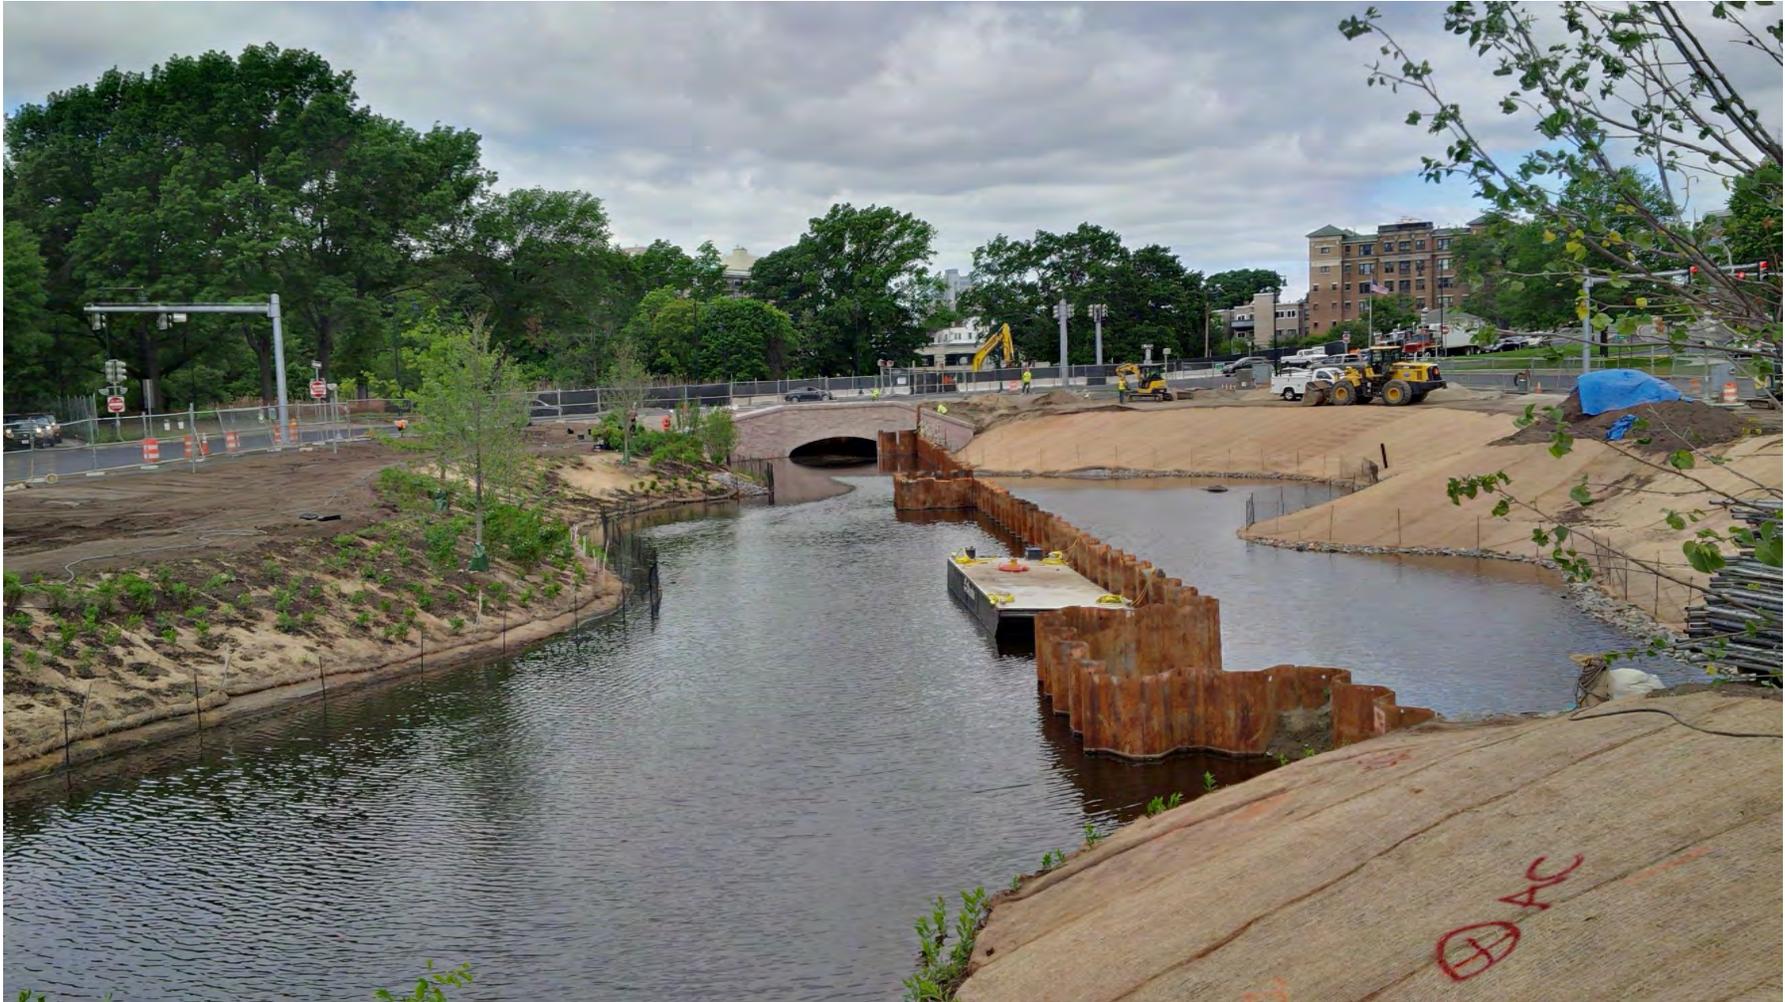
Former Sears Parking Lot – looking upstream at the new Riverway Culvert – filling of the northside of the FRM channel once the lower portion of the channel was constructed; note the continued planting on the southside of the bank of the channel – early June 2016.

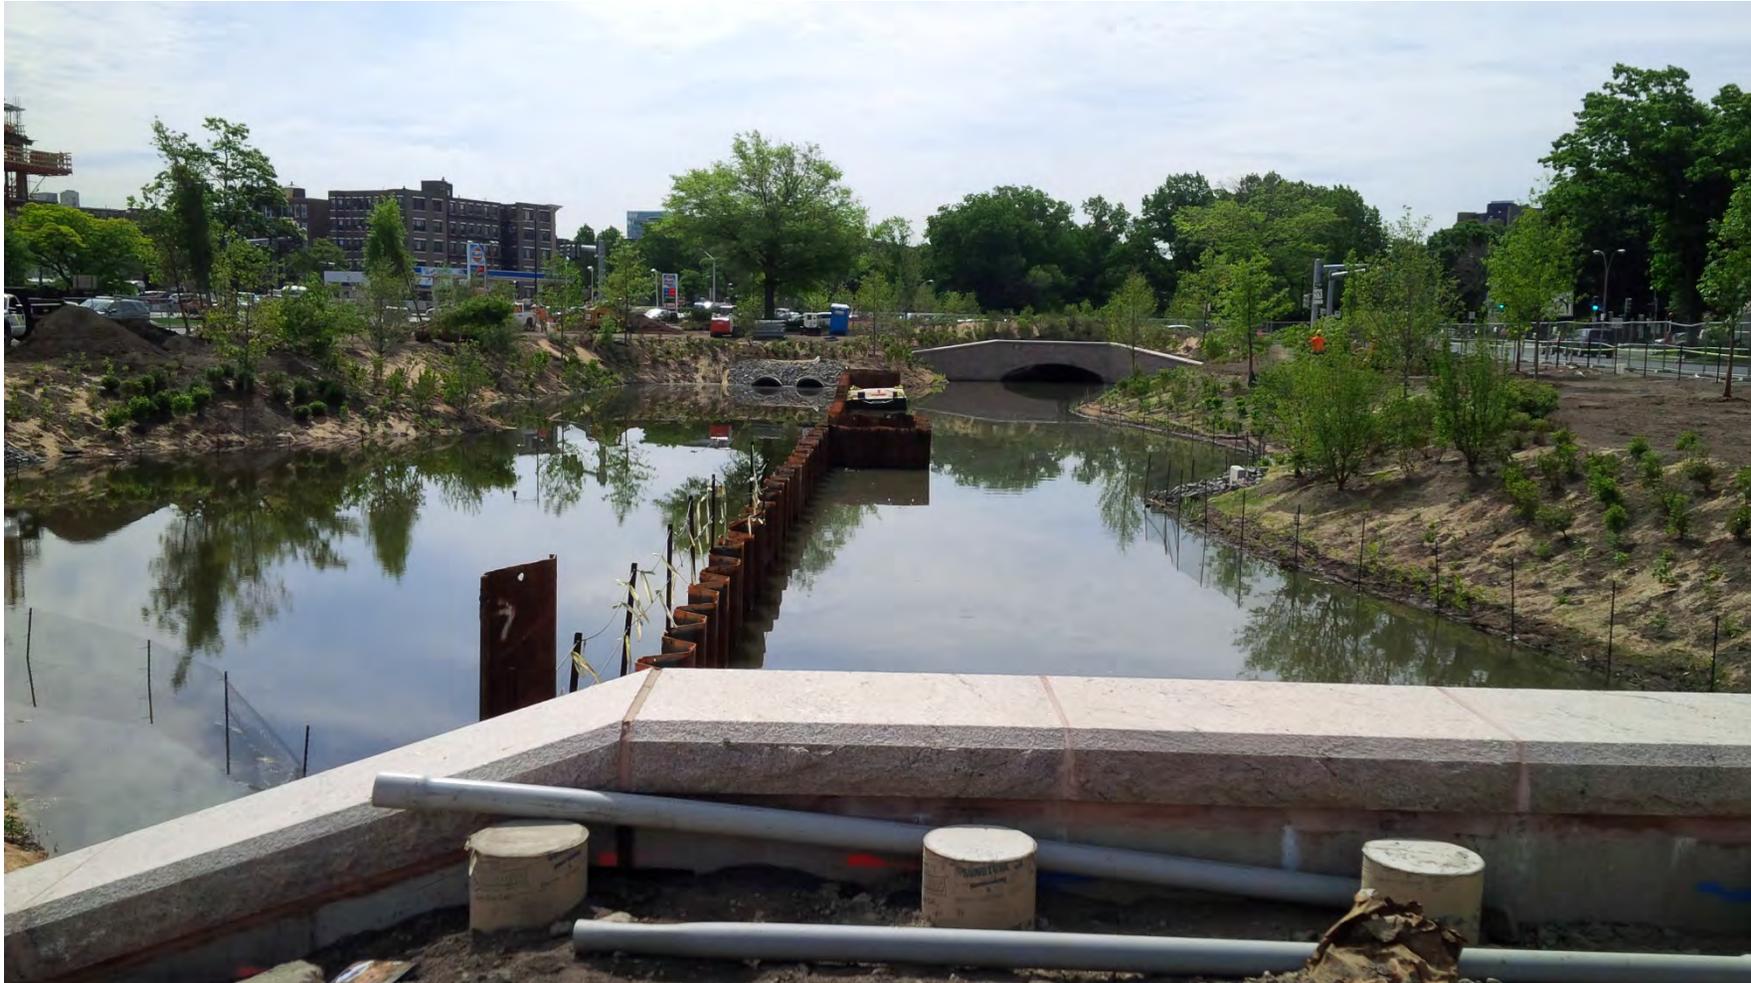
Former Sears Parking Lot – looking downstream at the new Brookline Avenue Culvert – filling of the left side (looking downstream) of the FRM channel is complete, awaiting the extraction of the river diversion sheeting. Note that both banks have been planted; and plantings will continue. Note also the footings for the permanent steel handrail at the culvert headwall – mid June 2016.

- With the removal of the existing twin 72" culverts, the downstream northeast wing wall of the Brookline Avenue Culvert was constructed early May and the FRM channel constructed in mid-May. Since that time, plantings have been installed and the river diversion steel sheeting was removed late May which completed the daylighting of the former Jug Handle Roadway. Upcoming activities include installation of the permanent steel handrail at the new downstream Brookline Avenue Culvert headwall.

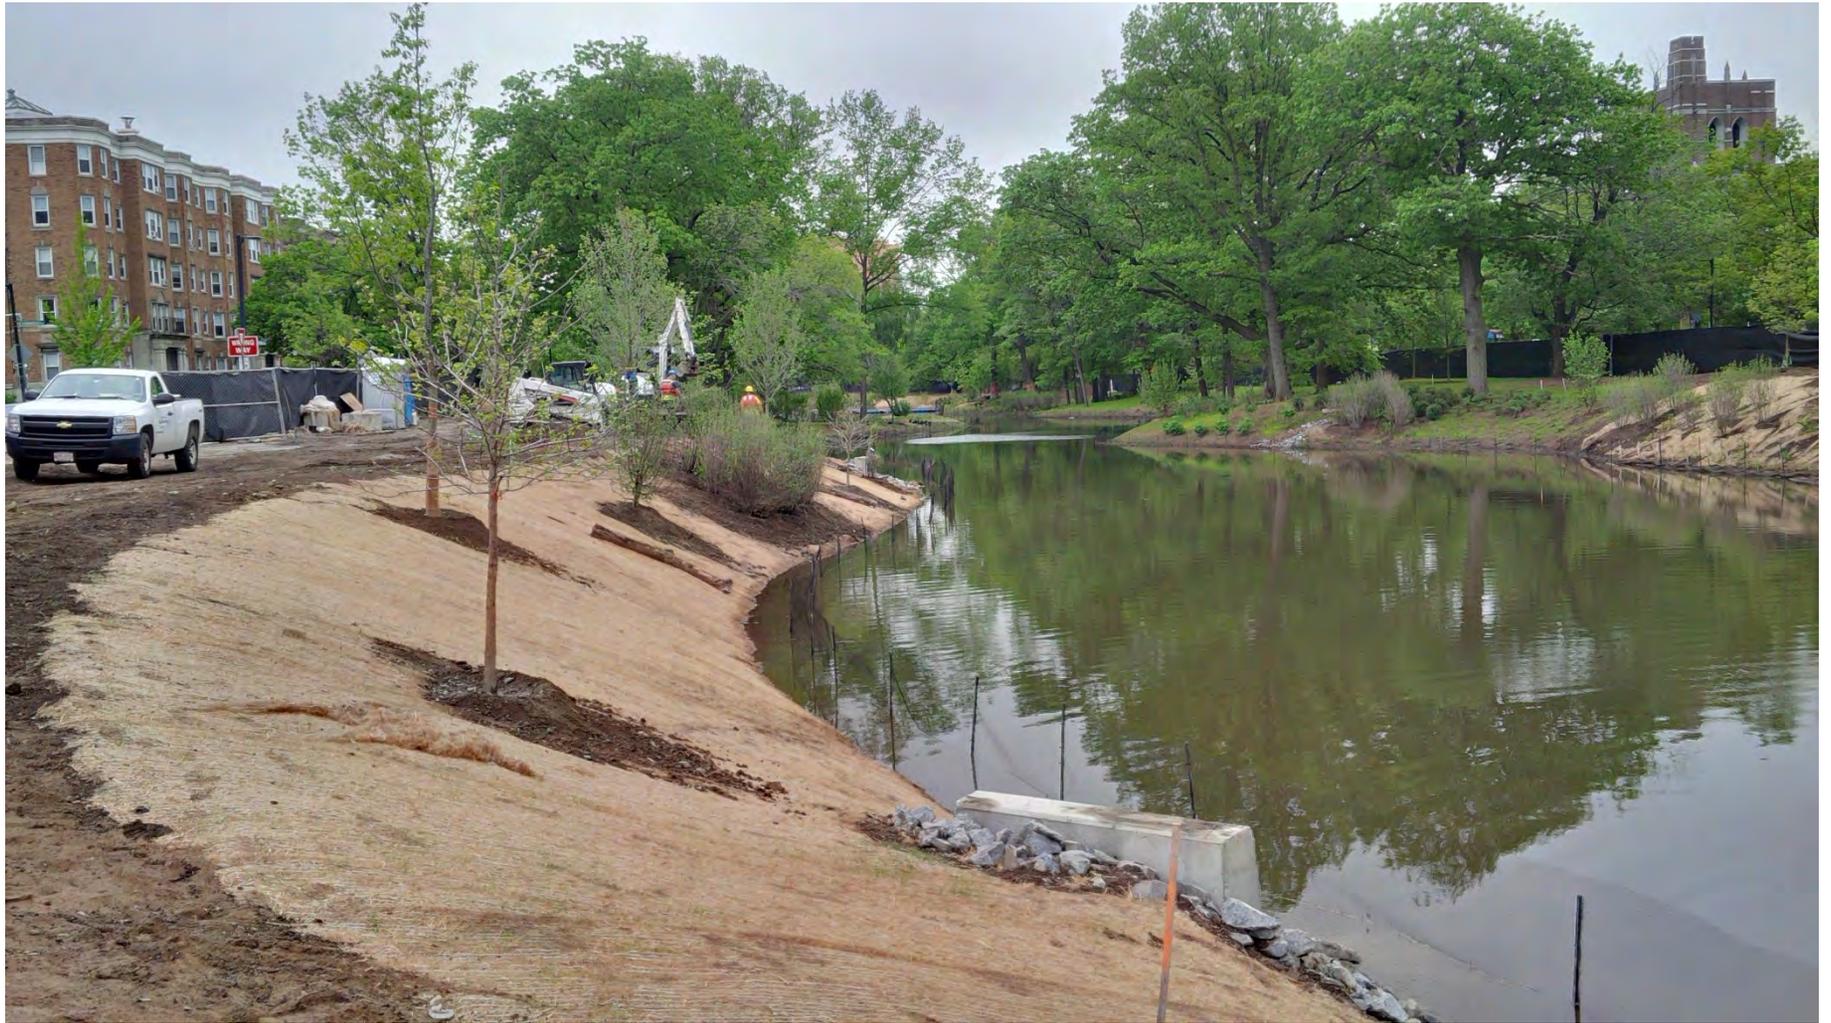
Former Jug Handle Roadway – area completely daylighted and river diversion sheeting extracted. Note the beginning of plantings on the left bank, looking downstream – late May 2016.

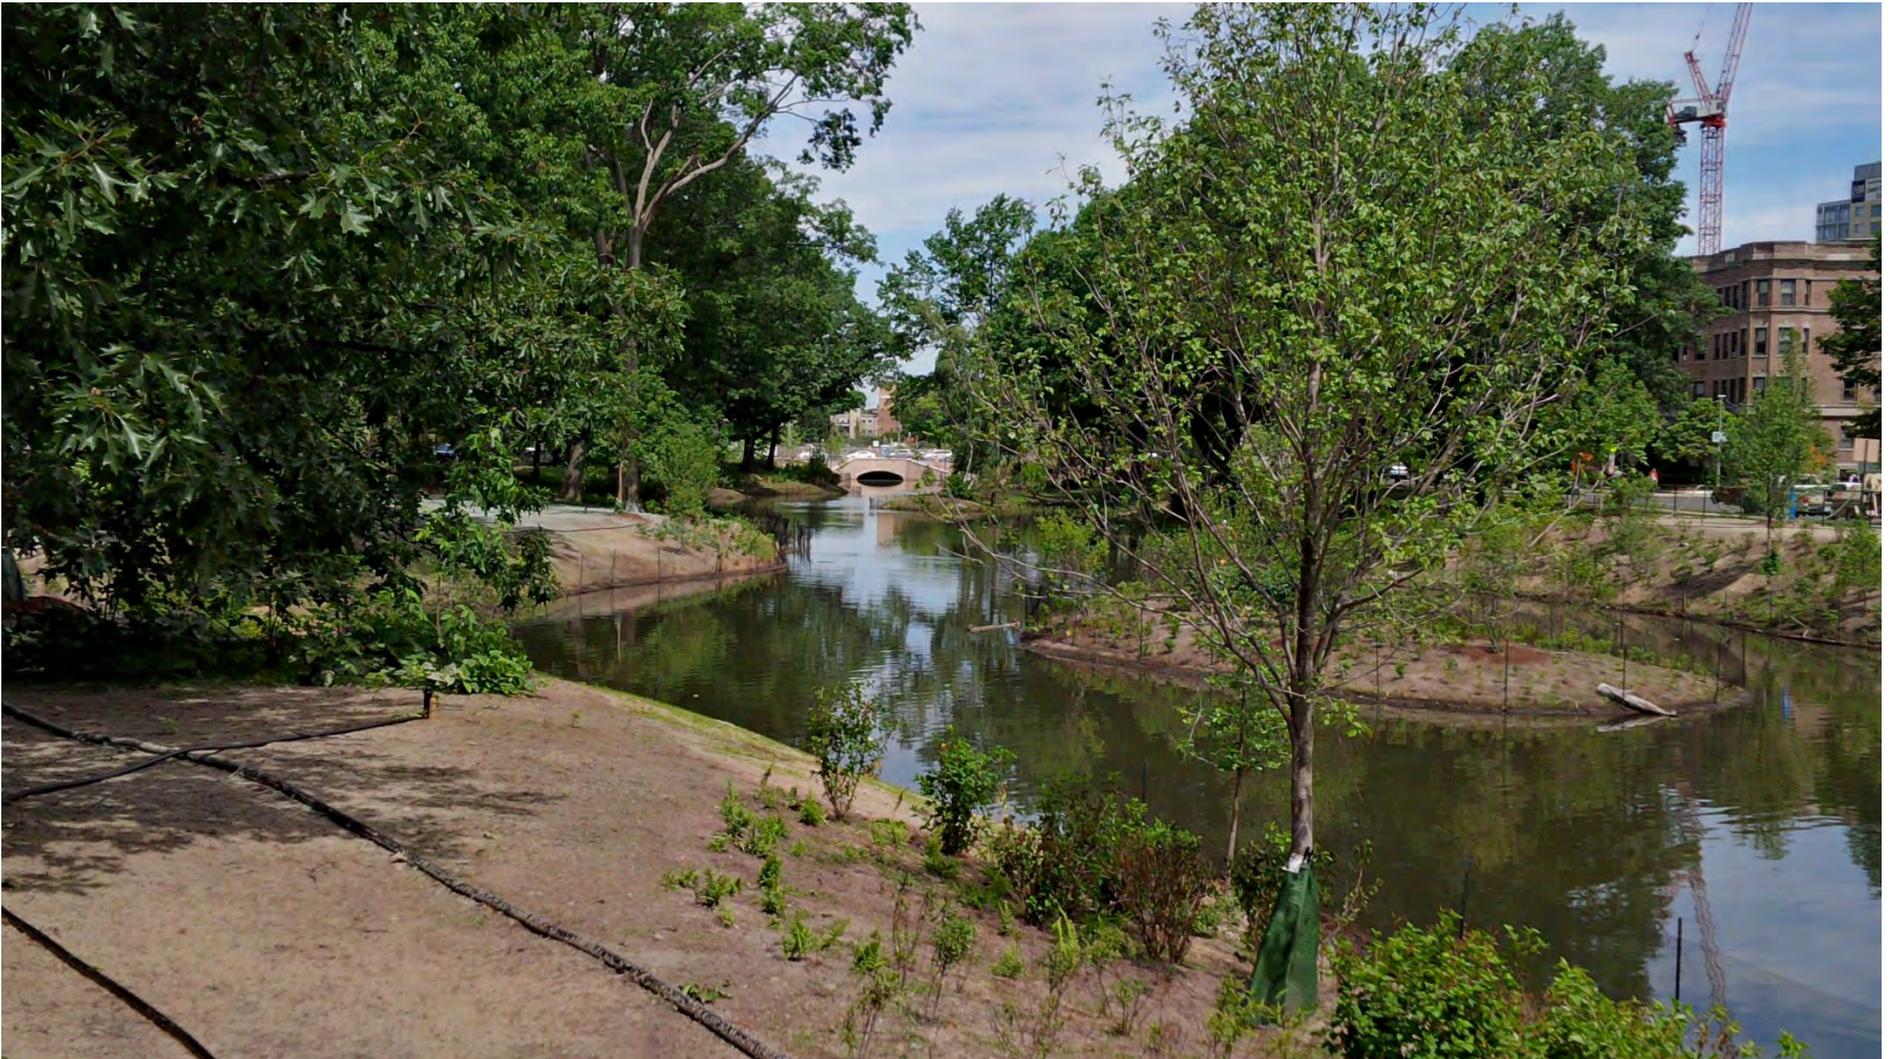
Upper Fens Pond area – looking upstream towards the new Brookline Avenue Culvert. Note the plantings on the banks and on the historic Olmsted Island – mid June 2016.

- In the Upper Fens Pond area, upcoming activities will include continued inspection, maintenance and care of the plantings; restoration of the impacted landscaped areas; and completion of the temporary landscape protection fencing and installation of the permanent steel handrail at the upstream Avenue Louis Pasteur culvert headwall.
