Muddy River Flood Risk Management & Environmental Restoration Project
Phase 1 Construction Activities Next 90 Days
June 2016

Muddy River Flood Damage Reduction & Environmental Restoration Project

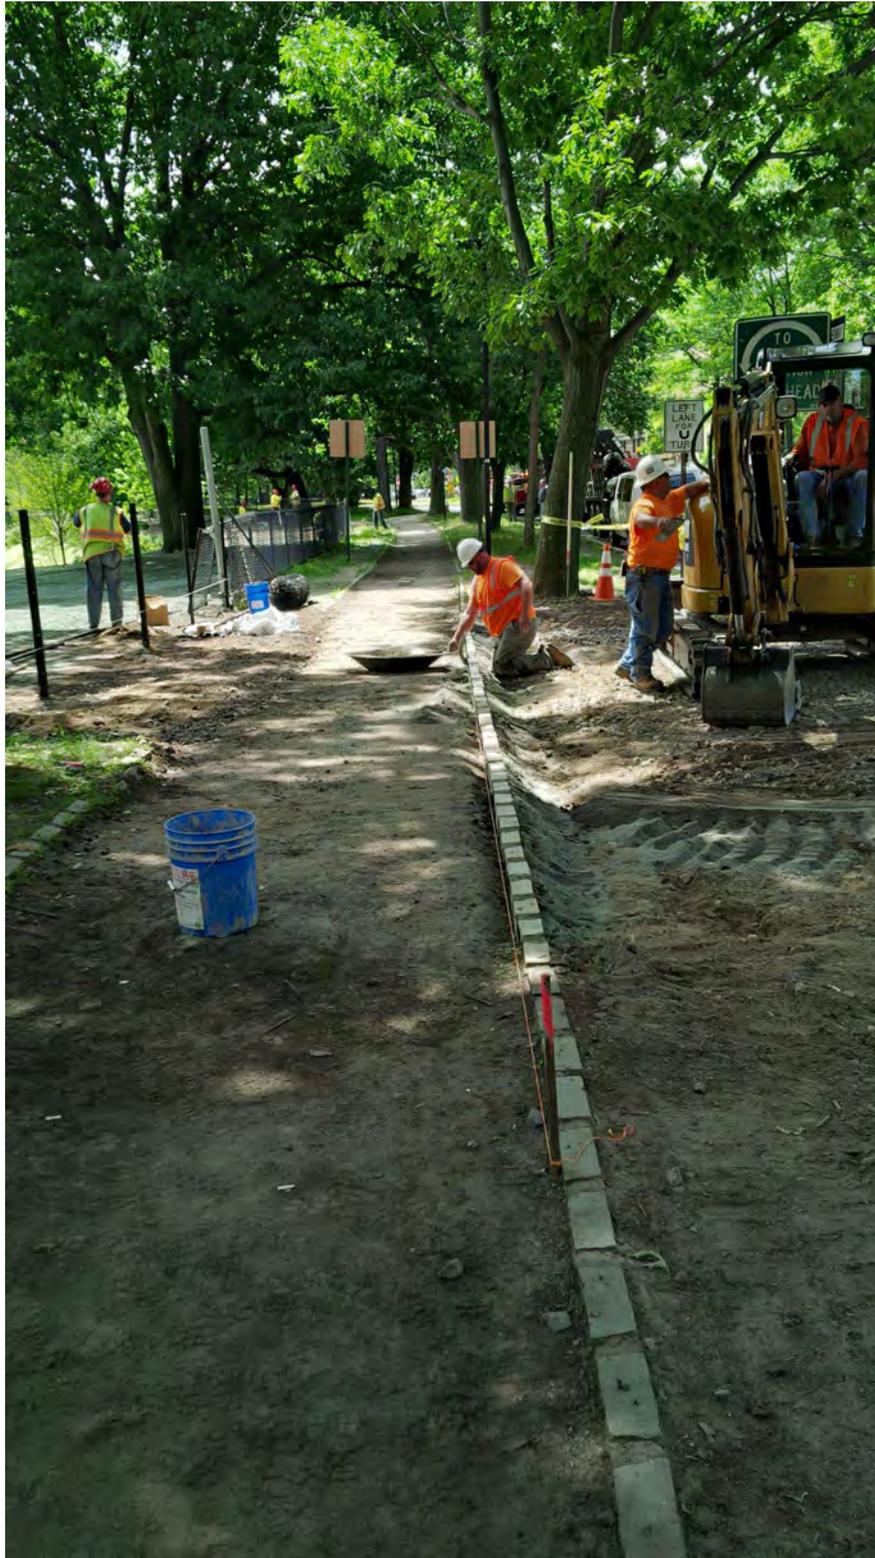
Reconstruction of impacted area – resetting the granite blocks delineating the stone dust pathway along the Fenway roadway. Note the installation of the temporary landscape protection fencing in the location of the construction access gate, which will no longer be used – mid-June 2016.

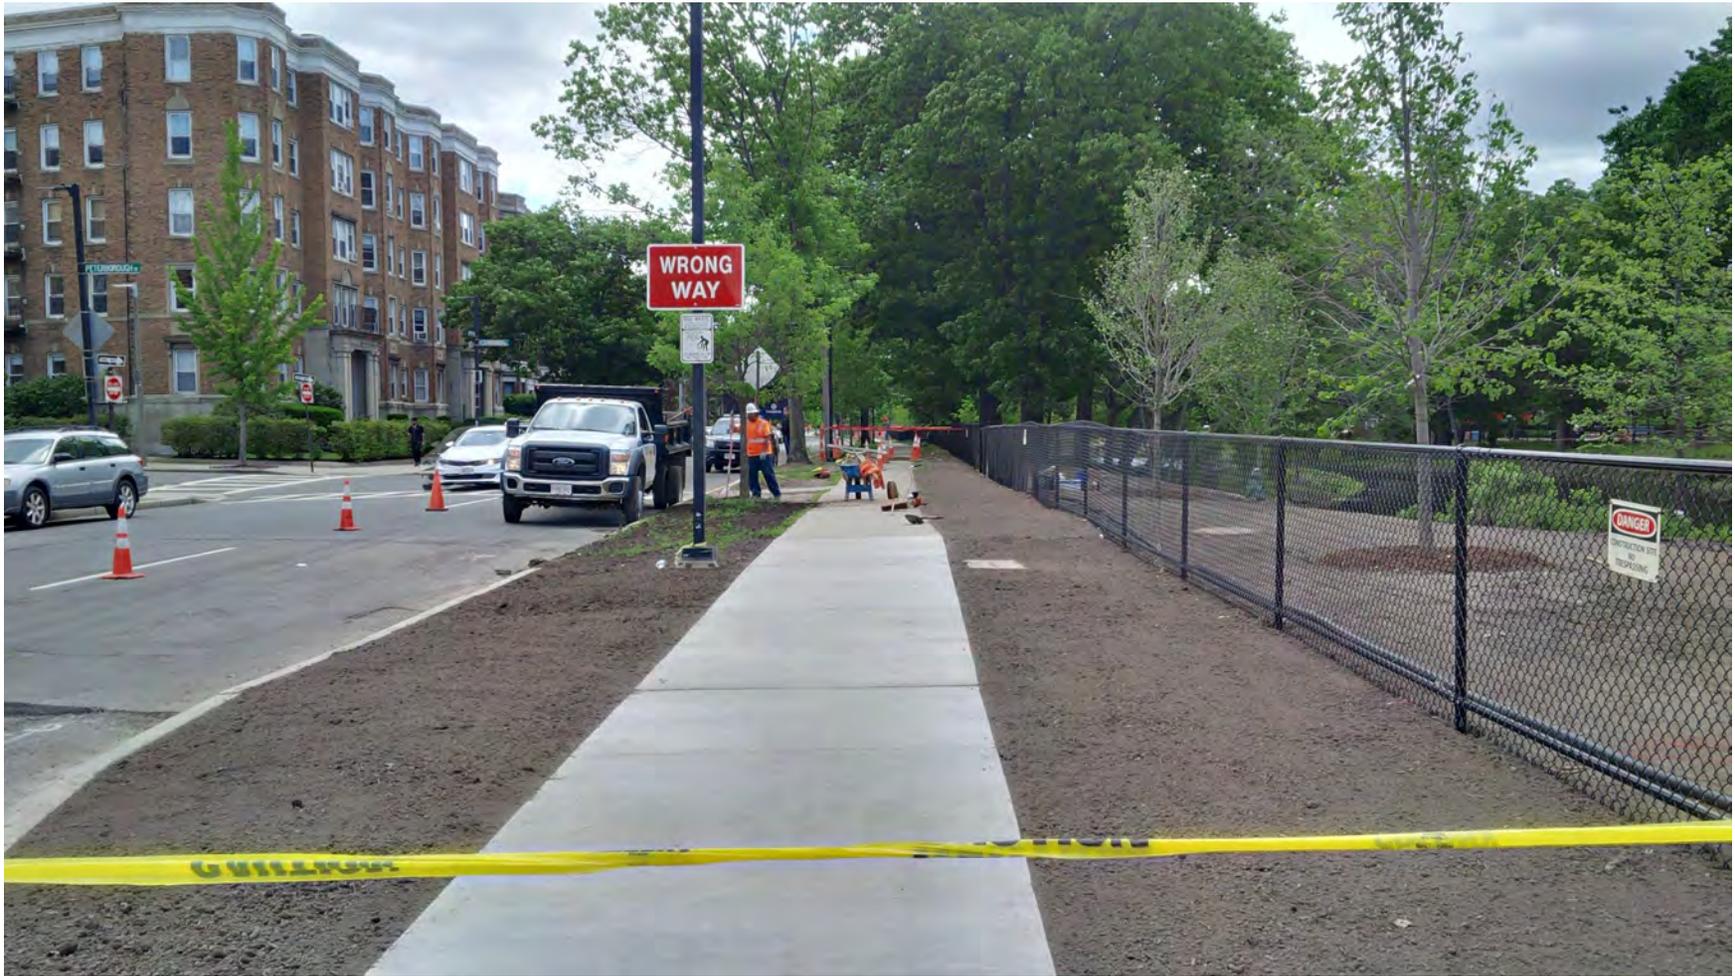
Construction of the end condition concrete sidewalk on Park Drive, in the vicinity of the former Jug Handle Roadway. Note the new loam on impacted landscaped areas, ready for hydroseed; and the installed temporary landscape protection fencing – early June 2016.

- Site work around the project – permanent sidewalk reconstruction on Brookline Avenue and Park Drive was completed early June; and final pavement on the majority of the roadways was completed early June. Upcoming activities include construction of the asphalt sidewalk in the vicinity of the new Riverway Culvert; final pavement on the stretch of Park Drive in front of the Landmark Center; and permanent striping of the newly paved roadways.
