US Army Corps of Engineers®
New England District

WOODS HOLE CHANNEL (THE STRAIT)
BRANCH AND BROADWAY CHANNELS
WOODS HOLE, MASSACHUSETTS
CONDITION SURVEY
13-FOOT CHANNELS

SHEET IDENTIFICATION
V-101
SHEET 1 OF 1

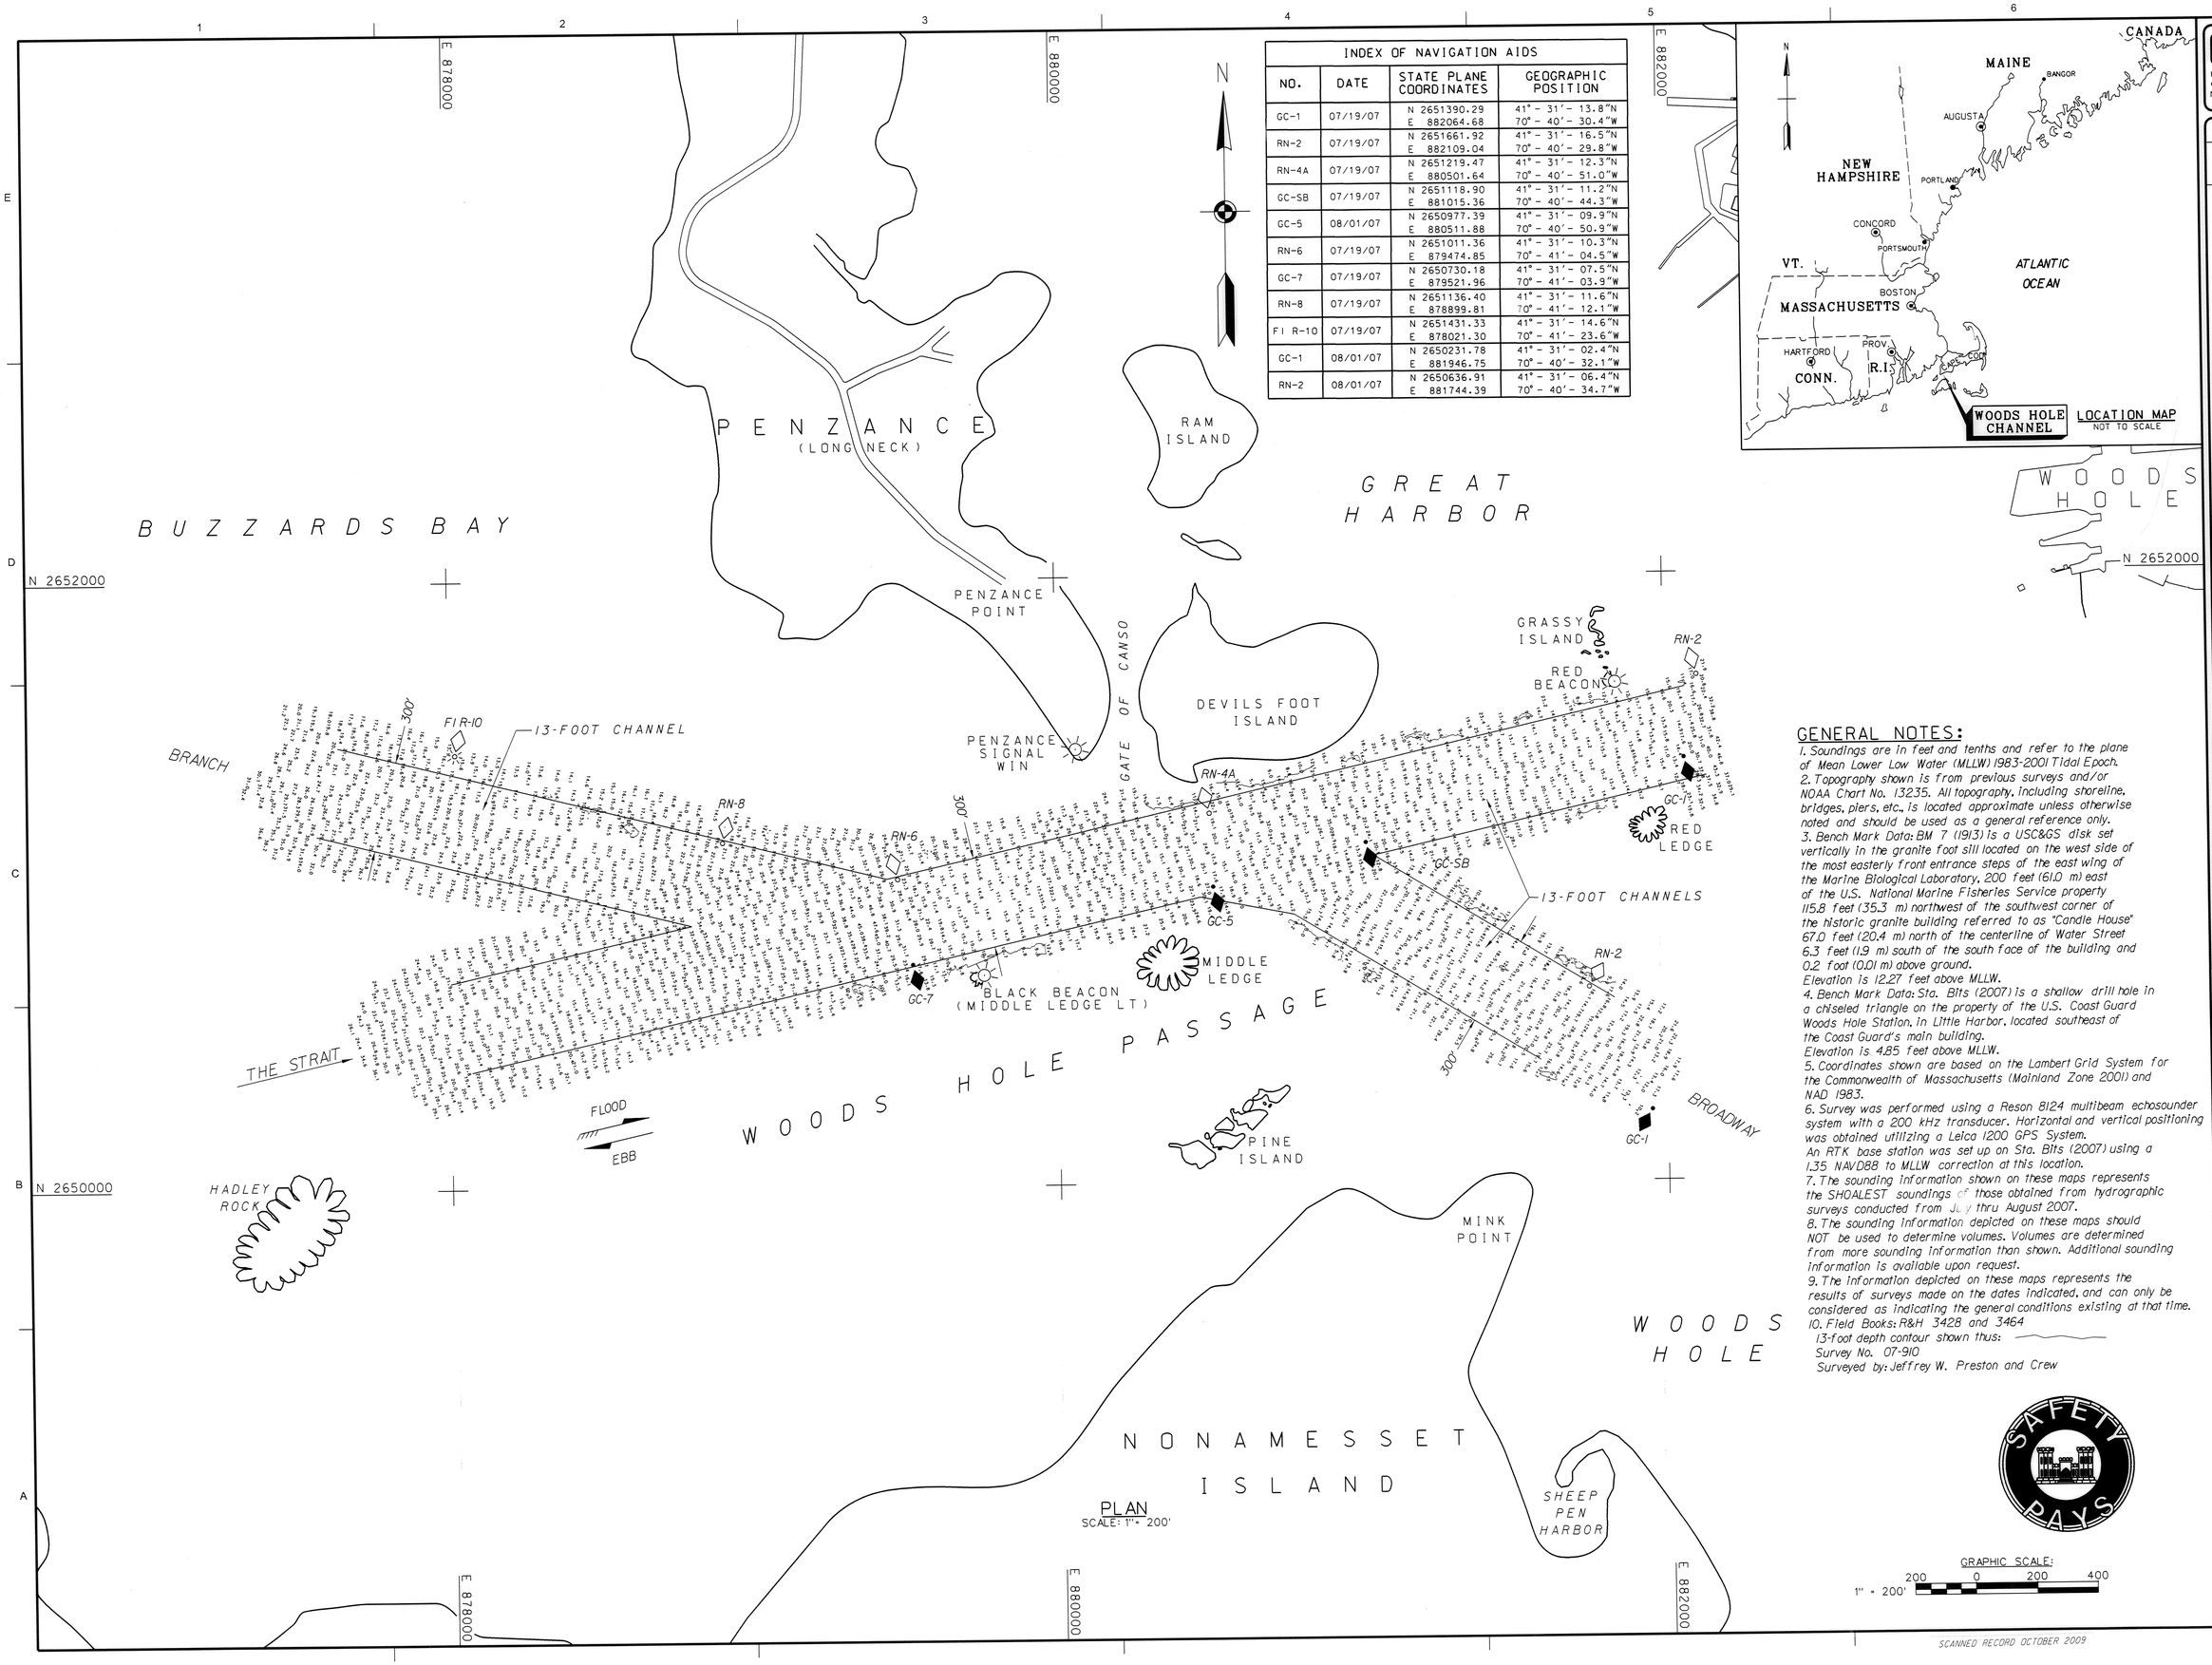
7. The sounding information shown on these maps represents the SHOALEST soundings of those obtained from hydrographic surveys conducted from July thru August 2007.

9. The information depicted on these maps represents the results of surveys made on the dates indicated, and can only be considered as indicating the general conditions existing at that time.
