Monitoring Survey at the Rockland Disposal Site
September 2003

Disposal Area Monitoring System DAMOS

Contribution 156
August 2004

US Army Corps of Engineers ®
New England District

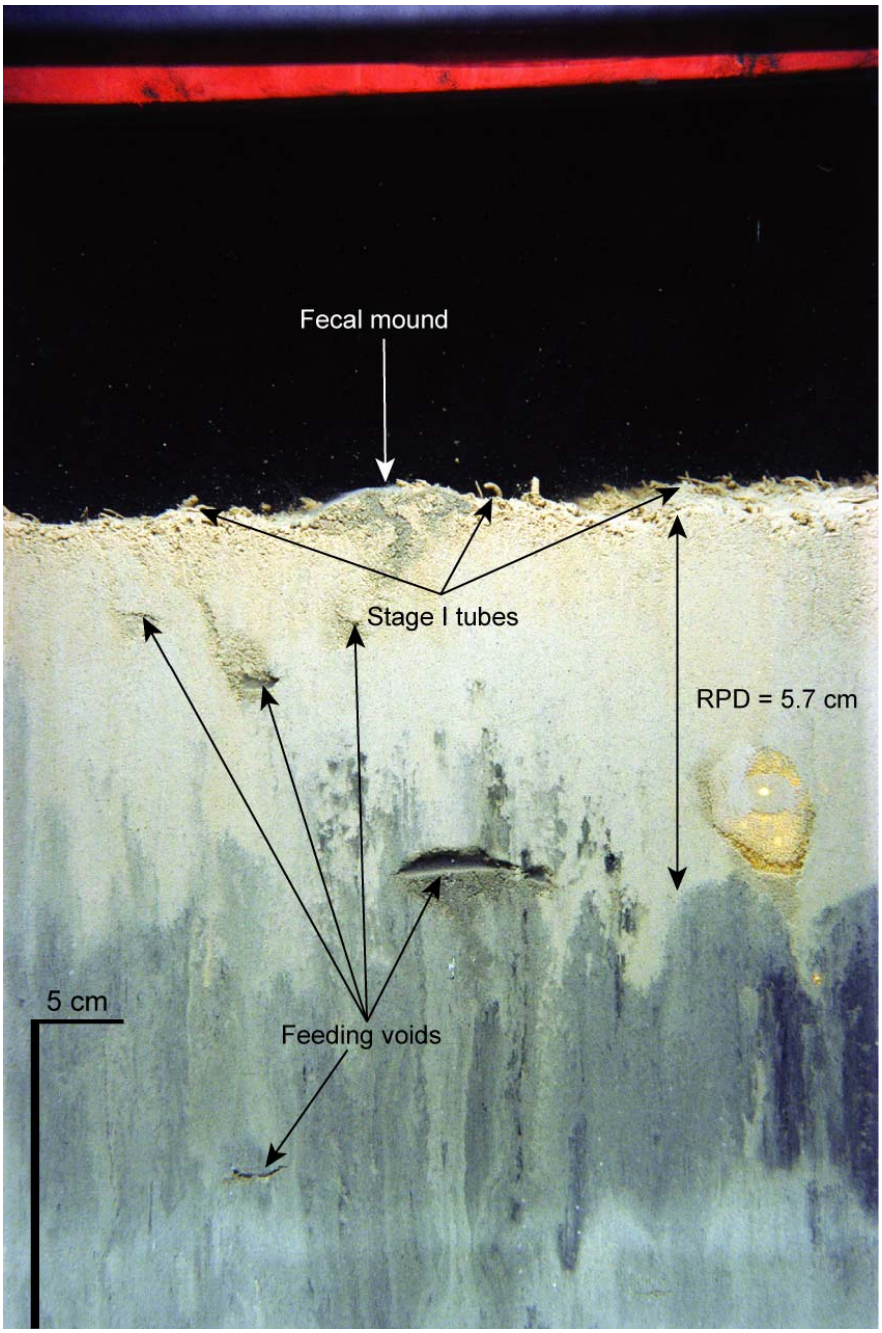
Figure 3-11. SPI image from East Reference Area Station ER-1 illustrating the soft, muddy sediment that typified all three RDS reference areas. The sediment is uniformly silt-clay (grain size major mode >4 phi), with the well-oxidized surface layer appearing light brown or tan in color, and the underlying reduced sediments appearing gray to black. Both the numerous small polychaete tubes visible at the sediment surface as well as several feeding voids at depth indicate a relatively diverse benthic community

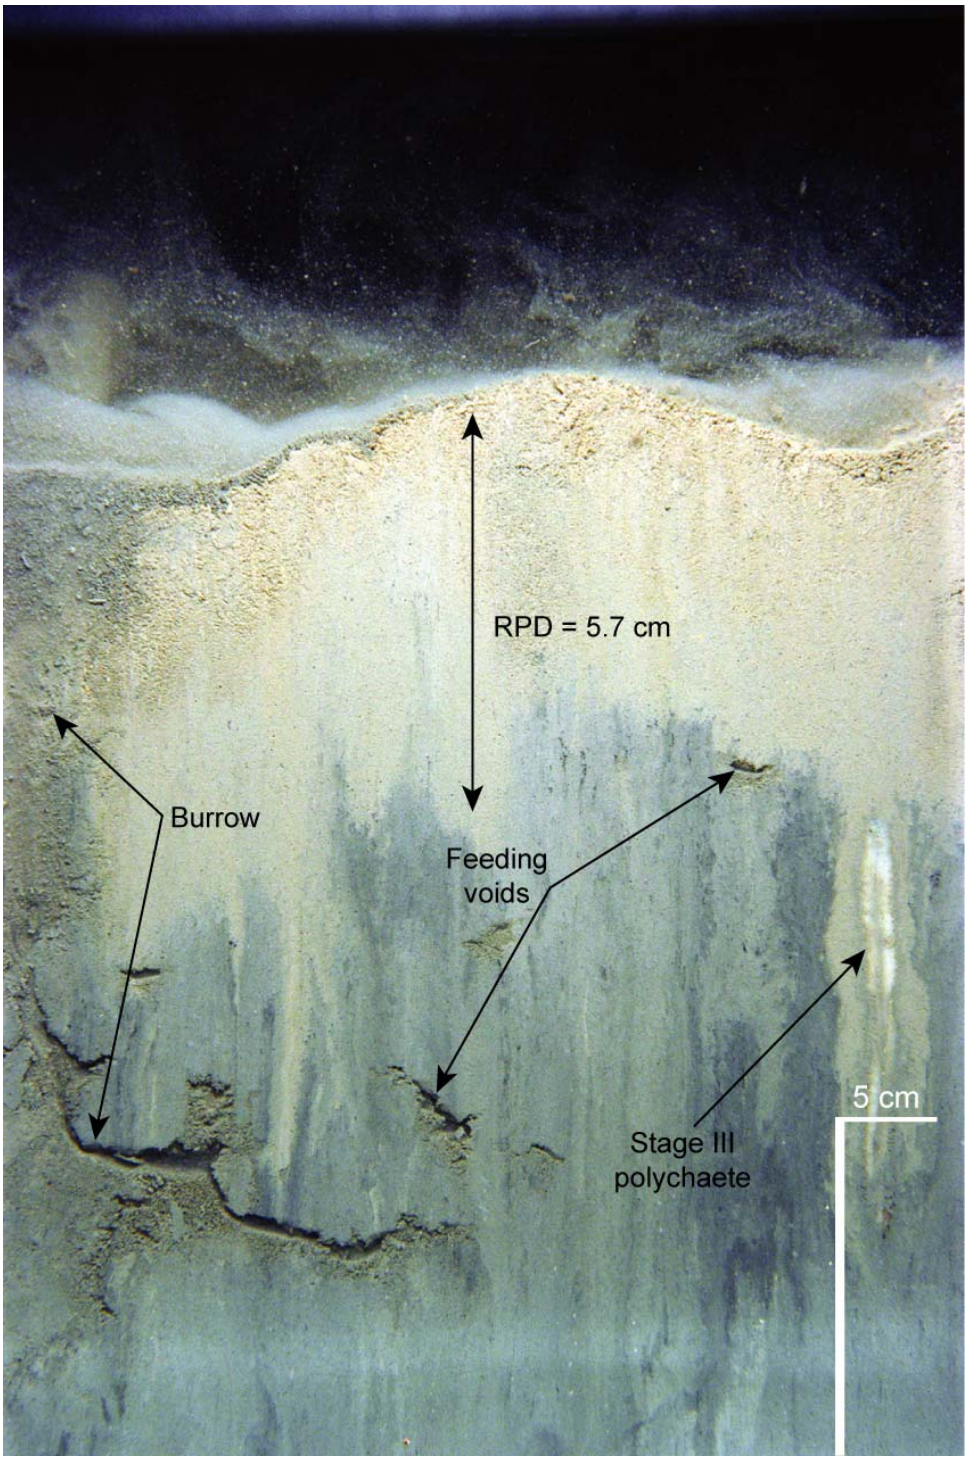
Figure 3-13. SPI image from North Reference Area Station NR-3 showing a well-developed RPD and abundant evidence of Stage III infaunal activity at depth (e.g., feeding voids, a burrow and a large errant polychaete).

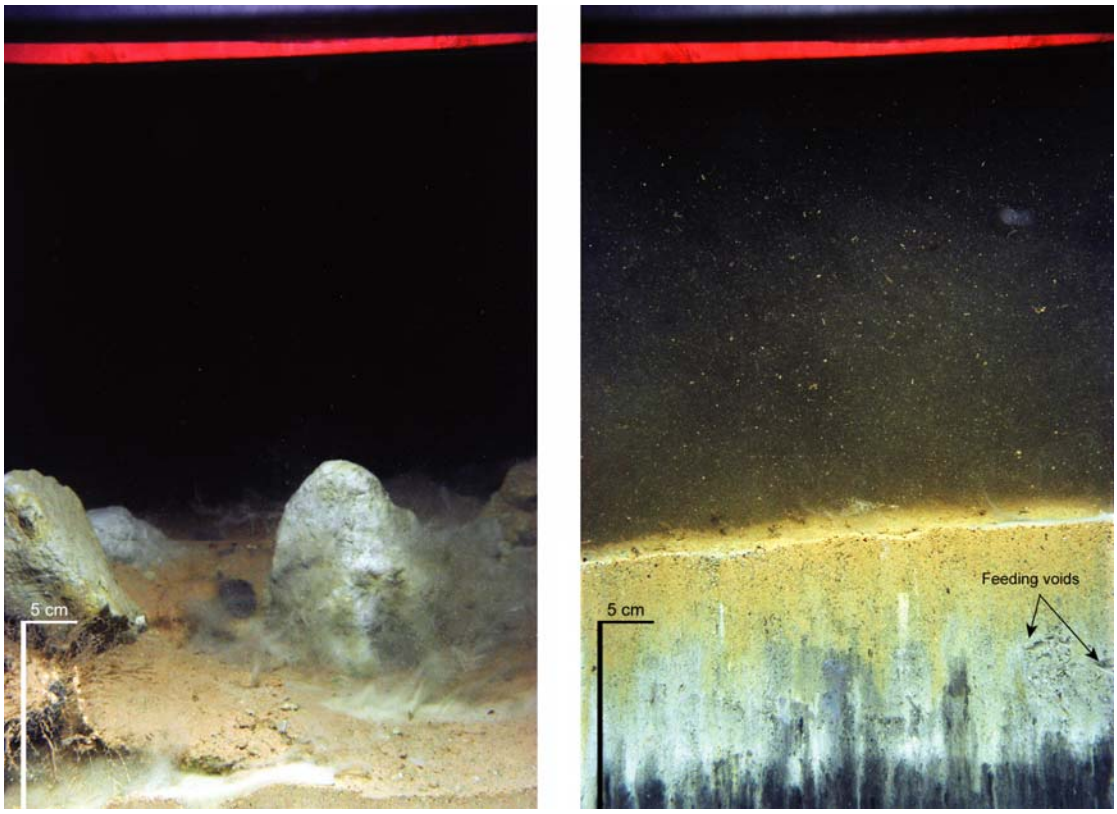
Figure 3-17. SPI images illustrating two types of recent dredged material observed at the inner stations. The left image shows pebble- to cobble-sized rocks at Station I15, while the right image shows muddy sediment with a significant component of very fine sand (major mode of 4-3 phi) at Station I16. Because the layer of recent dredged material in the right image extends from the sediment surface to below the imaging depth of the sediment-profile camera, its measured thickness is expressed as >7.2 cm (i.e., greater than the camera penetration depth). Two feeding voids also are visible within the dredged material in the right image.

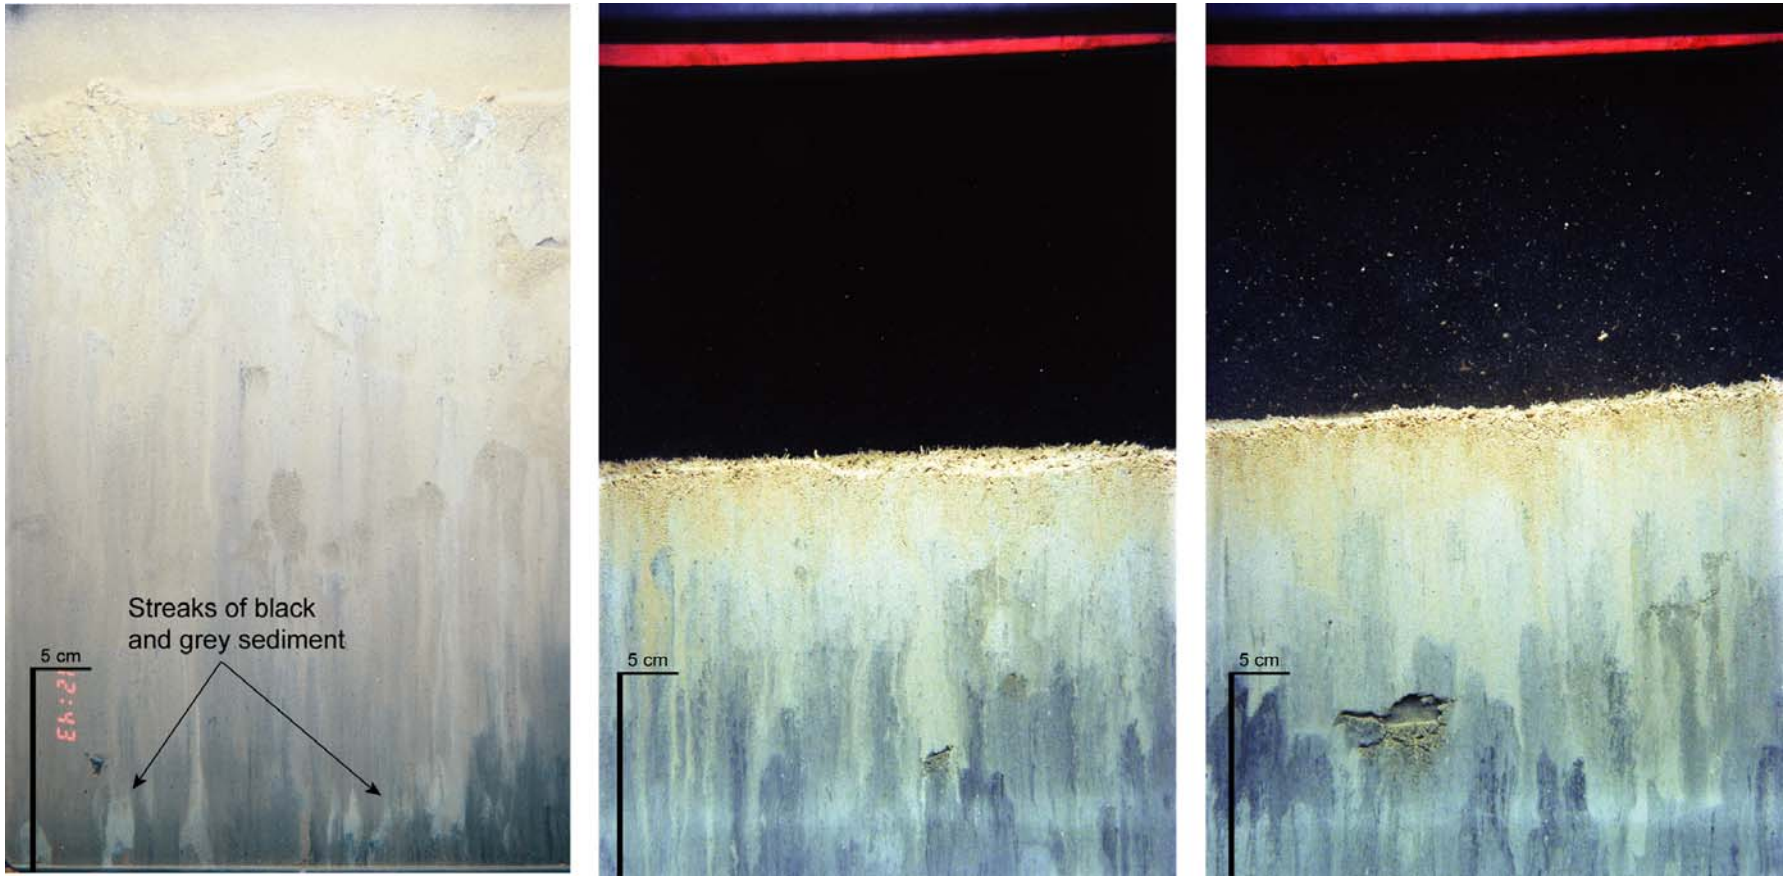
The 2003 SPI survey results therefore suggest two possibilities: (1) due to the acknowledged difficulties of distinguishing between the two types of sediments, ambient sediment was incorrectly identified as old dredged material at some of the inner and outer stations in 2000, or (2) old dredged material layers that were correctly identified as such in 2000 have continued weathering to the point of becoming indistinguishable from ambient sediments. Regarding this second possibility, selected images from Station I7 help to illustrate how old dredged material at some stations has weathered to the point of becoming indistinguishable from ambient sediment (Figure 4-1).

Figure 4-1. SPI images obtained at Station I7 in the September surveys of 2000 and 2003 compared to East Reference Area Station ER2. Deeper penetration of the SPI camera in 2000 (left) revealed streaks of black and gray sediment at depth that were interpreted as evidence of an old dredged material layer exceeding the camera's imaging depth. Such evidence was not observed in the 2003 survey; the sediment at Station I7 (center) appeared similar to the ambient sediment at the reference area (right).
