4. TITLE AND SUBTITLE
Monitoring Survey at the Tupper Ledge Disposal Site, August 2001

MONITORING SURVEY AT THE TUPPER LEDGE DISPOSAL SITE AUGUST 2001

Contract No. DACW33-00-D-0001
Work Order No. 10, Task 3
SAIC Report No. 570

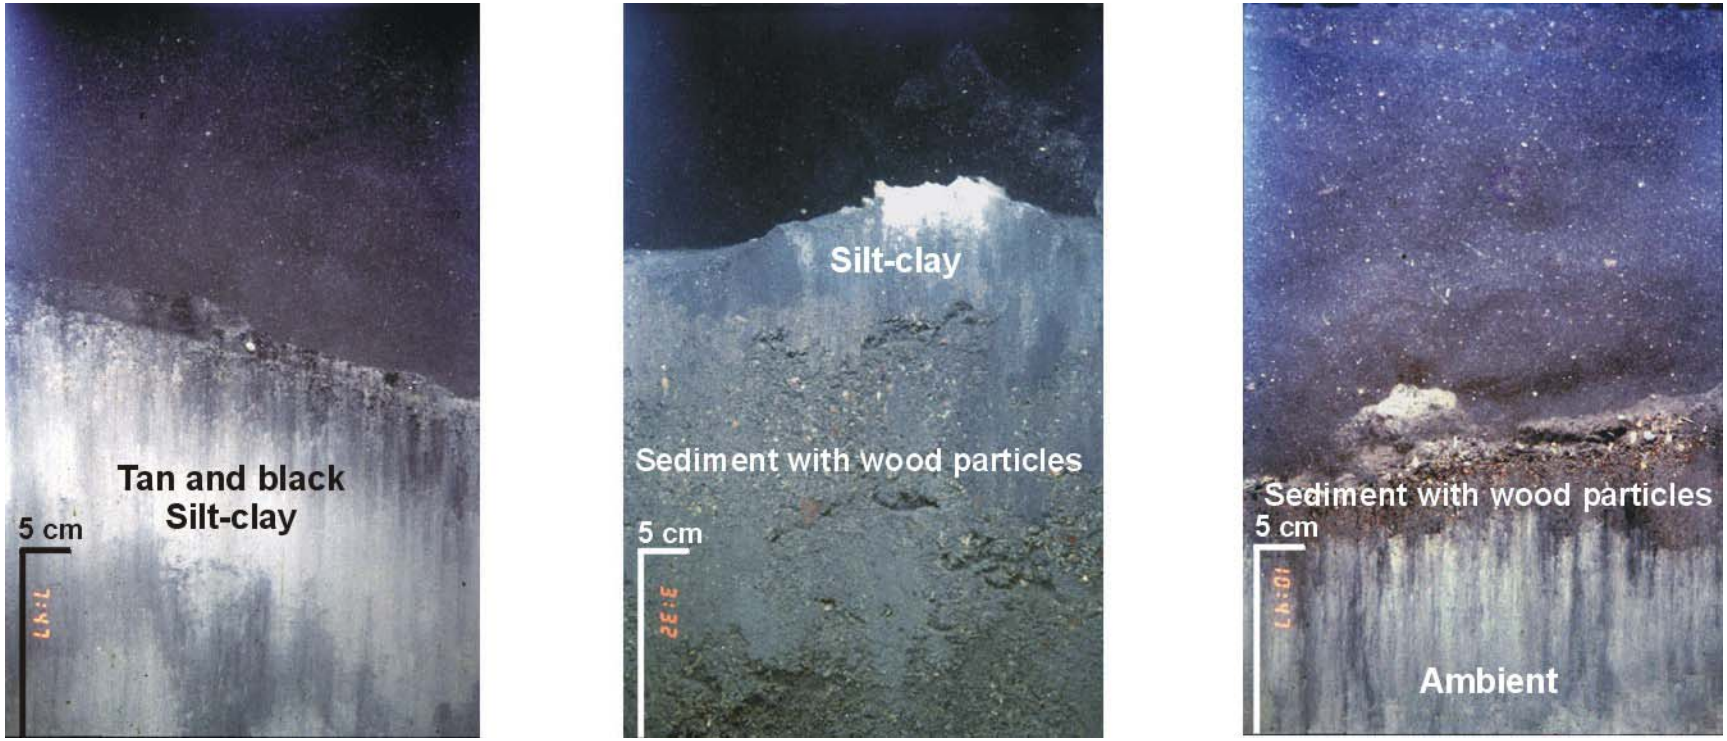
There was variability in the appearance and thickness of the dredged material. In some images, the dredged material consisted mainly of fine-grained sediment (i.e., silt-clay) having alternating bands of light and dark coloring (Figure 3-5, left image). Other images showed significant amounts of wood particles and/or small wood chips mixed with the silt-clay (Figure 3-5, middle image). Relatively thin, discrete, surface layers of dredged material over ambient sediment were observed at Stations I15, I19, I20 and I21 on the apron of the disposal mound (Figures 3-4 and 3-5, right image). These dredged material layers ranged in thickness from 0.3 cm at Station I21 to 3.0 cm at Station I19 (Table 3-1). One of the sediment-profile images obtained at Station I14 showed multiple dredged material layers, with a surface layer of silt-clay overlying silt-clay mixed with wood particles at depth (Figure 3-6).

Figure 3-5. REMOTS® images from inner disposal site stations displaying variability in the dredged material. The image on the left from Station I11 shows tan and black silt-clay dredged material greater than camera penetration. Station I08 (middle) has a silt-clay dredged material layer over silt-clay mixed with wood particles. The image from Station I15 (right) displays a discrete dredged material layer of particles and sediment over ambient silt-clay.

The REMOTS® images indicated that the dredged material constituting the TLDS disposal mound was mostly fine-grained sediment (i.e., silt-clay). However, wood particles mixed with the silt-clay (e.g., Figures 3-5 and 3-6) were observed in at least one sediment-profile image at 9 of the 25 disposal site stations (36%). The wood particles originated from the once active lumber milling industry in Ellsworth. Over the years, residual wood material from cut and processed lumber (e.g., wood chips, very fine wood particles and/or fibers) was discharged and eventually settled to the bottom of the Union River. During the maintenance dredging of the Federal Navigation Channel, the historic, deep layers of wood and wood particles were exposed and subsequently deposited at TLDS along with the fine-grained sediment.

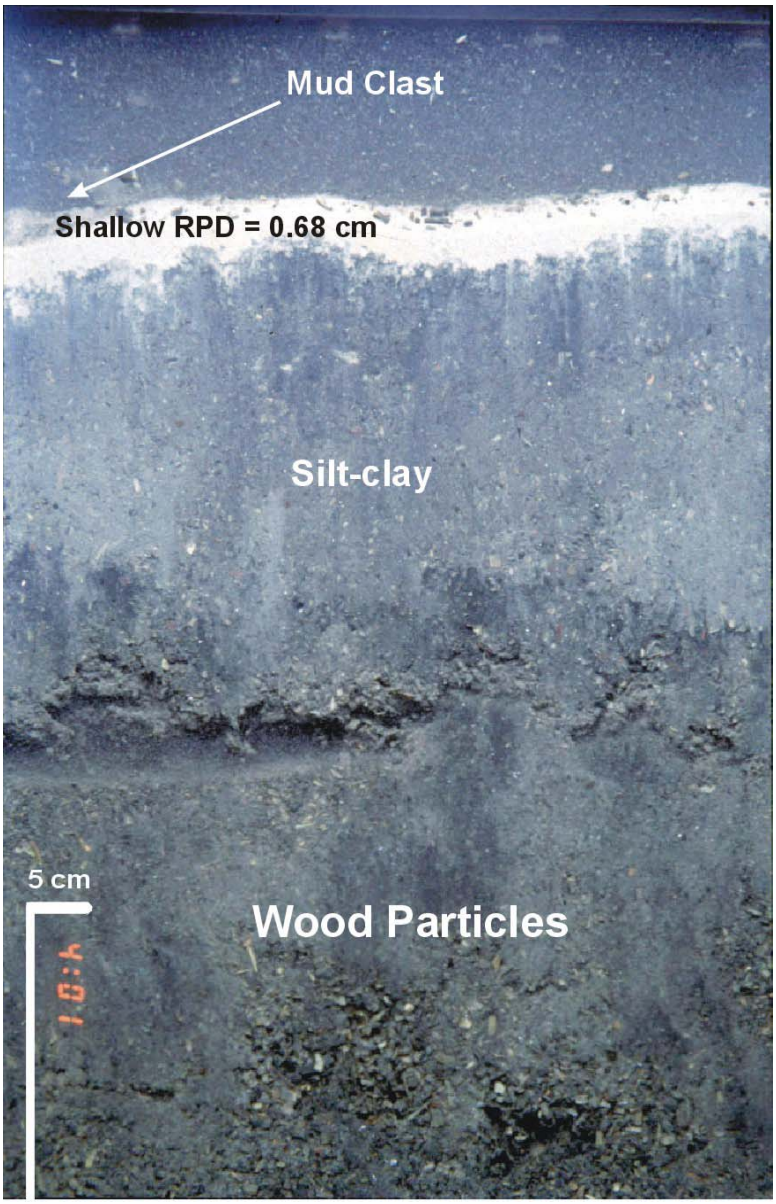
Figure 3-6. REMOTS® image obtained at Station I14 illustrating multiple dredged material layers, with a layer of silt-clay visible over a layer containing a significant proportion of wood particles. Note the thin veneer of oxidized sediment at the surface (shallow RPD) over black (anoxic) sediment below.

Although no evidence of redox rebound intervals was noted in the surficial sediment, relic RPDs (an indicator of sediment layering) were detected in eight inner stations and two outer stations. Relic RPDs usually occur when a relatively thin layer of dredged material is placed over an older deposit or ambient sediments, and represent the depth of oxygenation in the underlying material prior to being covered by the fresh deposit. A new RPD will be formed at the sediment surface as oxygen is incorporated into the surficial sediments via the bioturbational activity of benthic infauna. In addition, layering of dredged material is often detected due to different textures or composition of the sediment comprising the layers (e.g., Figure 3-6).

The extremely shallow RPD depths at the inner disposal site stations are most readily attributed to the elevated levels of organic carbon associated with the presence of wood particles. In general, sediments dredged from river channels and inner harbor areas often contain elevated levels of organic matter relative to ambient conditions on the seafloor surrounding an open-water disposal site. Wood particles contain a particularly high

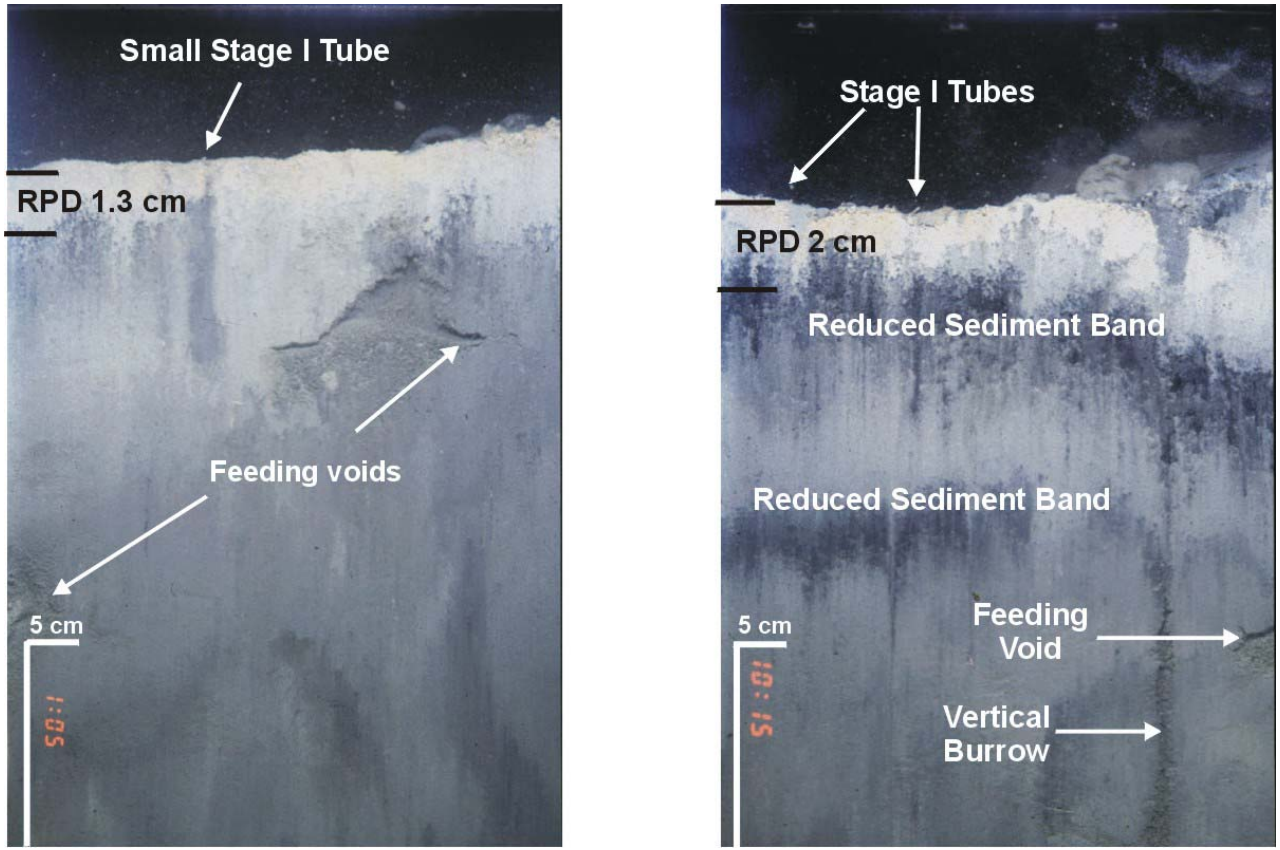
Ambient sediment consisting of tan and black silt-clay (e.g., Figure 3-7) was evident at several of the northernmost inner stations at TLDS (Stations I01, I03, I04), as well as at southern station I24 and in two replicate images at Station I21 (Figure 3-4). There was no dredged material detected at any of the outer stations surrounding the disposal site (Figure 3-4; Table 3-2). Likewise, ambient sediment was observed at all of the reference area stations. The ambient sediment at the reference area stations was also fine-grained, comprised of tan and black silt and clay, having a major modal grain size of >4 phi (Table 3-3 and Figure 3-7, right image).

Figure 3-7. REMOTS® images from outer Station O06 (left) and reference area WREF4 (right) showing ambient sediment. Stage I on III successional status was detected in both images. Bands of black sulfidic sediment ("reduced sediment bands") were evident at Station WREF4.

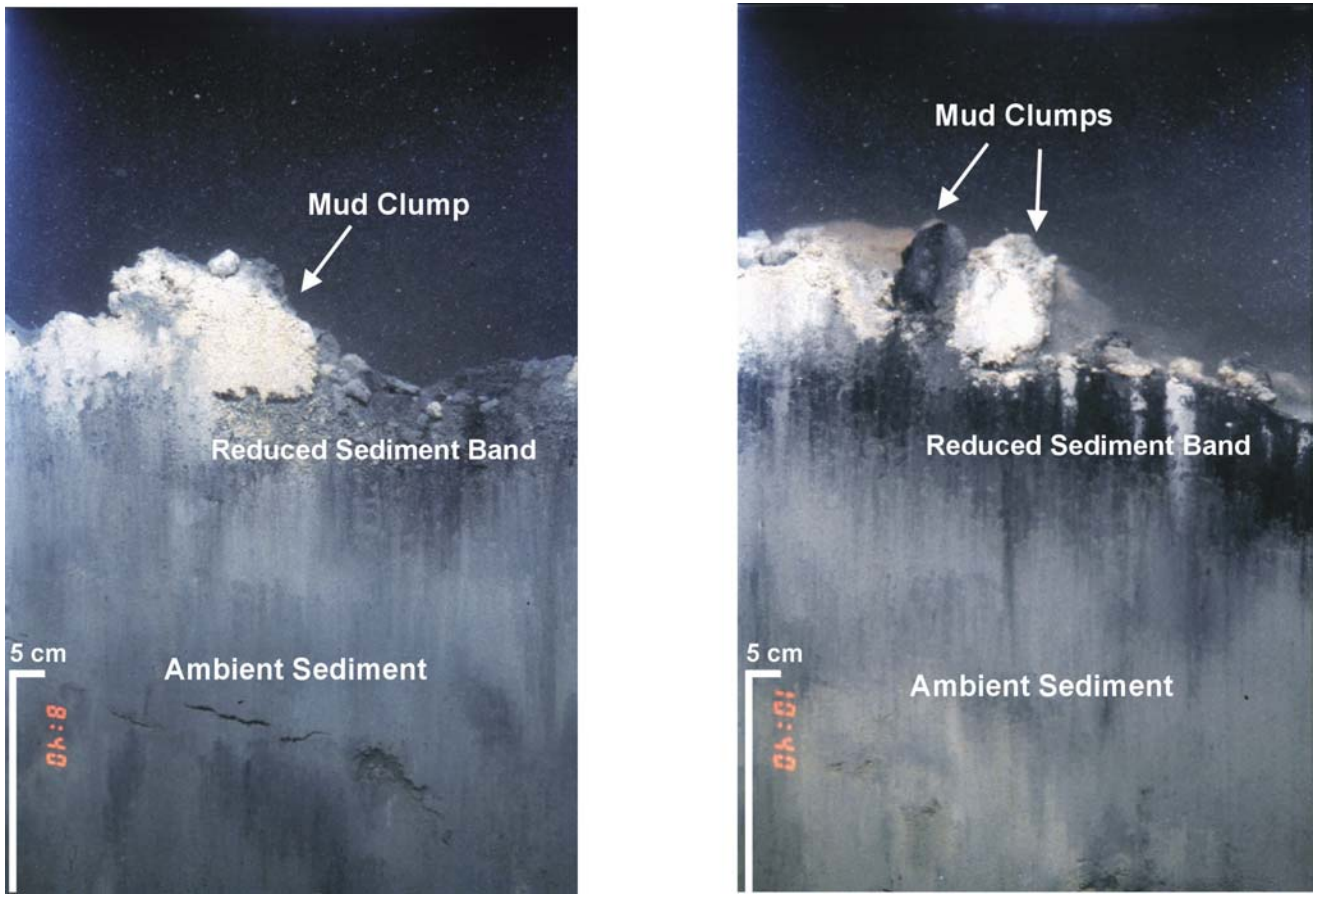
Replicate-averaged small-scale boundary roughness values for the inner REMOTS® stations over TLDS ranged from 0.7 cm to 3.4 cm (average of 2.1 cm), which was comparable to both the outer station and the reference area averages of 2.1 cm and 2.3 cm, respectively (Tables 3-1 through 3-3). Outer station replicate-averaged boundary roughness values varied from 1.4 cm to 2.8 cm (Table 3-2). There was no obvious spatial pattern to these relatively high boundary roughness values at the inner, outer, and reference area stations. At all of the stations, the surface roughness was predominately due to the presence of cohesive mud and mud clasts at the sediment surface (Figure 3-8).

Figure 3-8. REMOTS® image from outer station O04 (left) and TLDS reference area station WREF3 (right) displaying cohesive mud clumps at the sediment surface. Horizontal bands of black, sulfidic sediment are also visible near the sediment surface.

The presence of cohesive mud clumps at the sediment-water interface (e.g., Figure 3-8) was the primary cause of high small-scale surface relief (boundary roughness) at TLDS. These mud clumps were not previously detected during the March 2000 baseline survey, when the average small-scale boundary roughness at the TLDS stations was 1.7 cm compared to average values of >2.0 cm at the inner, outer and reference area stations in the present survey (SAIC 2000). Such angular mud clumps or clasts are frequently observed at the surface of recent dredged material deposits, as a result of muddy, cohesive sediment being dredged by mechanical methods (e.g., using a clamshell bucket) and remaining in a consolidated state during transport and disposal. Therefore, the mud clumps and associated high boundary roughness at the inner stations are most readily attributed to the recent disposal activities. However, the presence of mud clumps and relatively high boundary roughness at the outer and reference area stations (Figure 3-8) is not readily explained by dredged material disposal and suggests a more widespread, regional source of physical disturbance at the sediment surface.

One possible explanation for the mud clumps at the outer disposal site and reference area stations is disturbance of the bottom from the passage of fishing gear. According to information provided by the local harbormaster, Union River Bay supports a scallop fishery (R. Heckman, Ellsworth Harbor Master, pers. comm.). Local residents report witnessing scallop fishing vessels dragging in the bay throughout the winter, primarily when offshore weather conditions are unfavorable. Dragging a weighted net or scallop dredge along the seafloor can act to break up muddy, cohesive surface sediments into the discrete clumps or clasts observed in the sediment-profile images obtained in August 2001 (Messieh et al. 1991; Thrush et al. 1995).

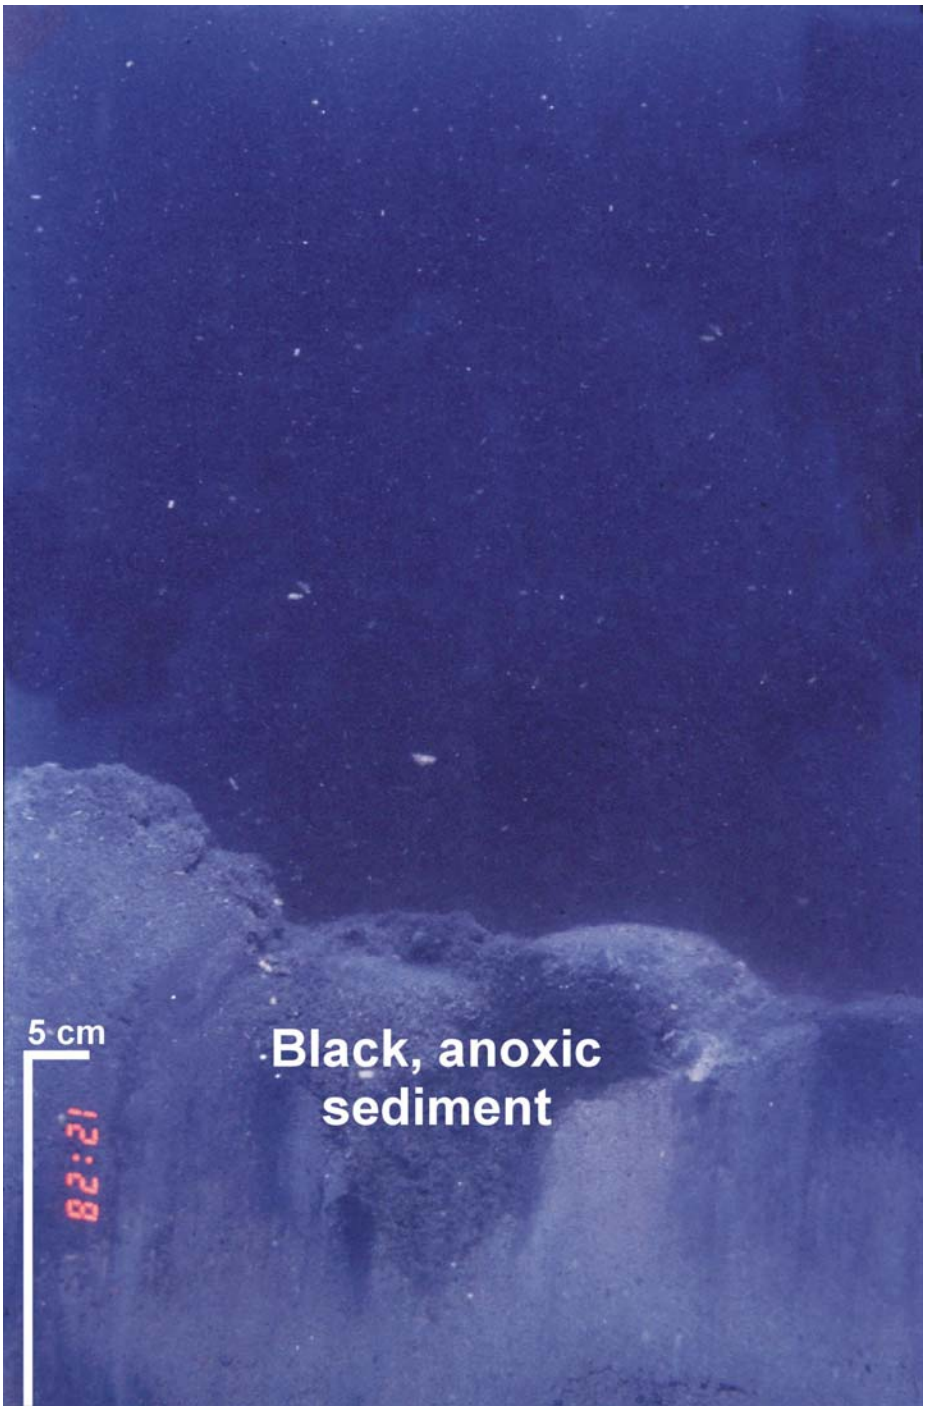
Black, anoxic sediment was visible at or near the sediment-water interface in many images from throughout the surveyed area (Figures 3-8 and 3-10). Low apparent sediment dissolved oxygen conditions were prevalent at the inner stations (14 of the 25 stations); however, they were also observed at two outer stations and one reference area station (Figure 3-10; Tables 3-1 through 3-3). Stations where wood particles were present in the sediment frequently had very shallow or no RPD (Figures 3-6 and 3-10). When present, the RPD appeared as a thin, tan iron oxide layer over black sulfidic mud or as small patchy oxidized mud clumps in the presence of reduced sediment (Figures 3-6 and 3-8).

Figure 3-10. REMOTS® image collected from Station I17 showing anoxic sediment with no apparent RPD and lacking visible macrofauna (azoic), resulting in an OSI value of –8

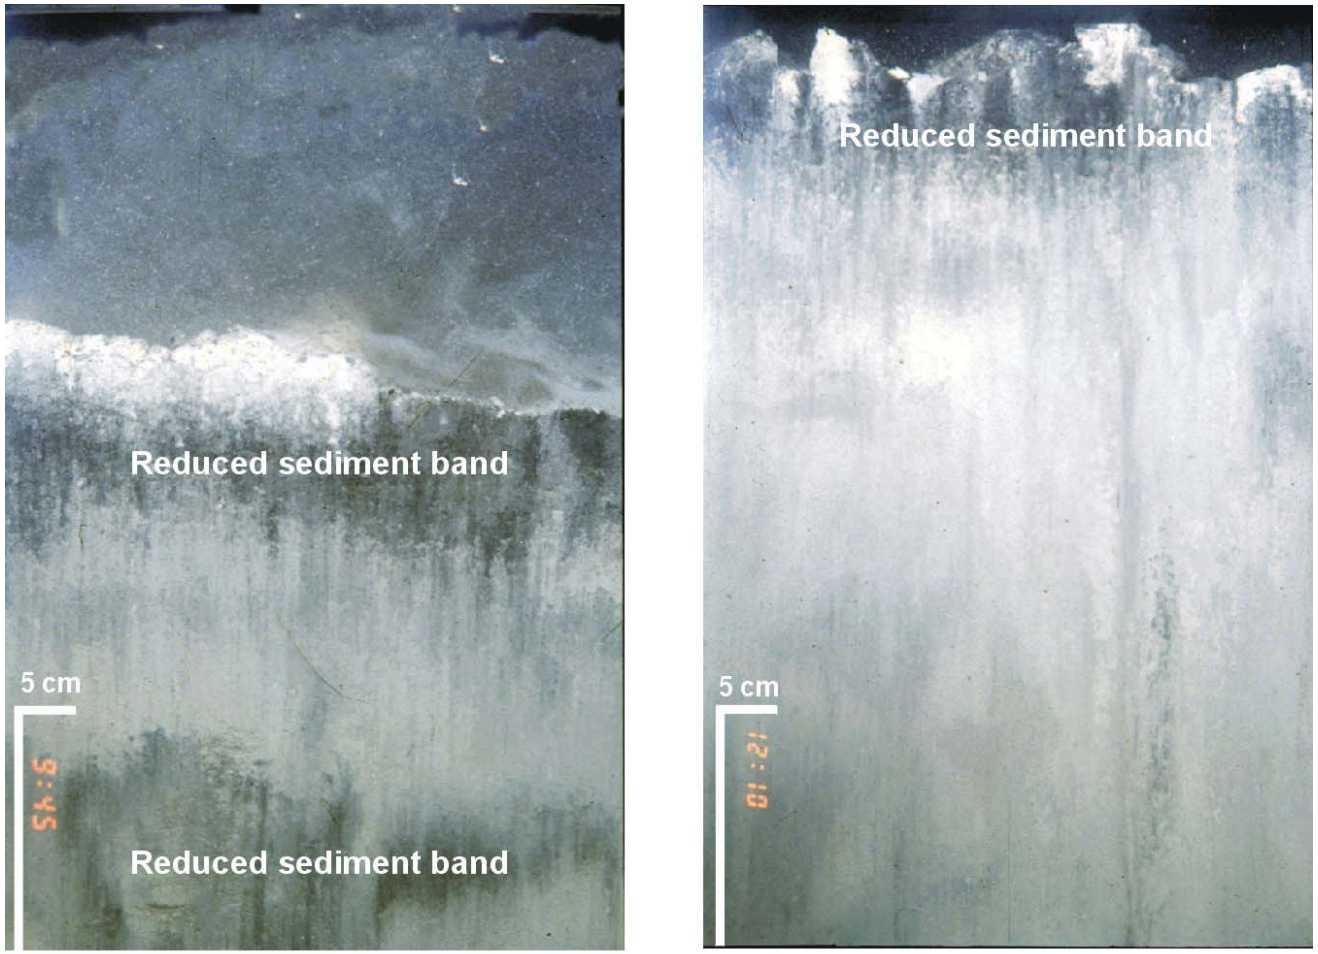
nearby reference area stations displayed distinct horizons or “bands” of black, sulfidic sediment at or just below the sediment surface. Such horizons of reduced sediment were frequently present over and/or under layers of oxidized sediment (Figures 3-7, 3-8, and 3-11). While wood particles were identifiable in the inner TLDS images, no wood particles were evident in conjunction with the reduced sediment layers in the images from the outer disposal site and reference areas.

Figure 3-11. REMOTS® image from inner Station I01 (left) and outer Station O05 (right) displaying the reduced sediment banding observed just below the sediment-water interface and at depth in the ambient sediment

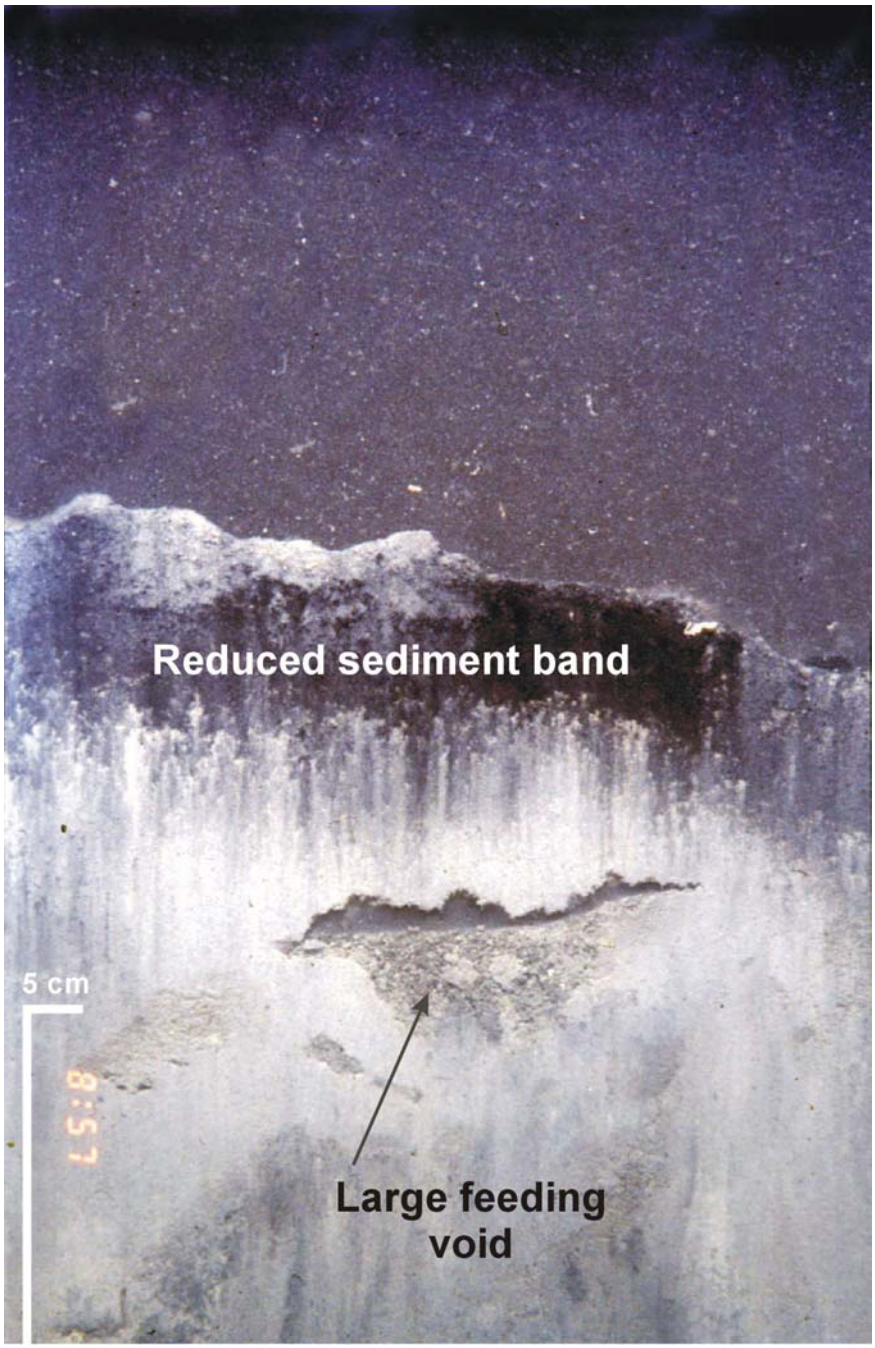
conditions. There was some spatial variability in benthic habitat conditions over the disposal mound, with stations such as I04 and I12 exhibiting deeper mean RPD depths, Stage III activity, and relatively well-aerated surface sediment that resulted in higher OSI values (Figure 3-9). In images from one outer and one inner station, Stage III feeding voids were visible at depth in sediment with no RPD and apparent low dissolved oxygen conditions (Figure 3-13).

Figure 3-13. REMOTS® image from outer Station O02 showing a large Stage III feeding void in ambient sediment with low dissolved oxygen conditions and no apparent RPD

Despite evidence of an organic loading pulse at the outer disposal site and reference area stations, advanced Stage III activity was widespread (e.g., Figures 3-13 and 3-14). Stage III was present at all but one outer disposal site and one reference area station, where only Stage I was present. Azoic conditions were evident in one replicate image obtained at outer station O04. In general, successional status appeared to be more advanced at the reference area stations than the disposal site stations, with no azoic conditions observed.

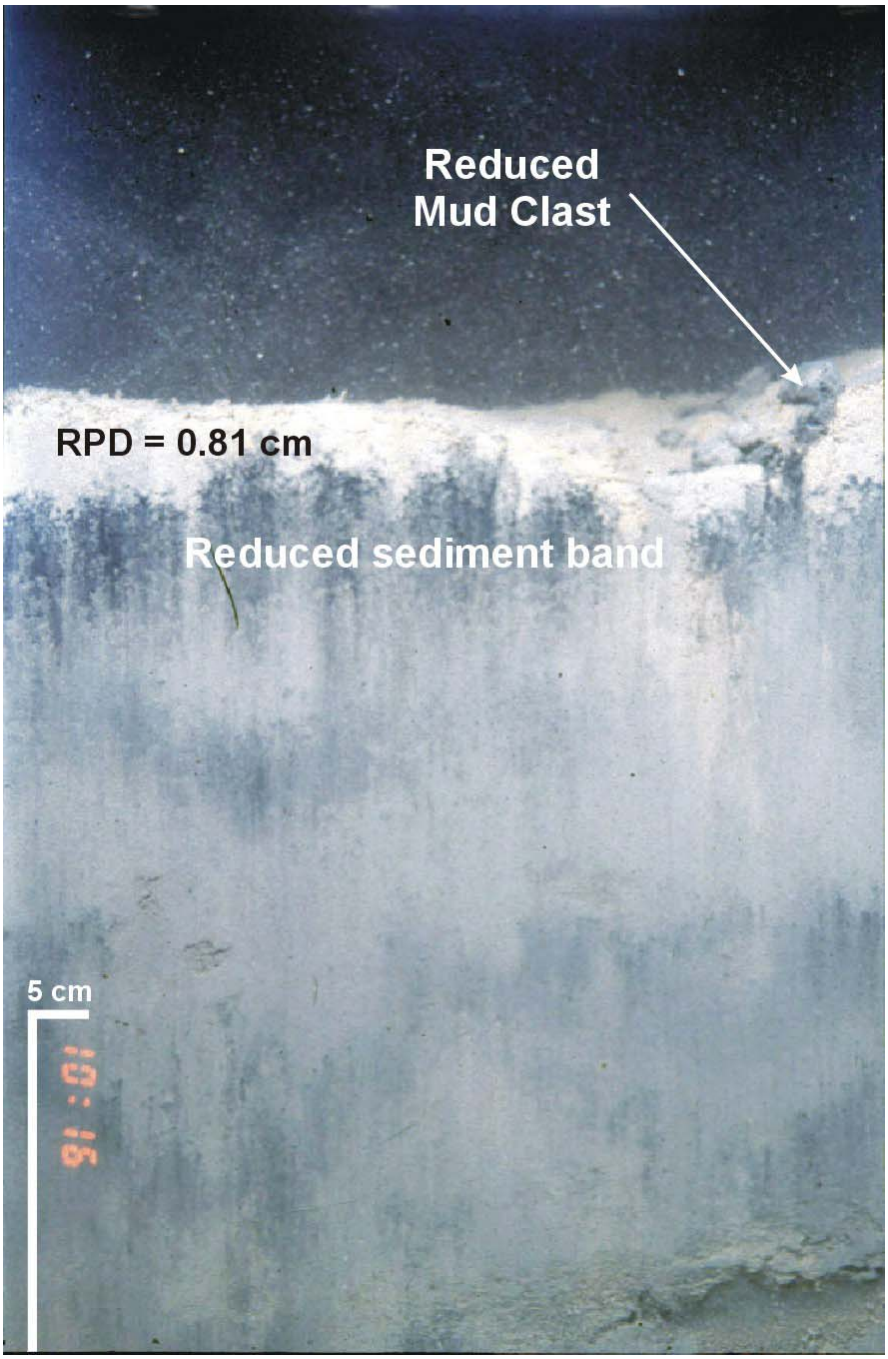
While the range of OSI values at the reference areas (+0.7 to +7.3) was comparable to those at the inner and outer TLDS stations, the median OSI values at the reference areas were consistently higher than those at the inner or outer stations, with an overall average of +5.3 (Table 3-3). Such a value is indicative of moderately degraded benthic habitat quality, mainly related to relatively shallow RPD depths at the reference area stations (Figure 3-14). Reduced sediment layers or bands were common at the sediment-water interface and at depth in many replicates for both the EREF and WREF reference areas (Figures 3-7, right image, and 3-14).

Figure 3-14. REMOTS® image from Station WREF 4 illustrating a reduced sediment band near the sediment surface under a relatively thin oxidized sediment layer with reduced mud clasts. Note the Stage III void at the bottom right of the image.

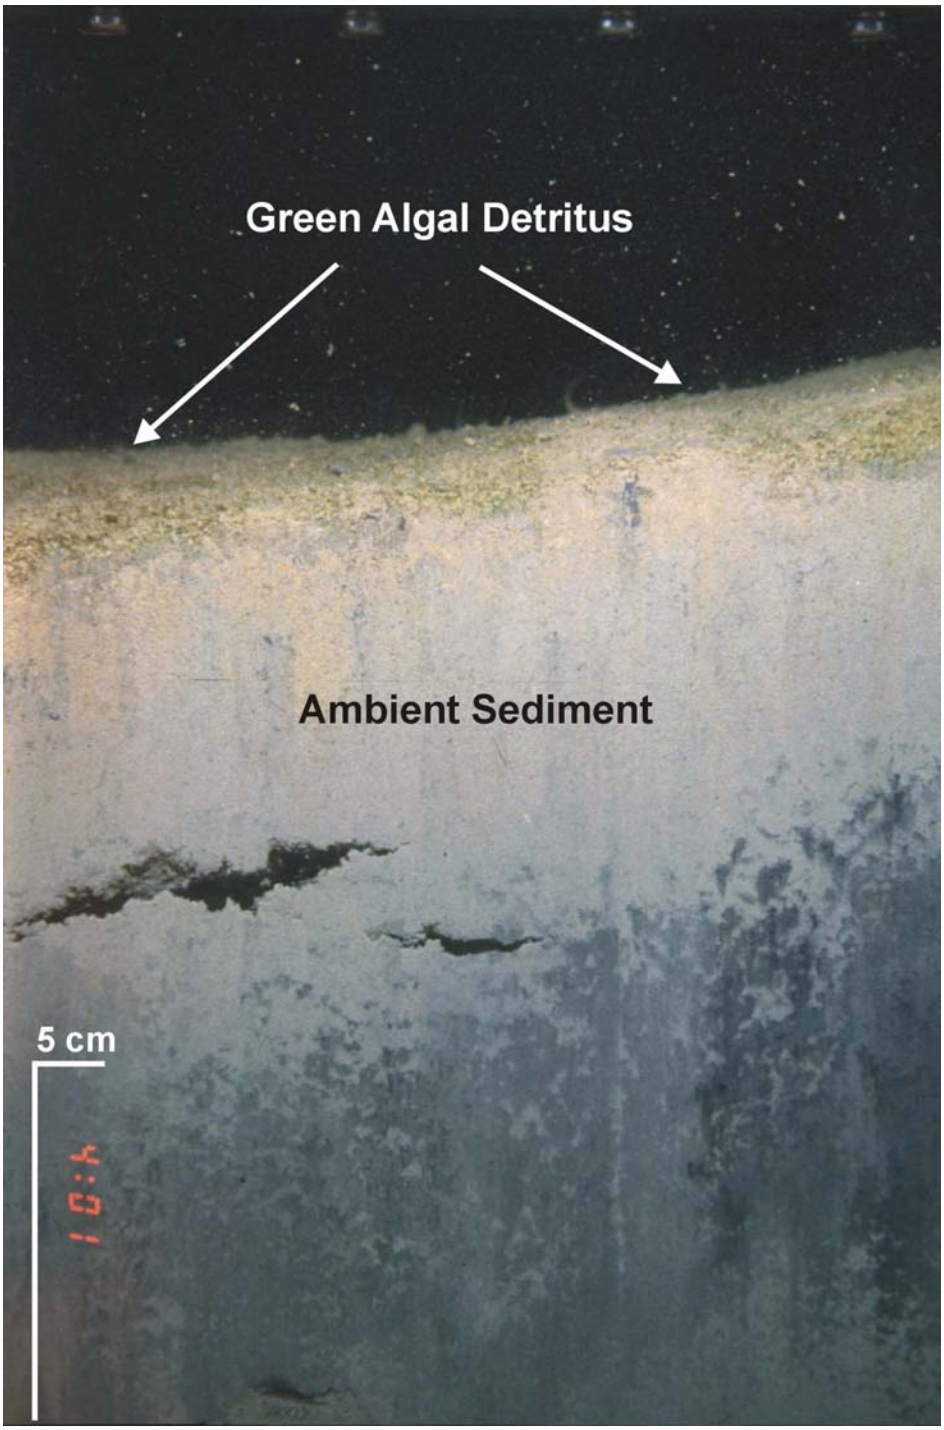
A more likely explanation for the widespread presence of sulfidic sediments at or near the sediment-water interface throughout the entire survey area (inner and outer TLDS stations and reference areas) is related to natural processes within the upper portions of the Union River Bay estuary. The pulse of organic carbon within the sediment may have been due to seasonal events such as spring runoff or phytoplankton blooms from the overlying water. Seasonal events like the spring runoff or sporadic phytoplankton blooms have the potential to add significant amounts of organic material to the sediment in a relatively short period of time. Once this material has settled to the seafloor, it becomes subject to decomposition. The resultant depletion of oxygen causes an anoxic zone to develop near the sediment-water interface; such a zone can become marked by the distinct horizontal "bands" of sulfidic sediment present in the August 2001 images. In the March 2000 baseline survey, a greenish tint was noted at the sediment surface in several REMOTS® images, possibly representing a depositional layer of algal detritus from the overlying water column (Figure 4-1). Although such algal layers were not observed in any of the sediment-profile images collected in the August 2001 survey, the observed black bands may represent a record of the decomposition of past blooms within the sediment column.

Figure 4-1. REMOTS® image obtained at Station I01 in the March 2000 baseline survey showing a greenish tint at the sediment surface, possibly indicating a recent depositional layer of algal detritus
