Monitoring Survey at the Massachusetts Bay Rock Reef Site Summer 2002

Disposal Area Monitoring System DAMOS

Contribution 151
March 2004

Report No.
SAIC-607

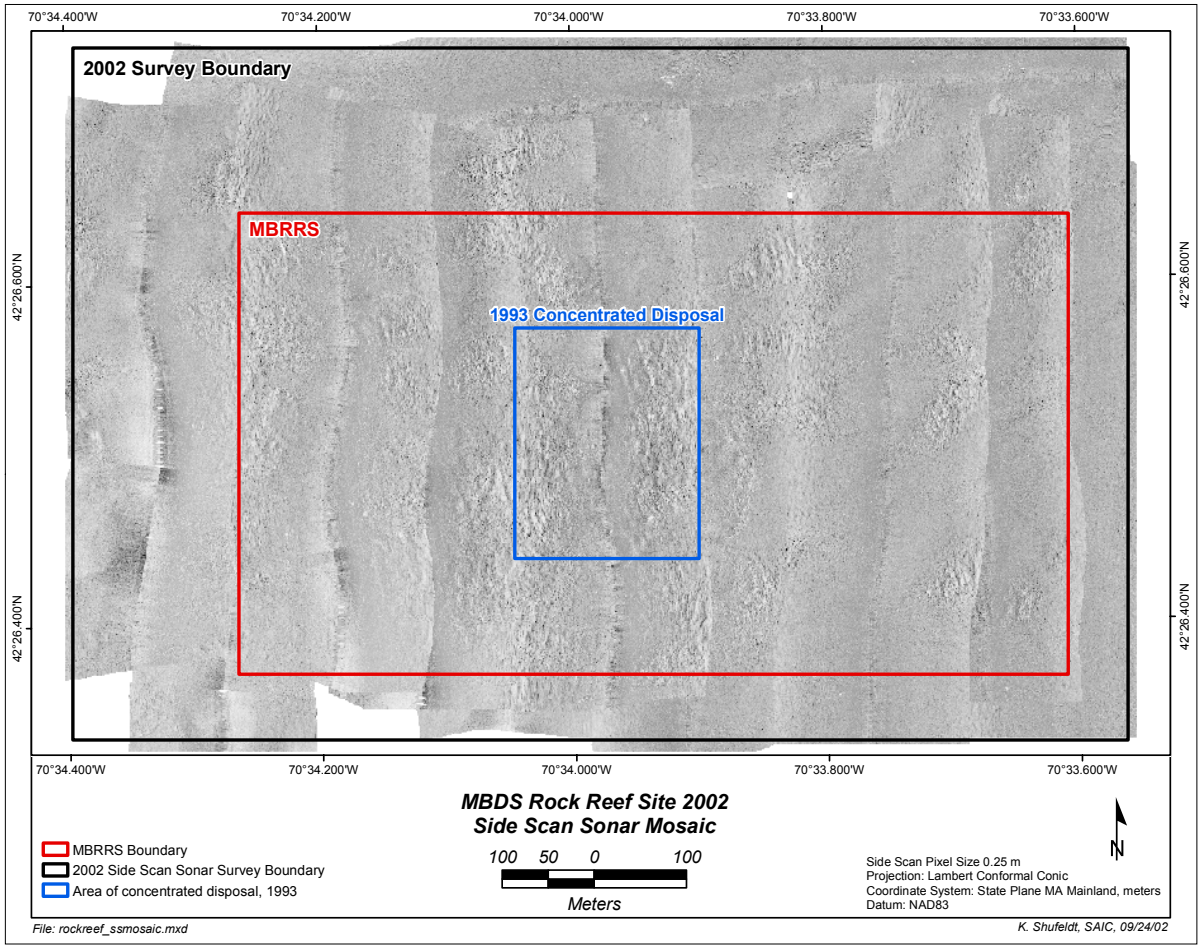
Based on the full area mosaic, about half the survey area is characterized by higher reflectance, stronger acoustic returns that are indicative of high density rock and cobble deposits that are surrounded by finer-grained sediments comprised of silt and sand (Figure 3-6). Rather than a single dense reef at the site of the historic disposal, there are numerous elongated and overlapping deposits of rock with cobble at the periphery, ranging from 50 to 150 m in length. The spatial extent of the rock deposits extends slightly to the north and west of the MBRRS boundary, although it appears the swath coverage of the side-scan sonar imaged the majority of the rock placed at the site (Figure 3-6). A significant percentage of the rock appears to be concentrated near the center of MBRRS, as surface texture appears quite rough and irregular within the mosaic in that area (Figure 3-7A). In addition, isolated rock deposits located within the eastern portion of the survey area provide a strong contrast to the sands and silts of the smooth ambient seafloor (Figure 3-7B). Sand waves were present in sonar images obtained over the northernmost side-scan survey lanes (Figure 3-7C). These features are likely the product of sediment transport forced by the passage of storm-generated waves over this area of Stellwagen Bank. In the southwest corner of the site, lower reflectance returns indicate fewer rock deposits and a predominance of softer sediment (Figure 3-6). This area lies west of Stellwagen Bank within the deeper basin of Massachusetts Bay, which offers deeper water depths and ambient sediments composed of silty clay (SAIC 2002).

Figure 3-6. Side-scan sonar mosaic developed for MBRRS showing differences in surface texture and strength of acoustic return due to the presence of rock deposits on the seafloor

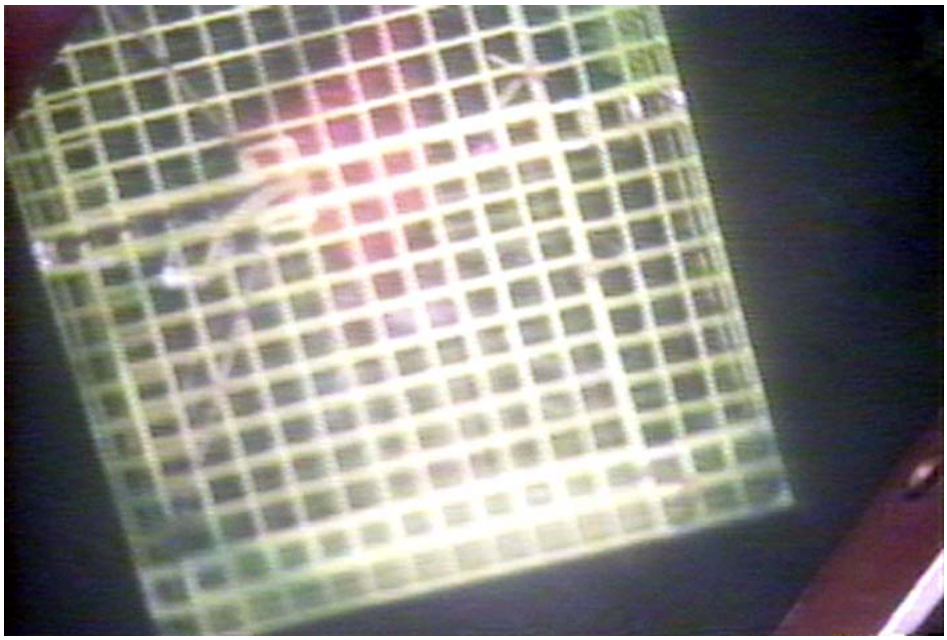
A

Several other species of invertebrates, *Corymorpha pendula* (a stalked solitary hydroid), *Neptunea decemcostat* (the ten-ridged whelk), and *Homarus americanus* (the northern lobster) were only seen once during the survey (Table 3-1). Although abundance of lobster was low based on the drop video data, several sets of lobster fishing gear were documented on site (Figure 3-5). The video imagery revealed the presence of both actively fished and abandoned lobster gear, suggesting this area may have developed into a relatively productive lobster fishing area over the past ten years (Figure 3-12).

Figure 3-12. Example images obtained from the towed video footage showing actively fished (A) and abandoned (B) lobster traps within MBRRS
