U.S. ARMY CORPS OF ENGINEERS
NEW ENGLAND DISTRICT
CONCORD, MASSACHUSETTS
www.nae.usace.army.mil

JOSIAS RIVER
OGUNQUIT, MAINE
CONDITION SURVEY
7-FOOT CHANNEL
5 AND 7-FOOT ANCHORAGES

SHEET IDENTIFICATION
V-101
SHEET 1 OF 1

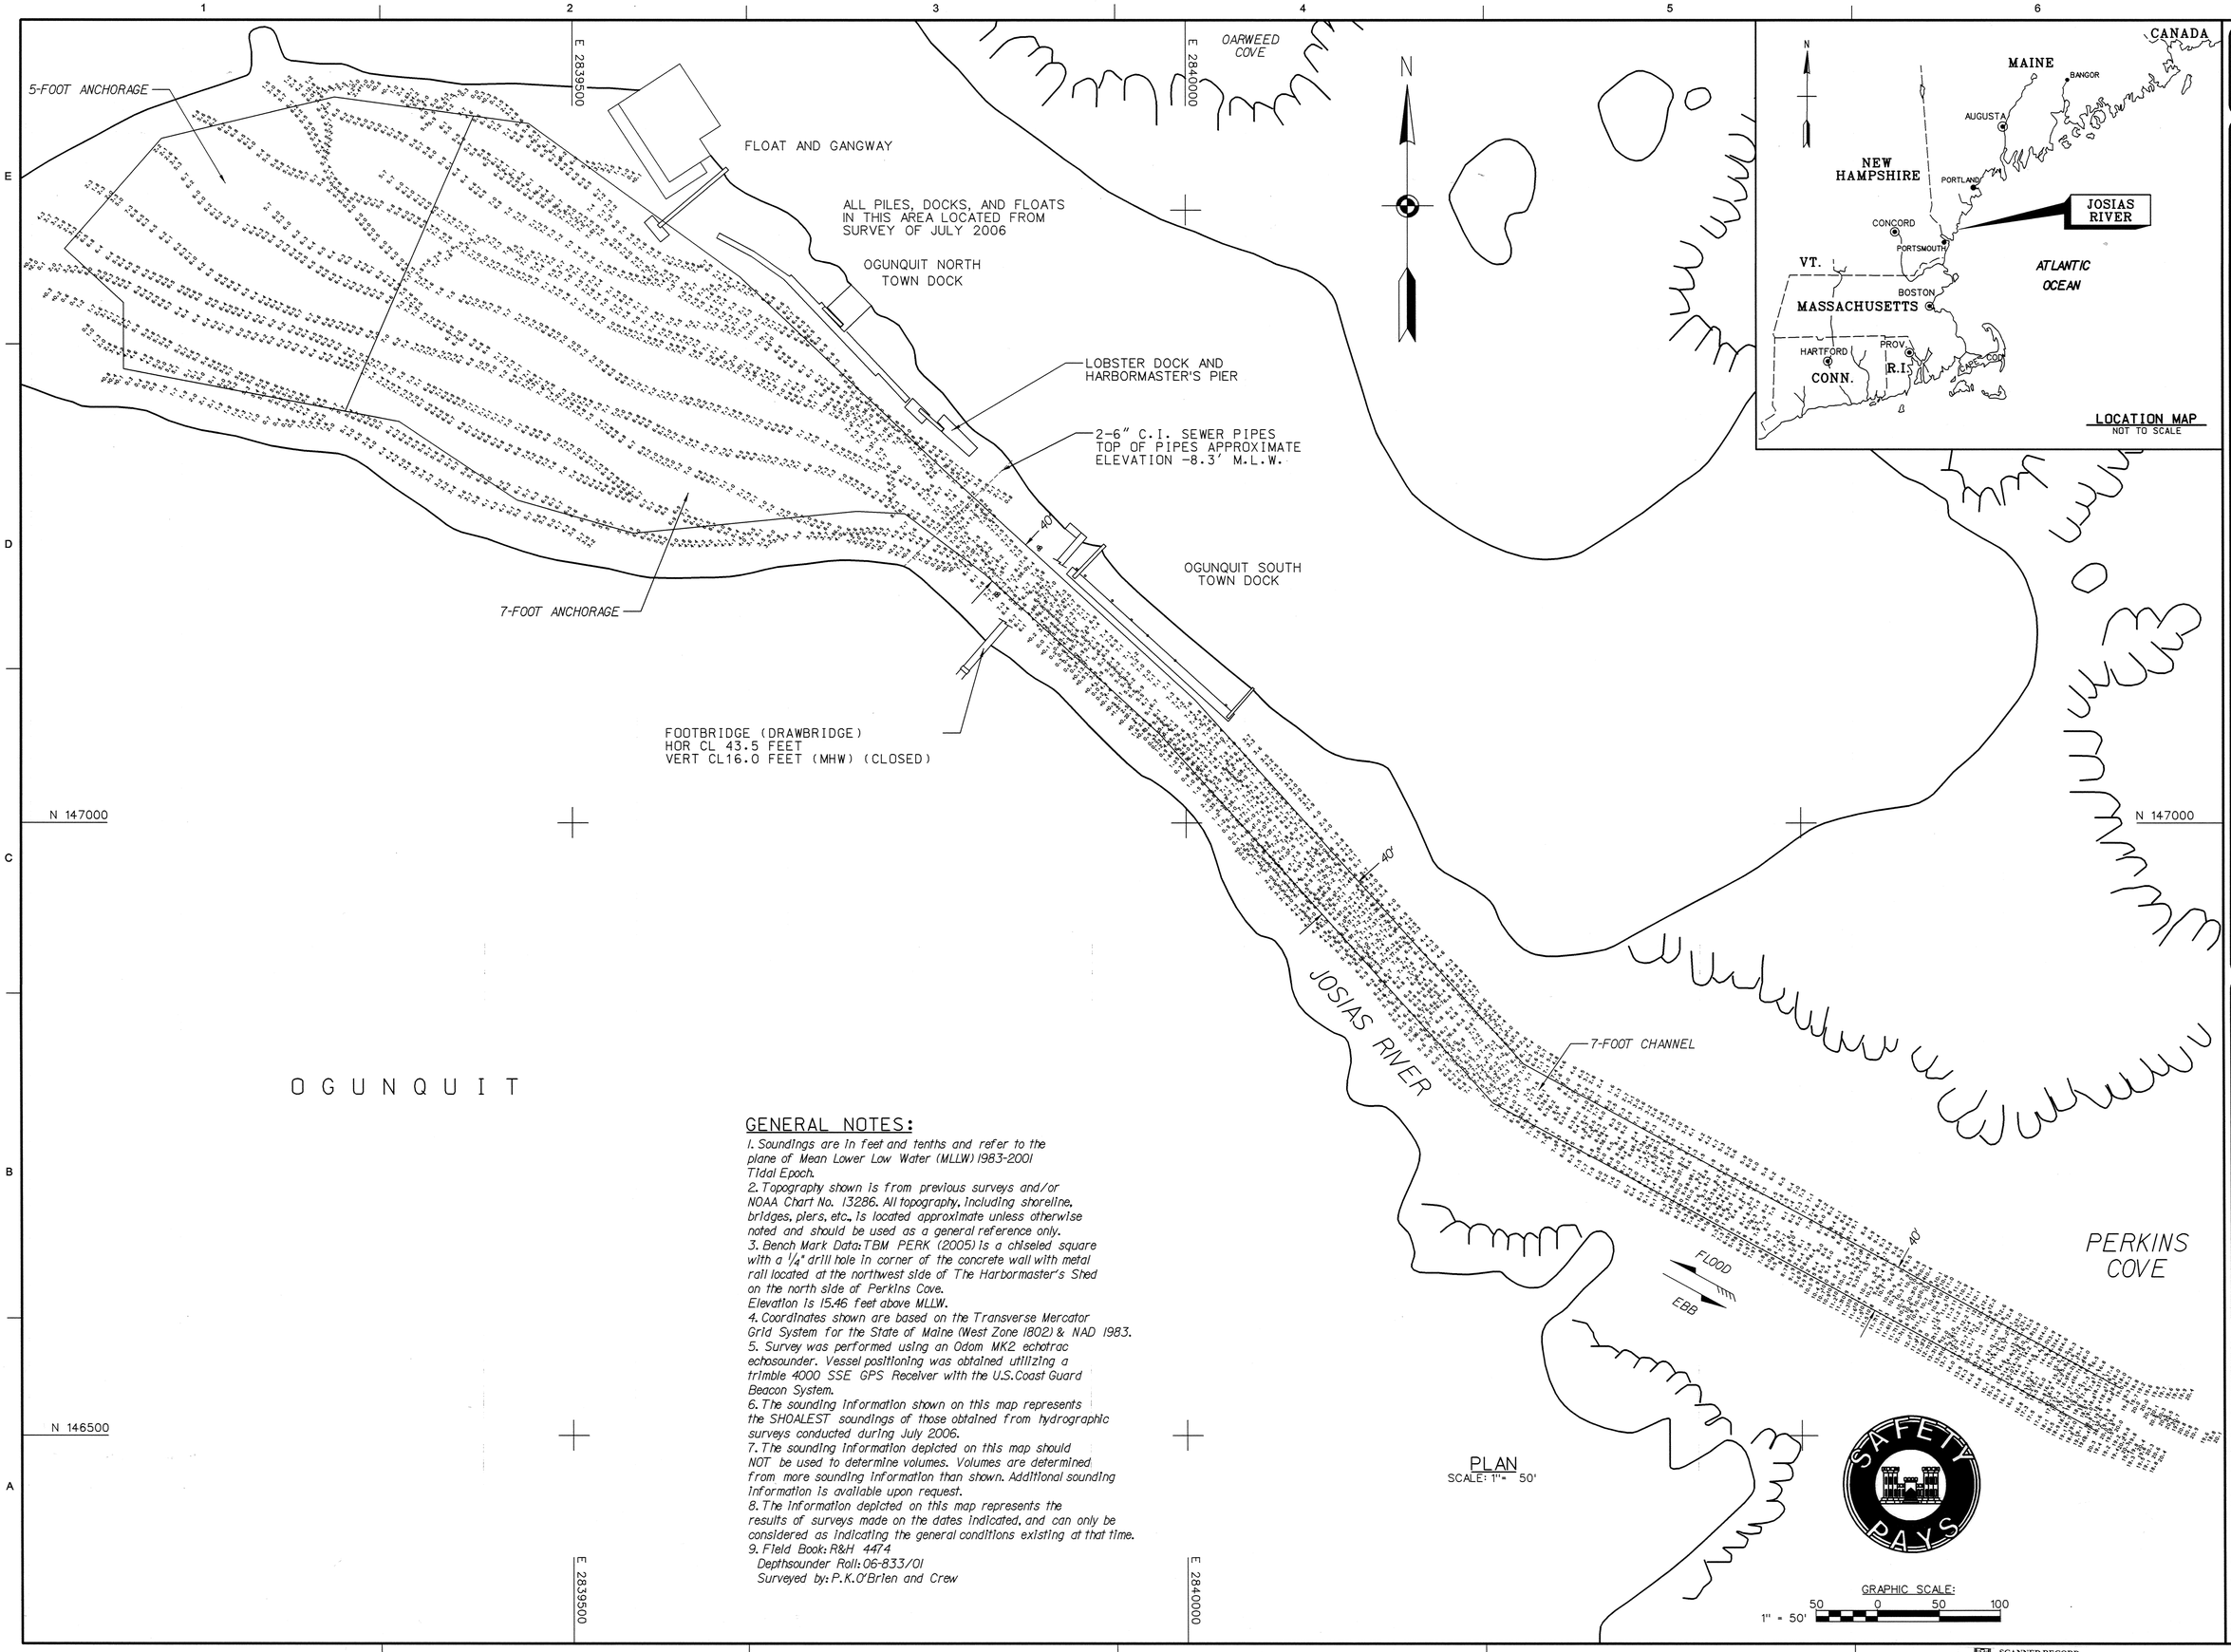
6. The sounding information shown on this map represents the SHOALEST soundings of those obtained from hydrographic surveys conducted during July 2006.
