Data Summary Report for the Monitoring Survey at the Massachusetts Bay Disposal Site
June 2019

DATA SUMMARY REPORT FOR THE ACOUSTIC MONITORING SURVEY AT THE MASSACHUSETTS BAY DISPOSAL SITE JUNE 2019

DATA REPORT
FEBRUARY 2021

Contract No. W912WJ-17-D-0003

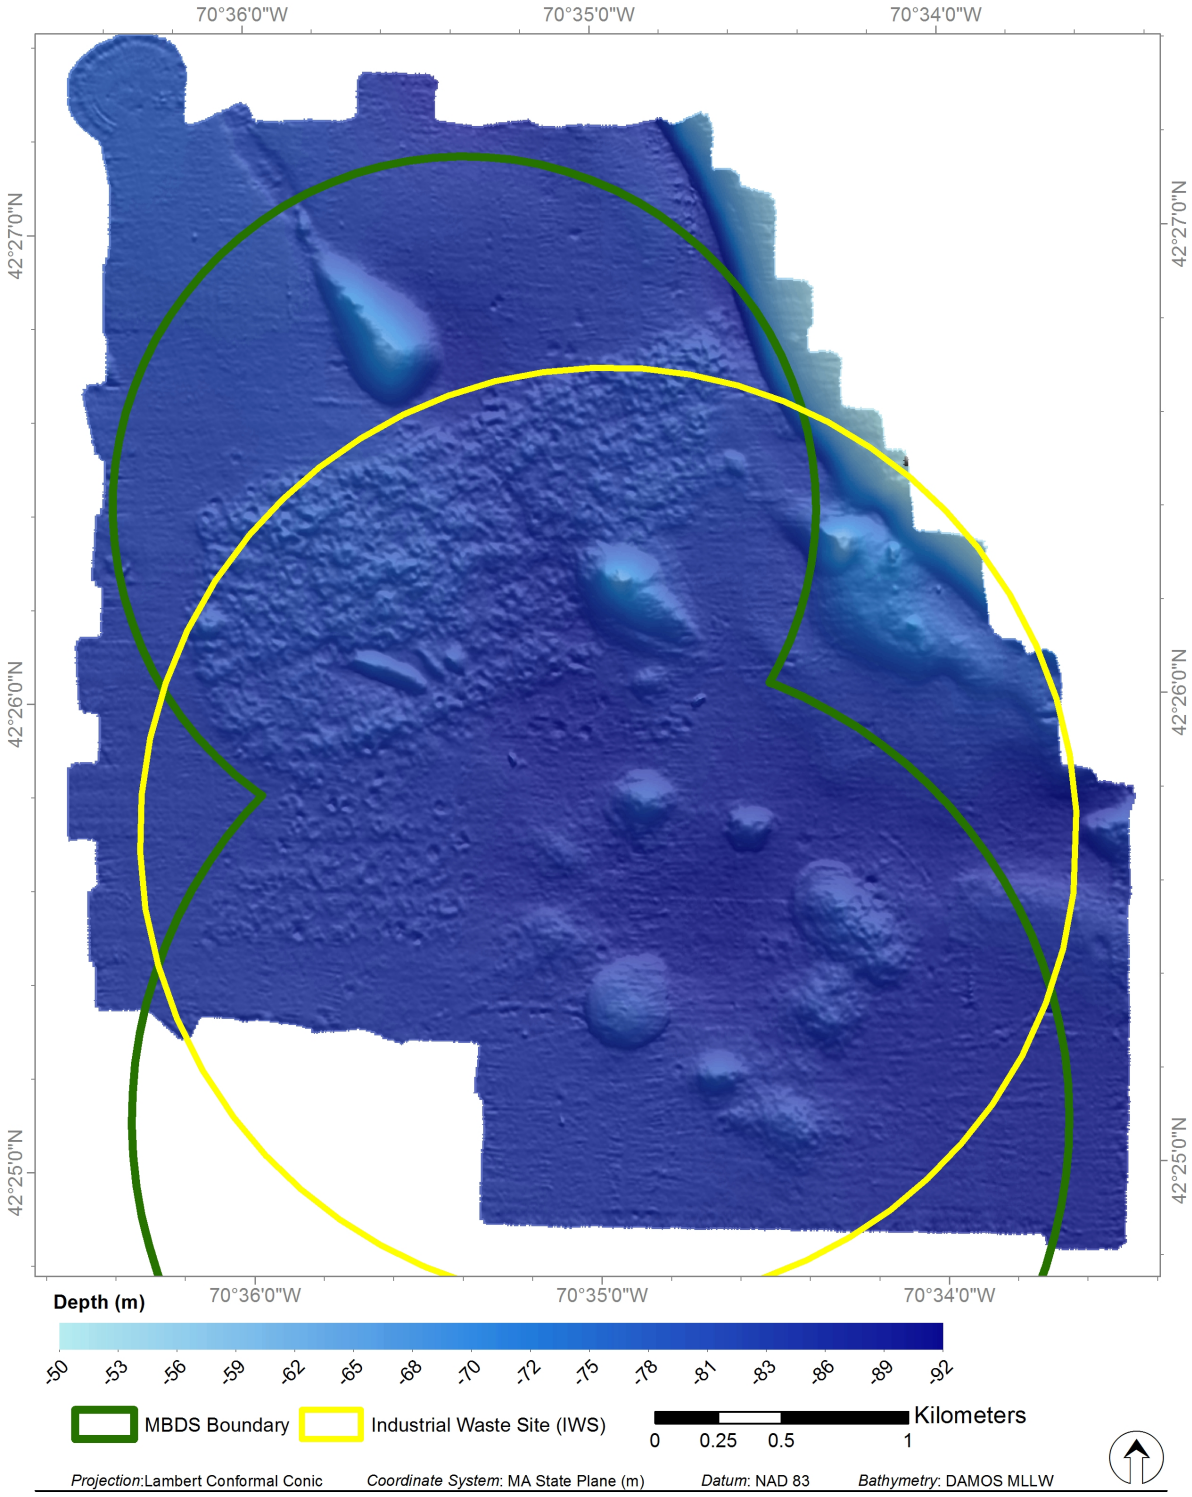
Figure 3-1. Bathymetry of MBDS Survey Area Over 5x Vertical Relief Model, June 2019

The MBDS depths ranged from approximately 51 – 93 m over the survey area. Within the southern portion of the survey area, historic mounds, varying in size were visible, forming a ringed feature on the seafloor. Two glacial features (drumlins) were visible to the north and south of the IWS active restoration area. These seafloor features (drumlins) were present within the restoration area prior to the 1999 survey, and were also documented during previous surveys (Oldale et al., 1994; Carey et al., 2013; USACE, 2015). Depths are relatively much shallower along the eastern portion of the site where a slope break which defines the border of Stellwagen Bank National Marine Sanctuary (SBNMS) was visible. Over the high priority coverage area of the expanded site, impact features where dredged material has been methodically placed were visible as a rough surface across the entire area (Figure 3-1).

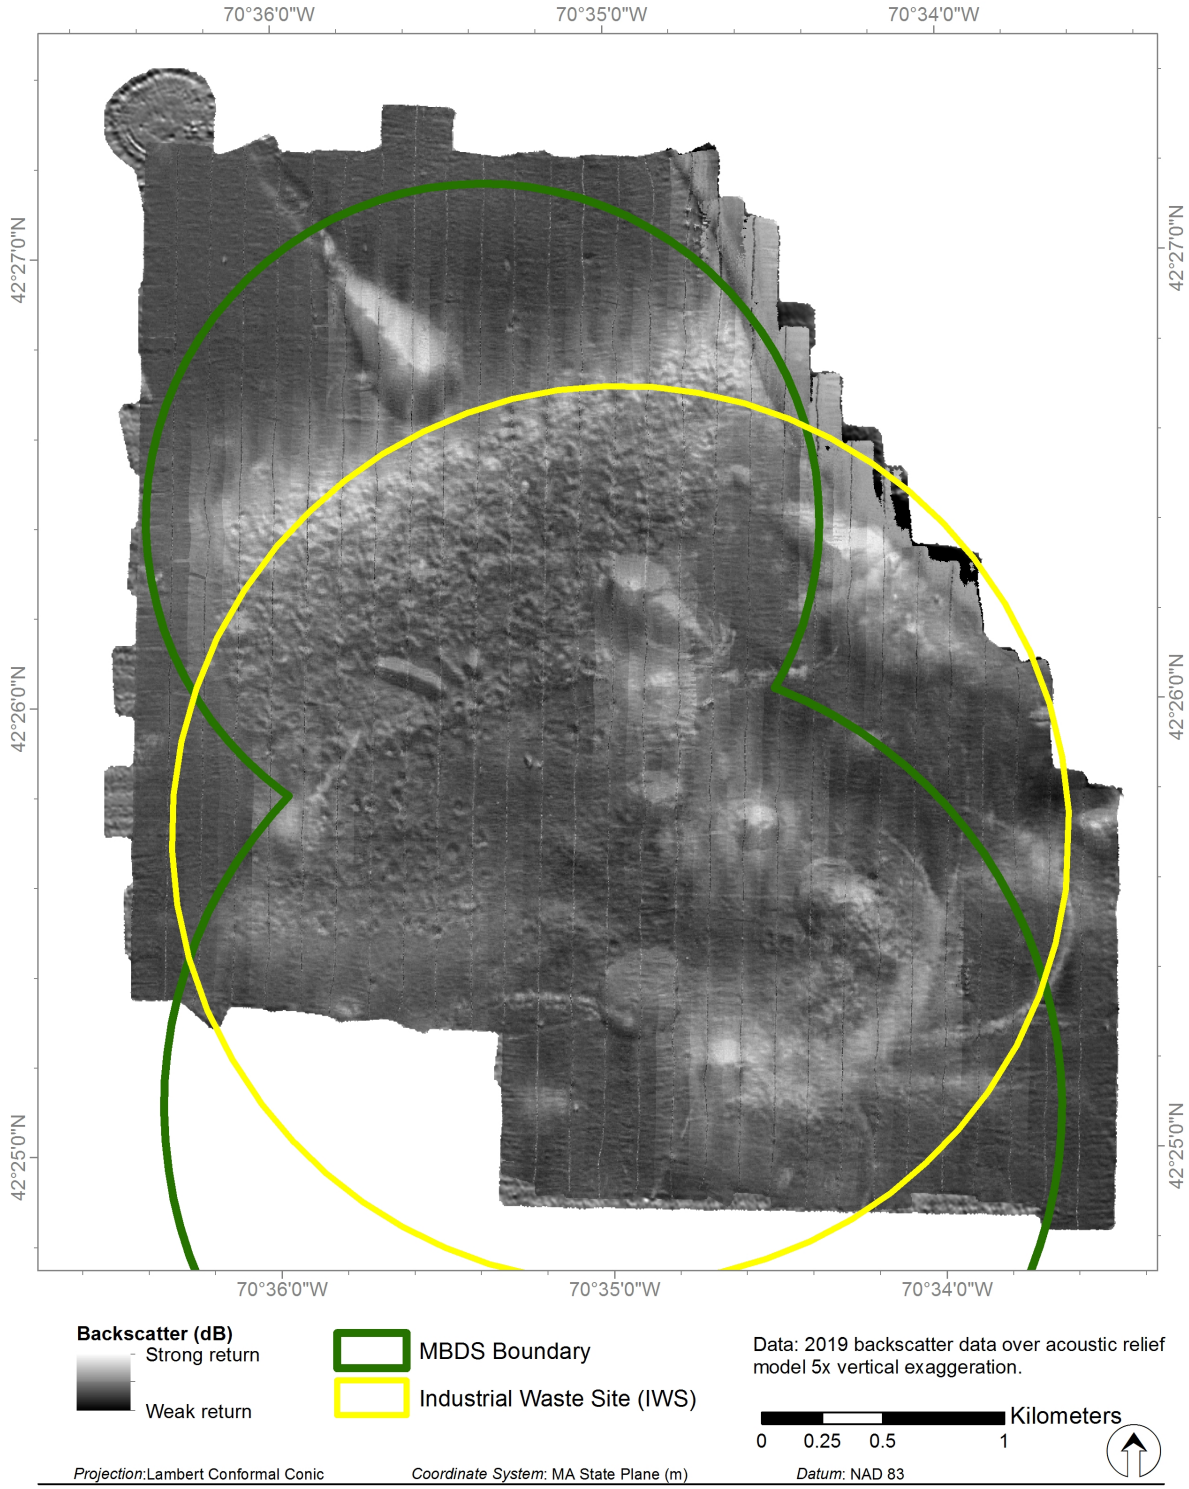
The MBDS backscatter survey results (measured in dB) displayed the variation in sediment type over the MBDS. Backscatter signals ranged from -10 to -32 dB; coarser substrate was visible on the leading edge (northern portion) of the active disposal area and on/around the glacial drumlins. A distinct change in sediment type, distinguished by the variability in color within the filtered backscatter and the intensity of shading on the backscatter mosaic, is visible on the backscatter around areas where disposal has occurred (Figures 3-5 and 3-6).

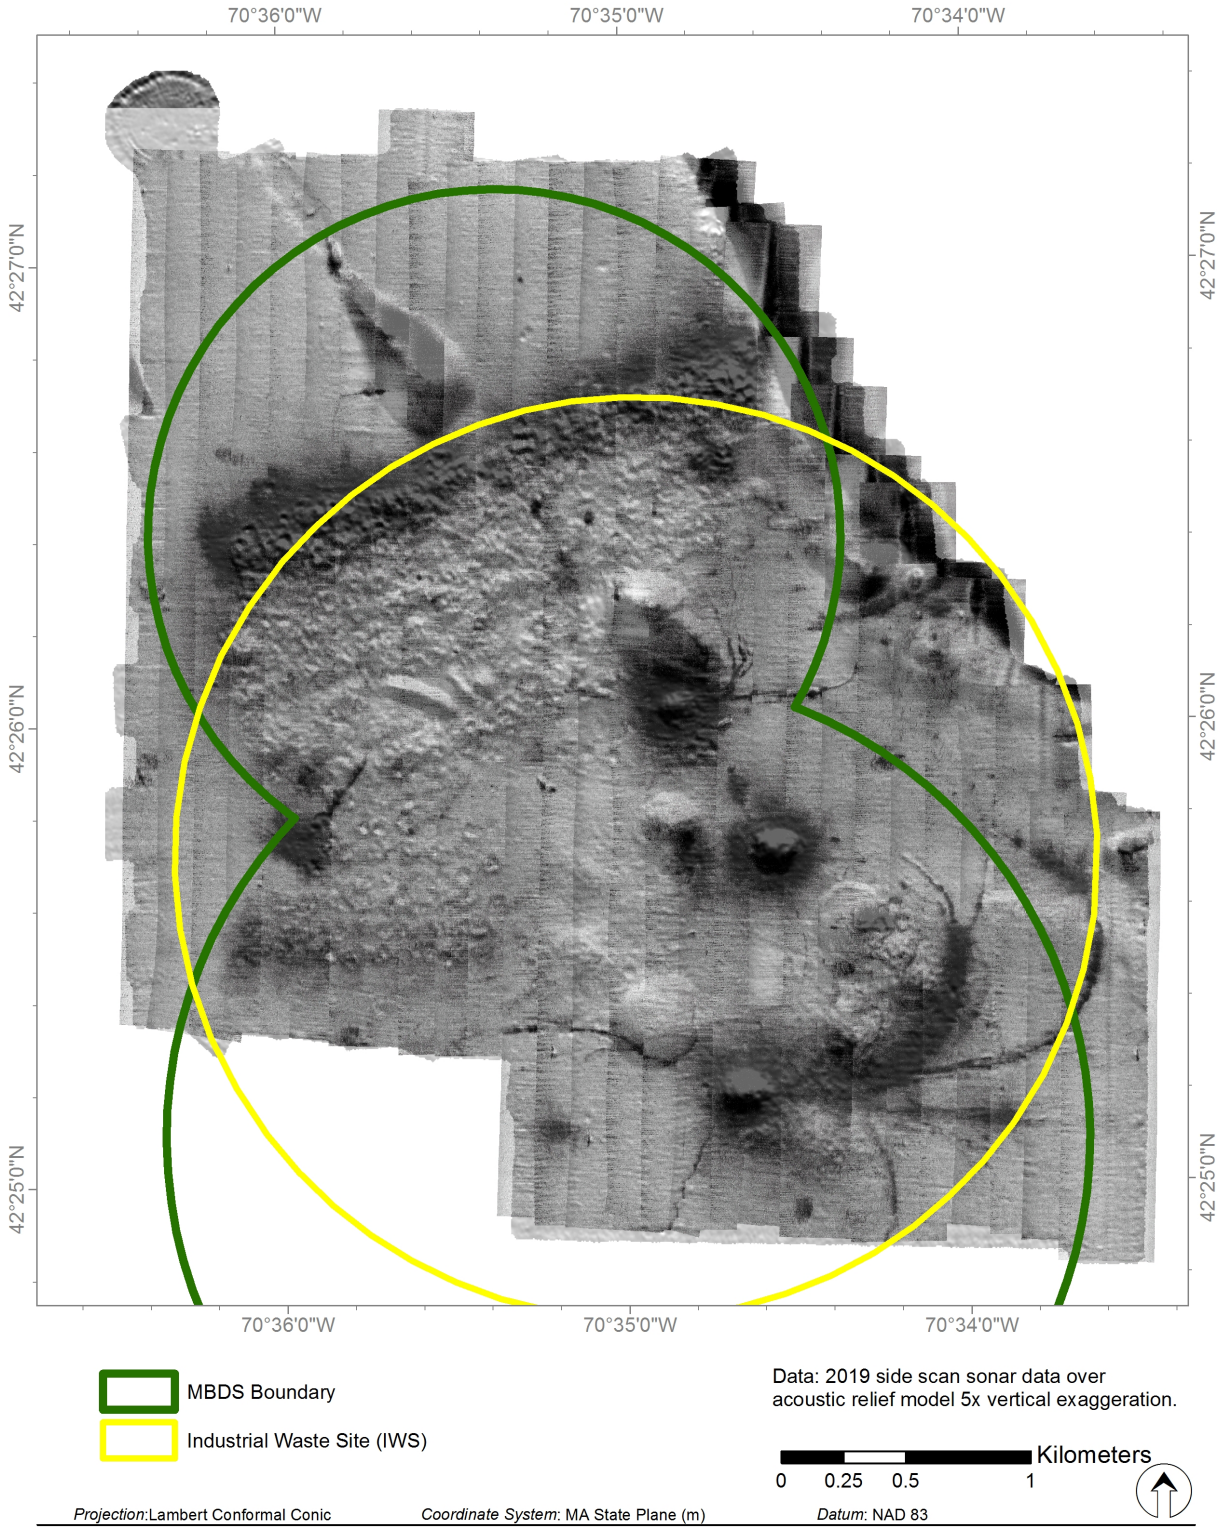
Figure 3-7. Side-scan Sonar at MBDS, Over 5x Vertical Relief Model, 2019

A side-scan sonar mosaic of the survey area allowed for interpretation of surficial features within the site. Similar to the backscatter results, the side-scan sonar results displayed the variation in sediment texture, visible by the variation of gray shading, over areas where disposal events have occurred (Figure 3-7).

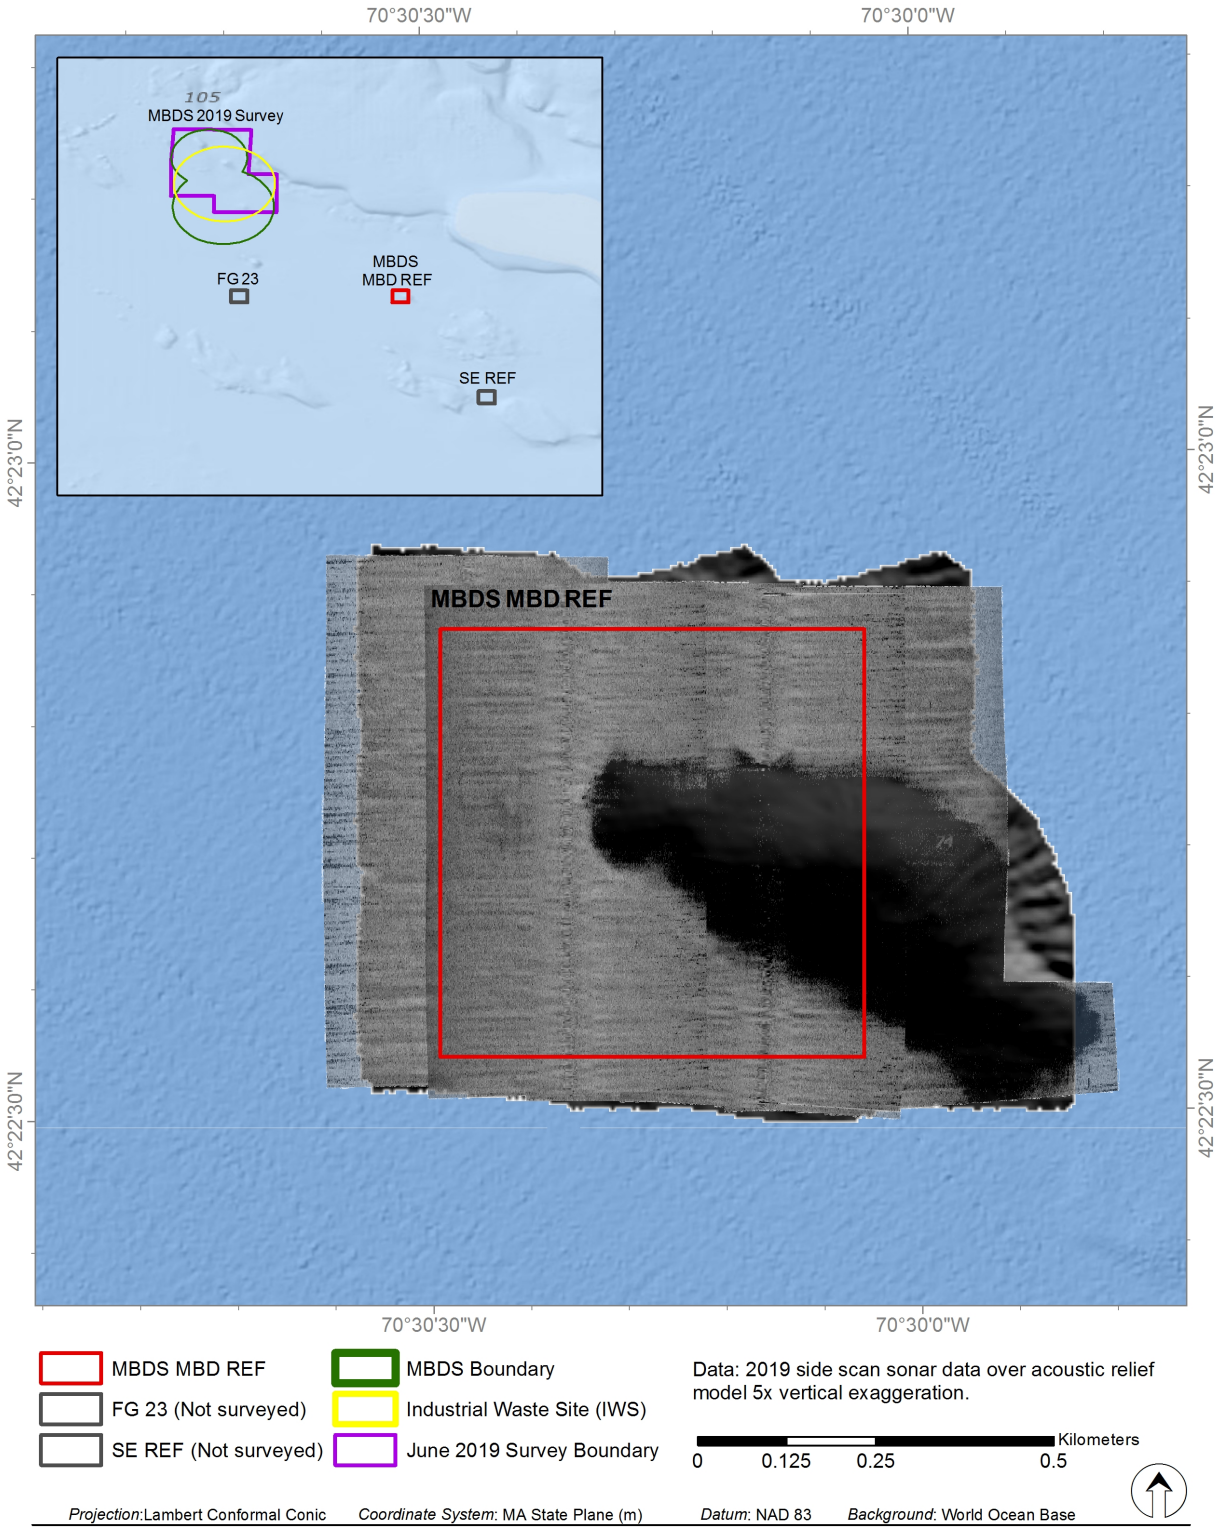
Figure 3-10. Side-scan sonar at MBDS MBD REF, Over 5x Vertical Relief Model

Backscatter survey results over the MBDS MBD REF area ranged from -12 to -32 dB. Backscatter measurements (in dB) over the apparent glacial drumlin in the central portion of the reference area generated the highest backscatter signals, indicating that a coarser substrate was present over this feature. The ambient seafloor within the reference area exhibited similar backscatter intensity to the ambient seafloor within the MBDS, ranging from -32 to -28 dB (Figures 3-8 and 3-9). Side-scan sonar results over the reference area display the variation in sediment texture between the apparent glacial drumlin in the central portion of the reference area and the ambient sediment (Figure 3-10).
