Monitoring Survey at the Central Long Island Sound Disposal Site
September 2003

Disposal Area Monitoring System DAMOS

Contribution 159
September 2004

US Army Corps of Engineers ®
New England District

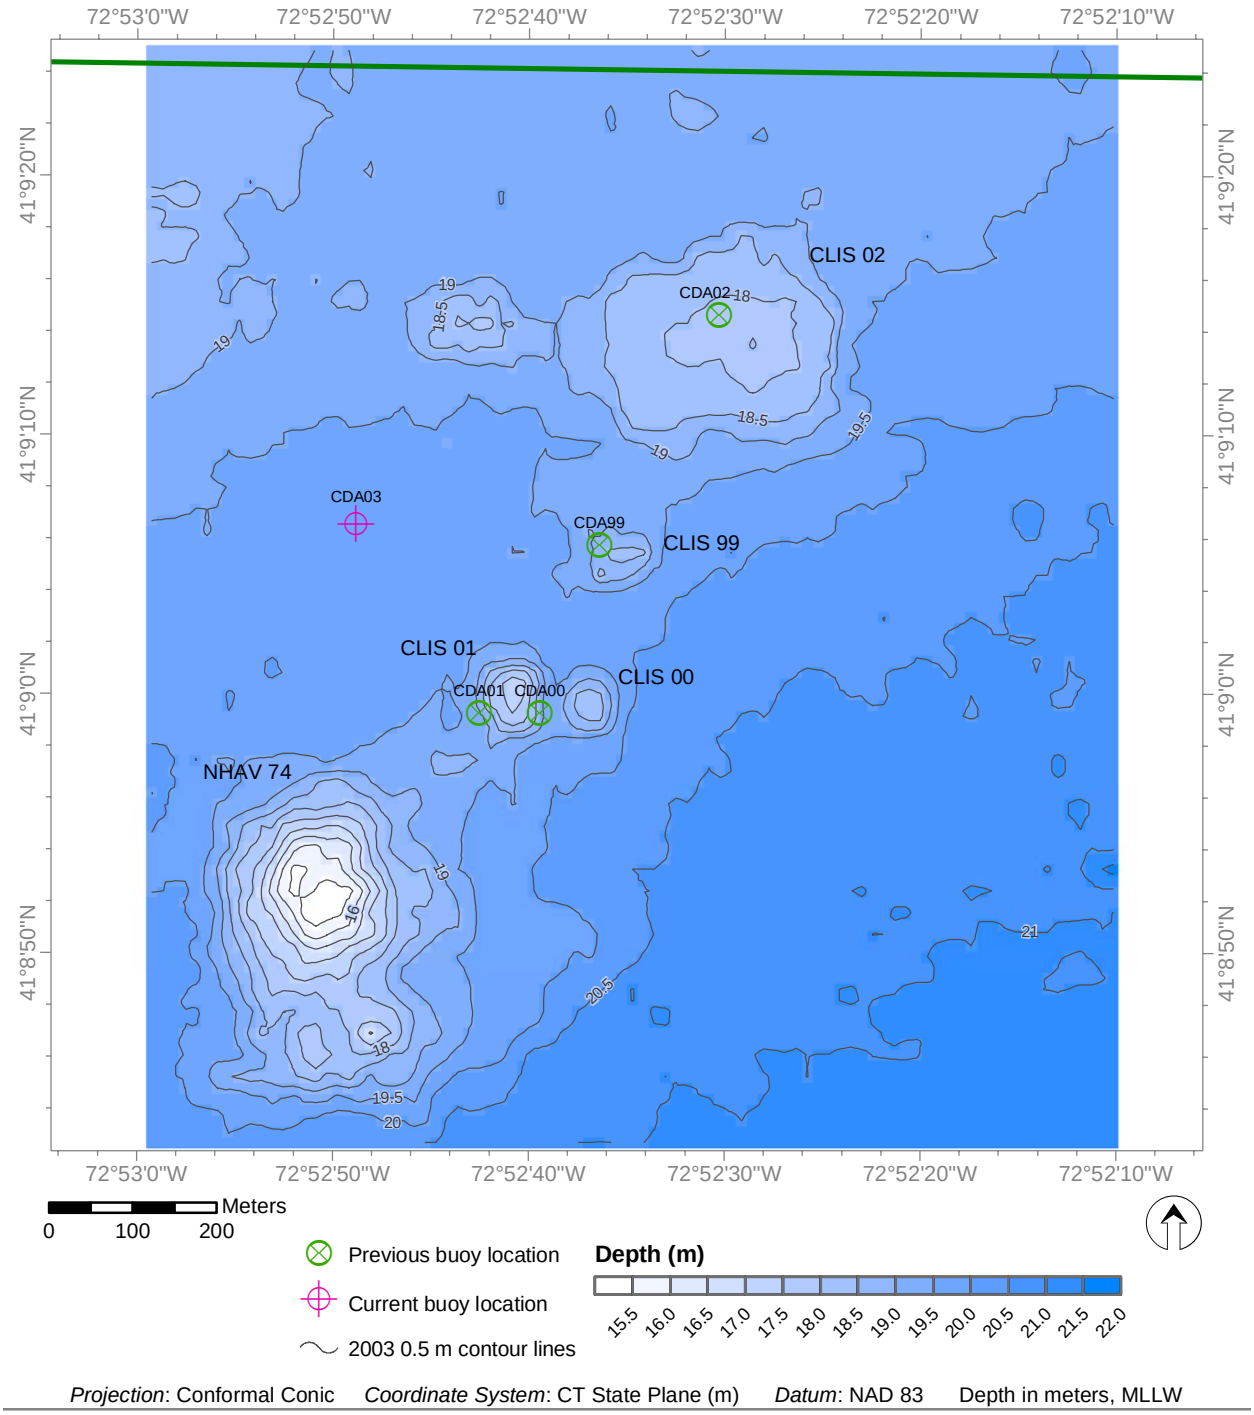
Figure 3-1 Bathymetric contour map of CLDS survey area, September 2003 (0.5-m contour interval).

The September 2003 bathymetric survey results for CLDS were consistent with earlier survey results, with the notable exception of the mounds (designated as CLIS 01 and CLIS 02) formed at the location of the CDA01 and CDA02 buoys during the 2001–2002 and 2002–2003 disposal seasons (Figure 3-1). The natural seafloor slopes from the northwest to the southeast across the survey area (a subset of the disposal site), with depths ranging from approximately 19 m in the northwest to 21 m in the southeast (Figure 3-1, depths reported as MLLW).

Six distinct mounds were evident: four the result of earlier disposal events and two the result of disposal events after the 2001 survey. The CLIS 99 Mound and CLIS 00 Mound were first identified during the 2001 survey and were approximately 1 to 1.5 m in height (Figure 3-2). The historic NHAV 74 Mound was approximately 4 m above the surrounding seafloor. The fourth historic feature was a small mound, approximately 1.5 m in height, which was present during the 2001 survey. This mound, which has no official designation, was located approximately 300 m west of the newly formed CLIS 02 Mound (Figures 3-1 and 3-2).

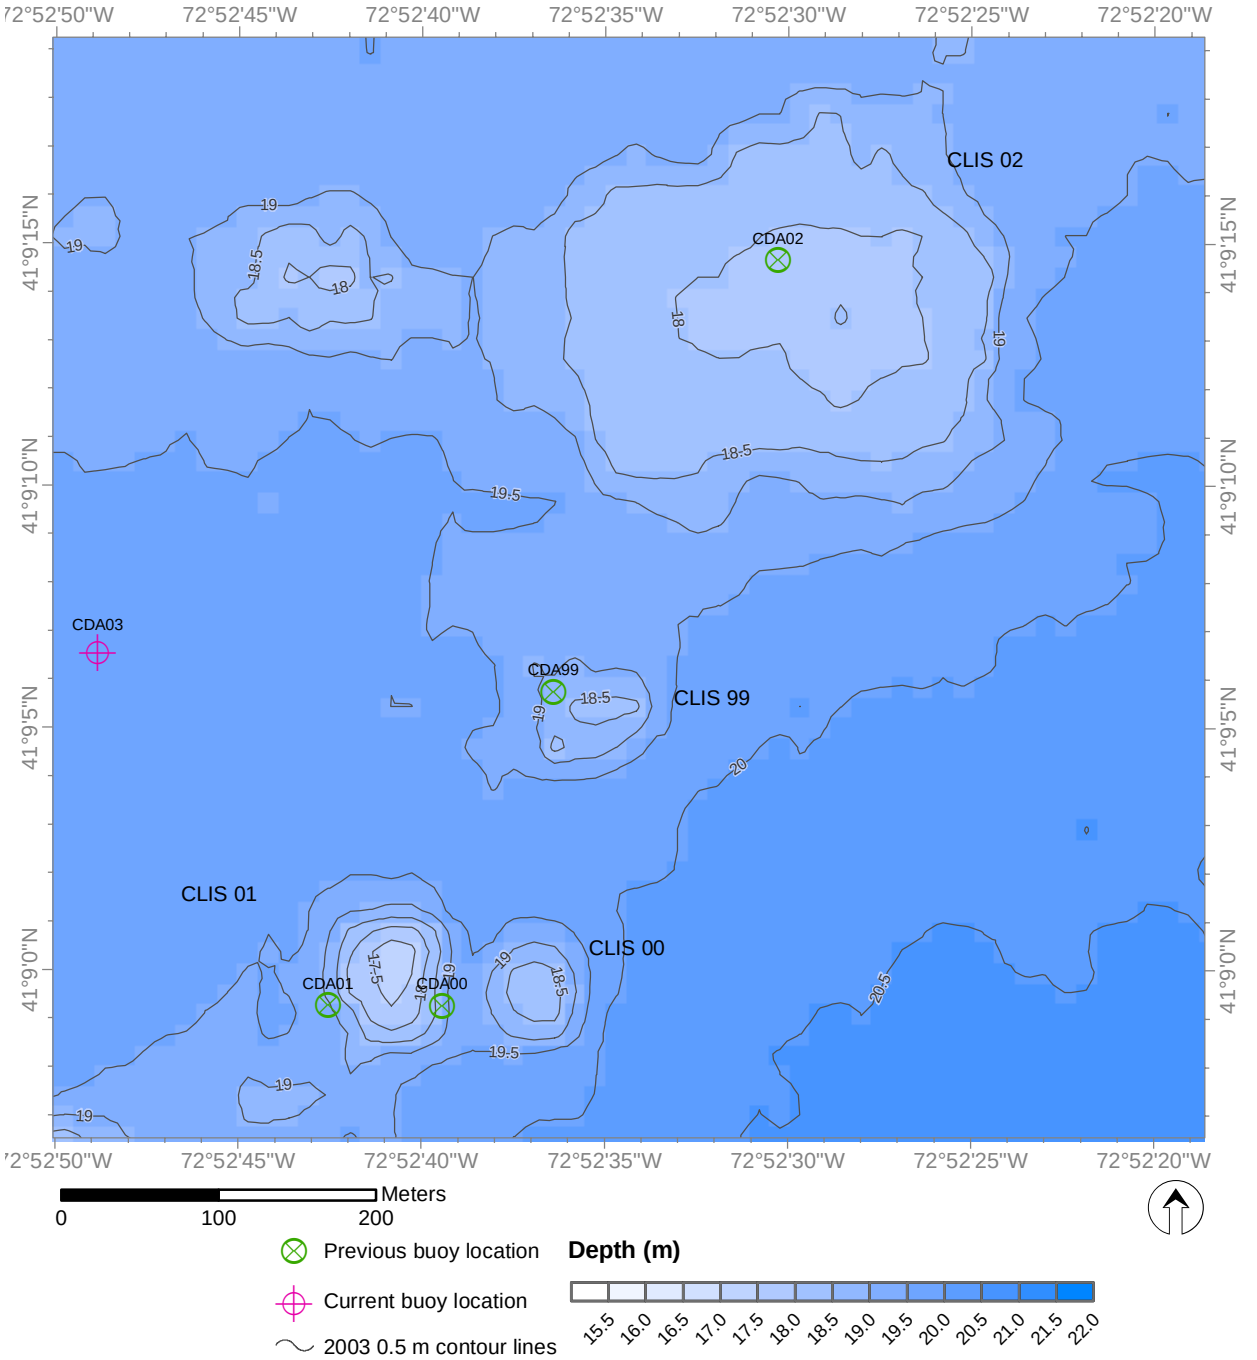
Figure 3-3 Bathymetric contour map of CLDS survey area (close-up), September 2003 (0.5-m contour interval).

The newly formed CLIS 01 Mound was located approximately 100 m west of the CLIS 00 Mound and was generally conical in shape. It was formed primarily from the disposal of approximately 53,000 m^3 of material during the 2001–2002 season. The base of the mound was approximately 90 m in diameter. The minimum water depth at the apex of the mound was approximately 17.5 m and the surrounding water depths averaged about 20 m, indicating that the height of the mound was approximately 2.5 m above the surrounding seafloor (Figure 3-3).

The recently formed CLIS 02 Mound, approximately 250 m northeast of the CLIS 99 Mound, formed from the disposal of approximately 312,000 m^3 of material during the 2002–2003 disposal season. The base of the mound was approximately 300 m in diameter. The minimum water depth at the apex of the mound was approximately 17.5 m and the surrounding water depths averaged about 19.5 m, indicating that the height of the mound was approximately 2 m above the surrounding seafloor (Figure 3-3).

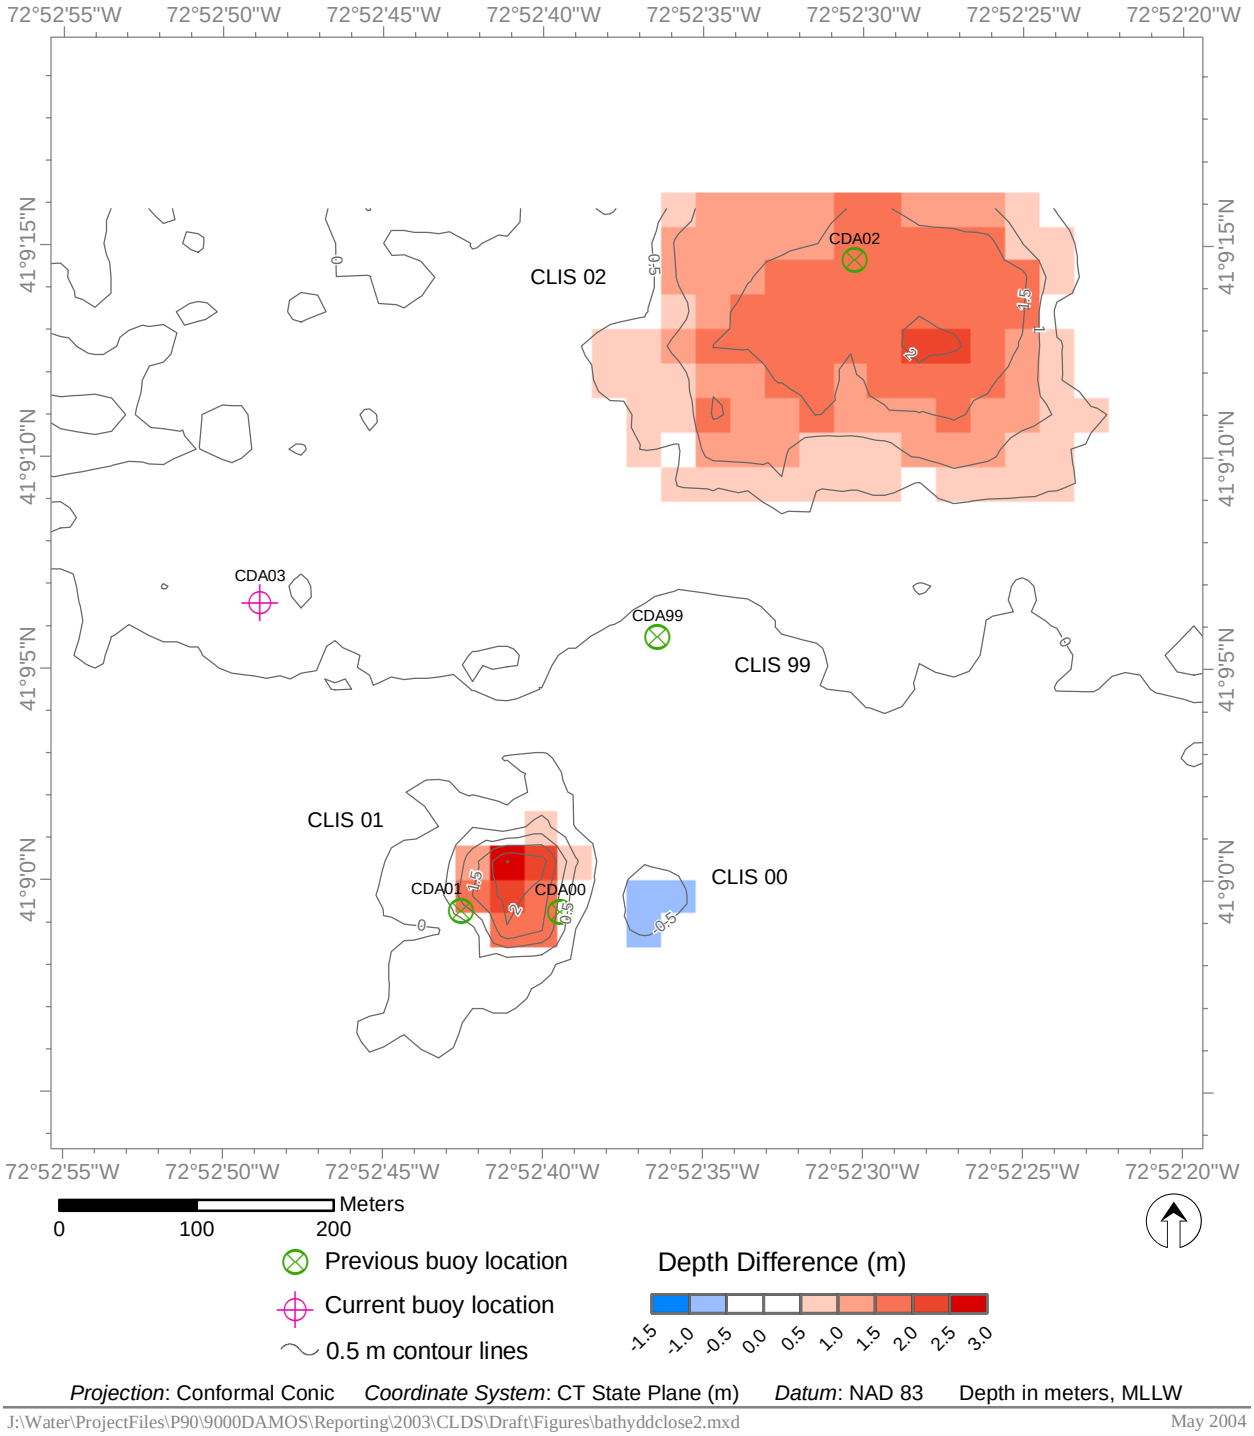
Figure 3-4 Depth difference contour map of CLDS survey area, June 2001 vs. September 2003 survey results (0.5-m contour interval).

The depth-difference map for the 2001 and 2003 bathymetric data was plotted at 0.5-m contour intervals (Figure 3-4). The most significant features are the two newly formed disposal mounds, CLIS 01 and CLIS 02. The map also indicates a 0.5-m decrease in the height of the CLIS 00 Mound. This scale of volume decrease is typical of the self-weight consolidation of recently disposed dredged materials in Long Island Sound (SAIC 1995).

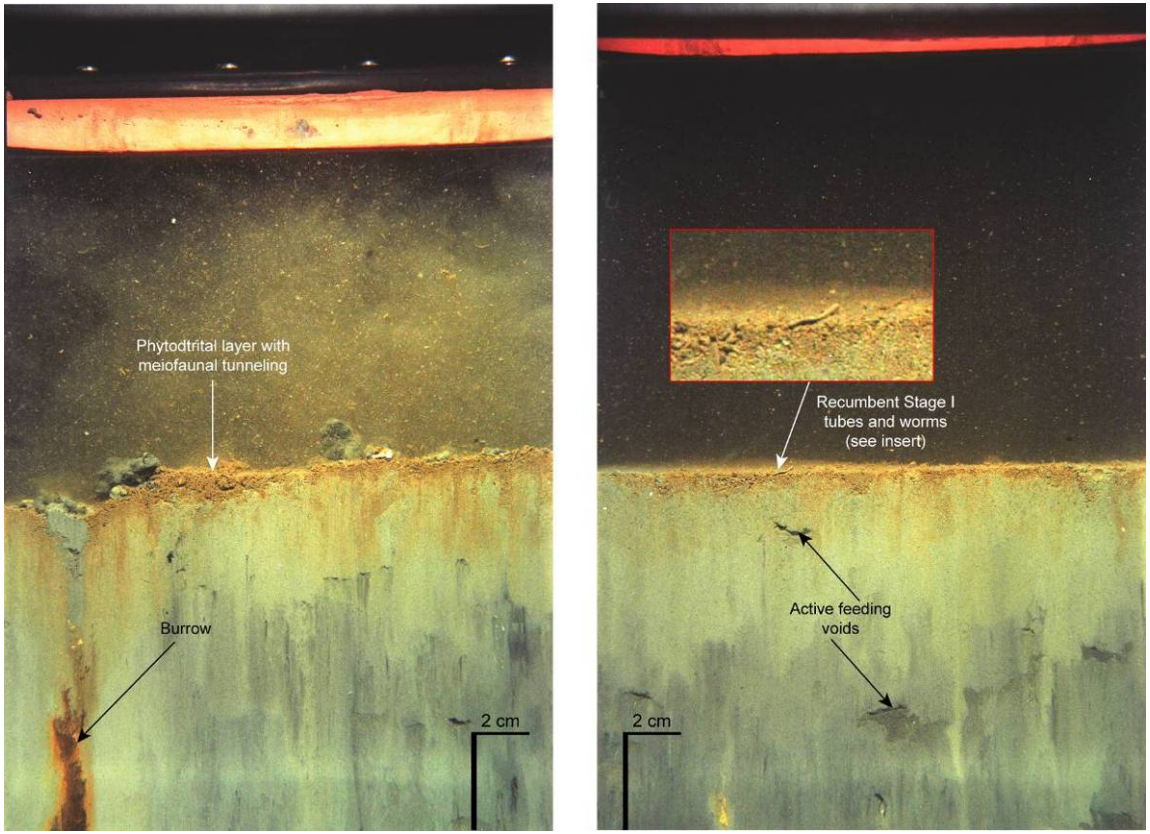
Figure 3-5 Sediment-profile images from Station REF 2500W 2B and REF 4500E 1A showing ambient bottom conditions. REF 2500W 2B (left): Note that the rust-colored phytodetritus has been brought down into the large burrow on the left. The near-surface phytodetrital layer shows extensive meiofaunal tunneling. RPD = 3.6 cm; Stage I on III; OSI = +10. REF 4500E 1A (right): Ambient bottom conditions characterized by high-reflectance sediment at depth, a well-developed apparent RPD, and several subsurface feeding voids. The inset shows broken and recumbent tubes of Stage I worms on a rust-colored phytodetrital layer. RPD = 3.8 cm; Stage I on III; OSI = +11.

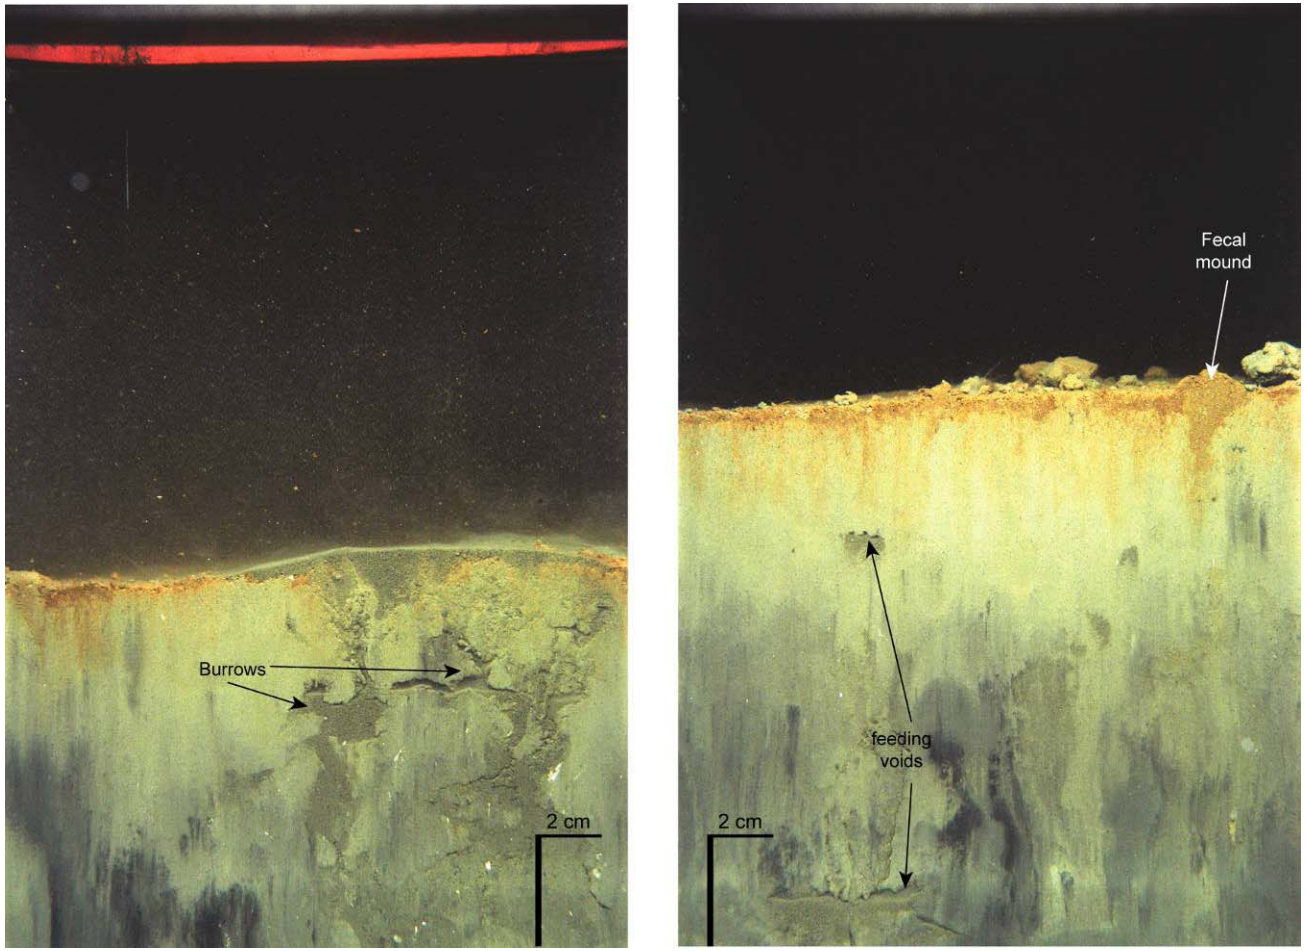
Figure 3-7 Sediment-profile images from Station CLIS REF 3C and CLIS REF 6A showing mottled coloring of the sediment due to extensive burrowing and biological reworking (e.g. burrows, feeding voids, fecal mound).

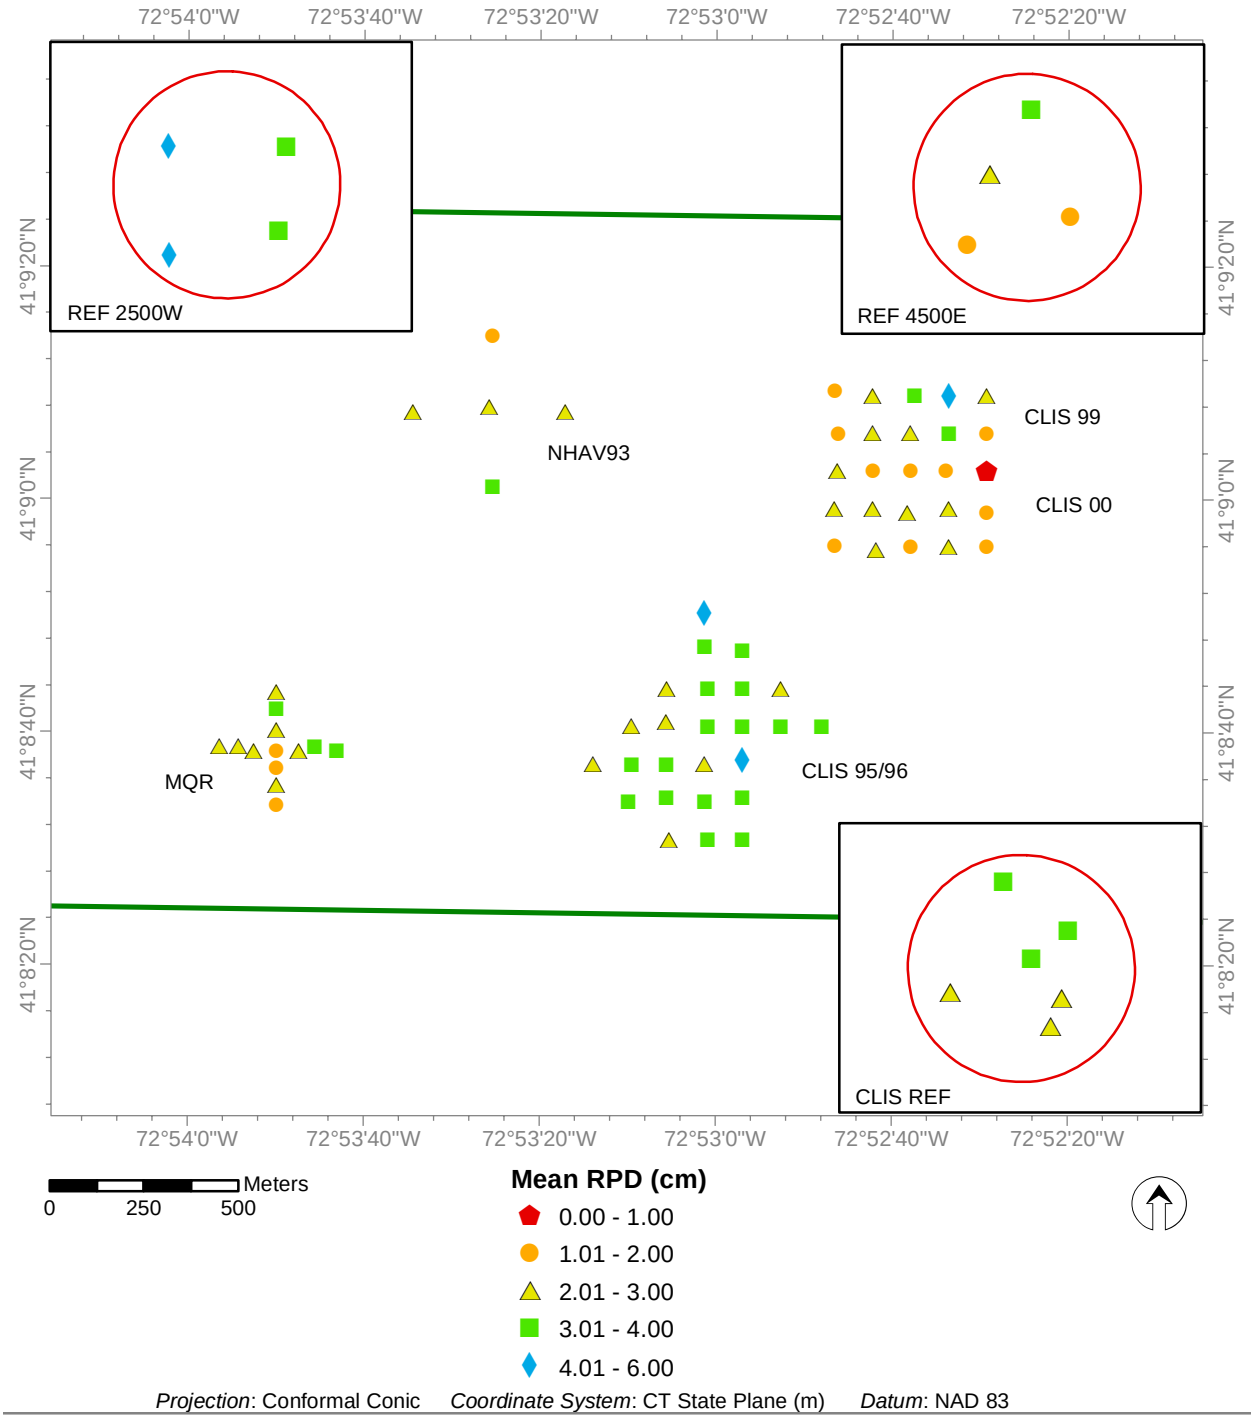
Figure 3-8. Mean apparent RPD depths at CLDS Reference Areas, September 2003

The mean apparent RPD depths at the reference areas ranged from 1.7 cm (4500E 4) to 4.6 cm (2500W 4), with an overall mean of 3.0 cm (Table 3-1, Figure 3-8). These values are typical of ambient bottom conditions in late summer in those areas of the central Sound not experiencing hypoxia. The deepest values were measured at reference area 2500W.

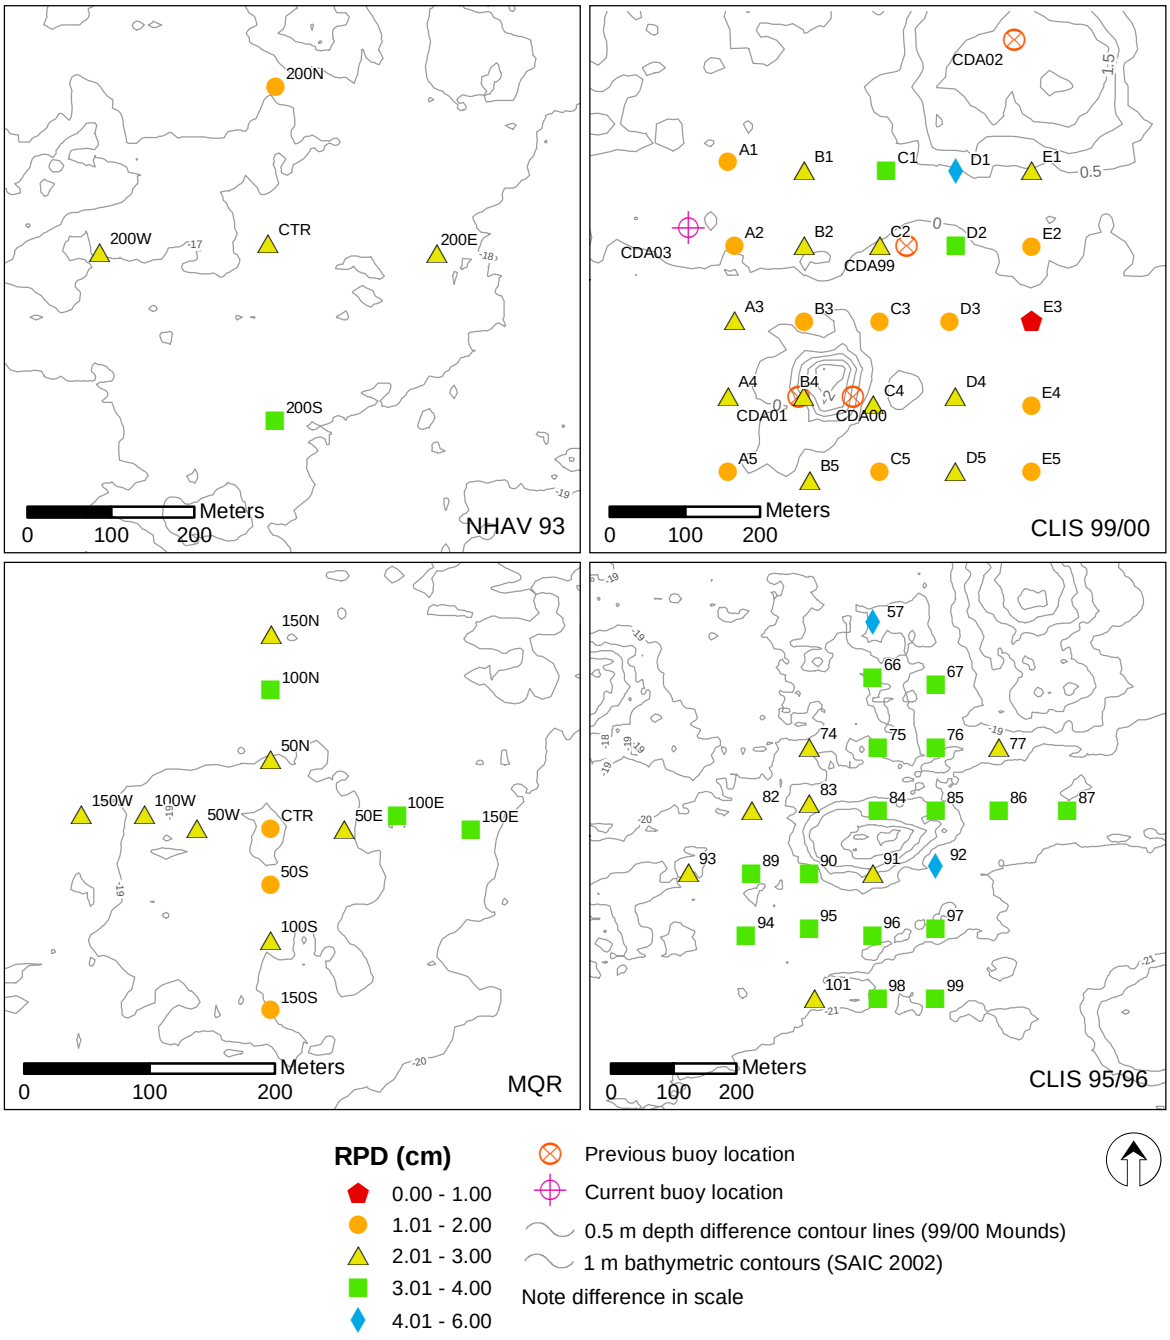
Figure 3-12 Mean apparent RPD depths at CLIS 99, CLIS 00, CLIS 95/96, NHAV 93 and MQR Mounds, CLDS, September 2003

Mean apparent RPD depths ranged from 0.5 to 4.0 cm (Table 3-2, Figure 3-12). The shallowest mean RPD (0.5 cm) was observed at Station 00-E3 located on the central eastern boundary, and the deepest (4.0 cm) was observed at Station 99-D1 in the northeastern corner of the sampling grid, suggesting that the areas of deep and shallow RPD horizons were patchy. Infaunal succession across the surface of the CLIS 99 and CLIS 00 mounds was advanced; Stage I on III was present in at least one replicate image

Mean apparent RPD depths were all deeper than 2.0 cm, with 18 of the 25 stations having RPD depths greater than 3.0 cm (Table 3-3, Figure 3-12). Of the five mounds investigated during this survey, the 95/96 Mound Complex had the deepest overall apparent RPD depths. All stations had Stage III infauna. Overall, the stations were dominated by Stage I on III infauna (Table 3-3, Figures 3-13 and 3-16).

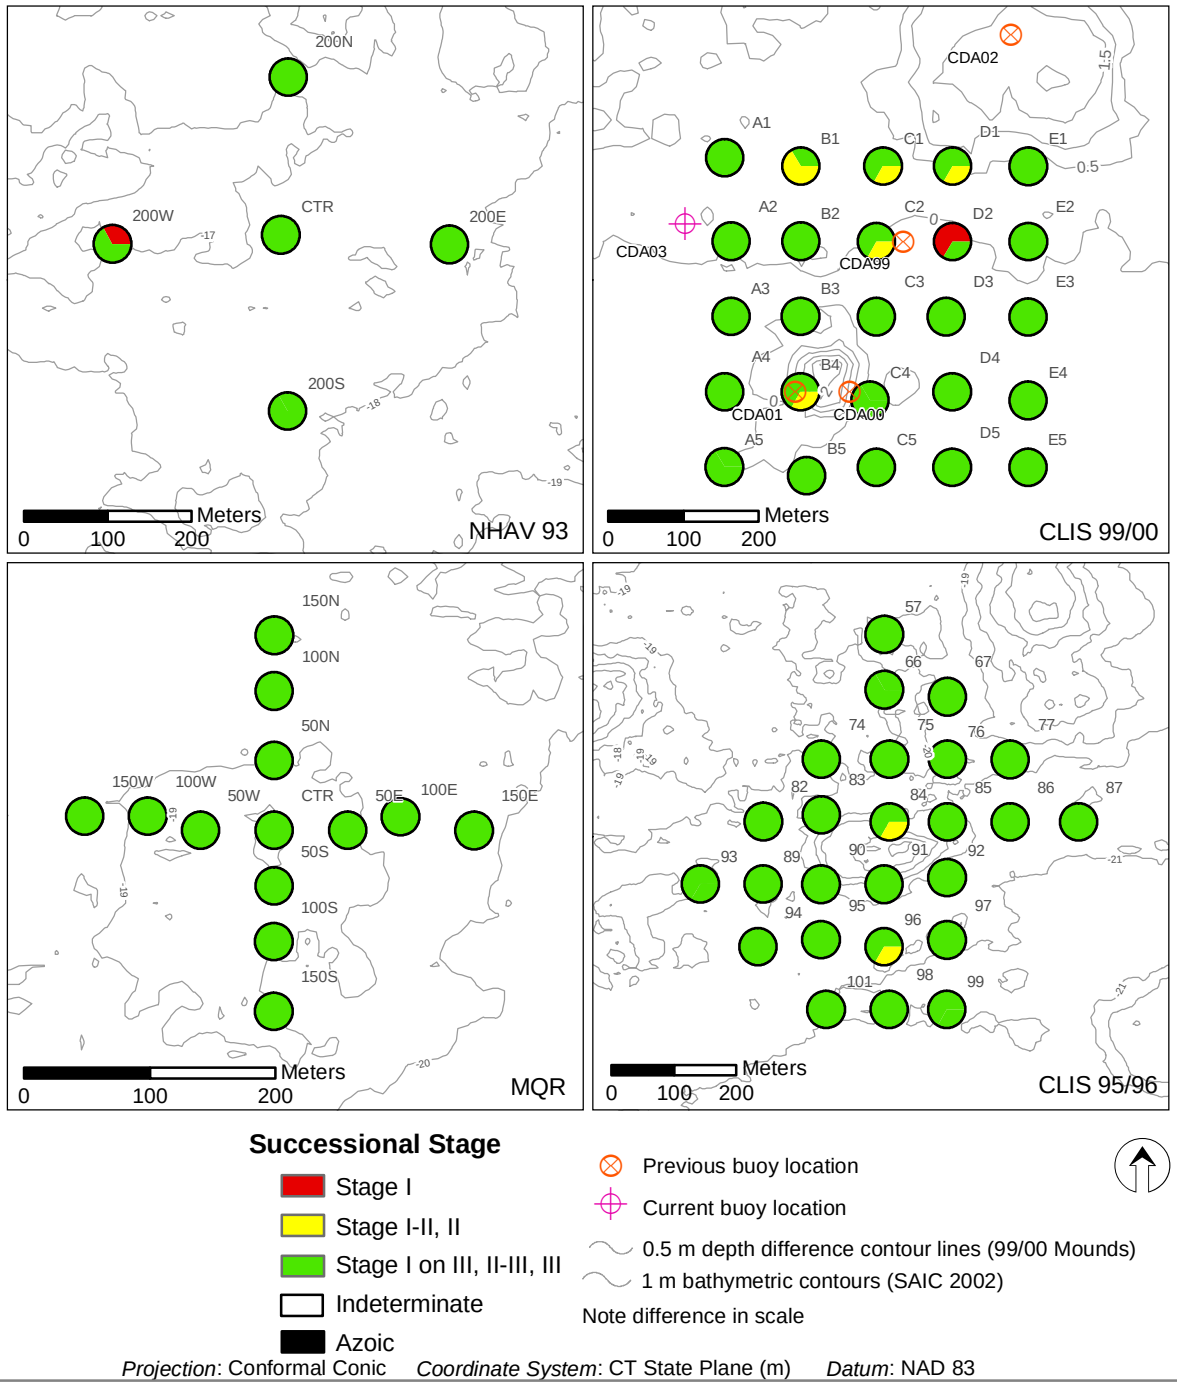
Figure 3-13 Infaunal successional stages at CLIS 99, CLIS 00, CLIS 95/96, NHAV 93 and MQR Mounds, CLDS, September 2003.

The ecological status of the CLDS disposal mounds, as reflected in the median OSI values, was compared to that at the reference areas (Table 3-6). The highest OSI values were found most consistently at the CLIS 95/96 Mound Complex, where the median OSI value of +10 was comparable to that of the combined reference stations (+9.5). Stage I on III infauna were present in at least one replicate image, and typically in all three images, at all 25 stations surveyed (Figure 3-13).

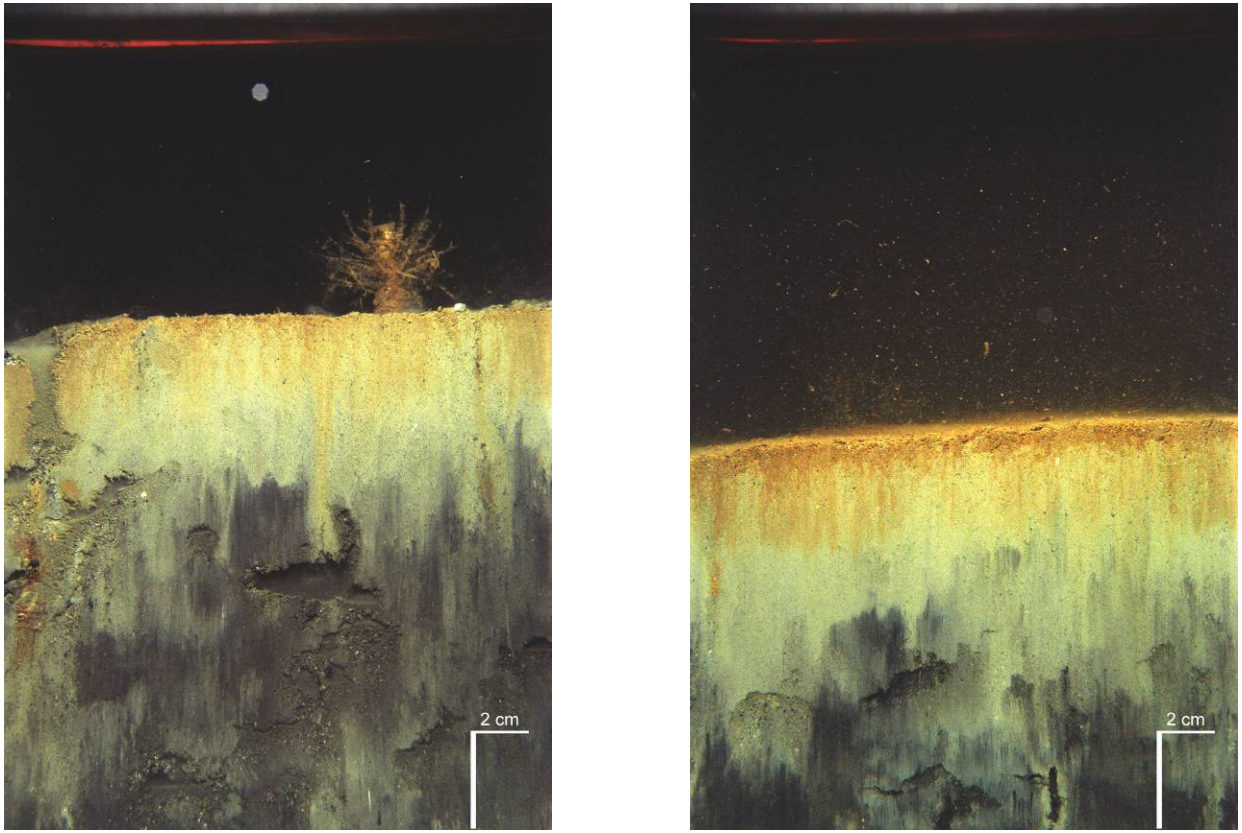
Figure 3-16 SPI images illustrating advanced successional status over the CLIS 95/96 Mound Complex. Station R5C10 76A (left): Dredged material with multiple Stage III feeding voids, Stage I surface tubes, a single *Chaetopterus* tube encrusted with hydrozoans, and a vertical burrow complex. RPD = 3.1 cm; Stage I on III; OSI = +10. Station R8C7 94B (right): Dredged material with a well-developed RPD of 3.3 cm, Stage I activity at the sediment surface, multiple Stage III feeding voids and an OSI of +11.

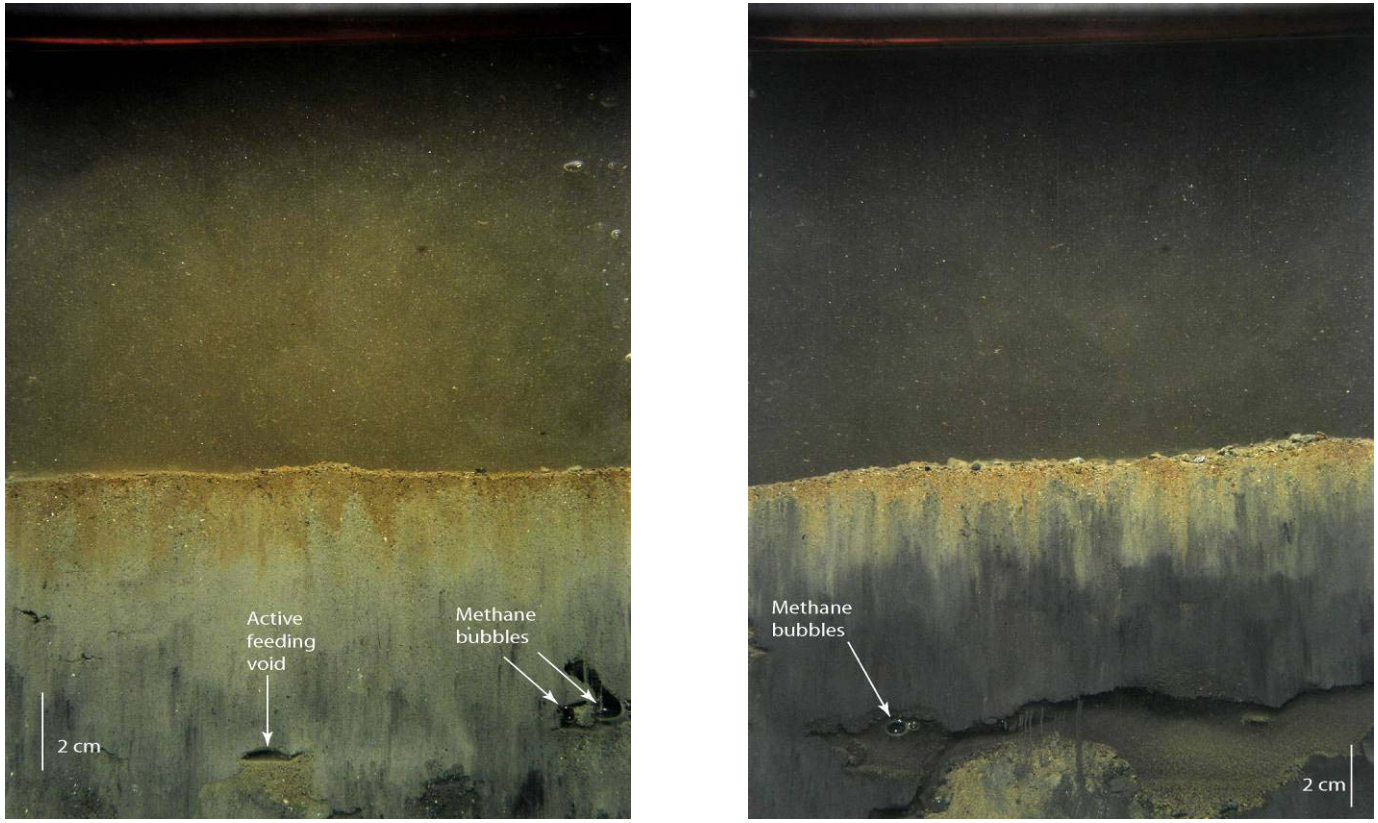
As in previous SPI surveys at the MQR mound (SAIC 2002b), methane gas was observed in images at Stations MQR-50E and MQR-50S (Figure 3-19). The methane may have migrated through the sediment toward the surface from a source deeper within the mound (Table 3-5, Figure 3-20). Boundary roughness was attributed to both physical and biological factors, with values ranging from 0.6 to 1.6 cm and an average of 1.1 cm.

Figure 3-19 Sediment-profile images from Stations MQR 50E B and MQR 50S D. MQR 50E B (left): Well-bioturbated muddy sand with methane gas bubbles. Gas rising through the sediment column commonly accumulates in biogenic voids such as the subsurface feeding voids seen here. RPD = 2.7 cm; Stage I on III; OSI = 7. MQR 50S D (right): Methane gas bubbles are trapped in a subsurface water-filled void as they rise towards the surface. The origin of this particular void is uncertain. RPD = 0.6 cm; Stage I on III; OSI = 4.

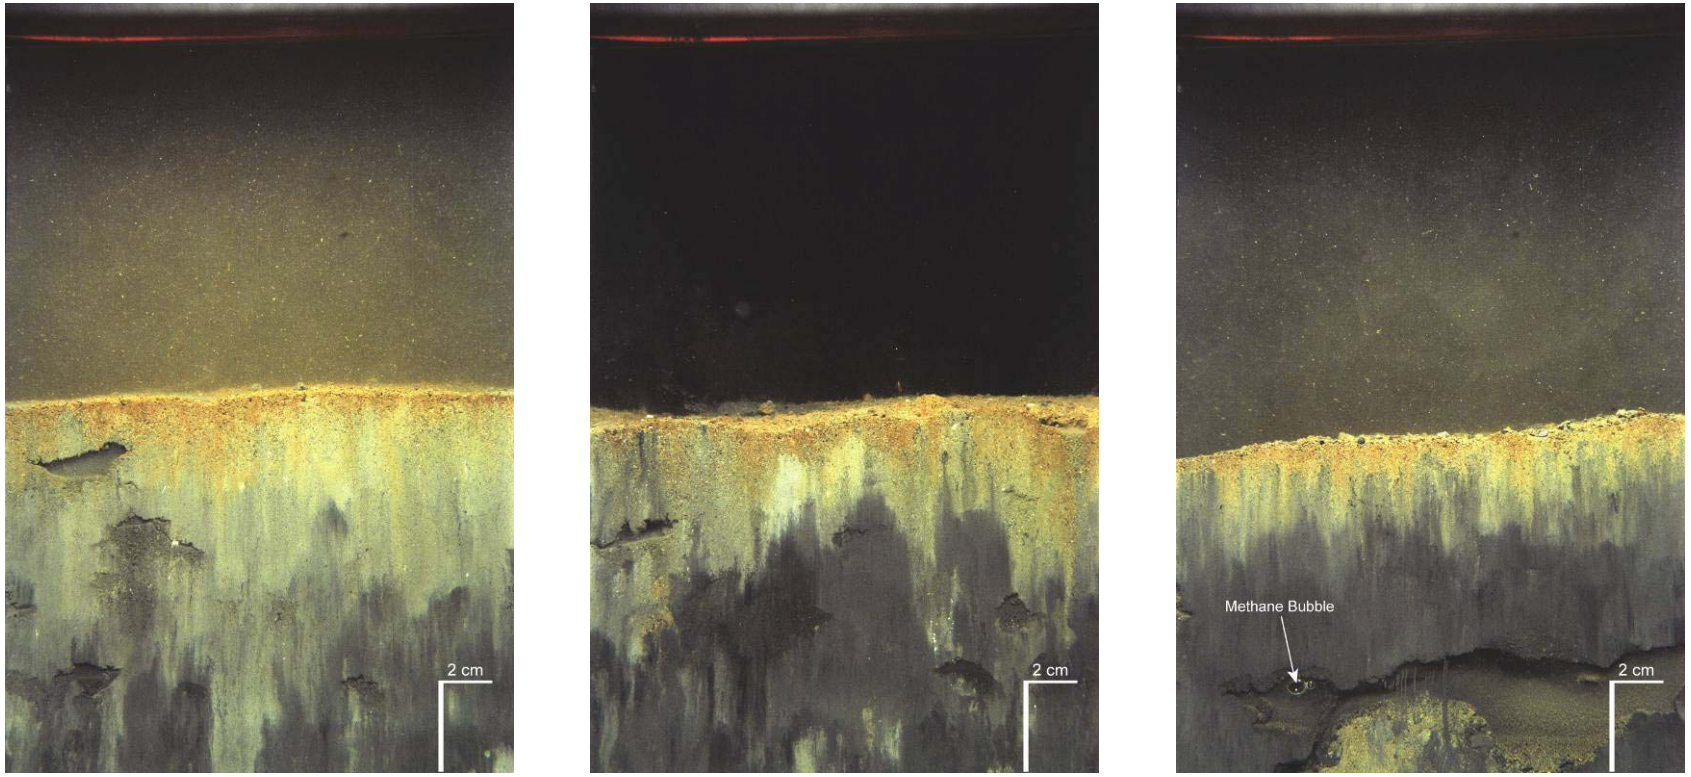
Figure 3-20 SPI images from Station MQR 50S. The methane gas bubble in the image at right was probably produced as a result of anaerobic decomposition of organic-rich dredged material located deeper within the MQR mound. Despite the presence of such organic-rich sediment at depth, all three images show evidence of extensive biological activity by Stage III organisms, in the form of multiple active feeding voids (left and center images) and the relatively large oxidized burrow (right image).

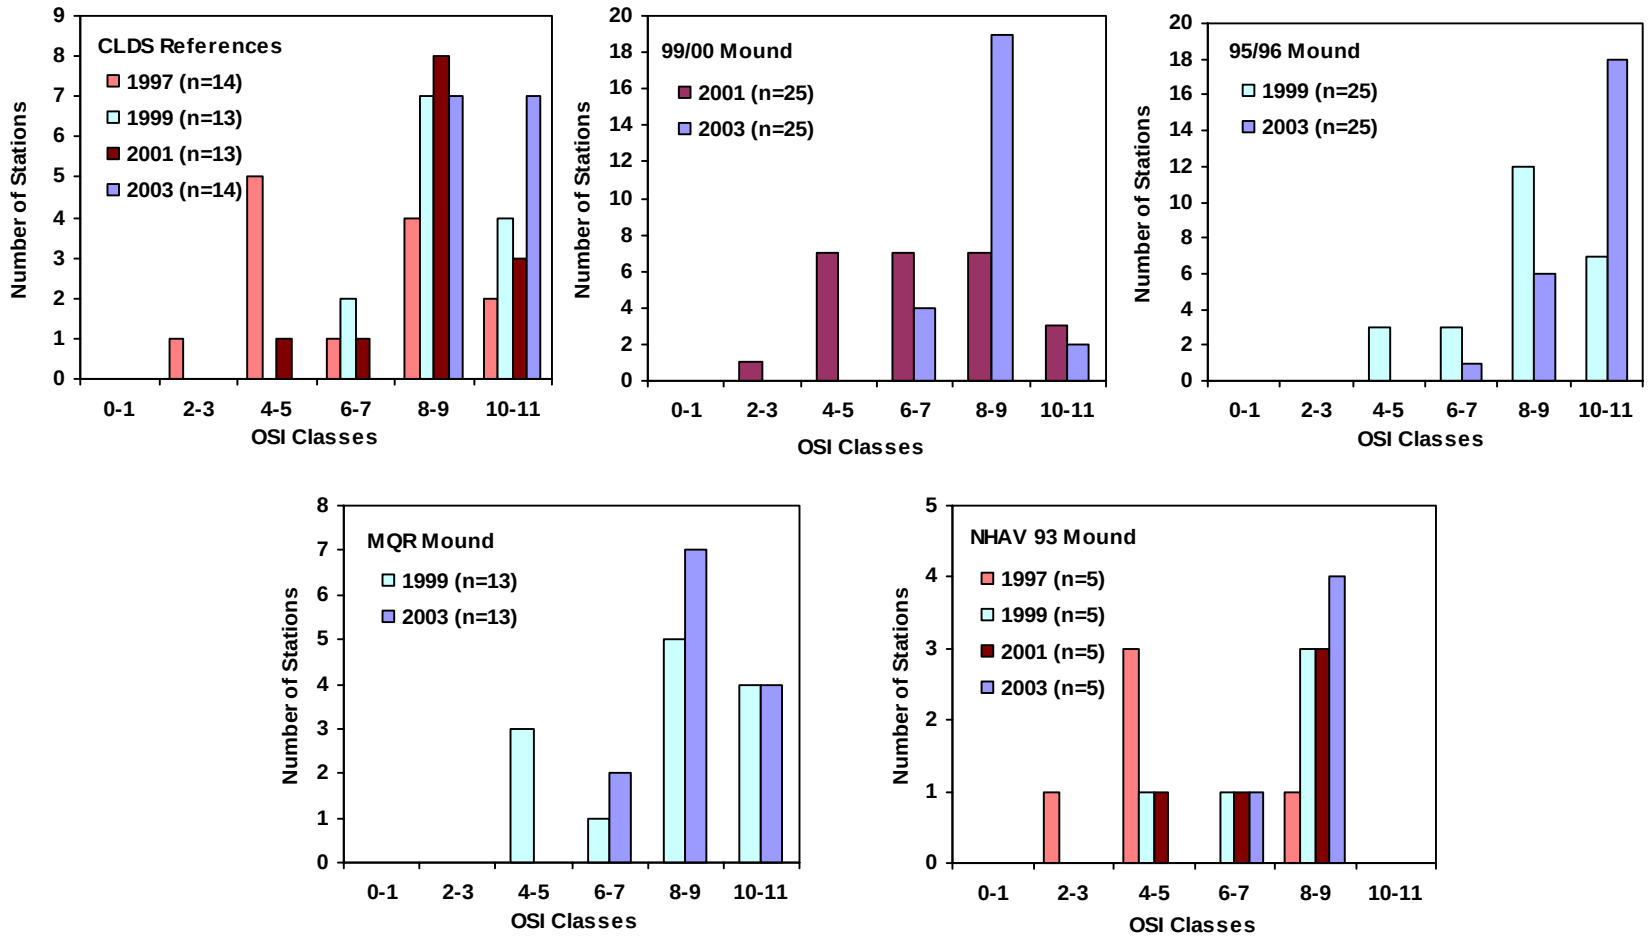
Figure 3-21 Frequency distribution of median OSI values for CLDS reference areas, CLIS 99 and CLIS 00 Mounds, CLIS 95/96 Mound Complex, NHAV 93 Mound and MQR Mound in 1997, 1999, 2001 and 2003.

Historic OSI data from the reference areas show that in 1997, 1999, 2001, and 2003 (this survey), most values were above +8 (Figure 3-21). In 1997, however, 6 of 15 stations had OSI values less than +6 (SAIC 2002a). The prevalence of low OSI values at the reference stations in 1997 was attributed to relatively thin apparent RPD intervals caused by low dissolved oxygen conditions and the absence of Stage III infauna (SAIC 2002a). Other than the 1997 anomaly, the reference areas have had consistently high OSI values.

A positive change in OSI values was evident in 2003 compared with 2001 results. The majority of OSI values in 2001 were distributed equitably over the ranges of +4 to +5, +6 to +7, and +8 to +9 (Table 3-6, Figure 3-21). In the 2003 survey, most OSI values ranged from +8 to +9, indicating a general improvement in site conditions.

OSI values at the NHAV 93 mound were compared over most survey years (Table 3-6; Figure 3-21). The lowest median OSI was in 1997 (+5). In 1999, the median OSI increased to +8, remained at +8 in 2001, and increased slightly to +9 in 2003 survey (Figure 3-21). The sediment at NHAV 93 in 2003 was rich in organic matter as evidenced by the reduced black color of the underlying sediment and the presence of methane in a single replicate image from Station 200E. Despite the presence of this

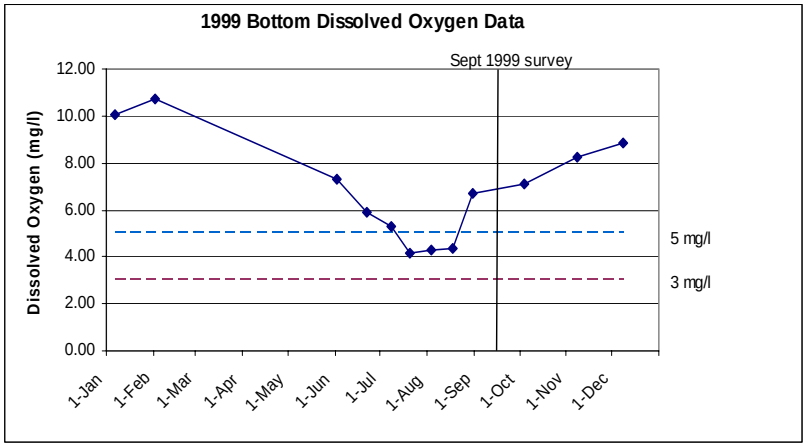
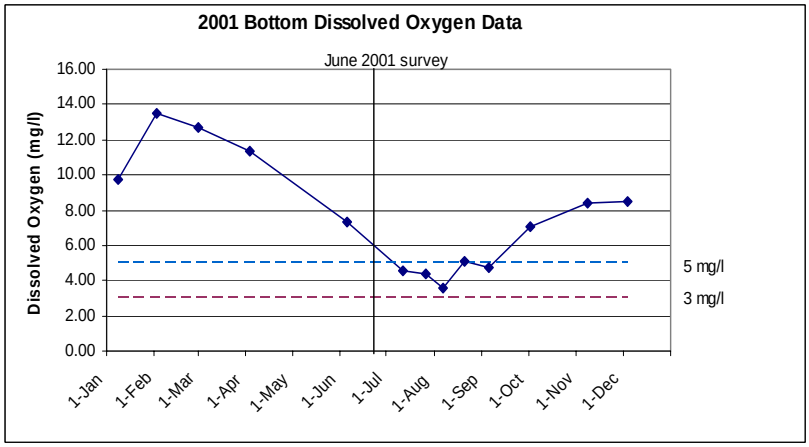
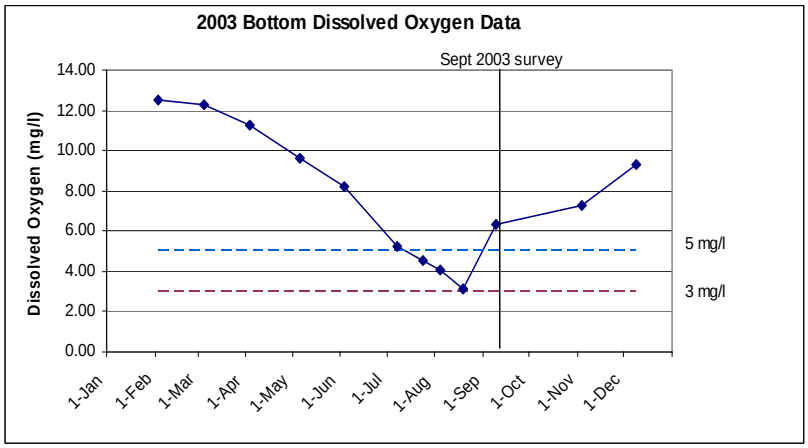
Figure 4-2 Dissolved oxygen concentrations in central Long Island Sound, Station H2, from CTDEP for 1999, 2001 and 2003

The results of the CTDEP 1999, 2001 and 2003 DO surveys at Station H2 are presented in Figure 4-2. Station H2 is the closest station to CLDS that has sufficient data allowing for multiyear comparisons (Figure 4-3). The lowest bottom water concentrations

were above the 3.0 mg/l threshold value but were below 5.0 mg/l suggesting the habitat was stressed but not hypoxic throughout July and August of 1999 and 2001. The 2003 data shows that the lowest oxygen concentrations at Station H2 were during July and August and did reach the hypoxic threshold of 3.0 mg/l during the last two weeks of August. The minimum DO value was observed at the same time as the previously discussed phytoplankton bloom. At the time of the September 2003 survey, however, the oxygen concentration in the bottom waters had rebounded to levels at or above 5.0 mg/l.
