Monitoring Survey at the Douglas Island Disposal Site
Outer Narraguagus Bay, Maine
April 2003 / April 2004 / September 2005

Disposal Area Monitoring System DAMOS

Contribution 173
June 2007

Report No.
ENSR-9000-383-400

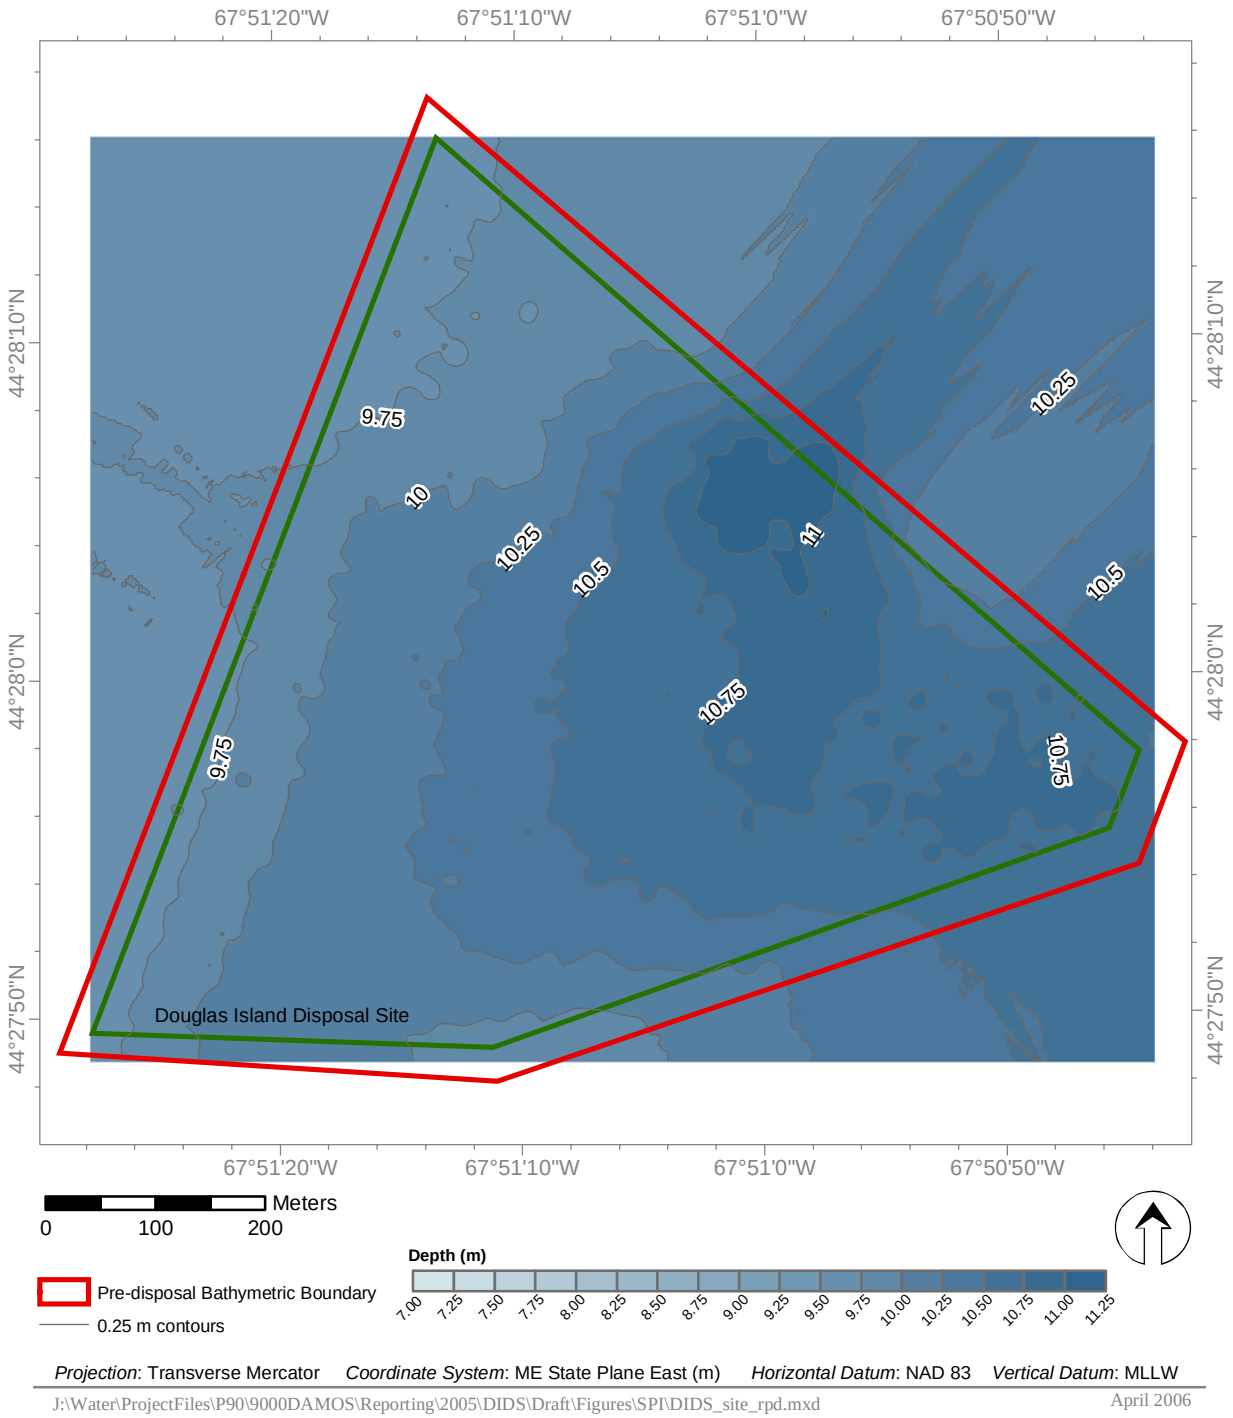
Figure 3-1. Bathymetric contour map of DIDS – April 2003 Pre-disposal Survey

Water depths at DIDS prior to disposal activity ranged from approximately 10 to 11 meters (33 to 36 feet) (Figure 3-1). Shallowest depths were located along the southern and western boundaries of the site. The deepest point was located midway along the northern boundary where depths reached 11.25 meters (36.9 feet). No disposal mounds were evident at DIDS prior to 2004.

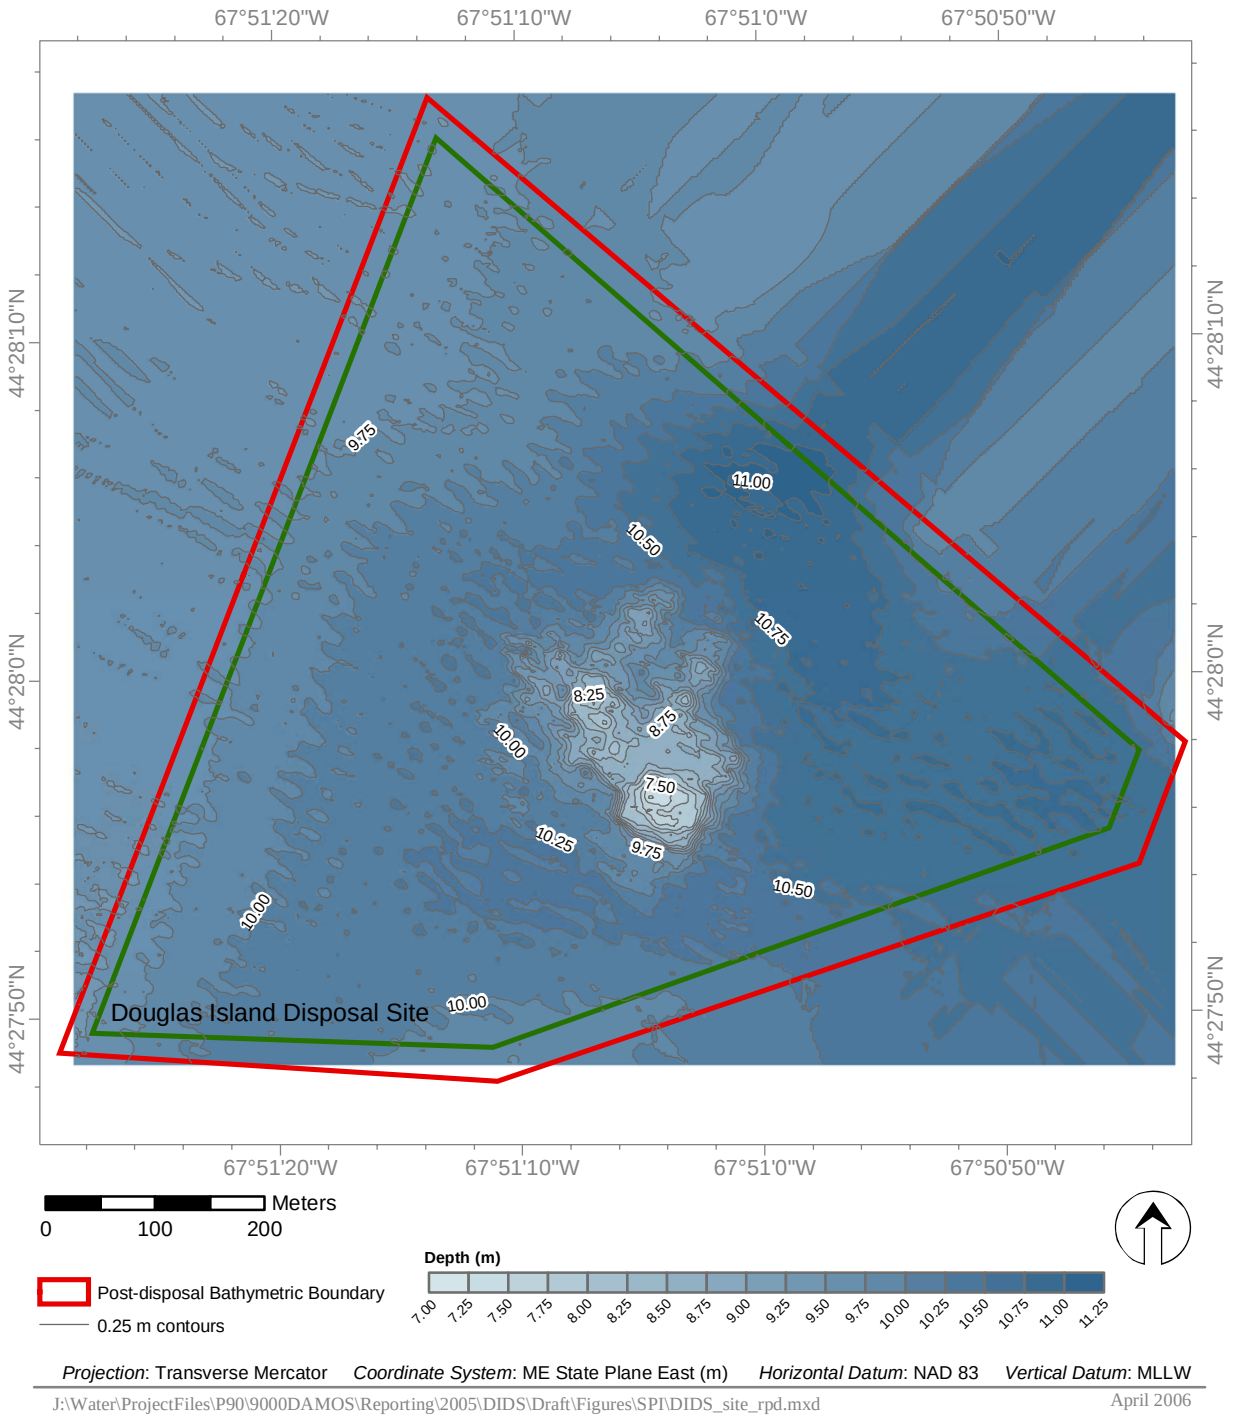
Figure 3-2. Bathymetric contour map of DIDS – April 2004 Post-disposal Survey

The disposal of approximately 77,000 m^3 (100,712 cubic yards) of material from the Narraguagus River Project in 2004 resulted in the formation of a mound in the center of DIDS (Figure 3-2). Depths ranged from approximately 7.5 meters (24.6 feet) in the center of the site to approximately 11.25 meters (36 feet) along the northern boundary (Figure 3-2). The new mound was irregularly shaped and on average rose approximately 2 meters (6.6 feet) above the surrounding seafloor. The highest point of the new mound rose

approximately 3 meters (9.8 feet) above the surrounding seafloor with a minimum depth of 7.5 meters (24.6 feet).

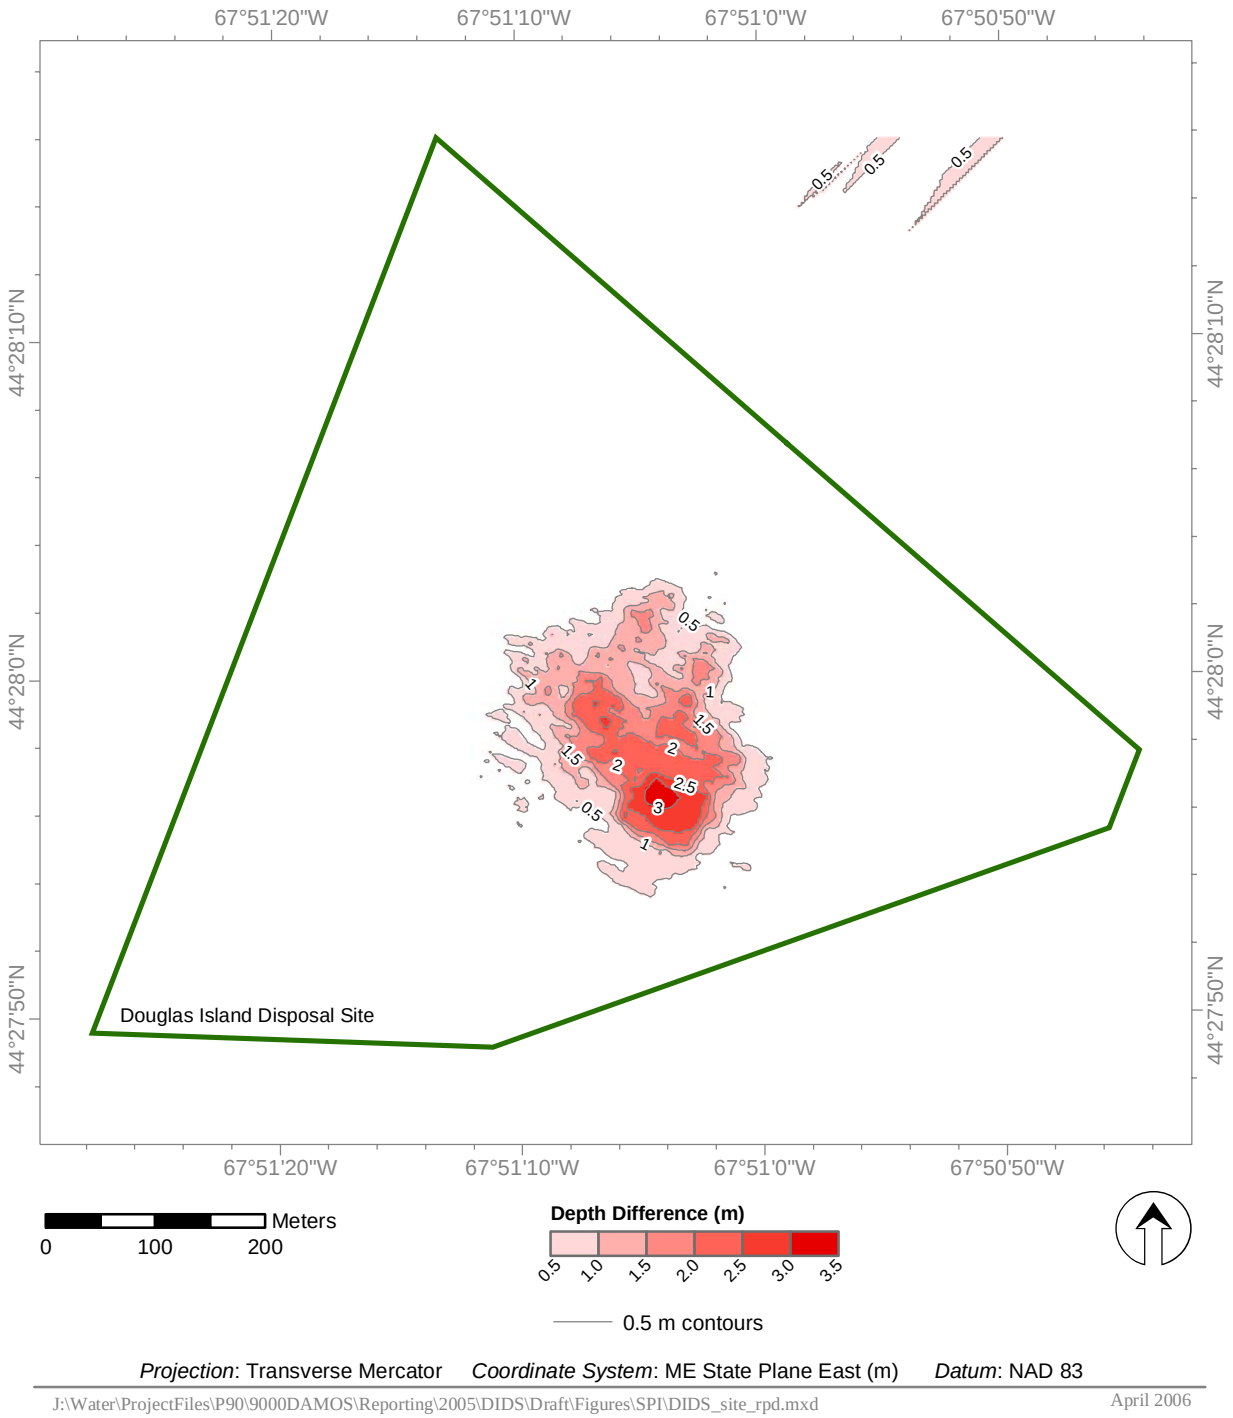
Figure 3-3. Depth-difference map of DIDS, April 2003 – April 2004

A depth-difference map was generated using the pre- and post-disposal bathymetric datasets (Figure 3-3). The depth-difference map confirmed the formation of a mound at the center of DIDS, approximately 200-250 meters (656-820 feet) in diameter and approximately 3 meters (9.8 feet) in height.

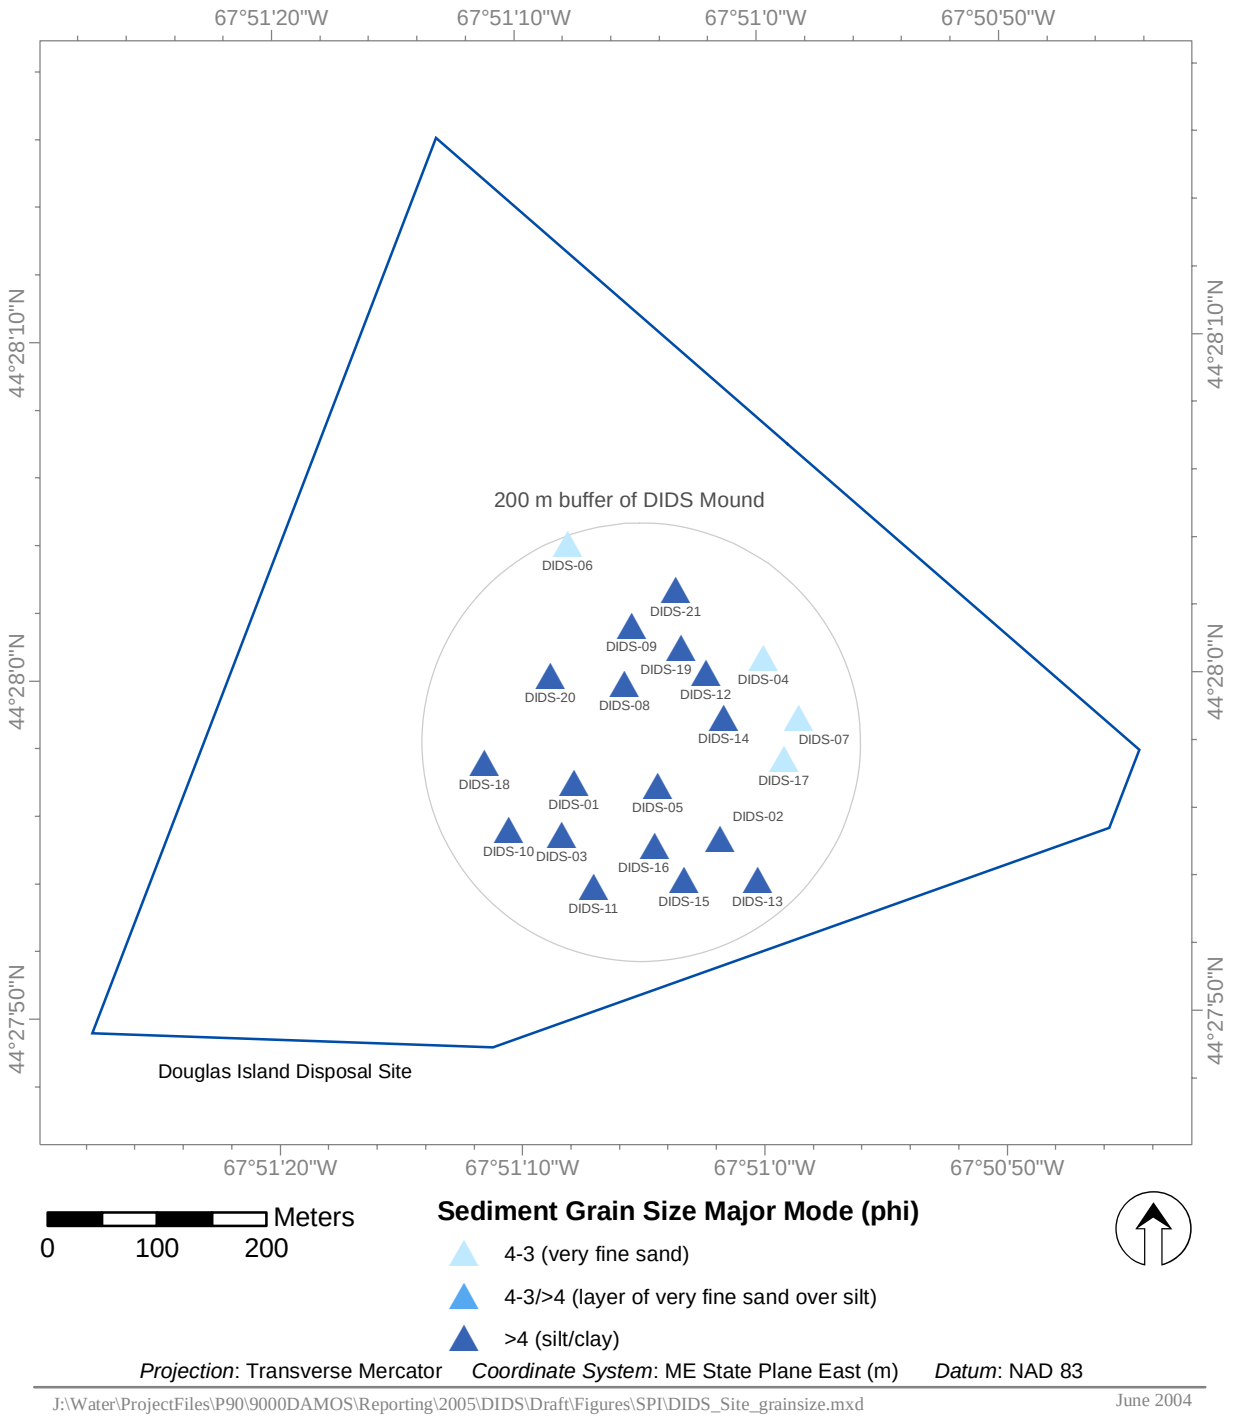
Figure 3-4. Distribution of sediment grain-size major mode (phi units) at the Douglas Island Disposal Site

The sediments at the stations sampled within the disposal site boundary were primarily sandy silts, i.e., poorly-sorted muds with varying degrees of fine sand. The sediment grain-size major mode was $\geq 4\ \Phi$ at all but 4 stations (Stations 4, 6, 7, and 17), where sediments were primarily very fine sand instead of silt-clay (Figure 3-4, Figure 3-5). Dredged material was present at all stations sampled except two (Stations 6 and 7) within the disposal site (Table 3-1, Figure 3-6); some of the stations showed evidence of wood chips/debris in the disposed sediments (Figure 3-7).

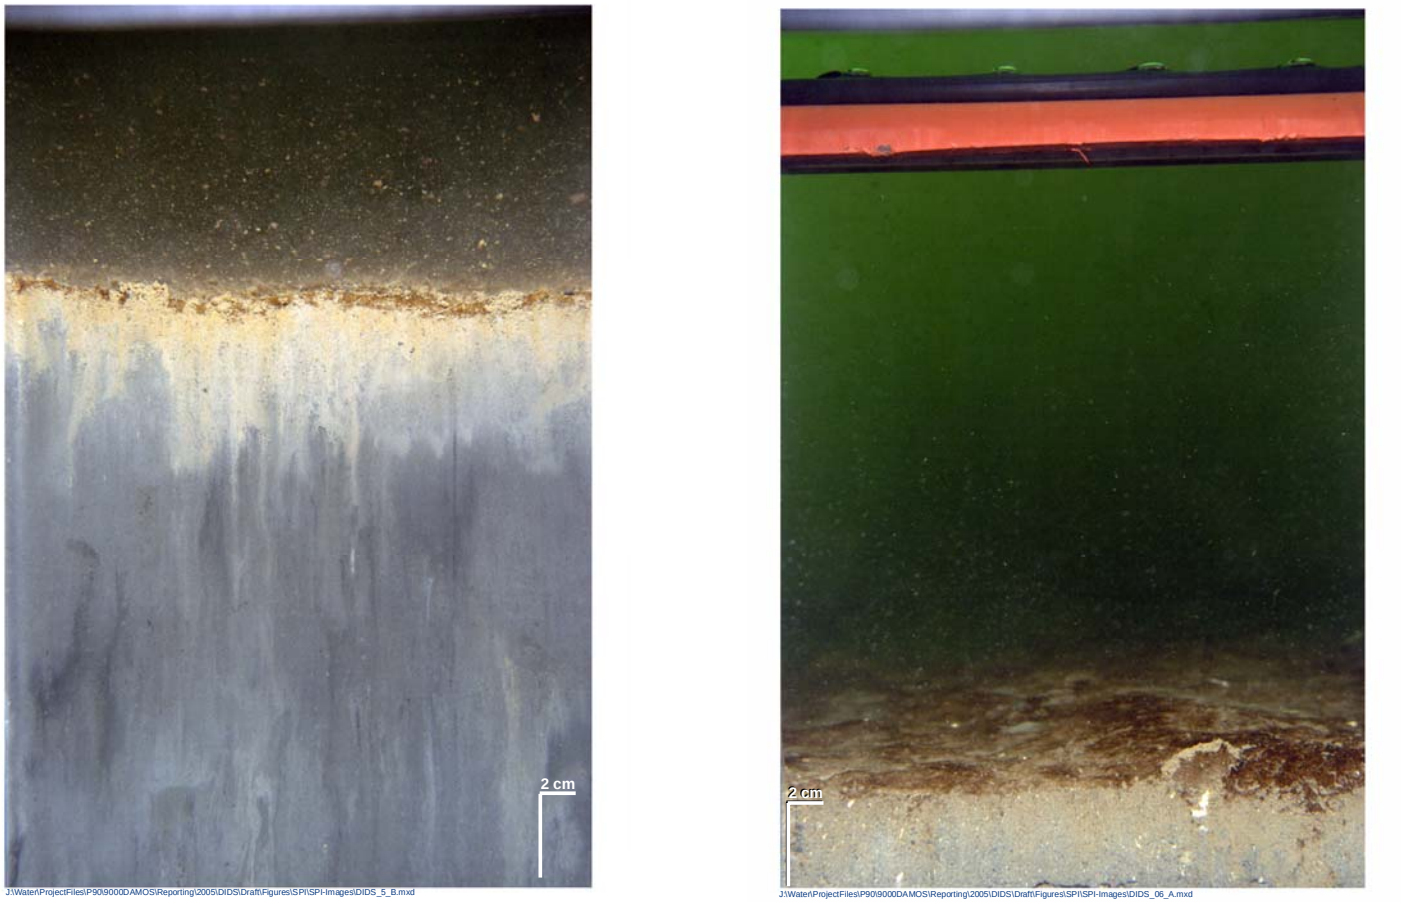
Figure 3-5. While the majority of stations sampled within the Douglas Island disposal site boundary had a sediment grain-size major mode in the silt-clay range as shown in this image from Station 5 (left), a few stations, as shown in this image from Station 6 (right), had a sediment grain-size major mode in the very fine sand range

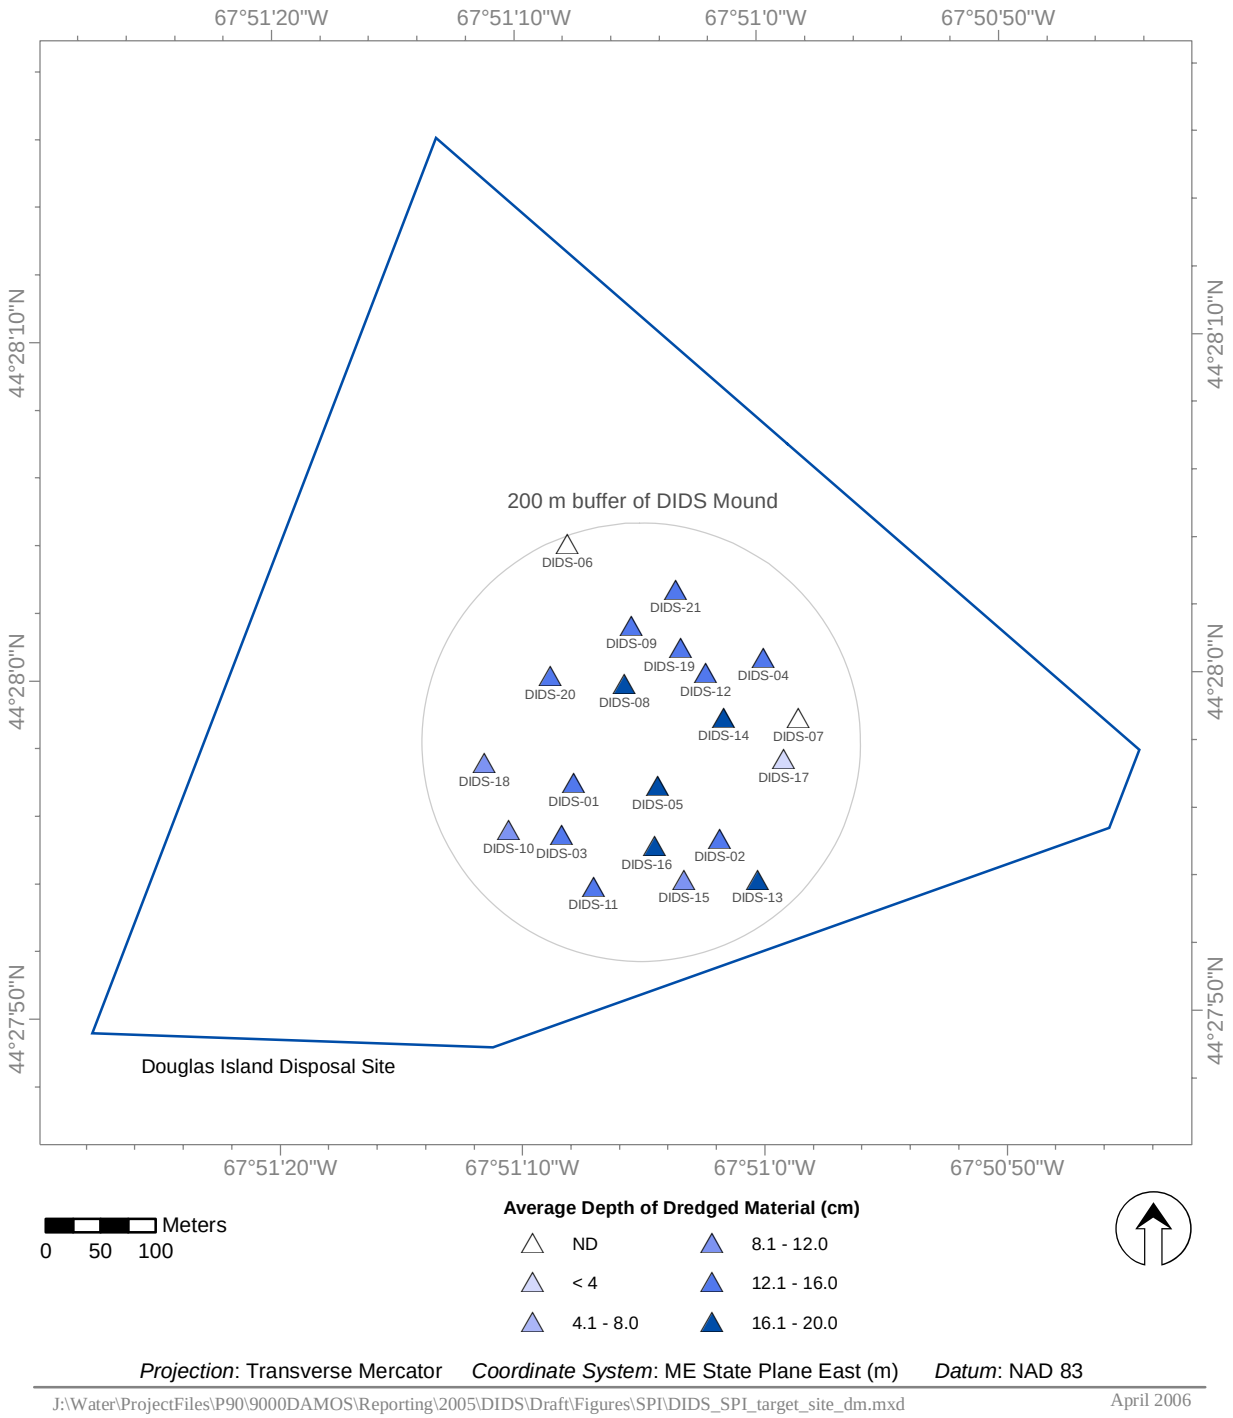
Figure 3-6. Distribution of dredged material thickness (cm) as detected by sediment-profile imaging at the Douglas Island Disposal Site; dredged material was thicker than camera prism penetration at most stations surveyed

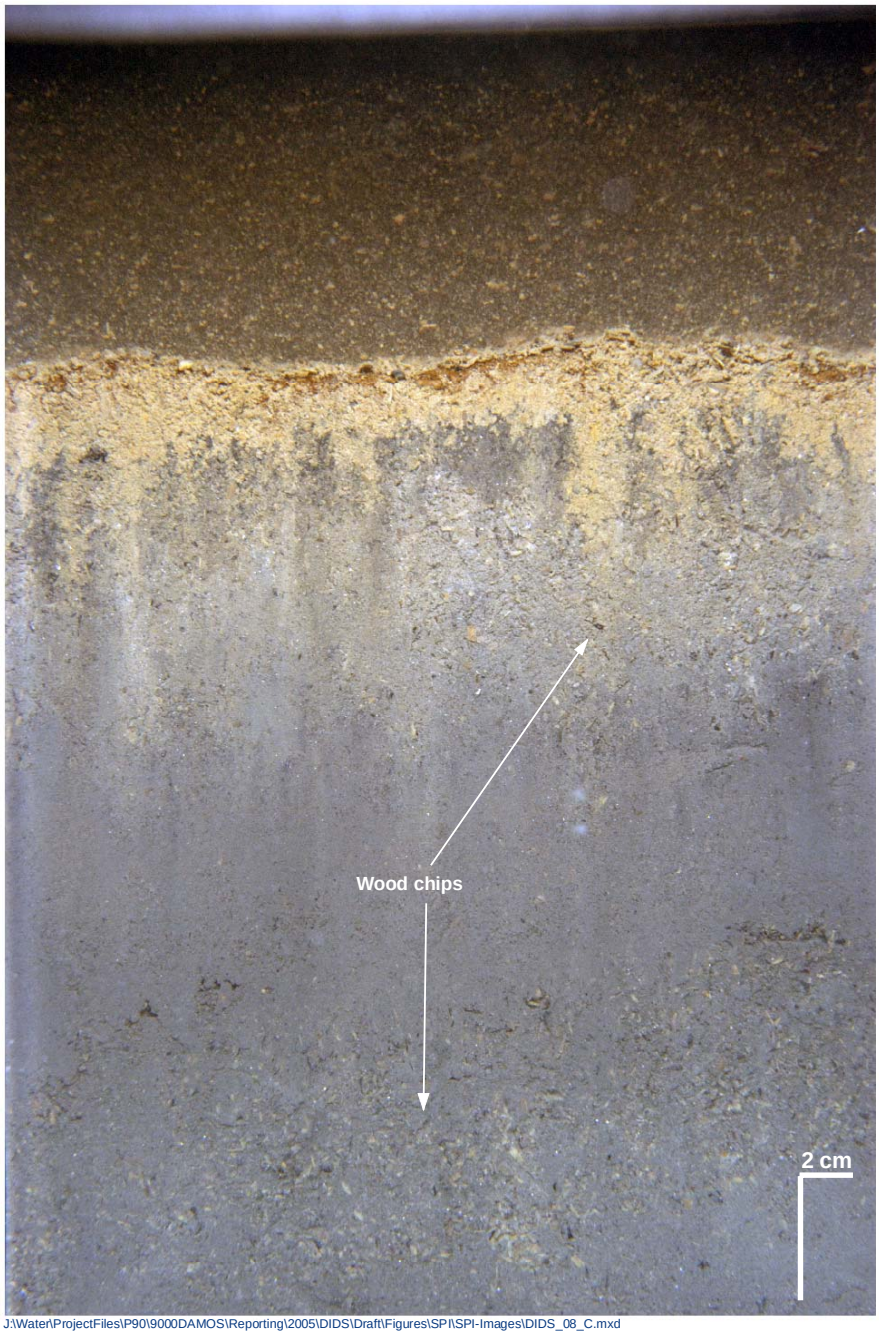
Figure 3-7. Evidence of wood chips in sediments from the Narraguagus River can be seen just below the oxidized surface layer as well as at depth (arrows) in this sediment profile image from Station 8

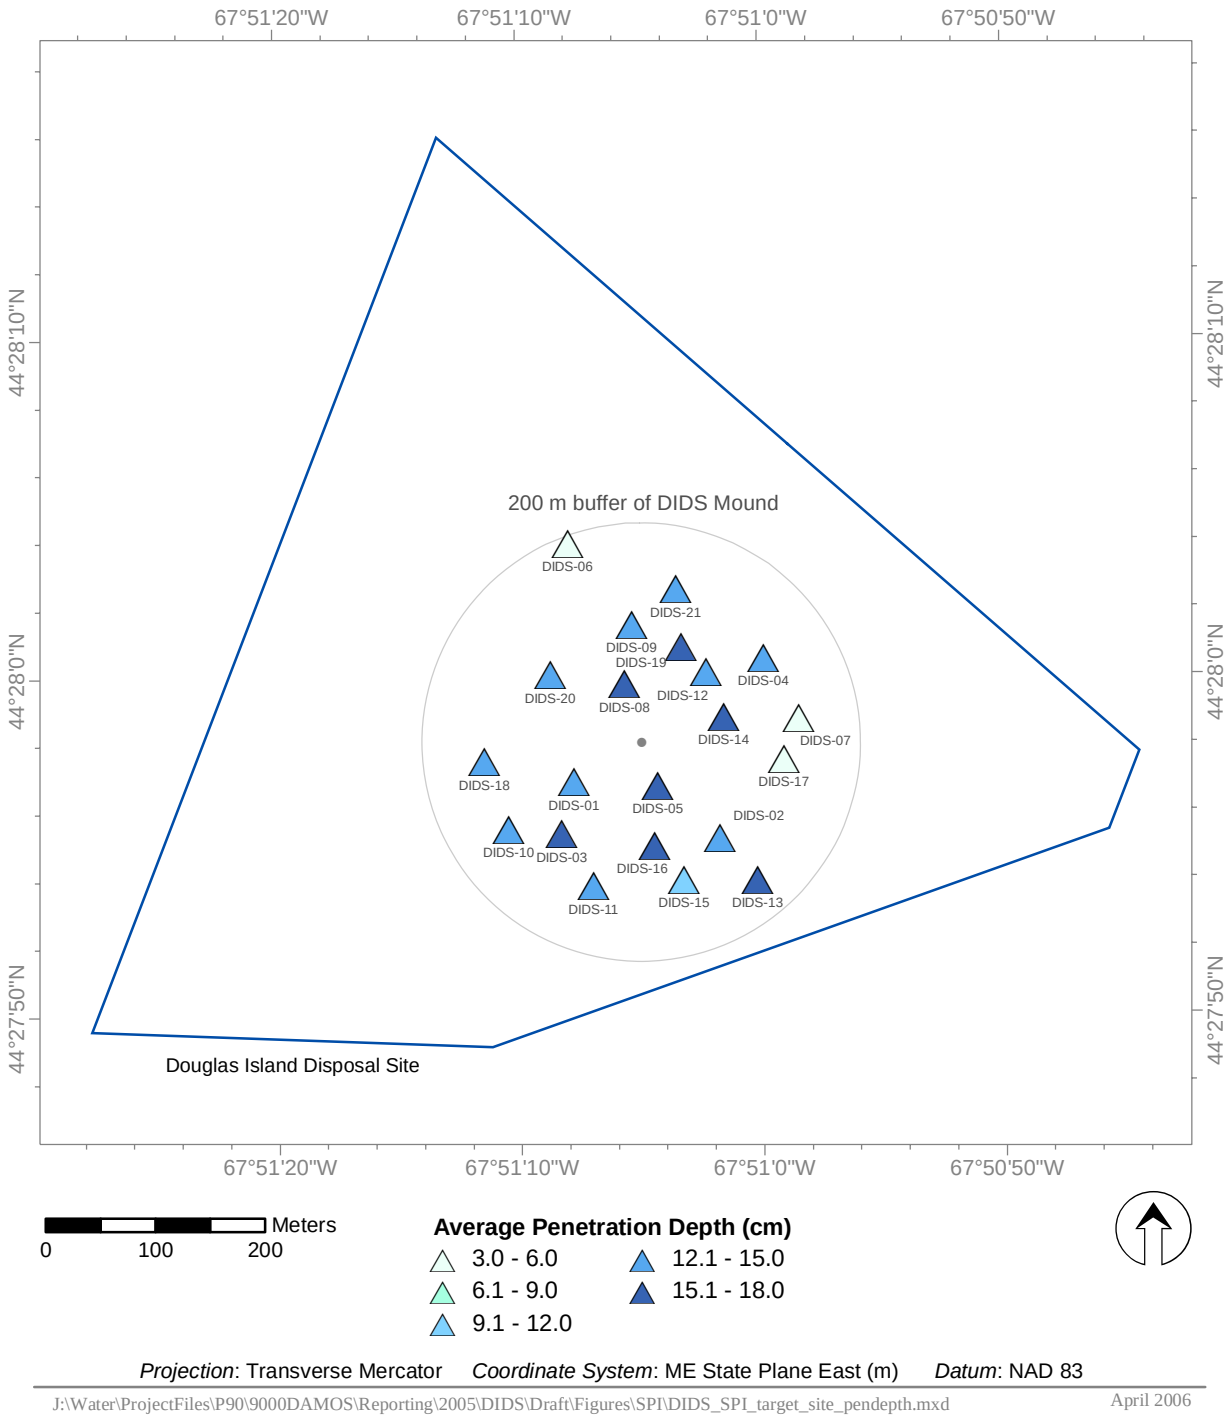
Figure 3-8. Distribution of mean camera prism penetration depths (cm) at the Douglas Island Disposal Site

Average prism penetration ranged between 3.2 to 17.8 cm at stations within the disposal site, with an overall site average penetration of 13.2 cm (Table 3-1, Figure 3-8); not surprisingly, the shallowest penetration values were found at the stations with the highest sand fractions. Small scale surface boundary roughness values ranged from 0.7 to 3.9 cm, with an overall site average of 1.5 cm; the majority (70%) of the small-scale topographic roughness elements were due to biogenic feeding pits and mounds (Appendix A). No stations exhibited any evidence of low dissolved oxygen in the overlying water or signs of methane in the subsurface sediments.

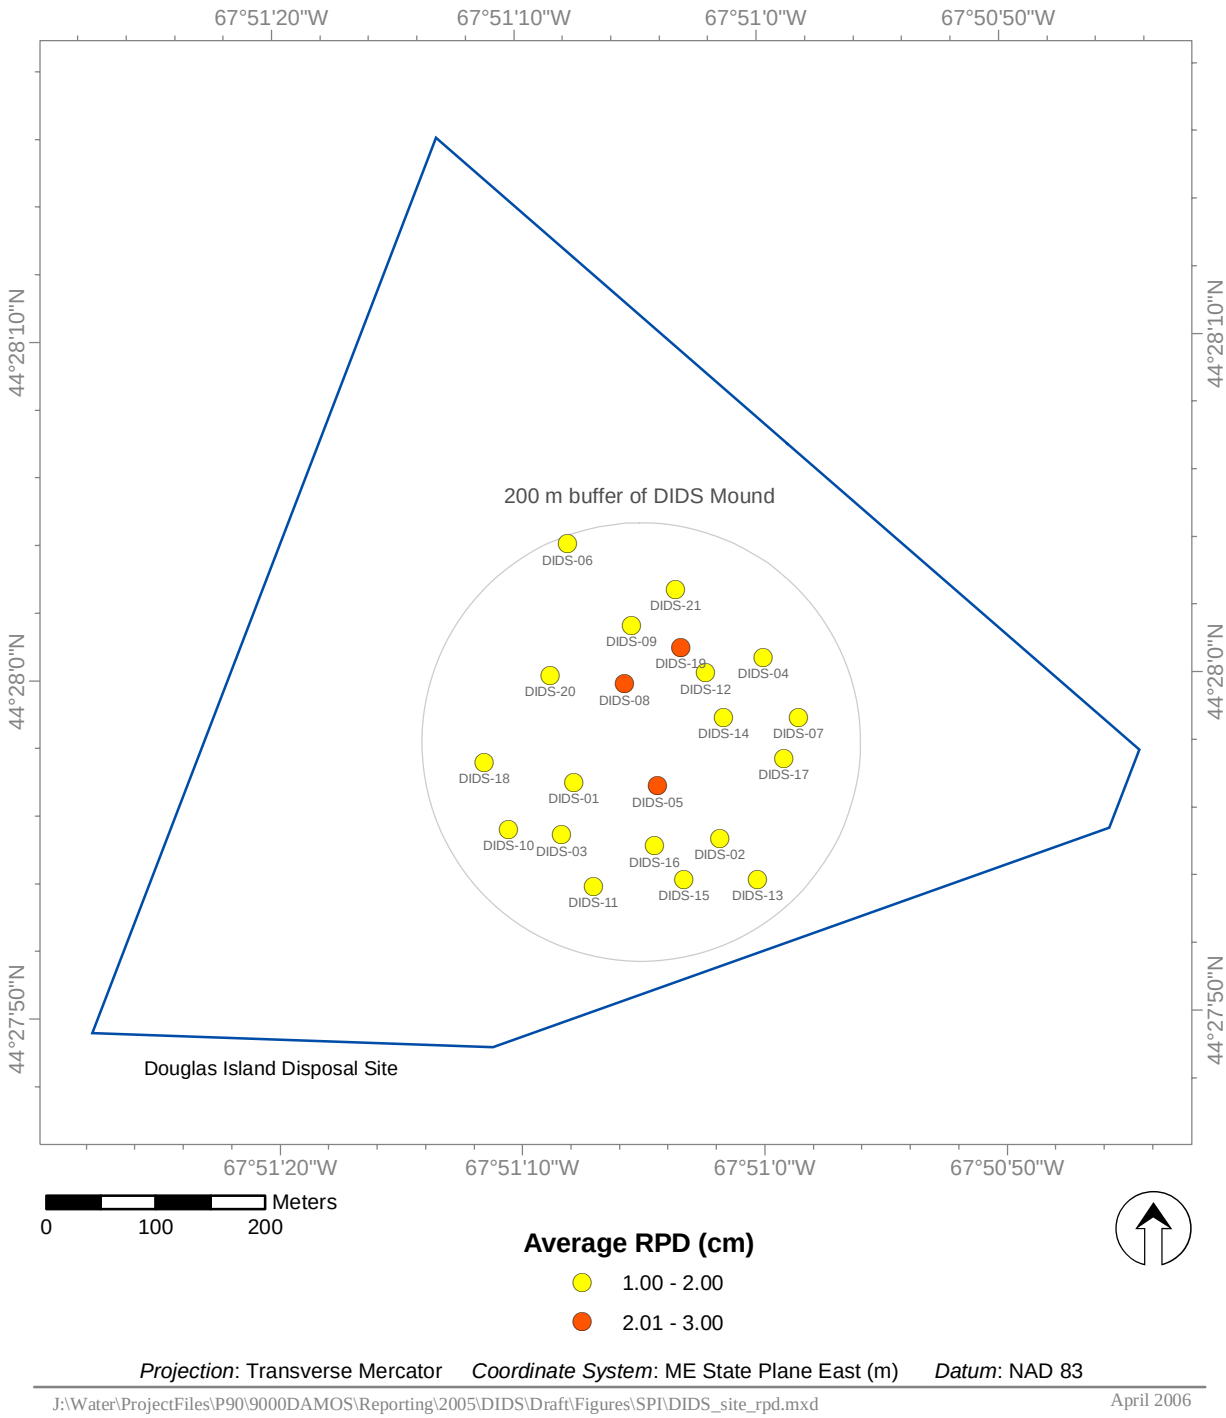
Figure 3-9. Distribution of mean apparent RPD values (cm) at the Douglas Island Disposal Site

The mean apparent RPD values measured at this mound ranged from 1.2 to 2.2 cm, with an overall mound-averaged depth of 1.7 cm (Table 3-1; Figure 3-9). Evidence of mature, deposit-feeding benthic taxa was found at most stations within the disposal site (Figure 3-10, Figure 3-11); only two stations of the 21 sampled over the disposal mound did not have a well-developed community of Stage 3 taxa (head-down, deposit-feeding invertebrates) (Figure 3-10, Table 3-1).

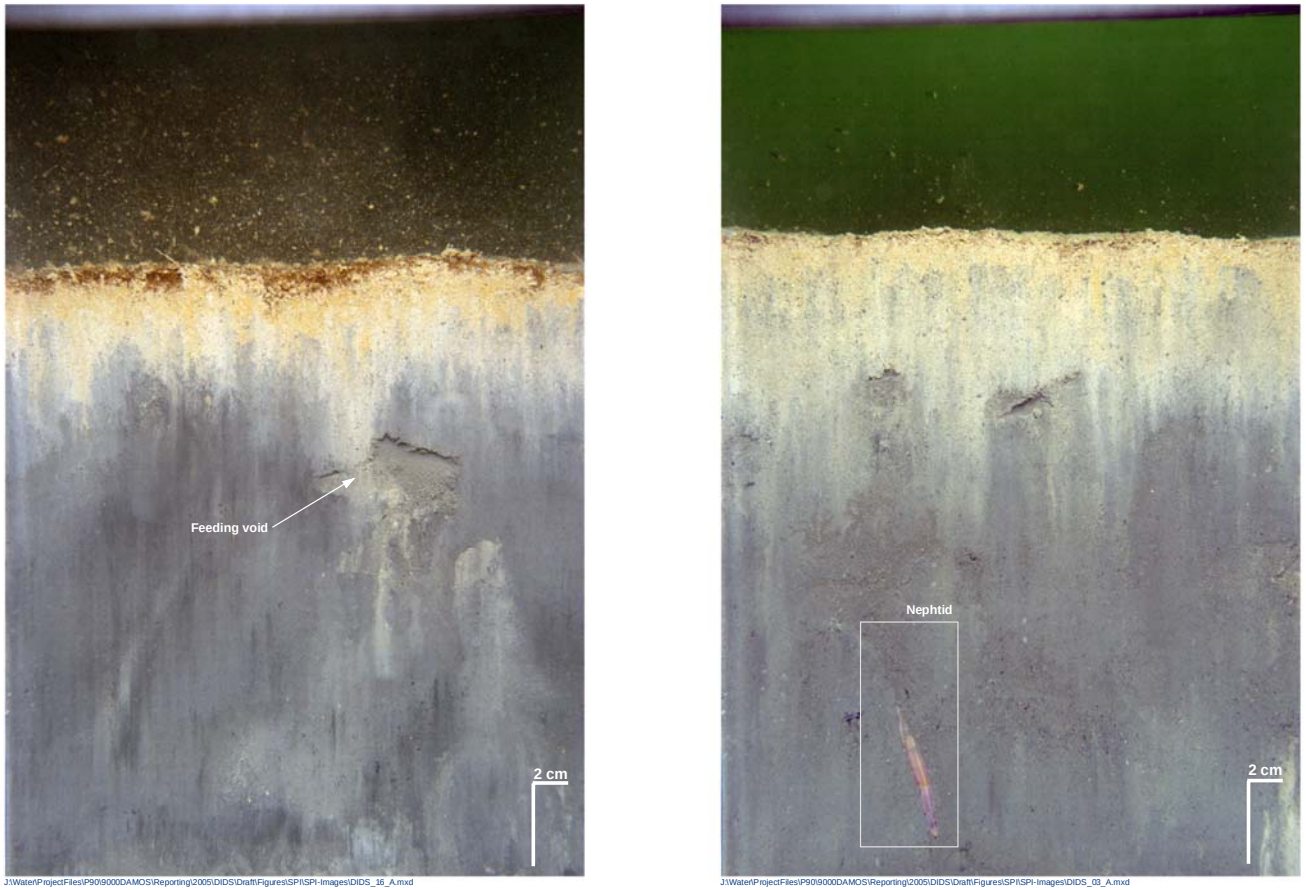
Figure 3-11. Evidence of Stage 3 taxa could be seen at the majority of stations on the dredged material mound, either in the form of sub-surface feeding voids as seen in this image from Station 16 (left), or an image of the actual organism, as seen in this image from Station 3 (right) showing a large nephtid against the camera faceplate

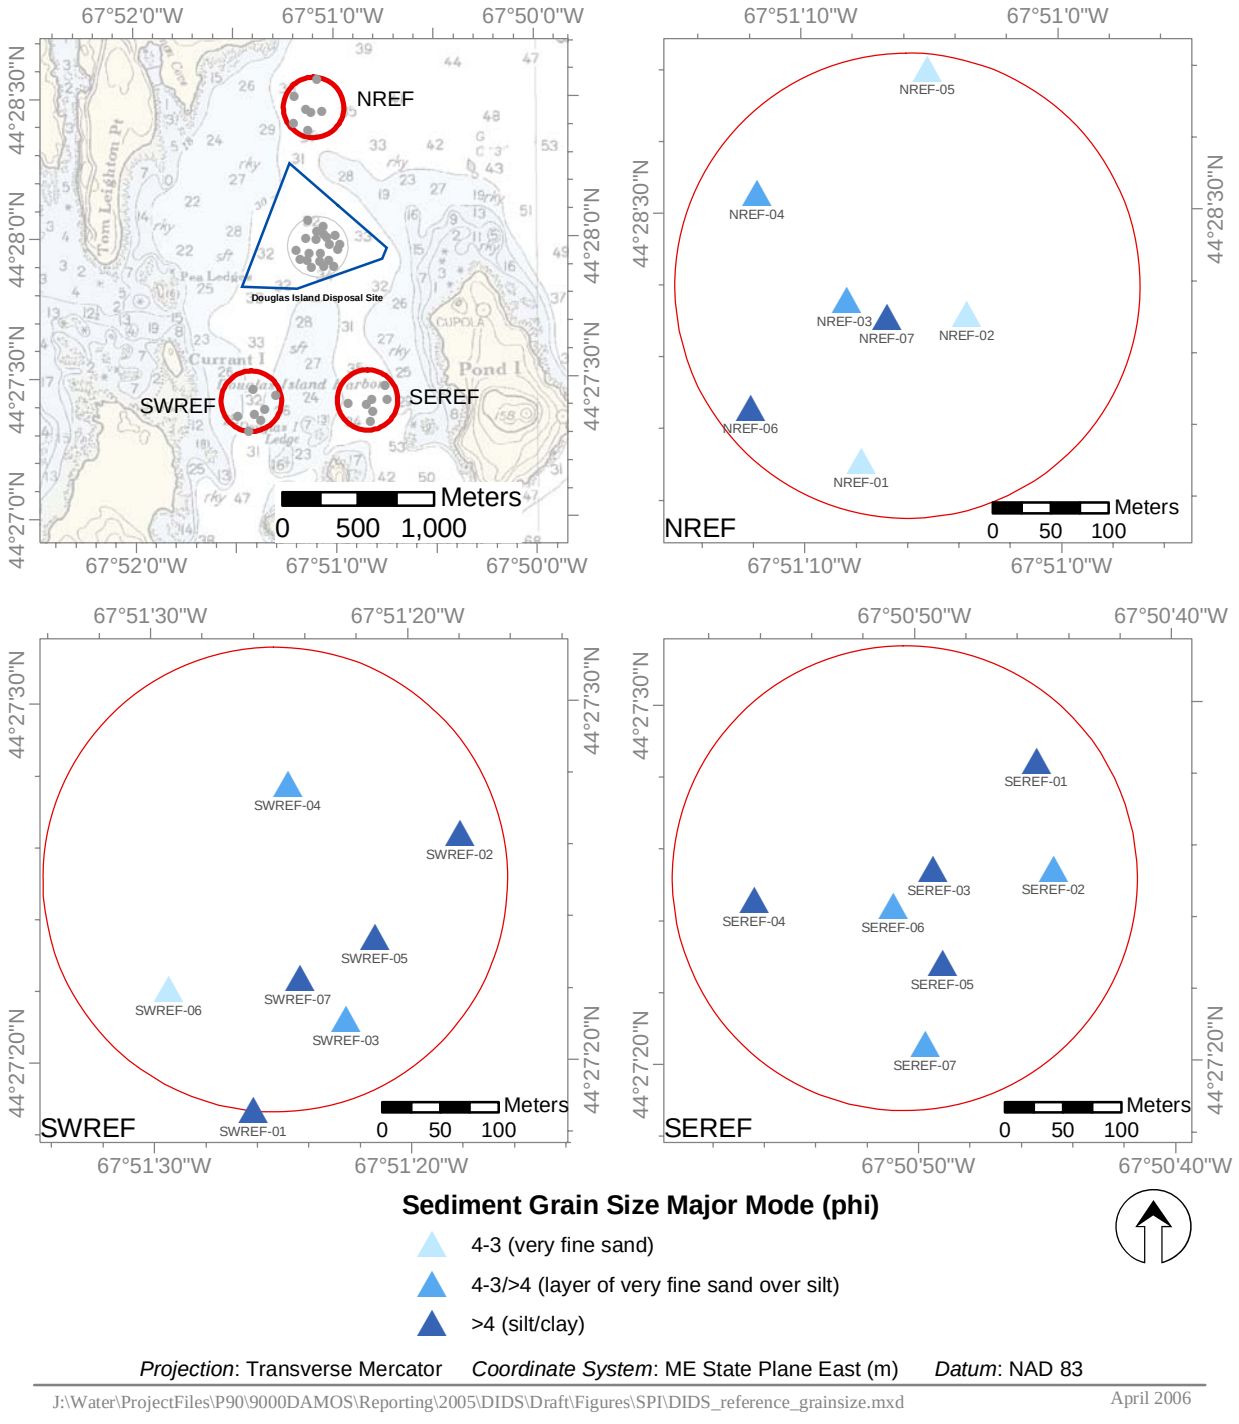
Figure 3-12. Distribution of sediment grain-size major mode (phi units) at the Douglas Island reference areas

The sediments at the three reference areas were much more variable in grain-size than those at the disposal site (Figure 3-12). Sediment grain-size major mode on the ambient seafloor outside the disposal site (as characterized by the surveyed reference stations) ranged from silt/clay to very fine sand, with transitional areas (layers of very fine sand over mud) interspersed. Evidence of past sediment transport events could be seen in the profile images with alternating layers of fine sand and mud (Figure 3-13). There was no evidence of dredged material at any of the reference stations.

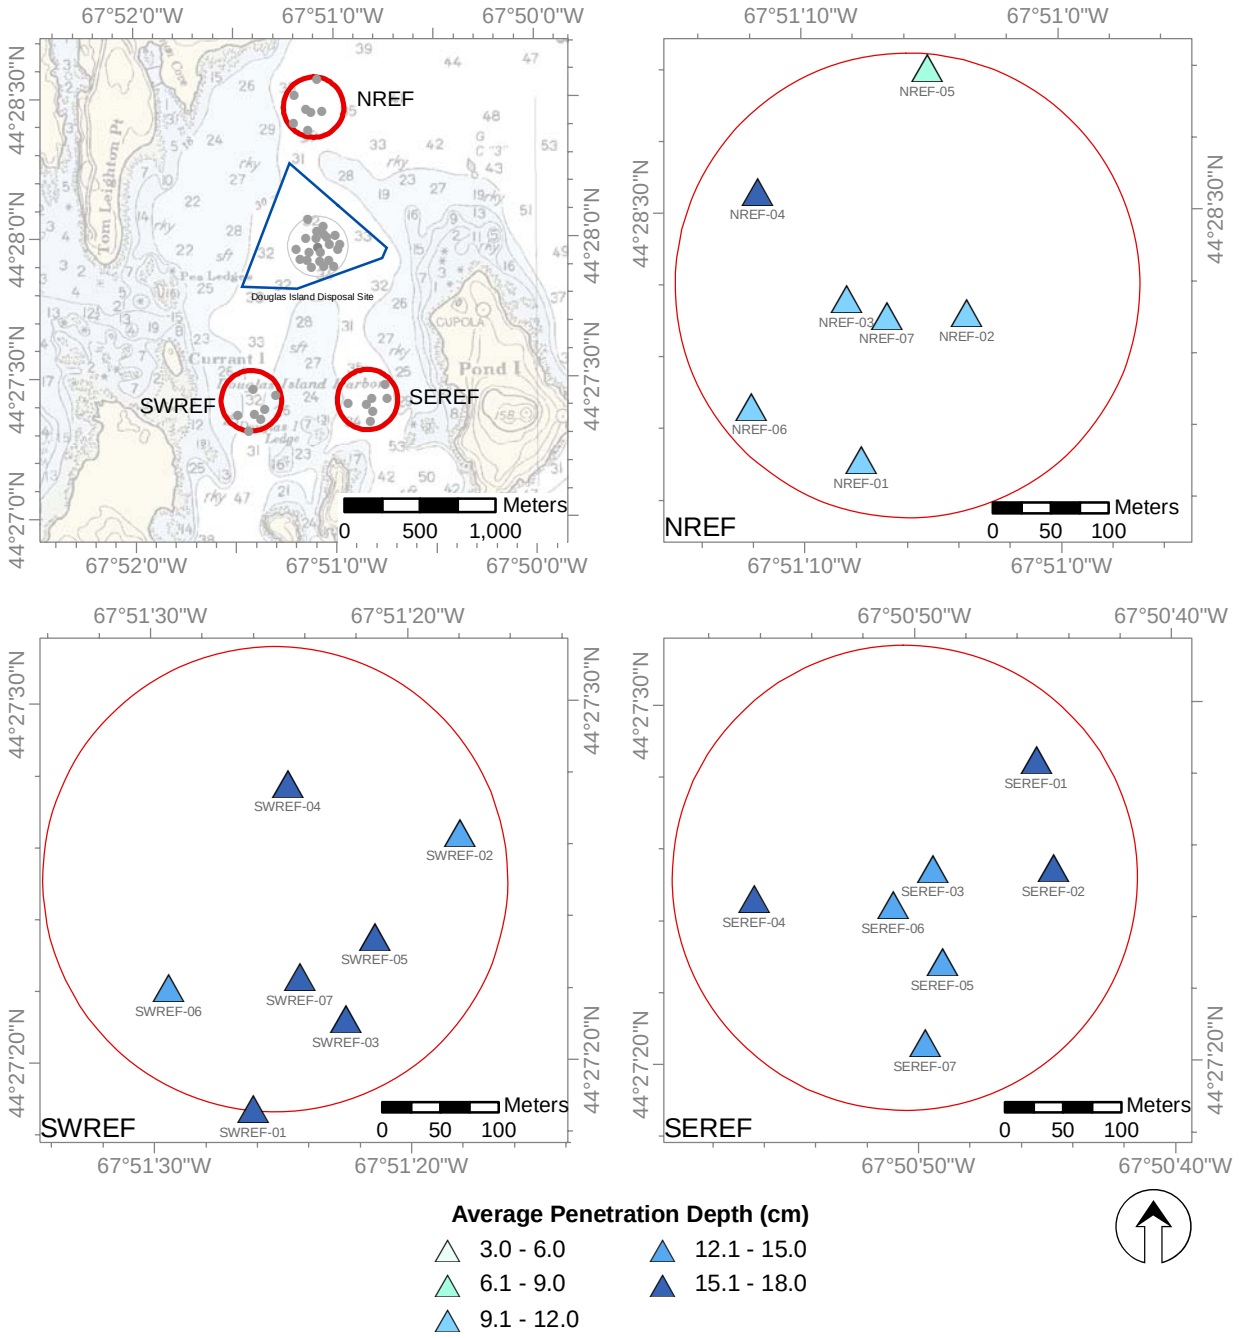
Figure 3-14. Distribution of mean camera prism penetration depths (cm) at the Douglas Island reference areas

Camera prism penetration ranged from 8.4 – 17.5 cm, with an overall reference area average penetration of 13.8 cm (Table 3-2, Figure 3-14). Small scale surface boundary

roughness values ranged from 0.7 – 2.7 cm, with an overall site average of 1.3 cm; the majority (80%) of the small-scale topographic roughness elements were due to biogenic feeding pits and mounds (Appendix A). No stations exhibited any evidence of low dissolved oxygen in the overlying water or signs of methane in the subsurface sediments.

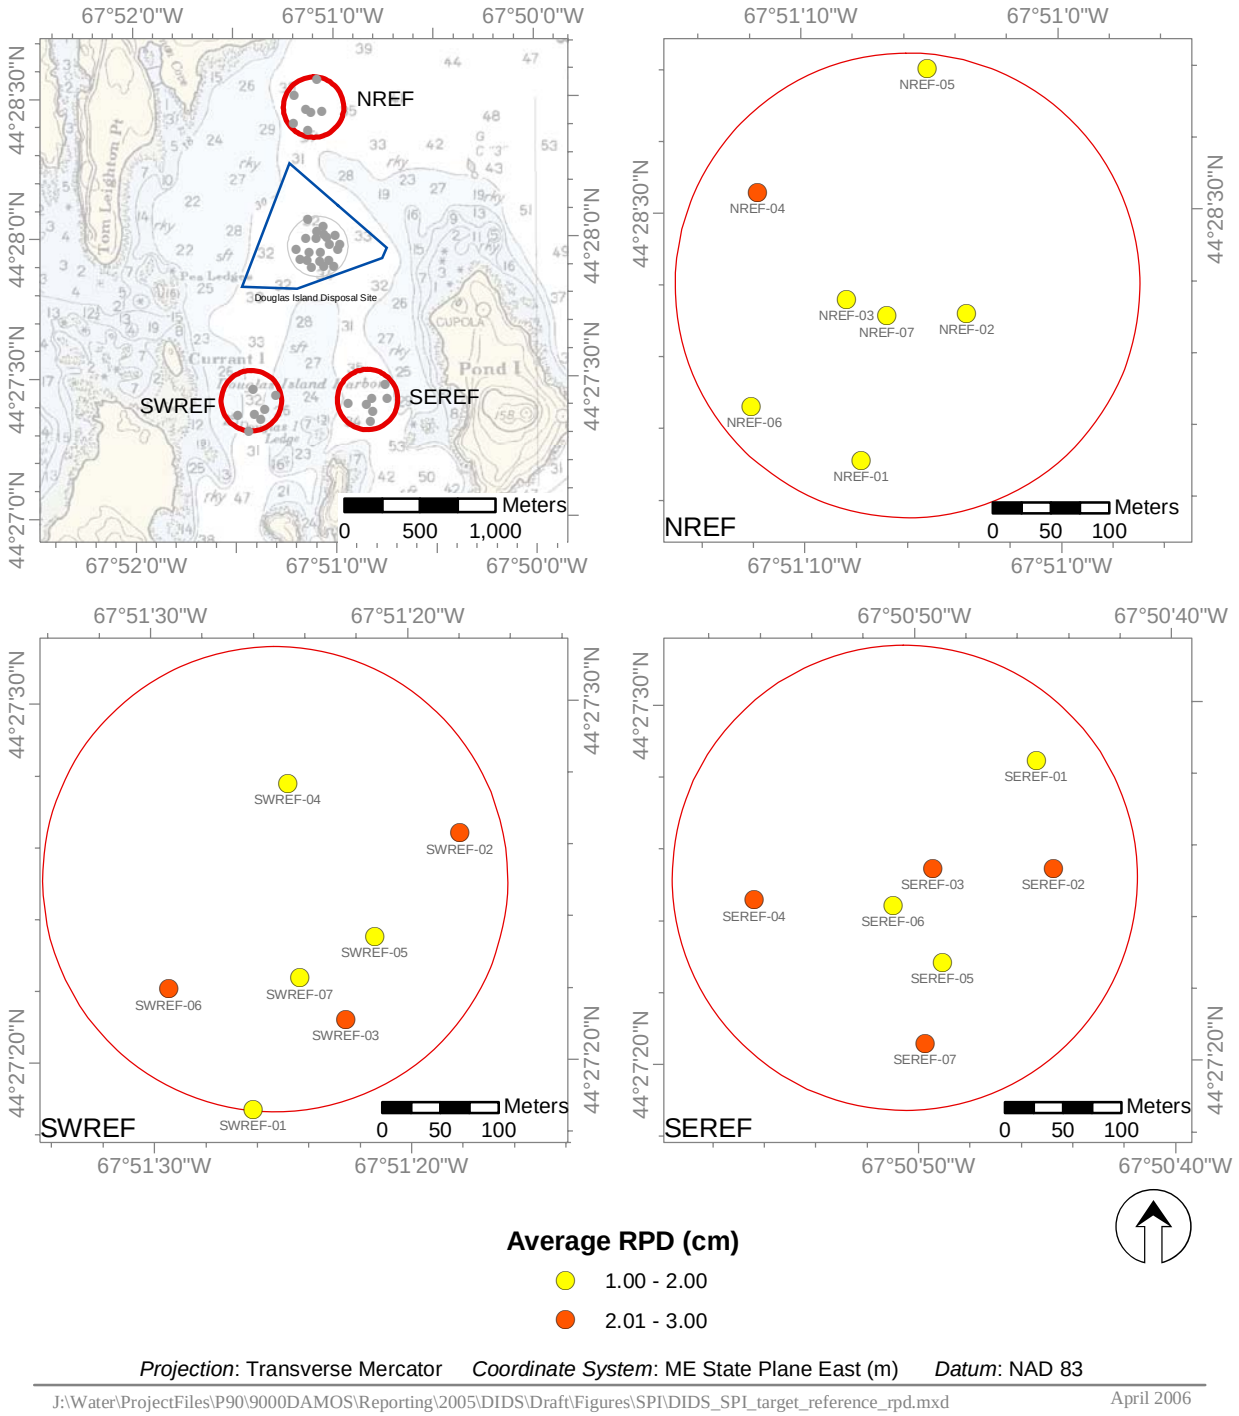
Figure 3-15. Distribution of mean apparent RPD values (cm) at the Douglas Island reference areas

The mean apparent RPD values measured at the reference areas ranged from 1.2 – 2.4 cm, with an overall mound-averaged depth of 1.8 cm (Table 3-2; Figure 3-15). Evidence of mature, deposit-feeding fauna (Stage 3 communities) was found in every replicate image from all 21 stations surveyed in the reference areas (Figure 3-16). The maximum depth of subsurface infaunal structures (feeding voids/burrows) ranged from 7.8 – 17.2 cm (Table 3-2); these structures often were present at the limit of the camera prism penetration depth (Figure 3-17), indicating that the resident infauna were most likely reworking the sediment at many locations even deeper than recorded in the profile images.
