Monitoring Survey at the Douglas Island Disposal Site
Outer Narraguagus Bay, Maine
April 2003 / April 2004 / September 2005

Disposal Area Monitoring System DAMOS

Contribution 173
June 2007

Report No.
ENSR-9000-383-400

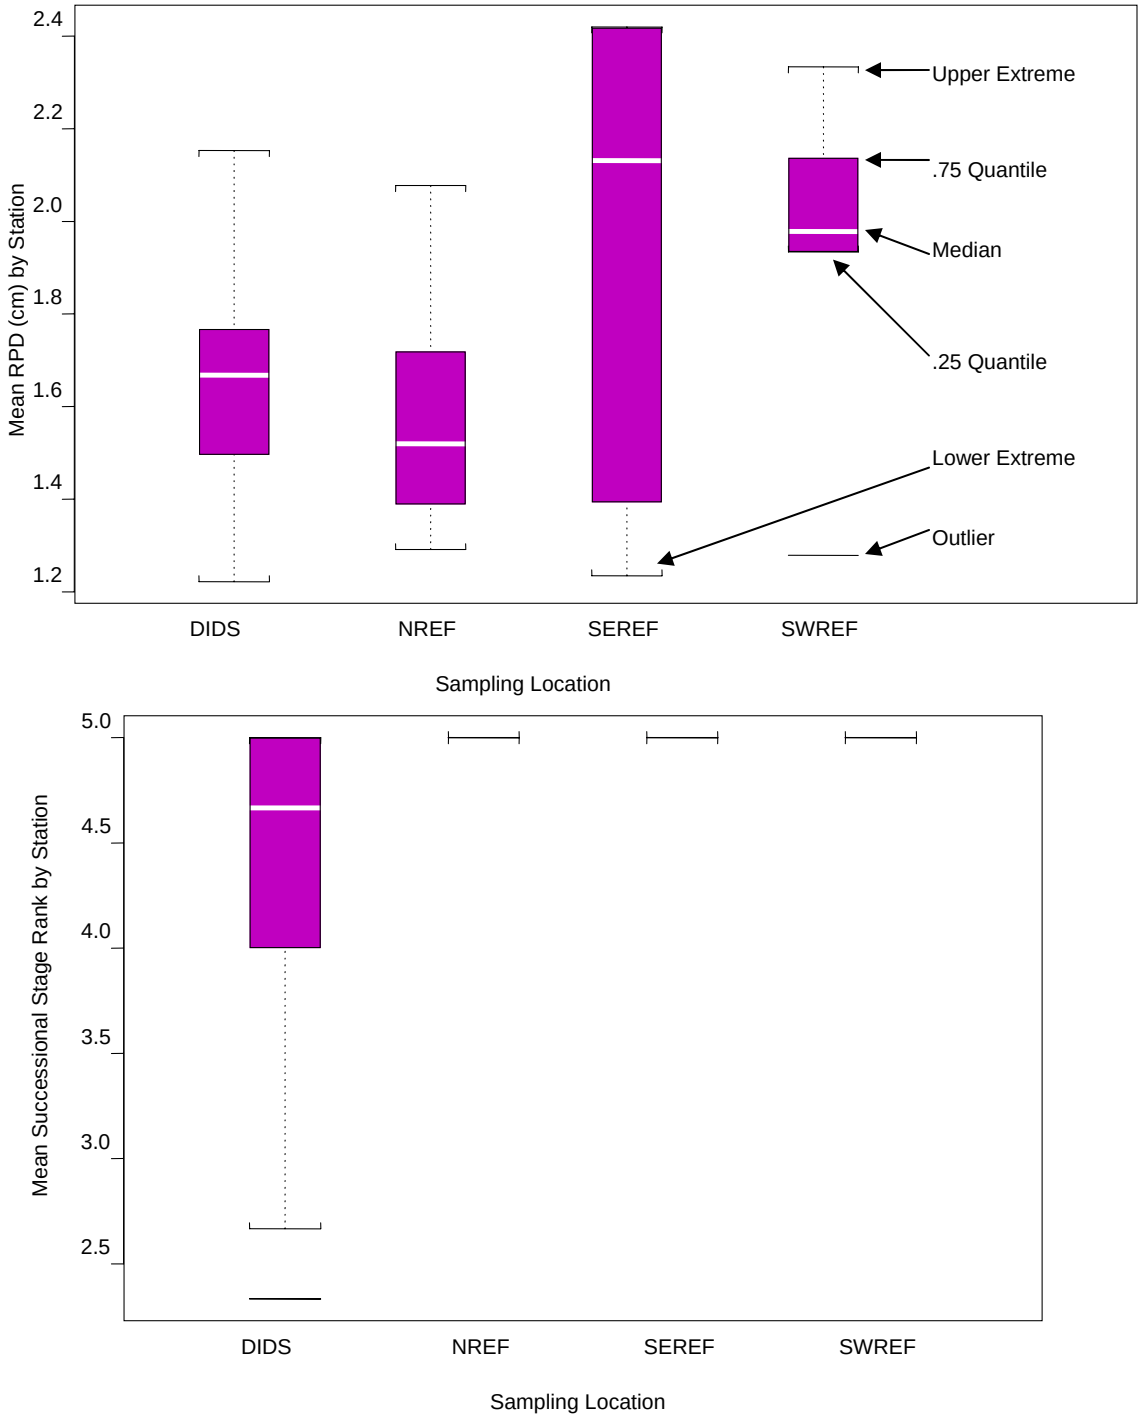
Figure 3-18. Boxplots showing distribution of station mean values for Douglas Island RPD values and successional stage rank

The three reference areas showed some differences in mean values (Table 3-3, Figure 3-18) with N Ref having a lower mean than the other two. The maximum difference among reference locations was 0.37 (1.96 – 1.59), which is within the noise for these data as it is less than one standard deviation of the reference areas (0.39). The difference was minor, but the reference areas were included separately in the following analysis.

The three reference areas were identical with all stations displaying successional stage rank values of 5 (Table 3-3, Figure 3-18). With no variance among reference stations, the confidence interval for the bioequivalence test was determined exclusively by the variance among mound stations. The assumption of normality for the mound stations was rejected by the Shapiro-Wilk's test (p = 0.0003). A normalizing transformation could not be found for these left-skewed data. A non-parametric confidence interval was constructed on the difference between 5 (the reference mean, with no variance) and the mound mean using a bootstrap-t interval (Manly, 1997 pp. 56 – 59). (See bootstrap methods in Appendix B)

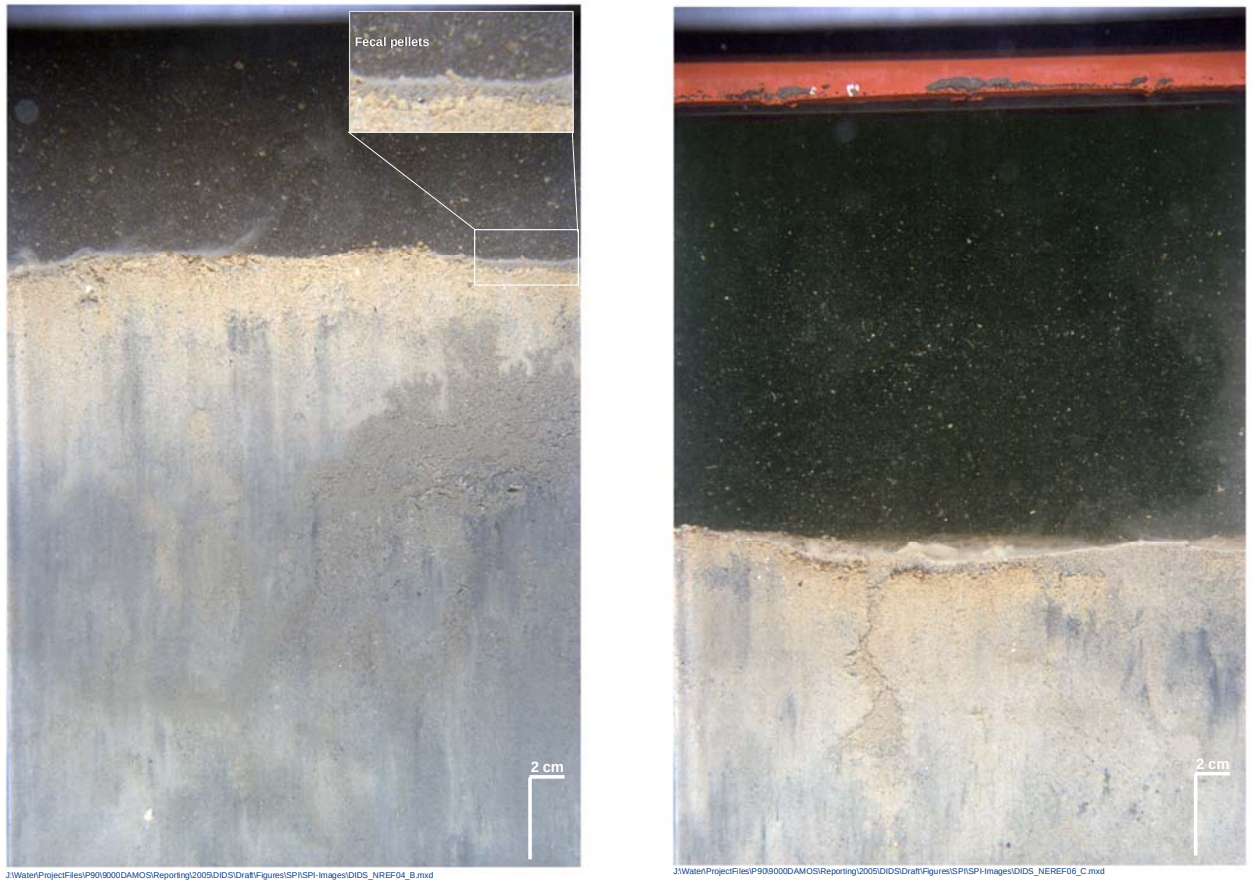
Figure 4-2. Evidence of subsurface particle advection by infaunal deposit feeders can be seen in the form of a layer of reduced fecal pellets and particles at the sediment surface in these profile images from Station NREF 04 (left) and NREF 06 (right).
