INTERIM SURVEY OF WESTERN LONG ISLAND SOUND III DISPOSAL SITE

CONTRIBUTION #18

May 17, 1982

CONTRACT #DACW33-82-D-0001

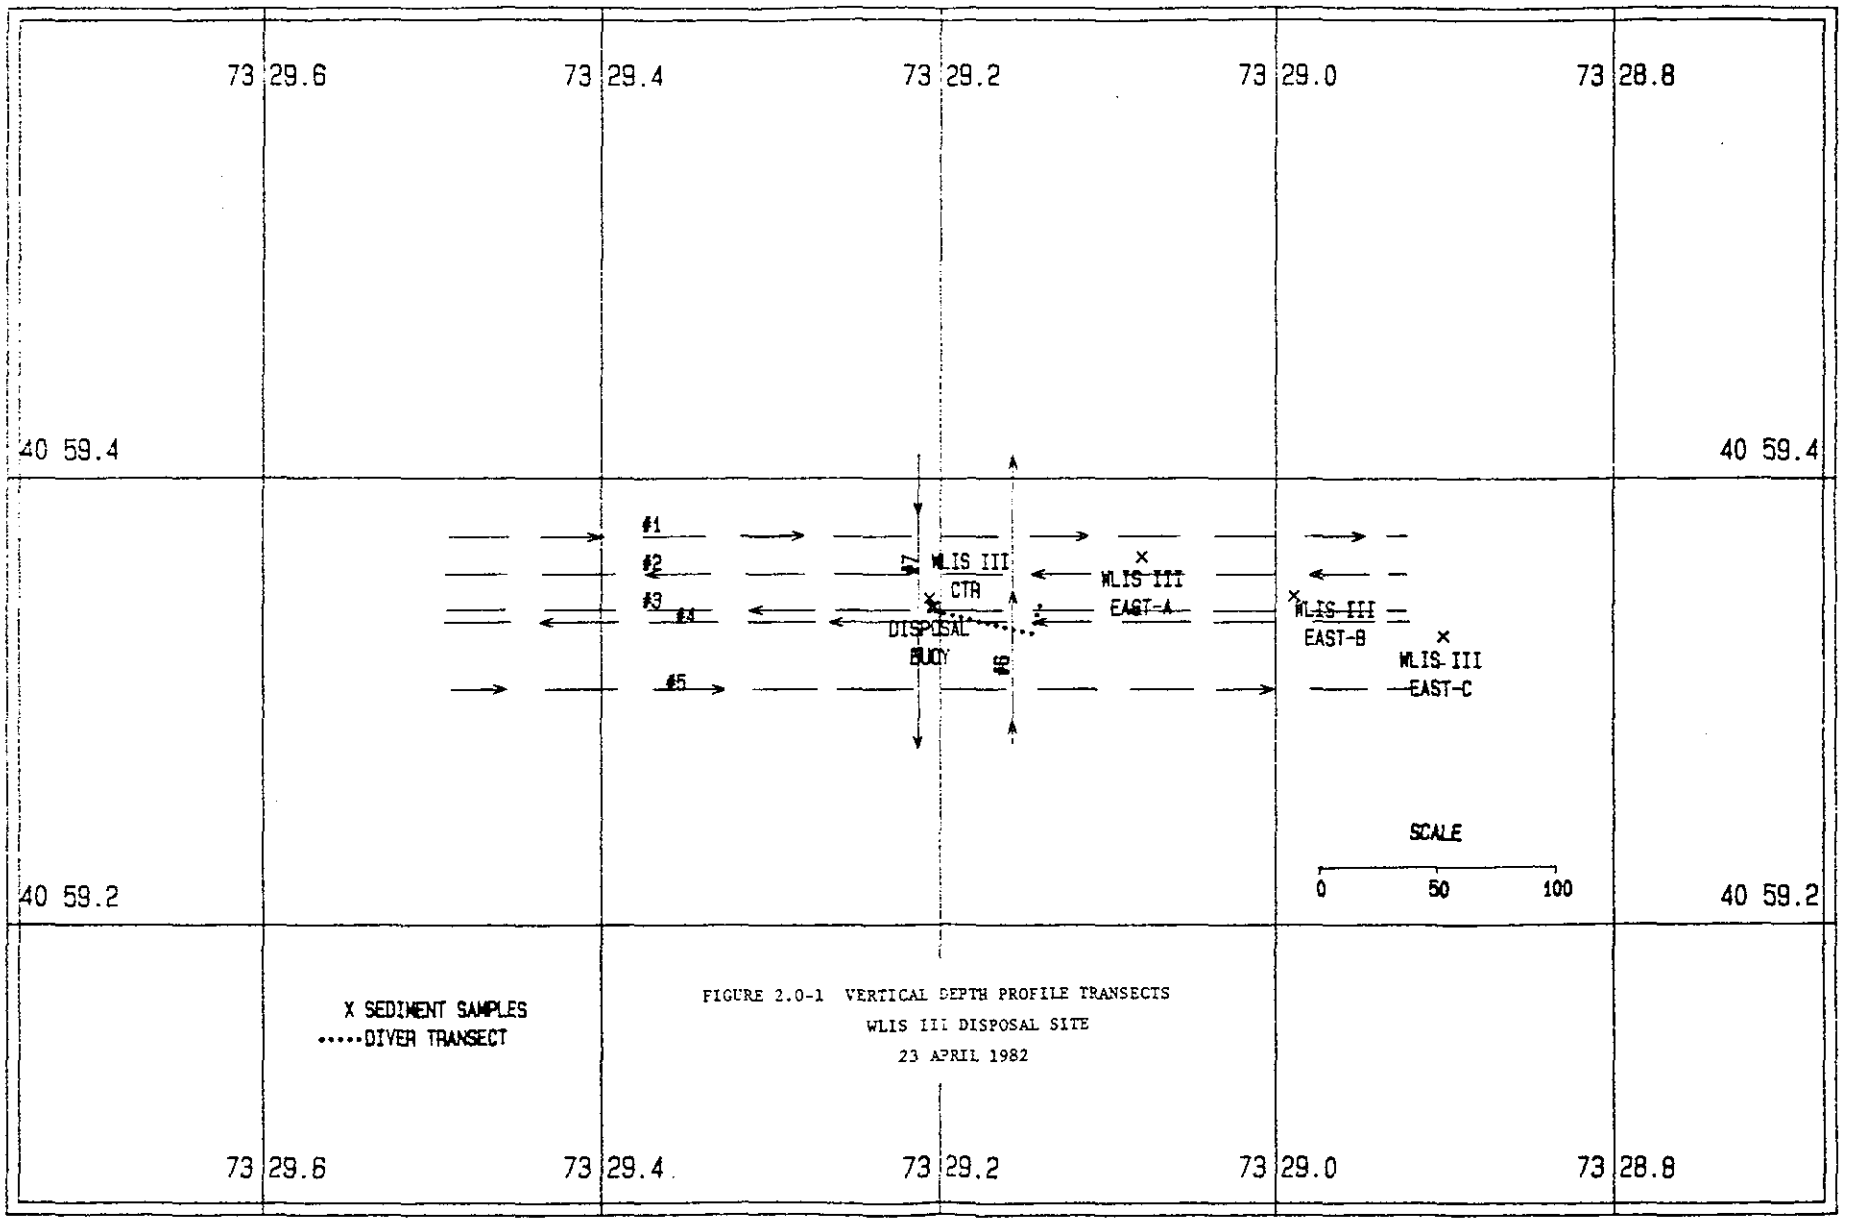
FIGURE 2.0-1 VERTICAL DEPTH PROFILE TRANSECTS
WLIS III DISPOSAL SITE
23 APRIL 1982

A series of vertical depth profiles were made in the vicinity of the disposal buoy consisting of five east-west transects and two north-south transects as shown in Figure 2.0-1. Navigation control was provided by calibrated Loran-C and depth measurements were made with the 24 KHz EDO fathometer used on all DAMOS surveys. The transects ranged approximately 400 meters east and west of the disposal buoy at distances north and south of the buoy as follows:

Profile	1	50m north
	2	20m north
	3	10m south
	4	20m south
	5	75m south

The two north south profiles were made 10 meters west and 70 meters east of the buoy.

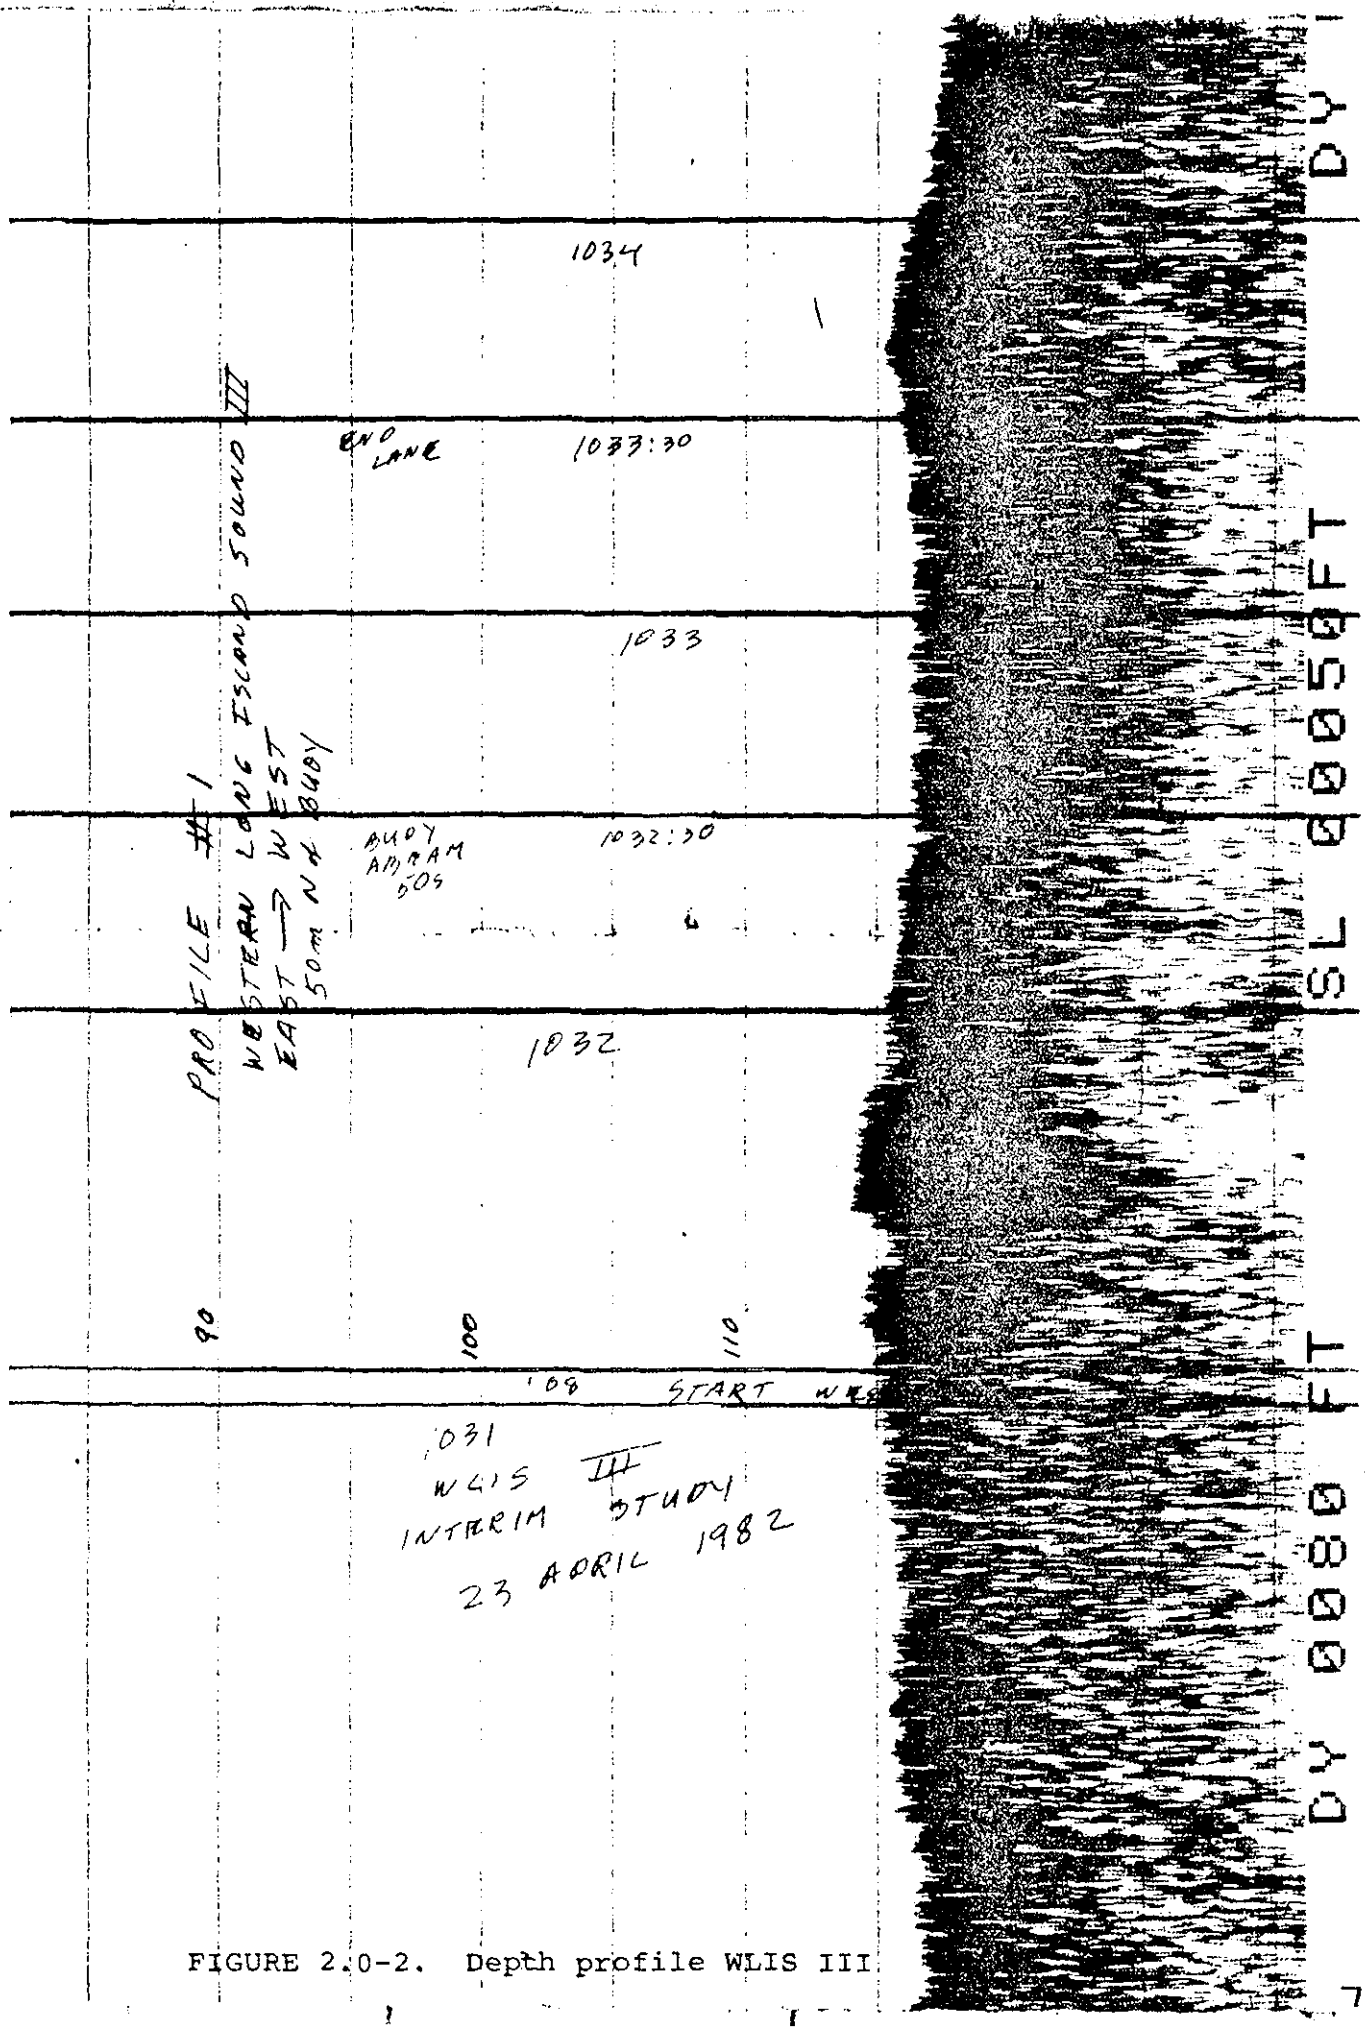
FIGURE 2.0-2. Depth profile WLIS III

Results of the profile measurements are presented in Figures 2.0-2 through 2.0-8. In general, the data indicate that the dredged material has formed a distinct mound immediately south and east of the disposal buoy with maximum thickness approaching 4 meters on profile 3. The mound has a radius of approximately 100 meters in the east west direction, and somewhat less than 50 meters in the north south direction.

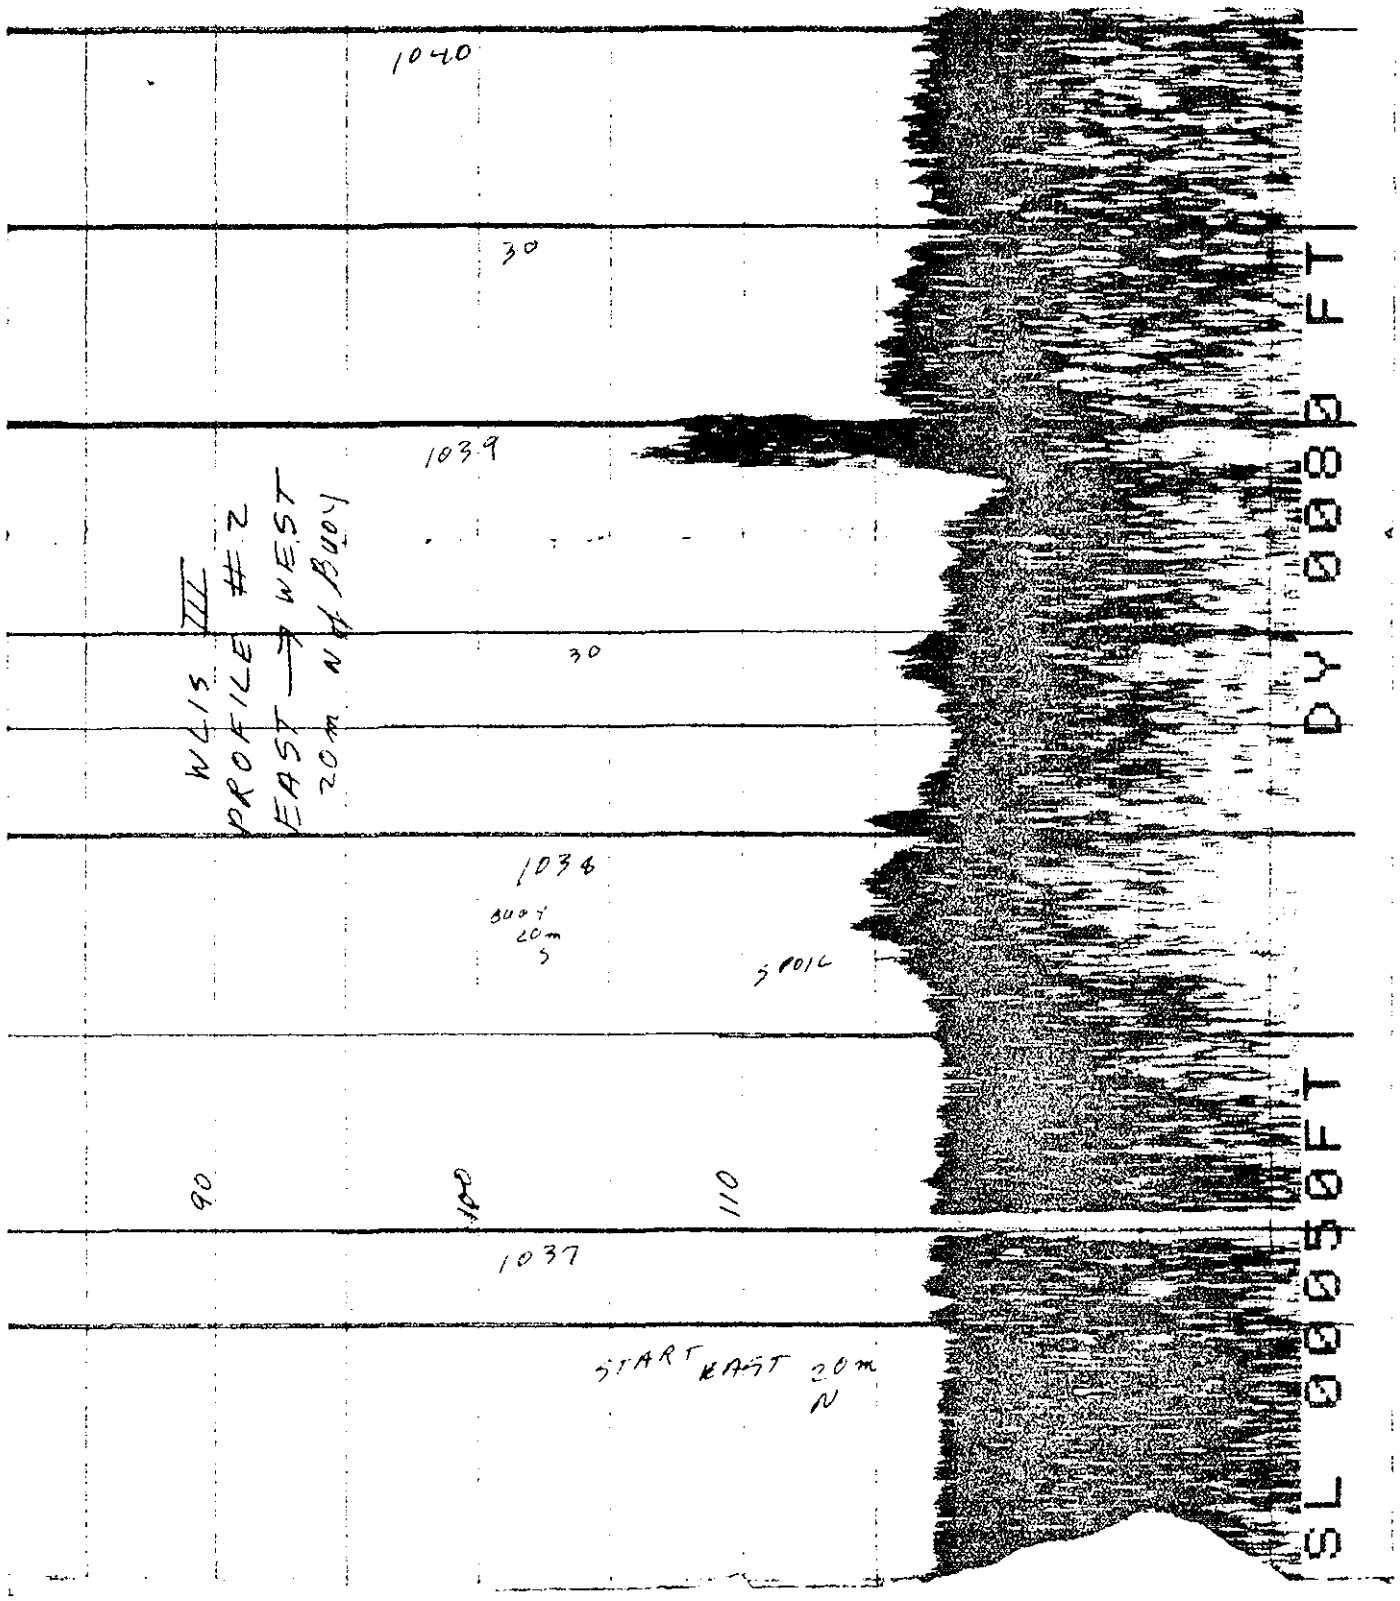
FIGURE 2.0-3. Depth profile WLIS III

An interesting feature was observed in Profile 2 (Fig. 2.0-3) approximately 200m east of the buoy. This feature is approximately 5 meters high, but shows vertical sides indicating it may be a wreck or other man made object. Side scan or diver observations will be used to investigate this formation during a future survey.

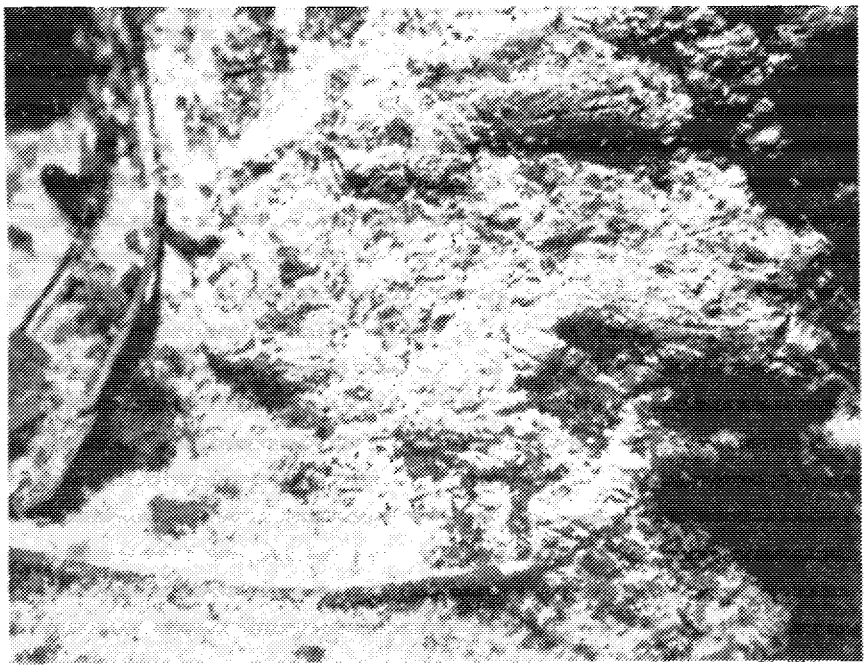
Fig. 1.

Figure 1. Surface texture typical of cohesive clay mound protruding from soft interspace dredge material. Note evidence of Zostera blades at base and to lee of mound. Horizontal Field of View (HFV) = 9 cm.

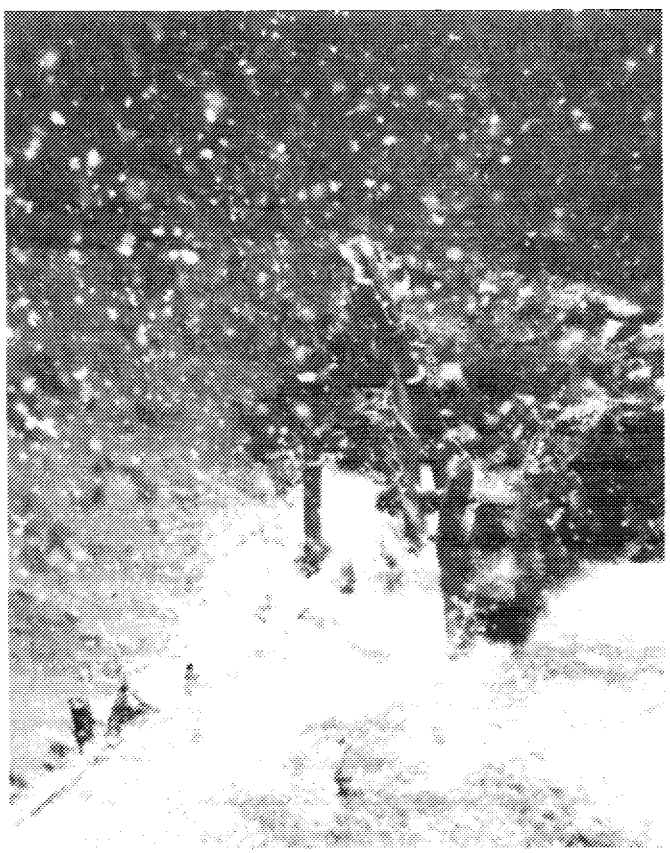
Fig. 2.

Figure 2. Marsh reed, Phragmites, stalks incorporated in clay material, peat fragments, and high organic debris were characteristics of the disposal pile. HFV = 7 cm.

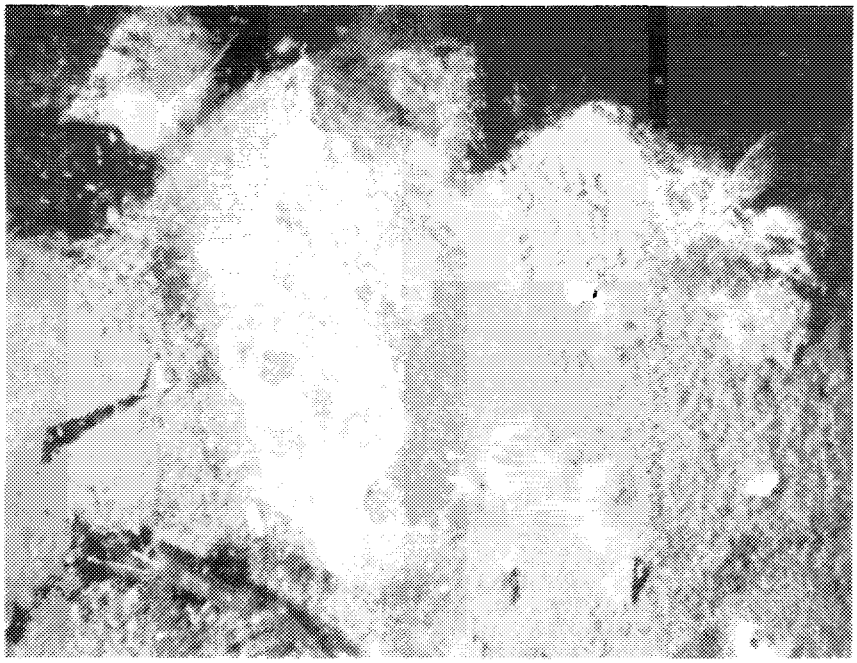
Fig. 3.

Figure 3. Faceted clay surfaces provide entrapment crevices for nephaloid layer material. Two Nassarius graze the upper mound surface. A Mercenaria valve shows in left background. HFV = 20 cm.

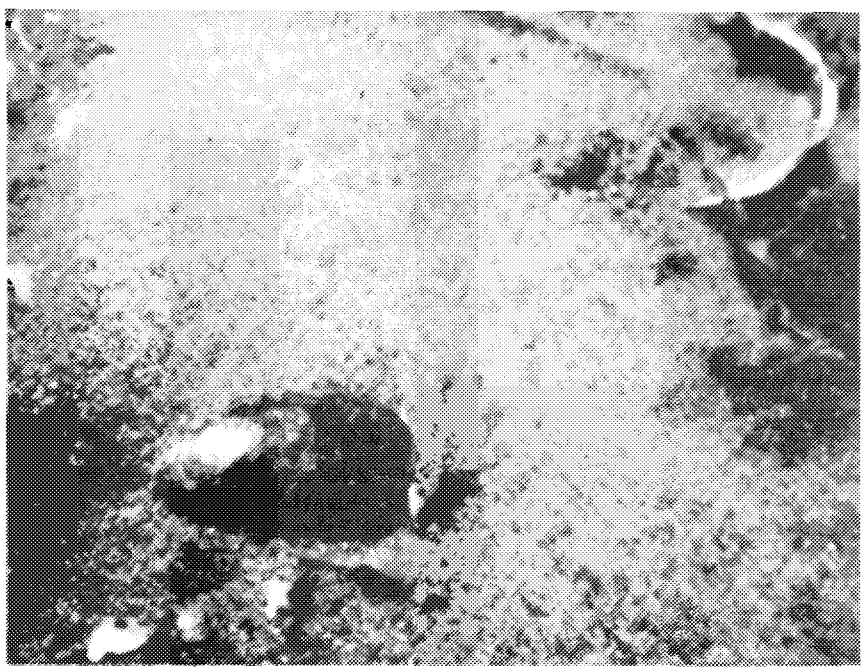
Fig. 4.

Figure 4. Granular, flocculant nature of natural nephaloid layer is illustrated in close-up photo within depression zones of spoil surface. HFV = 12 cm.

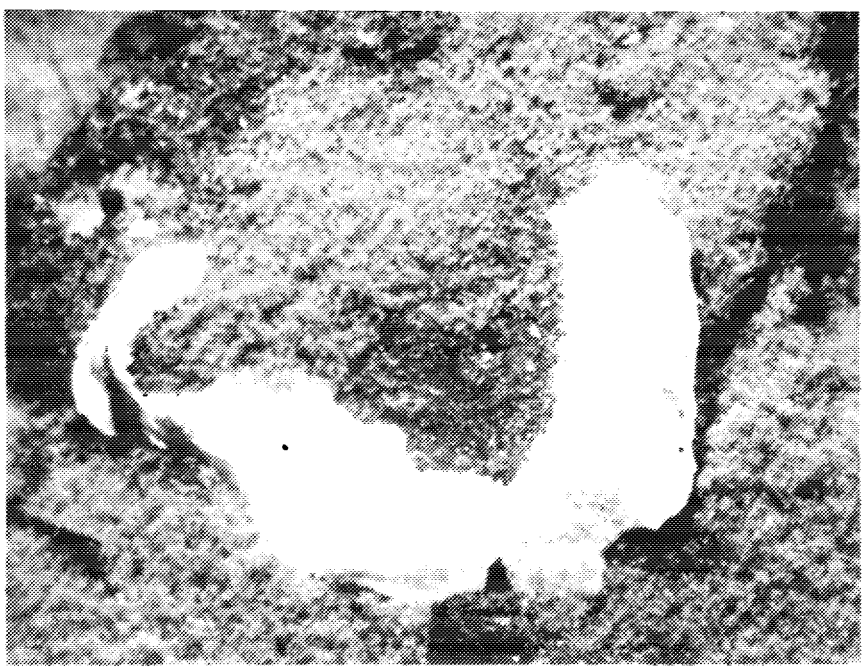
Fig. 6.

Figure 6. Shell fragments were often bleached white and did not reveal discolorations indicative of origin from H_2S or petroleum contaminate zones. The overlay of the light-brown nephaloid veneer is evident in this photo, as in previous prints. HFV = 7 cm.

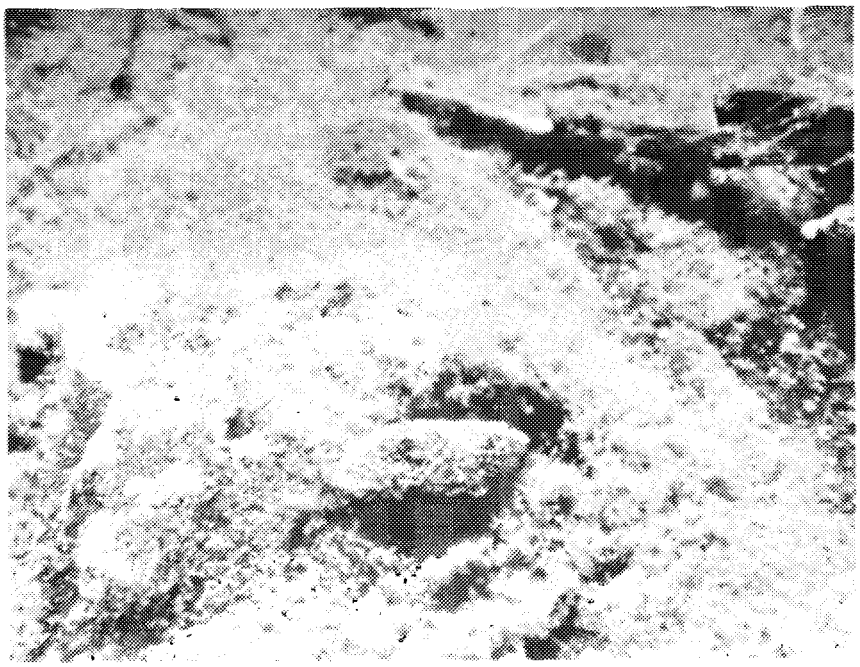
Fig. 7.

Figure 7. Typical dredge sediment surface conditions - small clay clusters, marsh vegetation, Nassarius presence, and the natural suspension nephaloid layer. HFV - 10 cm.

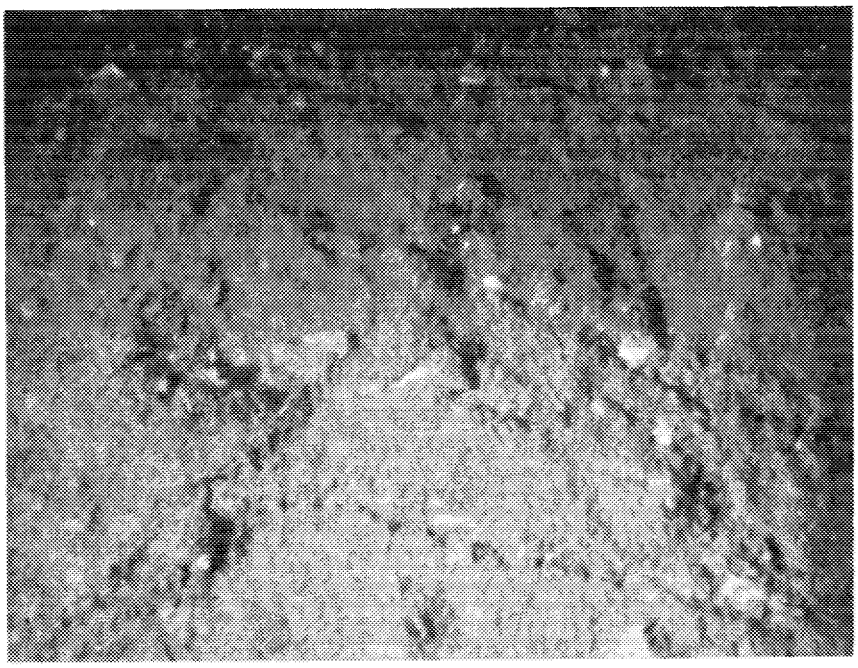
Fig. 9.

Figure 9. Numerous contagious concentrations of Nassarius and Mulinia valve patches were typical of natural bottom along the border region. HFV = 25 cm.

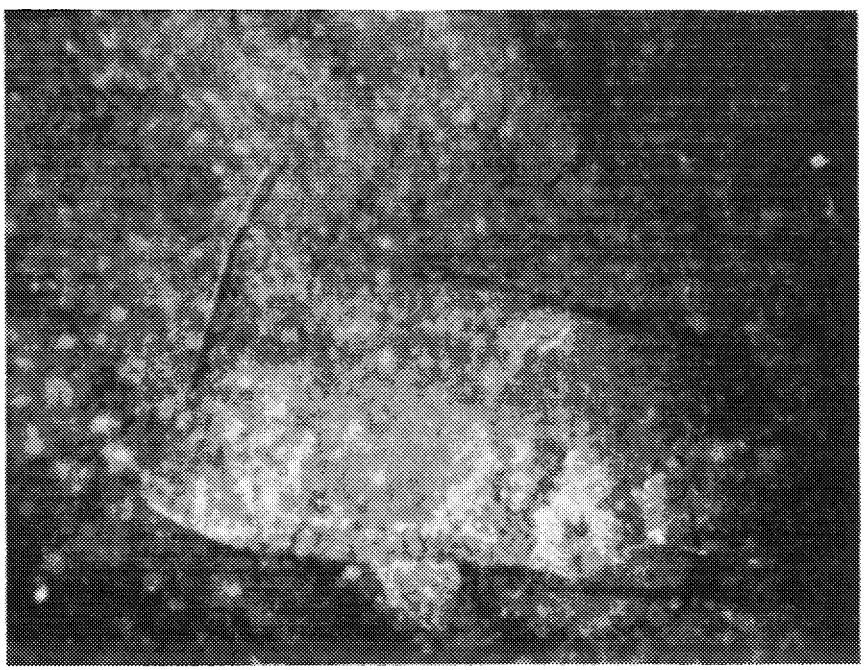
Fig. 10.

Figure 10. The tautog, Tautoga onitus (30cm t.l.) was observed in overwintering dormant state at the base of a border region clay mound. HFV = 40 cm.

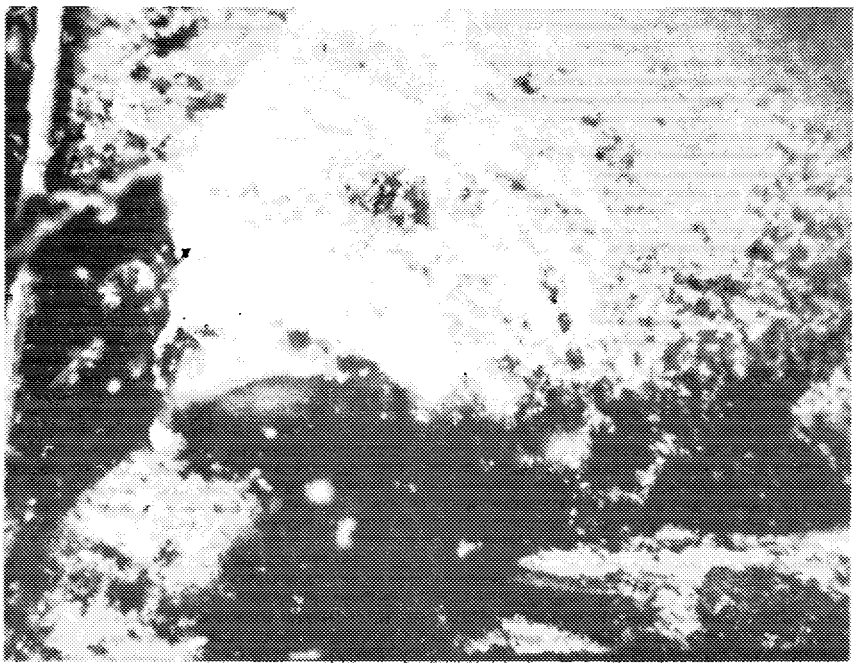
Fig. 11.

Figure 11. Close-up anterior photo of the dormant tautog revealed the vascularized fin condition and evidence of immobility (accumulation of tidal-flux nephaloid layer over tautog exterior). HFV = 10 cm.
