Rhode Island and Connecticut Coastal Nonstructural Assessment

February 2017

**USACE National Nonstructural Flood Proofing Committee
in support of the USACE-New England District**

Enclosure A Nonstructural Assessment Structure Inventory Attribute Sheets

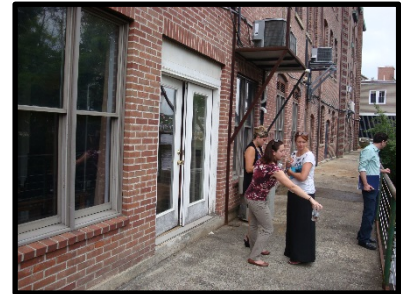
Structure Location:	12 High St, Westerly, RI
Occupancy / Built:	commercial / 1910
Structure Condition (visual):	good
1 st Floor Area (sq ft):	9,576
Exterior Wall Construction:	brick/masonry
Foundation Wall:	brick/masonry
Slab/Crawlspace/Basement:	basement
# Entrances / # 1 st Floor Windows:	multiple / multiple
Garage:	none
Exterior Mechanical/Electrical/Fuel:	AC, electric, oil
# Fireplace	0
Landscaping and Shrubs:	0

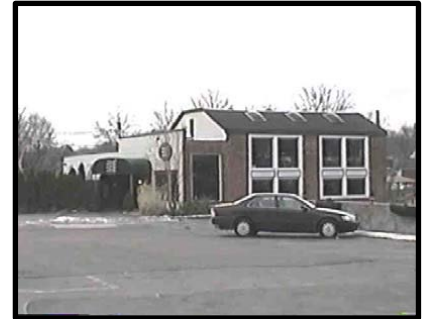
Structure Location:	37 Main St, Westerly, RI
Occupancy / Built:	commercial / 1900
Structure Condition (visual):	good
1 st Floor Area (sq ft):	4,026
Exterior Wall Construction:	CMU / concrete
Foundation Wall:	CMU
Slab/Crawlspace/Basement:	slab
# Entrances / # 1 st Floor Windows:	2 / multiple
Garage:	none
Exterior Mechanical/Electrical/Fuel:	AC, electric, gas
# Fireplace	0
Landscaping and Shrubs:	yes

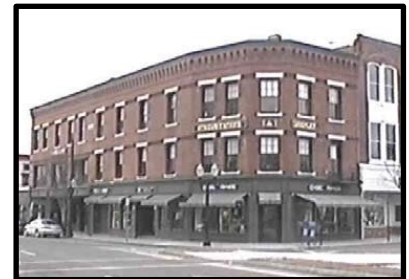
Structure Location:	2 Broad St, Westerly, RI
Occupancy / Built:	commercial / 1882
Structure Condition (visual):	good
1 st Floor Area (sq ft):	6,661
Exterior Wall Construction:	brick / masonry / clapboard
Foundation Wall:	brick / masonry
Slab/Crawlspace/Basement:	basement
# Entrances / # 1 st Floor Windows:	multiple / multiple
Garage:	none
Exterior Mechanical/Electrical/Fuel:	AC, electric, gas
# Fireplace	0
Landscaping and Shrubs:	0

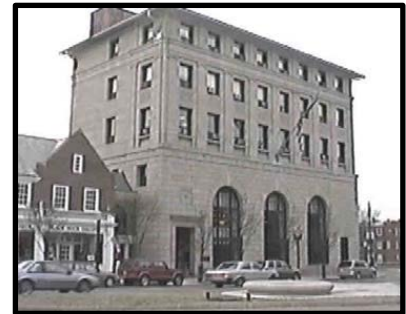
Structure Location:	23 Broad St, Westerly, RI
Occupancy / Built:	commercial / 1900
Structure Condition (visual):	good
1 st Floor Area (sq ft):	9,597
Exterior Wall Construction:	stone / masonry
Foundation Wall:	stone / masonry
Slab/Crawlspace/Basement:	basement
# Entrances / # 1 st Floor Windows:	3 / 14
Garage:	none
Exterior Mechanical/Electrical/Fuel:	AC, electric, oil
# Fireplace	0
Landscaping and Shrubs:	0

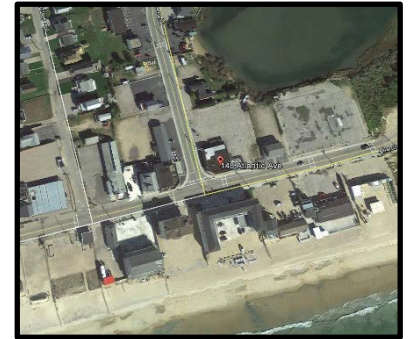
Structure Location:	148 Atlantic Ave, Westerly, RI
Occupancy / Built:	commercial / 1920's
Structure Condition (visual):	good
1 st Floor Area (sq ft):	NA
Exterior Wall Construction:	wood / vinyl
Foundation Wall:	CMU
Slab/Crawlspace/Basement:	half basement/crawlspace
# Entrances / # 1 st Floor Windows:	3-double / multiple
Garage:	none
Exterior Mechanical/Electrical/Fuel:	AC, electric
# Fireplace	0
Landscaping and Shrubs:	0

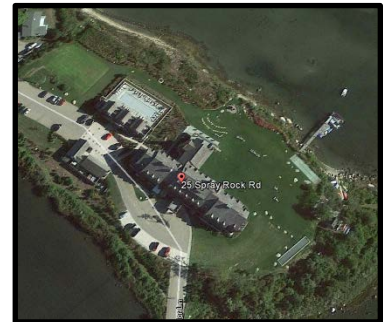
Structure Location:	25 Spray Road, Westerly, RI
Occupancy / Built:	commercial / NA
Structure Condition (visual):	good
1 st Floor Area (sq ft):	NA
Exterior Wall Construction:	wood
Foundation Wall:	concrete, CMU
Slab/Crawlspace/Basement:	NA
# Entrances / # 1 st Floor Windows:	multiple / multiple
Garage:	none
Exterior Mechanical/Electrical/Fuel:	NA
# Fireplace	NA
Landscaping and Shrubs:	yes

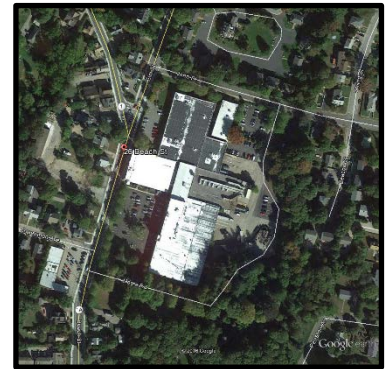
Structure Location:	26 Beach Drive, Westerly, RI
Occupancy / Built:	industrial / NA
Structure Condition (visual):	good
1 st Floor Area (sq ft):	NA
Exterior Wall Construction:	concrete, brick
Foundation Wall:	concrete, masonry
Slab/Crawlspace/Basement:	NA
# Entrances / # 1 st Floor Windows:	multiple / multiple
Garage:	none
Exterior Mechanical/Electrical/Fuel:	NA
# Fireplace	NA
Landscaping and Shrubs:	yes

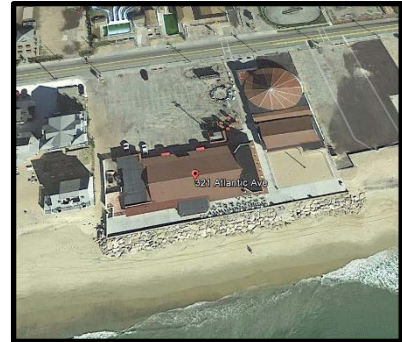
Structure Location:	321 Atlantic Avenue, Westerly, RI
Occupancy / Built:	commercial / NA
Structure Condition (visual):	good
1 st Floor Area (sq ft):	NA
Exterior Wall Construction:	CMU
Foundation Wall:	CMU
Slab/Crawlspace/Basement:	slab
# Entrances / # 1 st Floor Windows:	multiple / multiple
Garage:	none
Exterior Mechanical/Electrical/Fuel:	yes
# Fireplace	0
Landscaping and Shrubs:	0

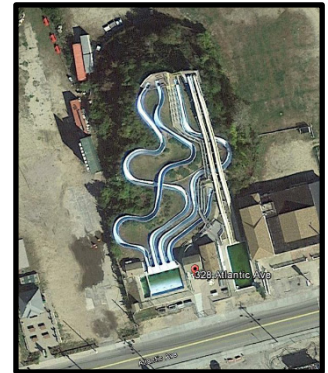
Structure Location:	328 Atlantic Avenue, Westerly, RI
Occupancy / Built:	commercial / NA
Structure Condition (visual):	good
1 st Floor Area (sq ft):	NA
Exterior Wall Construction:	wood
Foundation Wall:	post/piers
Slab/Crawlspace/Basement:	none
# Entrances / # 1 st Floor Windows:	multiple / multiple
Garage:	none
Exterior Mechanical/Electrical/Fuel:	yes
# Fireplace	0
Landscaping and Shrubs:	0

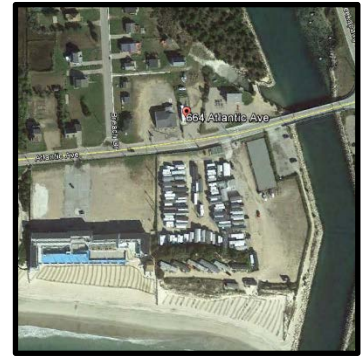
Structure Location:	664 Atlantic Avenue, Westerly, RI
Occupancy / Built:	commercial / NA
Structure Condition (visual):	good
1 st Floor Area (sq ft):	NA
Exterior Wall Construction:	masonry, stone
Foundation Wall:	masonry, stone
Slab/Crawlspace/Basement:	slab
# Entrances / # 1 st Floor Windows:	1 / multiple
Garage:	none
Exterior Mechanical/Electrical/Fuel:	electric, others NA
# Fireplace	0
Landscaping and Shrubs:	0

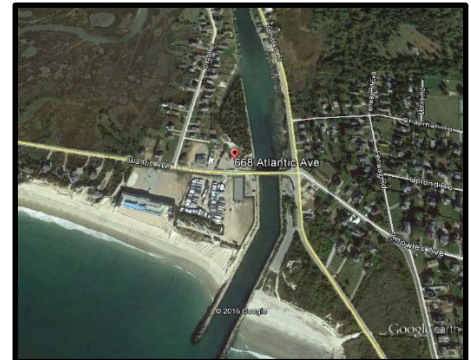
Structure Location:	668 Atlantic Ave, Westerly, RI
Occupancy / Built:	commercial / NA
Structure Condition (visual):	good
1 st Floor Area (sq ft):	NA
Exterior Wall Construction:	CMU
Foundation Wall:	CMU
Slab/Crawspace/Basement:	none
# Entrances / # 1 st Floor Windows:	3 / multiple
Garage:	none
Exterior Mechanical/Electrical/Fuel:	electric, propane
# Fireplace	0
Landscaping and Shrubs:	0

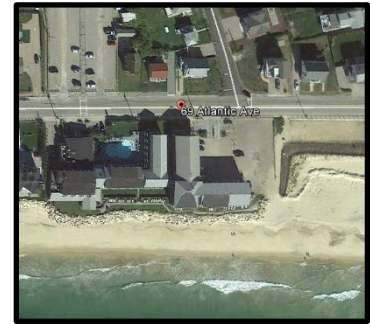
Structure Location:	69 Atlantic Avenue, Westerly, RI
Occupancy / Built:	commercial / NA
Structure Condition (visual):	good
1 st Floor Area (sq ft):	NA
Exterior Wall Construction:	wood shingle, concrete
Foundation Wall:	concrete
Slab/Crawlspace/Basement:	slab
# Entrances / # 1 st Floor Windows:	multiple / multiple
Garage:	none
Exterior Mechanical/Electrical/Fuel:	NA
# Fireplace	0
Landscaping and Shrubs:	0

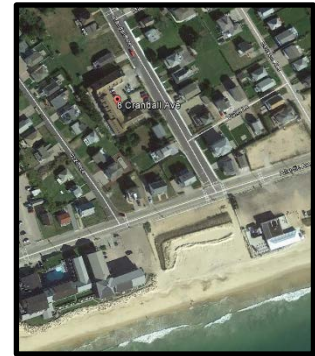
Structure Location:	8 Crandall Avenue, Westerly, RI
Occupancy / Built:	commercial / NA
Structure Condition (visual):	good
1 st Floor Area (sq ft):	NA
Exterior Wall Construction:	wood shingle, concrete
Foundation Wall:	concrete
Slab/Crawlspace/Basement:	slab
# Entrances / # 1 st Floor Windows:	multiple / multiple
Garage:	none
Exterior Mechanical/Electrical/Fuel:	AC, electric
# Fireplace	0
Landscaping and Shrubs:	yes

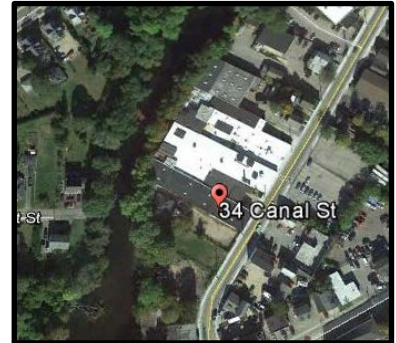
Structure Location:	34 Canal Street, Pawcatuck, CT
Occupancy / Built:	Industrial / 1900
Structure Condition (visual):	good
1 st Floor Area (sq ft):	63,778
Exterior Wall Construction:	brick / CMU
Foundation Wall:	concrete / CMU
Slab/Crawlspace/Basement:	slab
# Entrances / # 1 st Floor Windows:	multiple / multiple
Garage:	none
Exterior Mechanical/Electrical/Fuel:	electric, gas
# Fireplace	0
Landscaping and Shrubs:	0

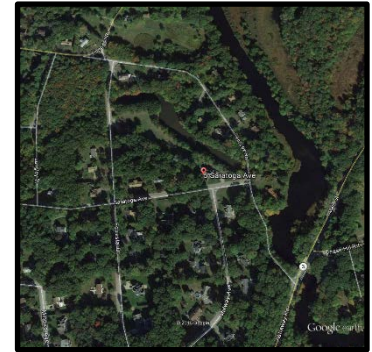
Structure Location:	5 Saratoga Ave, Westerly, RI
Occupancy / Built:	residential / 2002
Structure Condition (visual):	good
1 st Floor Area (sq ft):	2,095
Exterior Wall Construction:	wood, clapboard
Foundation Wall:	CMU
Slab/Crawlspace/Basement:	basement
# Entrances / # 1 st Floor Windows:	3 / multiple
Garage:	attached
Exterior Mechanical/Electrical/Fuel:	AC, electric, oil
# Fireplace	1
Landscaping and Shrubs:	yes

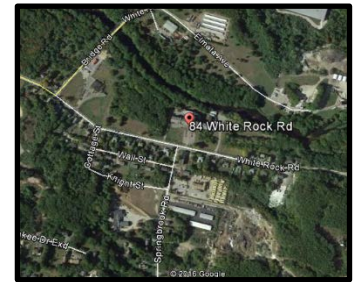
Structure Location:	84 White Rock Road, Westerly, RI
Occupancy / Built:	Industrial / 1849
Structure Condition (visual):	good
1 st Floor Area (sq ft):	36,395
Exterior Wall Construction:	brick / masonry
Foundation Wall:	brick / masonry
Slab/Crawspace/Basement:	basement
# Entrances / # 1 st Floor Windows:	multiple / multiple
Garage:	none
Exterior Mechanical/Electrical/Fuel:	electric, steam, oil
# Fireplace	0
Landscaping and Shrubs:	0

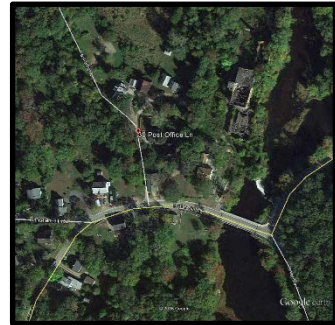
Structure Location:	30 Post Office Lane, Westerly, RI
Occupancy / Built:	residential / 1952
Structure Condition (visual):	below average
1 st Floor Area (sq ft):	950
Exterior Wall Construction:	wood, wood shingle
Foundation Wall:	CMU
Slab/Crawlspace/Basement:	basement
# Entrances / # 1 st Floor Windows:	2 / multiple
Garage:	attached
Exterior Mechanical/Electrical/Fuel:	electric, oil
# Fireplace	0
Landscaping and Shrubs:	yes

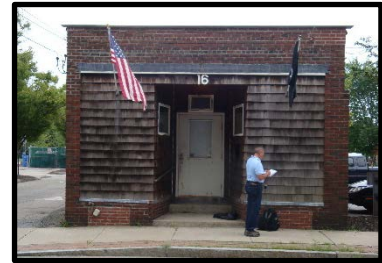
Structure Location:	16 Mechanic St, Stonington, CT
Occupancy / Built:	commercial / 1909
Structure Condition (visual):	below average
1 st Floor Area (sq ft):	2,200
Exterior Wall Construction:	brick / masonry / wood
Foundation Wall:	brick / masonry
Slab/Crawlspace/Basement:	crawlspace
# Entrances / # 1 st Floor Windows:	2 / multiple
Garage:	none
Exterior Mechanical/Electrical/Fuel:	AC, electric, oil
# Fireplace	0
Landscaping and Shrubs:	0

GE	FHT	4% Depth	2% Depth	1% Depth	.2% Depth
5.4	1.5	-0.5	-0.4	-0.3	0.7

Recommended Nonstructural Technique: Already has flood protection to the 1% flood event

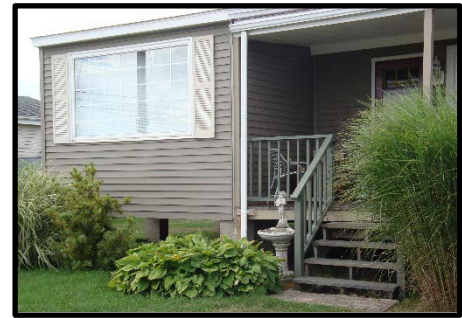
Structure Location:	Modular or Trailer Homes in AE Zone
Occupancy / Built:	residential / NA
Structure Condition (visual):	good
1 st Floor Area (sq ft):	NA
Exterior Wall Construction:	wood, vinyl
Foundation Wall:	piers or columns
Slab/Crawlspace/Basement:	none
# Entrances / # 1 st Floor Windows:	1 / multiple
Garage:	none
Exterior Mechanical/Electrical/Fuel:	varies
# Fireplace	0
Landscaping and Shrubs:	yes

Modular and trailer homes are susceptible to catastrophic damage if located within a high risk flood area. These structures should not be located within a FEMA V Zone as a precautionary measure to protect the inhabitants and/or first responders who may be required to provide assistance during a flood event.

Recommended Nonstructural Technique: Elevate to above the 1% flood depth (maximum 12 feet)

A recommendation for consideration is to elevate these structure types above the projected flood depth, up to 12 feet above the ground elevation. If the projected depth of flooding is greater than 12 feet, then the recommendation is to relocate the structure to an area outside of the FEMA Special Flood Hazard Area (outside of the 1% flood boundary).
