**CAPE COD CANAL HIGHWAY BRIDGES
BOURNE AND SANDWICH, MASSACHUSETTS
MAJOR REHABILITATION EVALUATION REPORT**

**APPENDIX A
ENGINEERING RELIABILITY ANALYSIS**

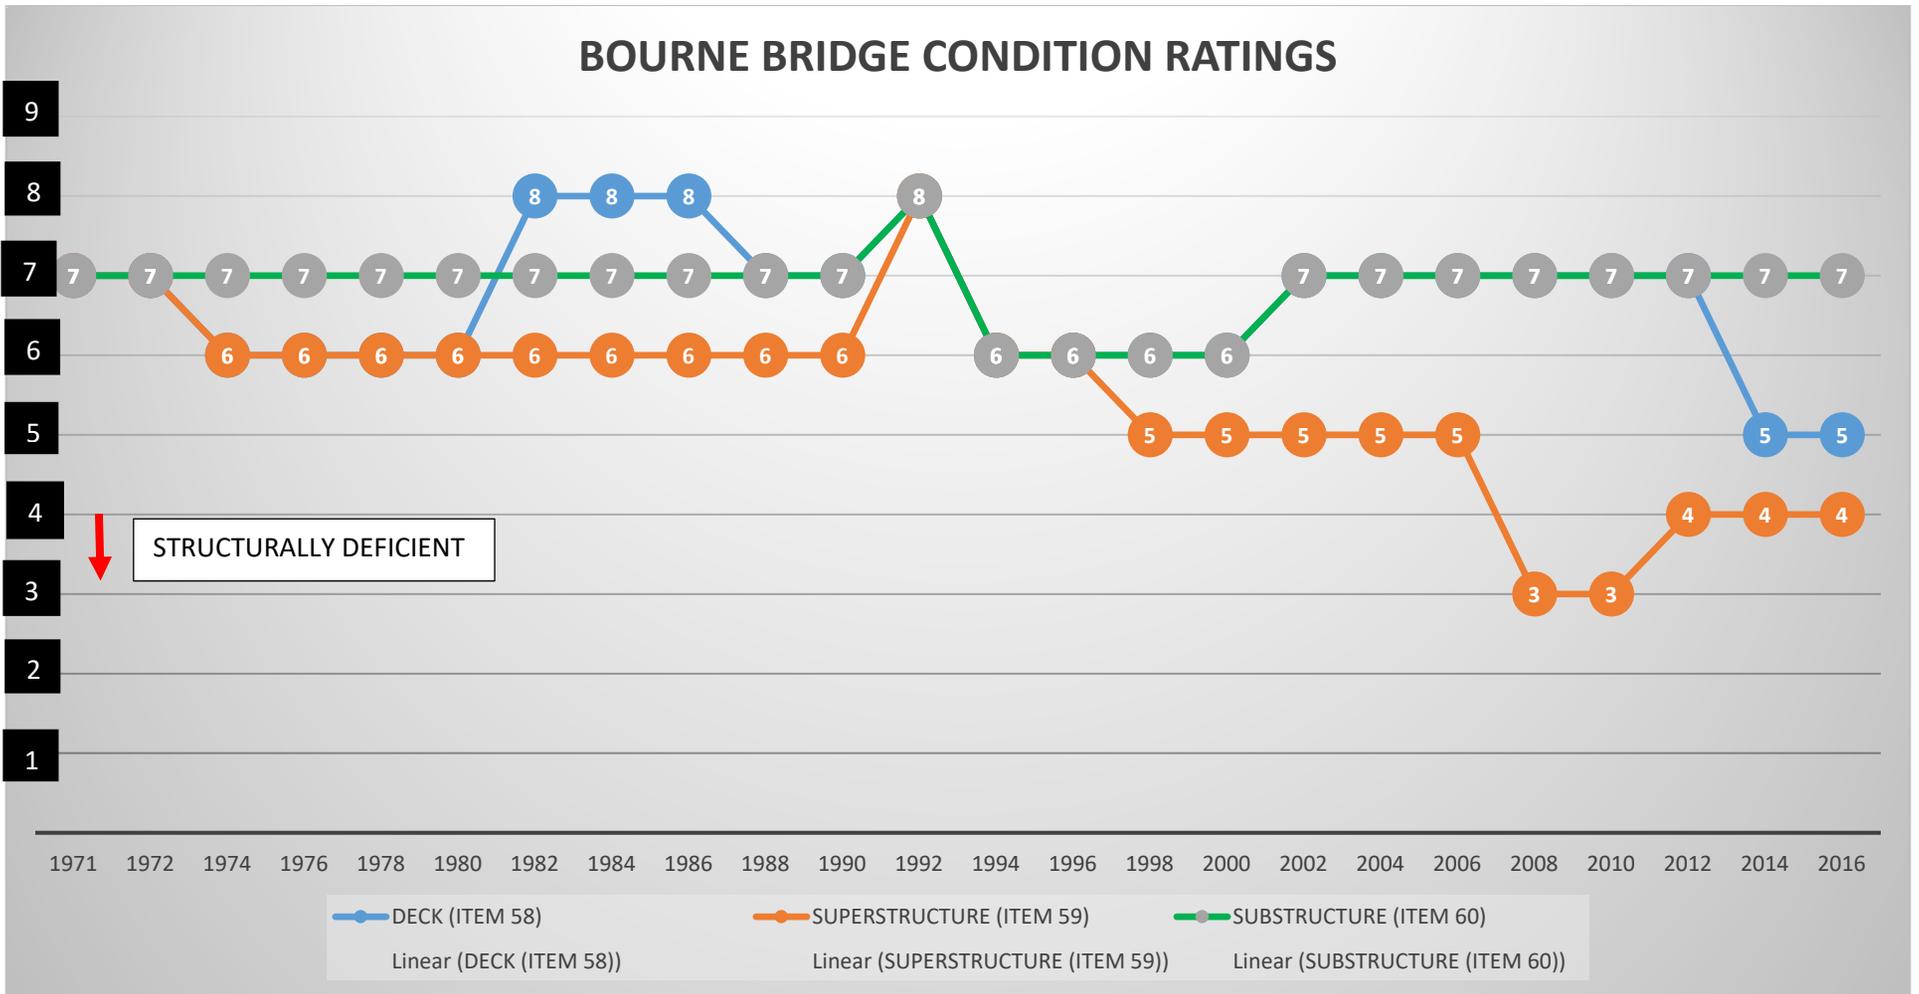
Figure A-4-1: Bourne Bridge History of Condition Ratings

The bridge traffic safety features, including the bridge railing, transitions, approach guardrails and approach guardrail ends, do not conform to current AASHTO or MassDOT Specifications. In general, these features are composed of nonstandard configurations and do not conform to

current MassDOT standards. Additionally, there are areas with no positive connections at the transitions between approach guardrails and the concrete end posts, and some of the W-beam approach guardrails do not conform to current MassDOT standards. These elements are thus rated as not meeting currently accepted standards. There are no scour issues associated with either pier in the water at the edge of the Canal.

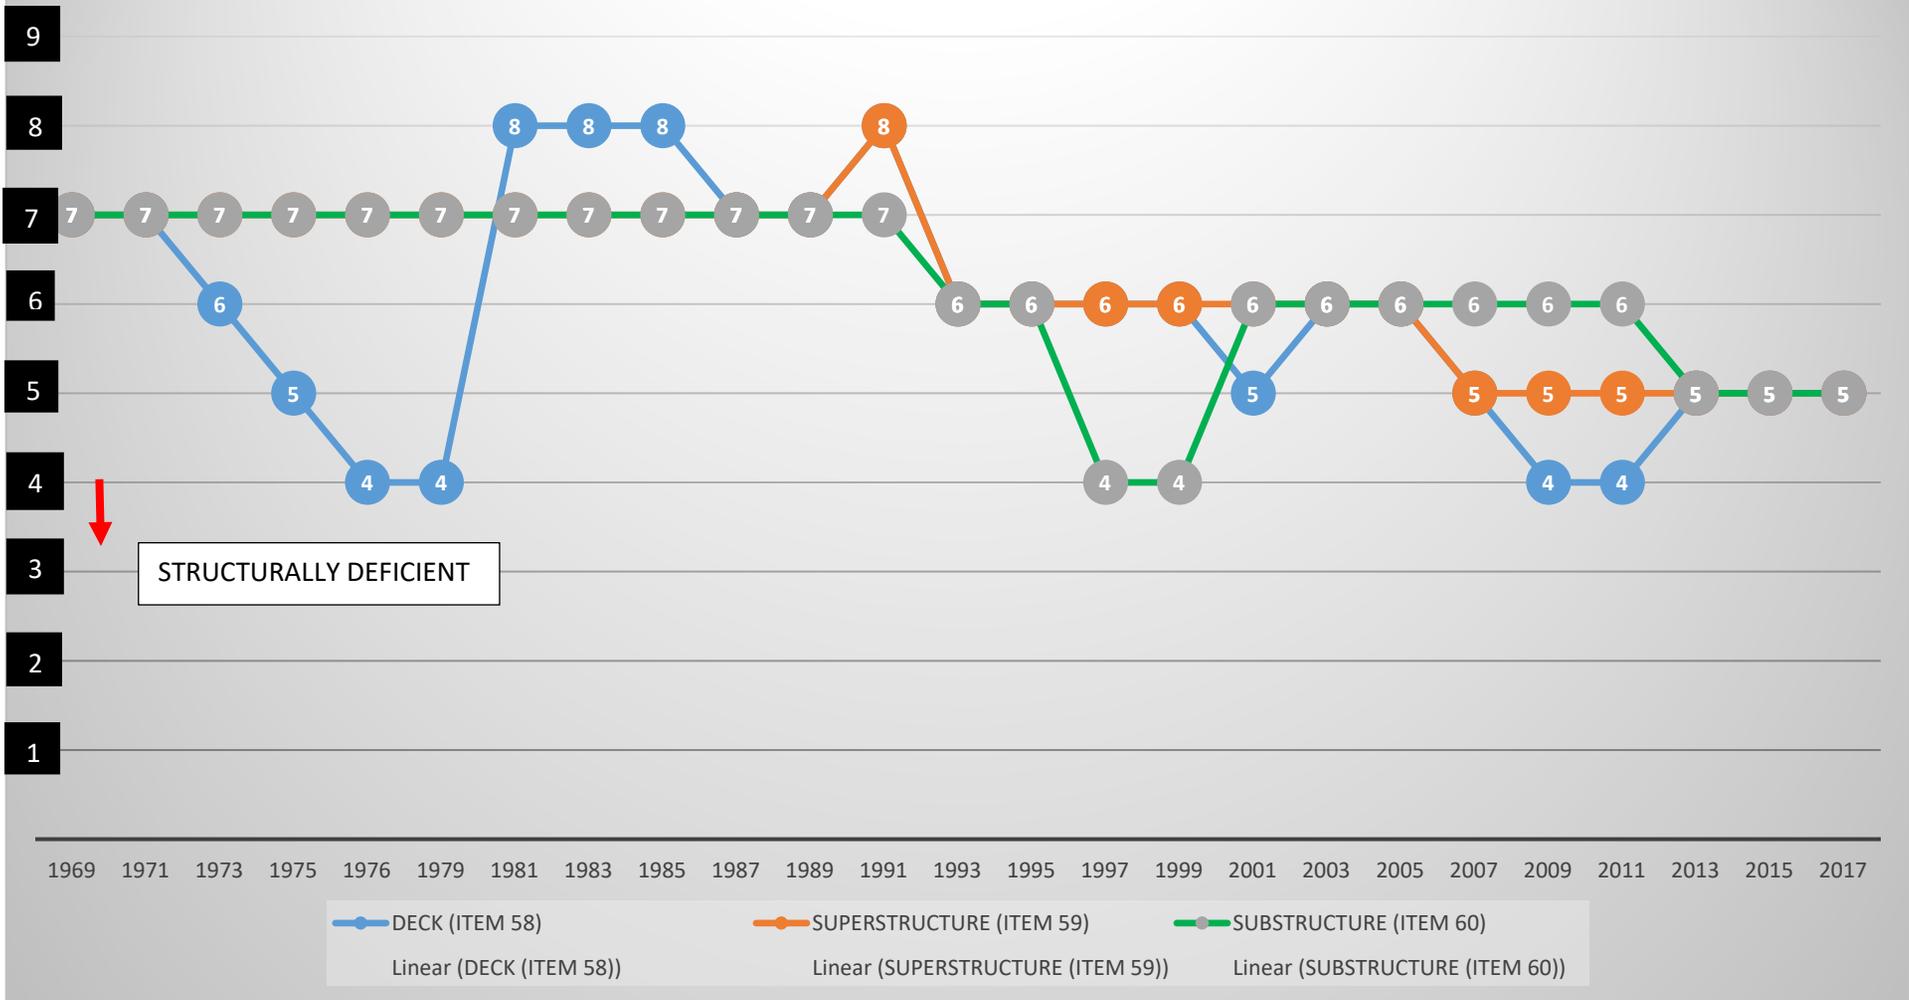
Figure A-4-2: Sagamore Bridge History of Condition Ratings

The Sagamore Bridge is functionally obsolete and has been structurally deficient in the past as recently as 2011. The deck (Item 58), superstructure (Item 59), and substructure (Item 60) are all currently in fair condition with condition ratings of 5. The overall condition of the Sagamore Bridge has not changed since the previous inspection. However, there are individual components that warrant condition ratings of “poor”, for example, the gusset plates and other connection plates.

A history of these condition ratings is shown in Figure A-4-2 at the end of this section.

The most significant inspection findings that warrant condition codings of fair for the deck, superstructure and substructure are as follows:
