## Daily Report

<b>Project:</b>	Durham Meadows Pipeline Installation
<b>Location:</b>	Talcott Ridge Drive, Middletown CT
<b>Project #:</b>	AECOM: 60445033
<b>Contractor:</b>	Ludlow Construction

**Date:** October 08, 2019  
**Day of Week:** Monday  
**Report No:** 10  
**Page:** 1 of 13

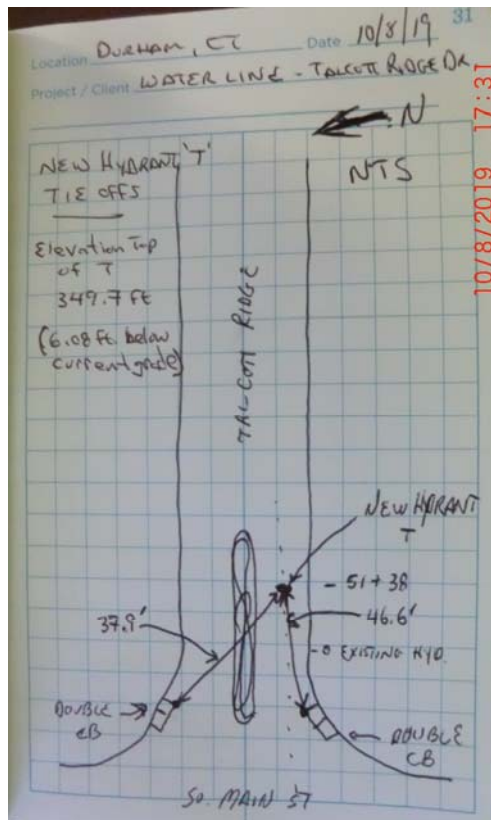
1330 – Drove up to top of Talcott Ridge Dr. A lot of pipe and equipment being staged in the cul-de-sac. Gravel is also being stockpiled along Talcott Ridge Rd. near the intersection of Watch Hill Drive. Off-site.
