# **Final 2005 ANNUAL REPORT**

## **WETLAND & UPLAND HABITAT RESTORATION AND LONG TERM ADAPTIVE MONITORING AND MAINTENANCE PROGRAM**

### **AREA OF CONTAMINATION (AOC) 57 DEVENS, MASSACHUSETTS**

**January 2007**

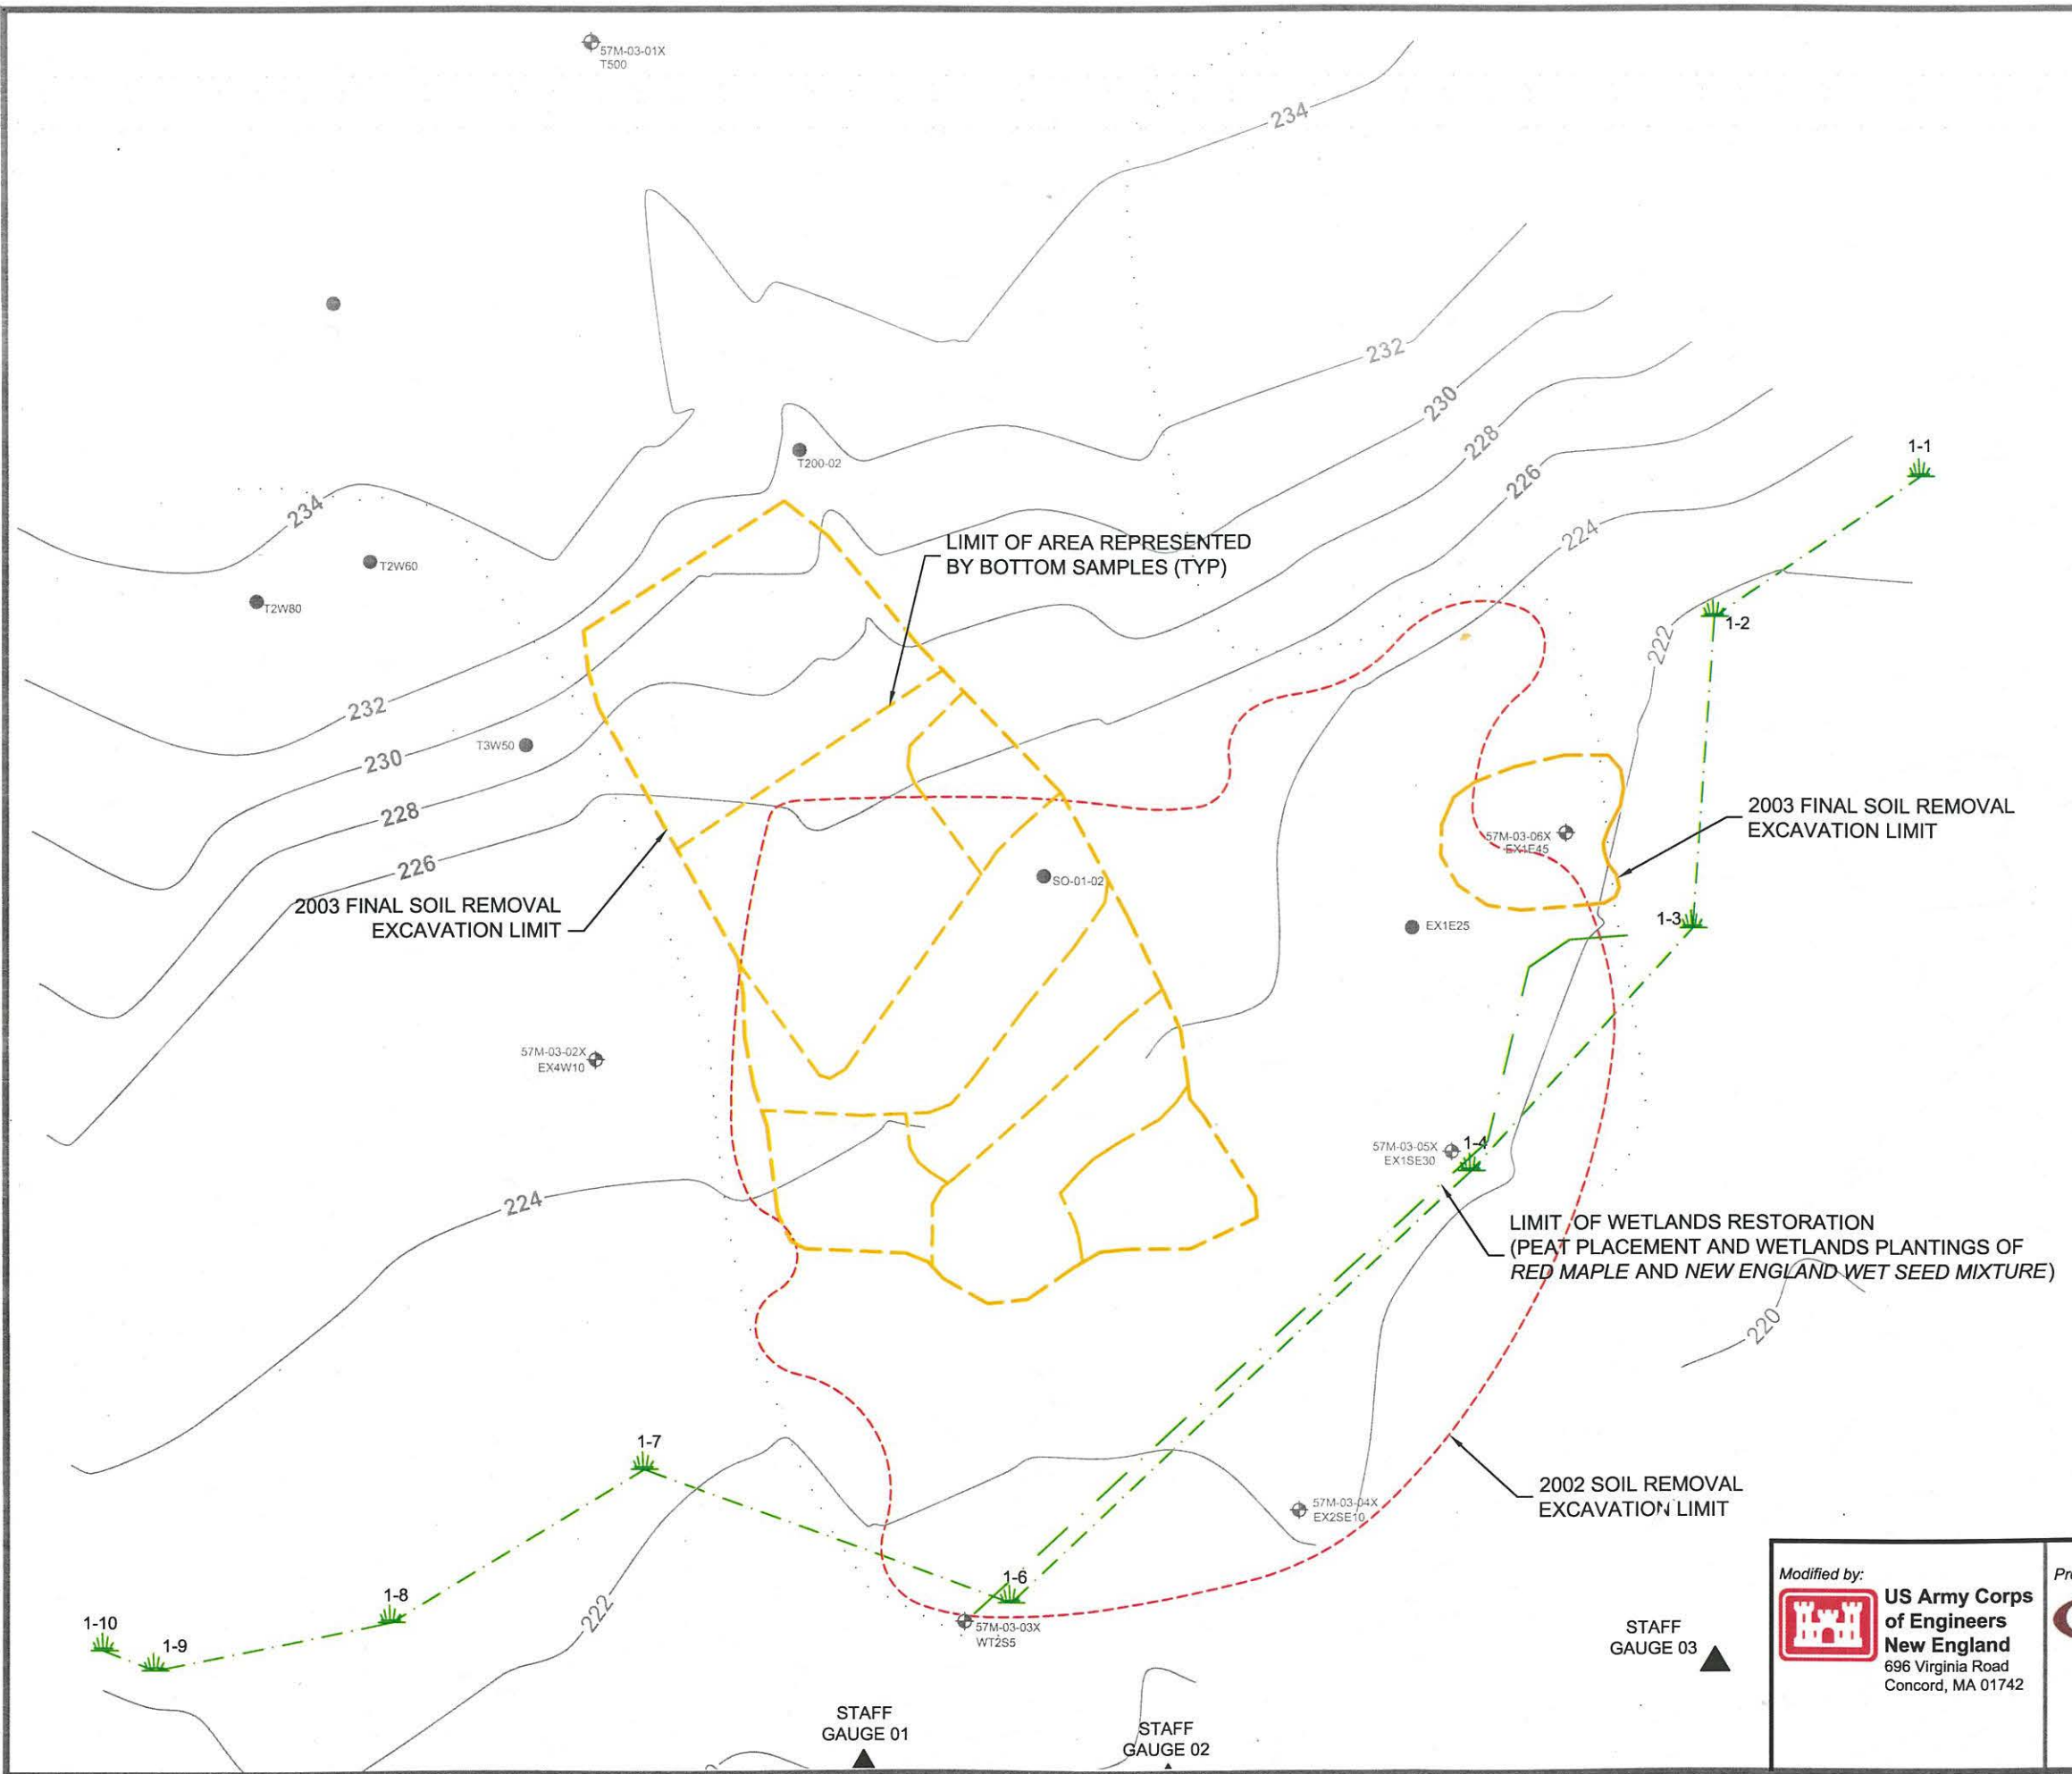
**2.1 Area 2:** The wetland boundary, 2002 and 2003 final soil removal excavation limits, and the limit of wetland restoration are shown in Figure 2. Details of the restoration approach and construction measures for the restoration of impacted wetland and upland habitat are provided in the Habitat LTMP (USACE 2007a). Approximately 1,744 square feet of wetlands was restored at Area 2 as shown in Figure 3.
