APPENDIX G (DRAFT):**FAIRFIELD AND NEW HAVEN COUNTIES, CT COASTAL STORM RISK
MANAGEMENT (CSRM) FEASIBILITY STUDY****USE OF I-95 EMBANKMENT IN NEW HAVEN, CT AS A CSRM FEATURE,
POTENTIAL FAILURE MODES ANALYSIS****1. Introduction**

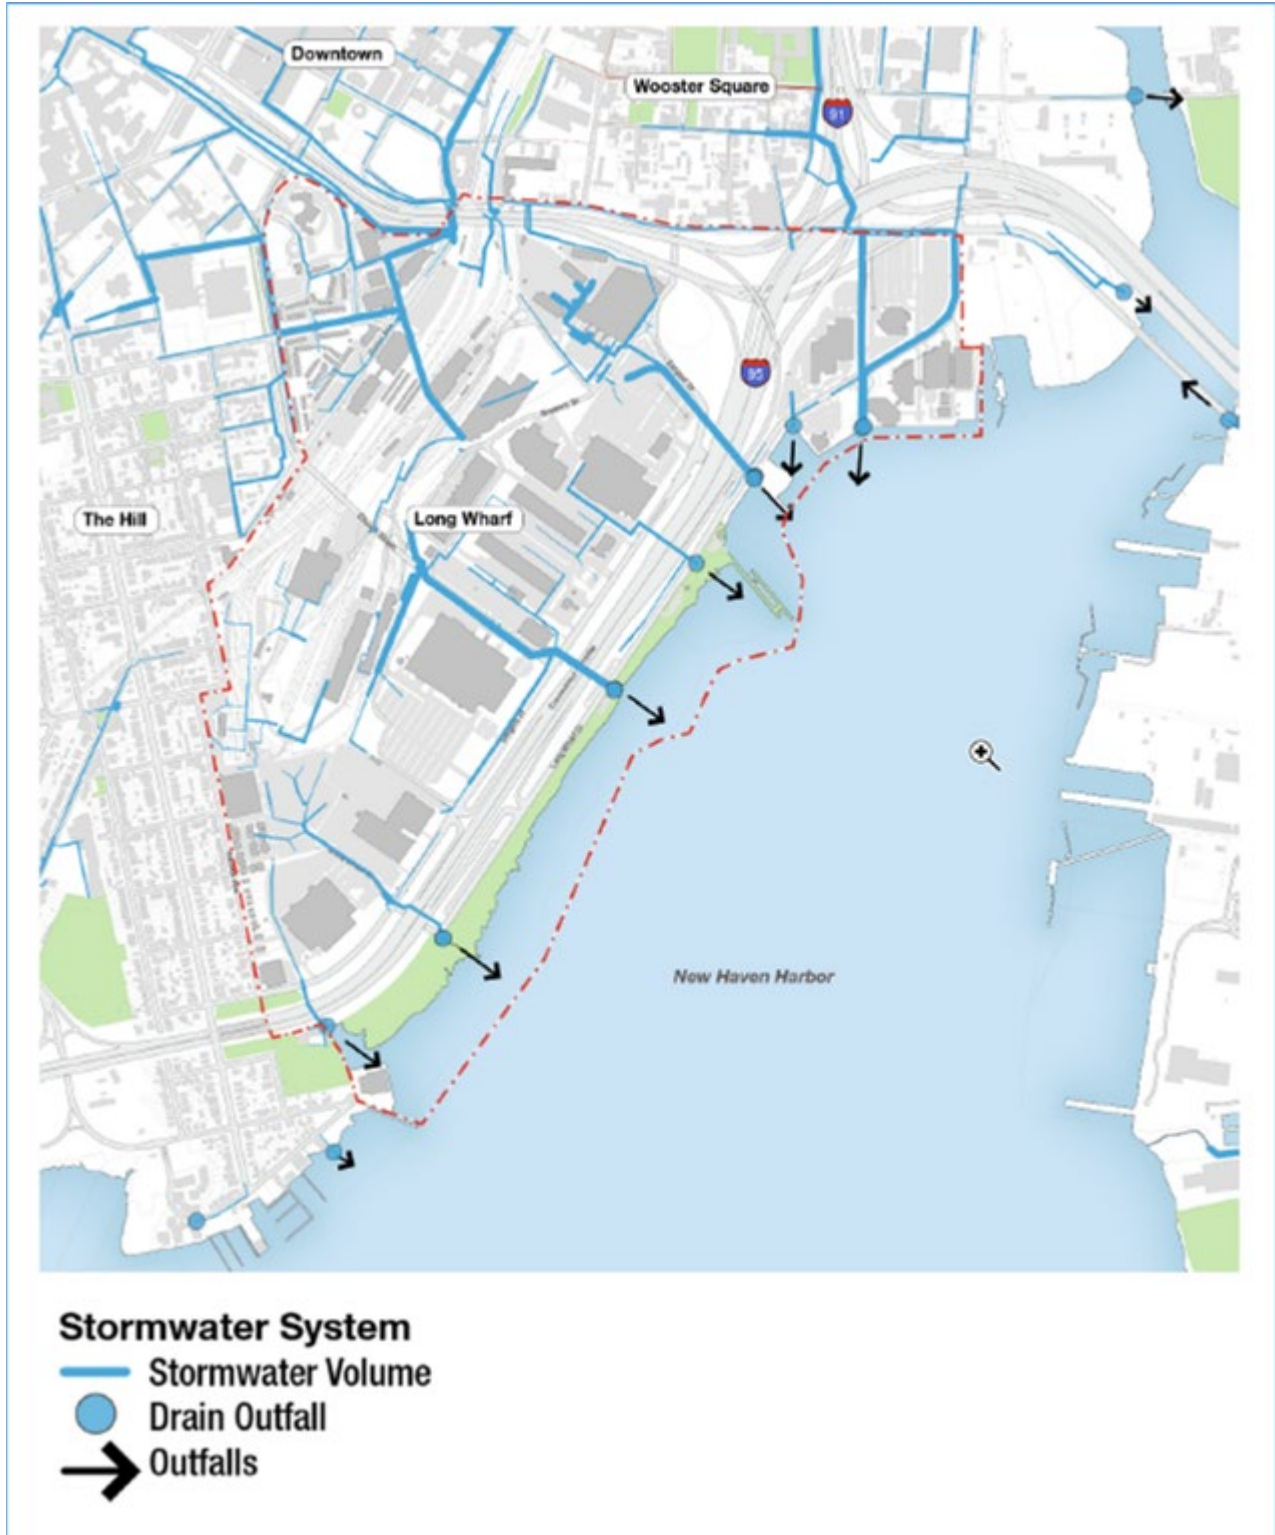
Figure 3: Known Outfalls along Long Wharf

As shown previously on Figure 3, there are several known storm sewer outfalls along the I-95 embankment. Based on limited as-built information available during the PFMA, as well as visual inspection of some of the outfall locations, it appears that these outfalls all pass well below the I-95 embankment (Figure 17). The PFMA team concluded that for this PFM to occur, a penetration would have to extend through the entire embankment at the base (maximum loading). Whether penetrations that meet this criteria exist along the embankment is unknown. The embankment is assumed to consist primarily of a silty sand that may have sufficient fines to hold a crack open. However, maximum gradients at future predicted high tide (with sea level rise) are very low (0.025) and would not be sufficient to initiate concentrated leak erosion. The duration of loading during the 100 year storm would not be sufficient to fully saturate the embankment, which would be required for this PFM to progress.

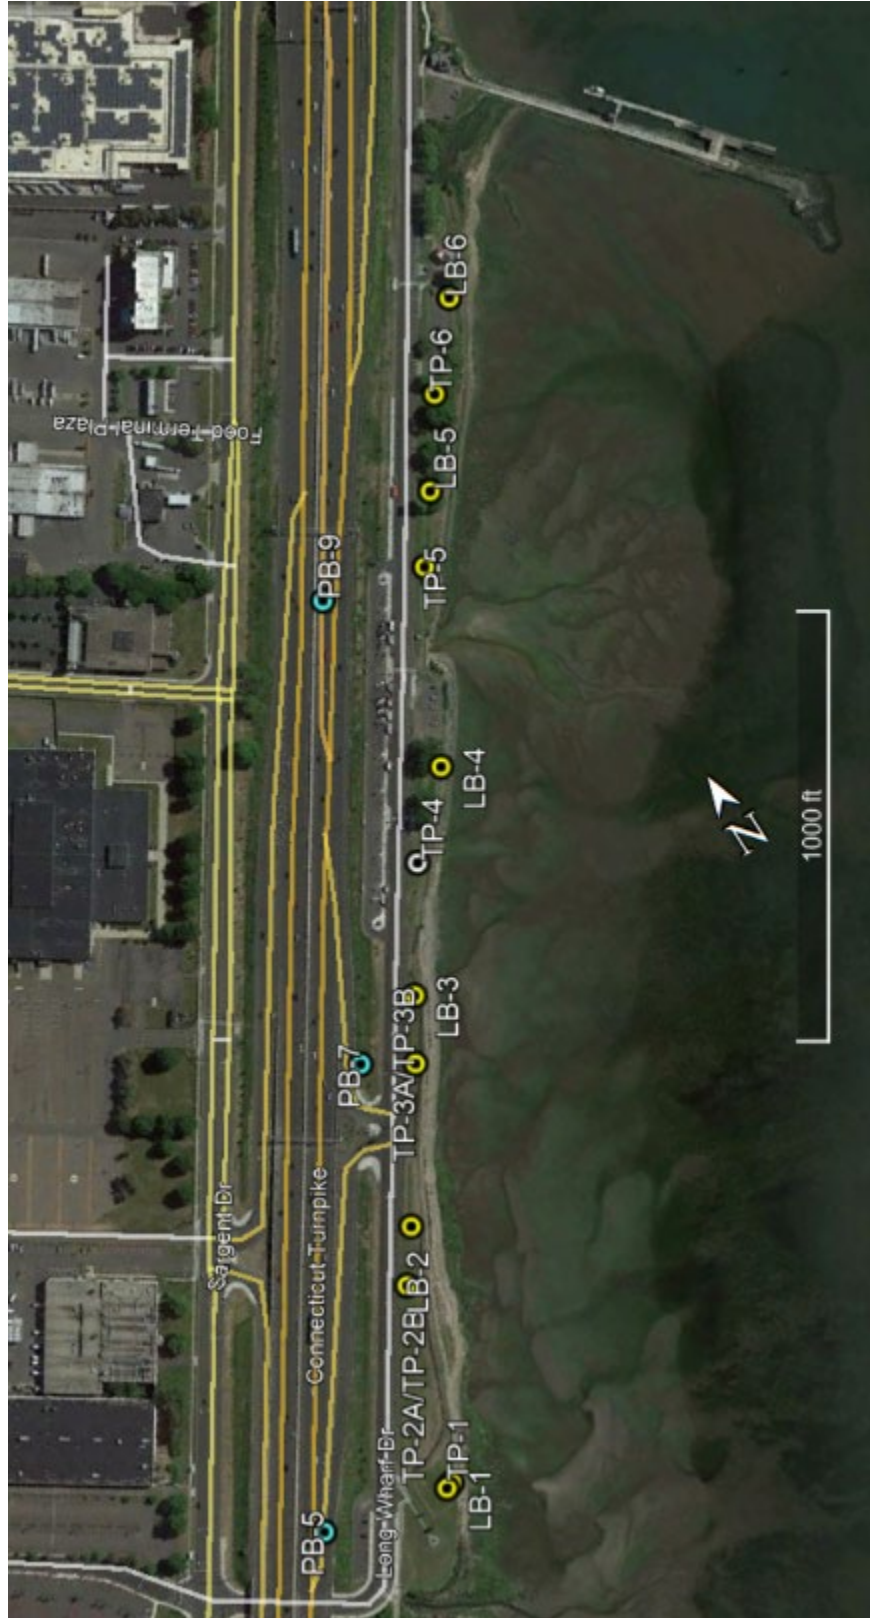
Figure 10: Approximate location of available I-95 Embankment Soil Borings

Information on embankment materials is limited. While there are many available explorations that were conducted in the area over the years, only one available boring, advanced during a 2000 exploration program, penetrated the I-95 embankment. (PB-5, Figure 10). Soil descriptions of the embankment materials indicate that the embankment is made primarily of compacted fine sand with silt. The embankment materials appear to have been placed directly on top of a thick layer of organic silts (approximately 30 to 40 feet). Additional discussions regarding foundation materials below the embankment is included in the main portion of the Geotechnical Engineering Appendix.

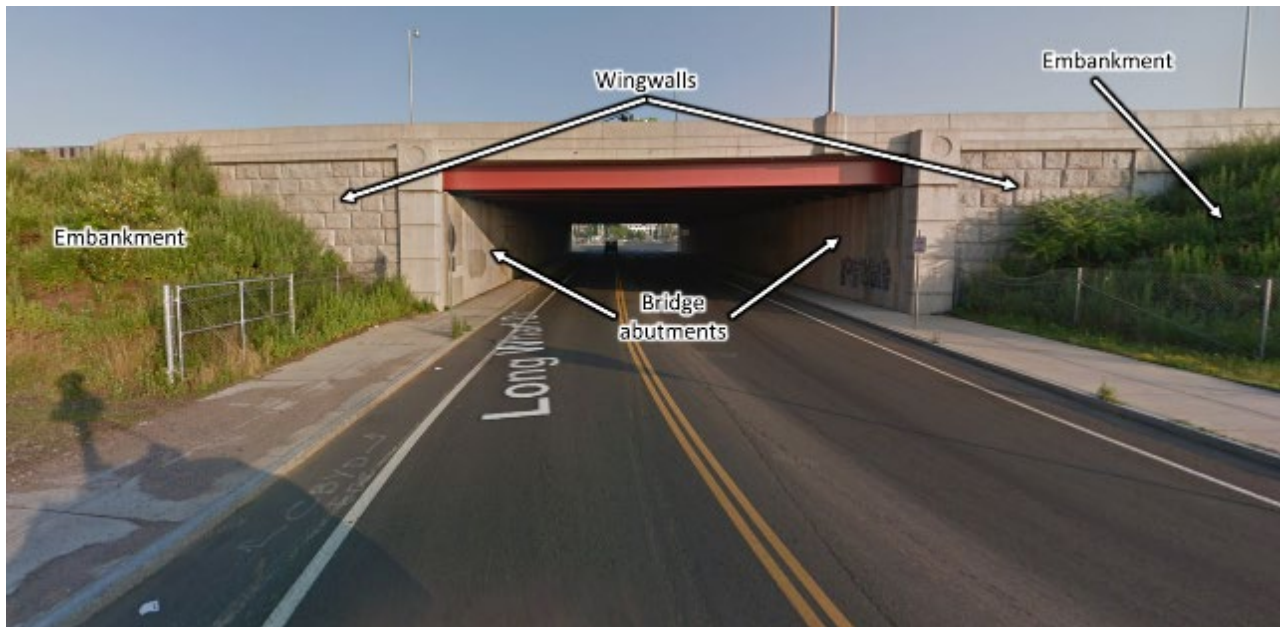
Figure 11: Bridge overpass at Long Wharf Drive viewed from ocean side.

As-built drawings of bridge overpasses in the area of concern were not readily available. However, based on preliminary design reports, the bridges are supported on pile caps, with Mechanically Stabilized Earth (MSE) wingwalls at either end (Figure 11). An MSE retaining wall is a composite structure consisting of alternating layers of compacted backfill (possibly lightweight fill) and soil reinforcement elements, fixed to a wall facing. The stability of the wall system is derived from the interaction between the backfill and soil reinforcements, involving friction and tension. The wall facing is relatively thin, with the primary function of preventing erosion of the structural backfill.

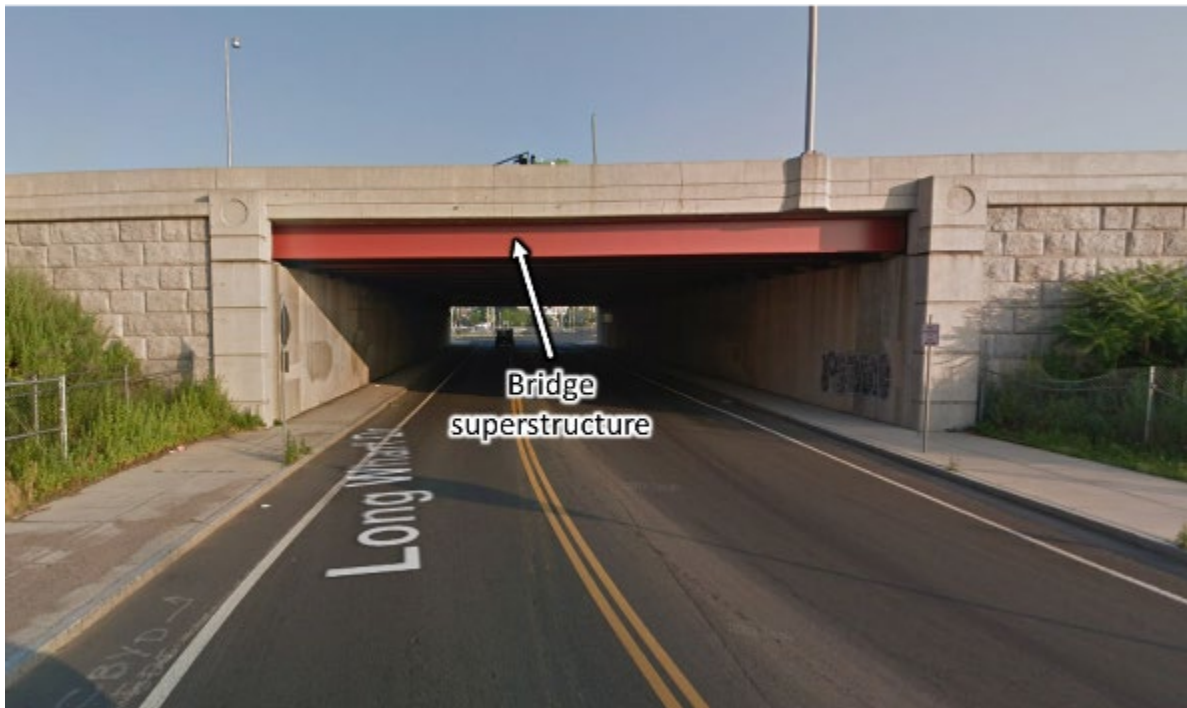
Figure 13: Photo showing typical bridge superstructure

During a severe storm, waves would intermittently hit the closure structure to be installed in front of the bridge (the closure structure would be designed to withstand this wave attack). The waves would intermittently splash over the closure structure, resulting in spray hitting the superstructure, but resulting in no significant additional wave loading. The bridge superstructure is significantly higher than top of the proposed closure structures for both overpasses. Given this, the team decided that this PFM was not a credible failure mode.

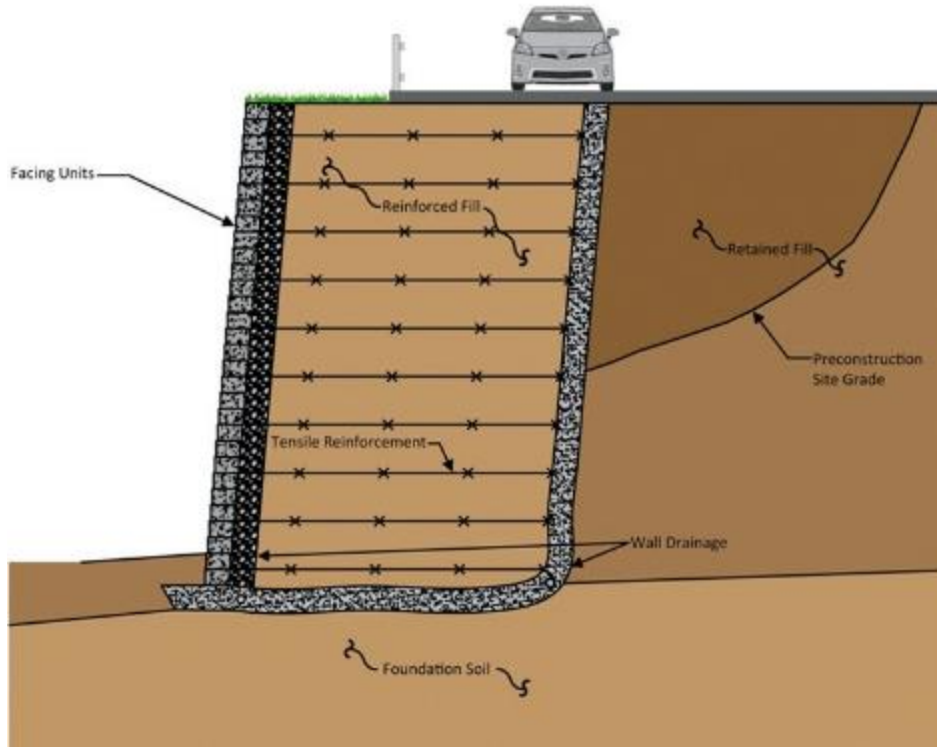
Figure 15: Typical MSE wall section (not specific to this project)

The team considered whether the MSE facing would be pervious enough to allow water to enter the backfill (which may be lightweight fill) resulting in excess hydrostatic pressures within the backfill that would lead to MSE wall instability. The team concluded that while it was possible that some seepage could enter the joints in the fascia during high water loading, the duration of loading would not be sufficient to fully saturate the wall. Additionally, the MSE wall structure has multiple layers of geogrid within the backfill that would provide resiliency. The team therefore concluded that it was very unlikely that loading during an extreme event would lead to instability of the MSE walls.
