New York Ordnance Works – Baldwinsville, New York

Historical Photographic Analysis

FINAL REPORT | JANUARY 2020
Prepared for USACE New England District

New York Ordnance Works Baldwinsville, New York Historical Photographic Analysis

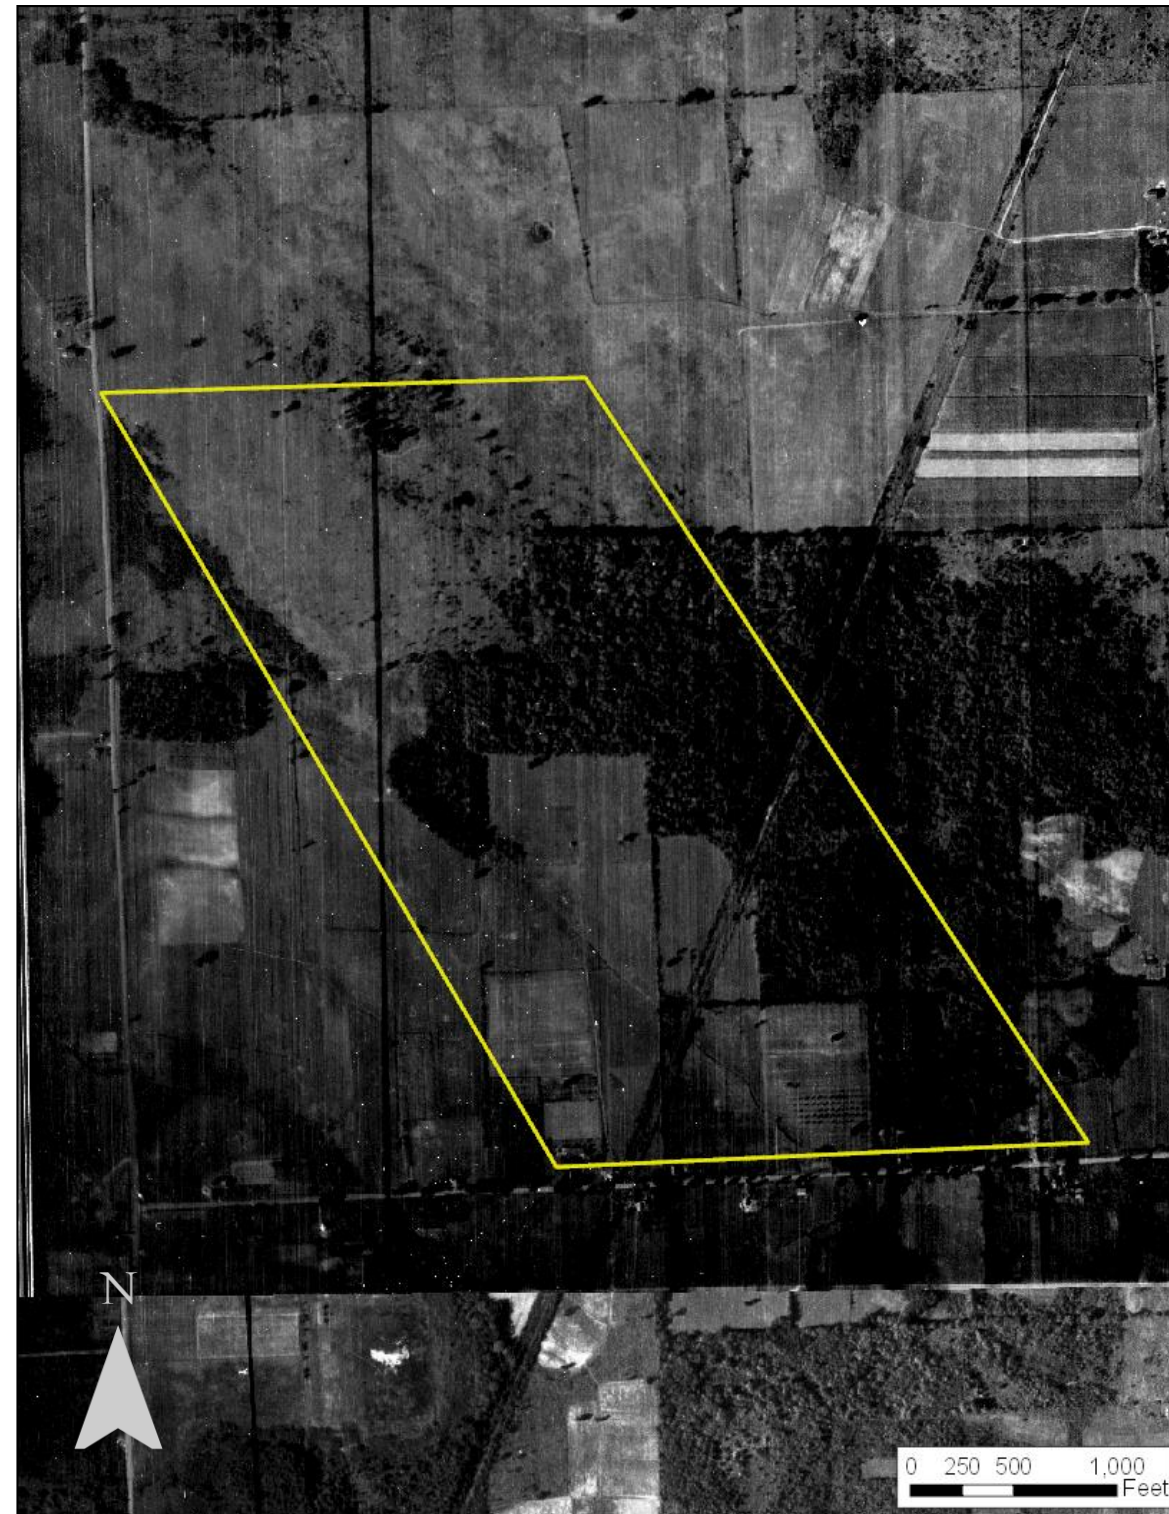
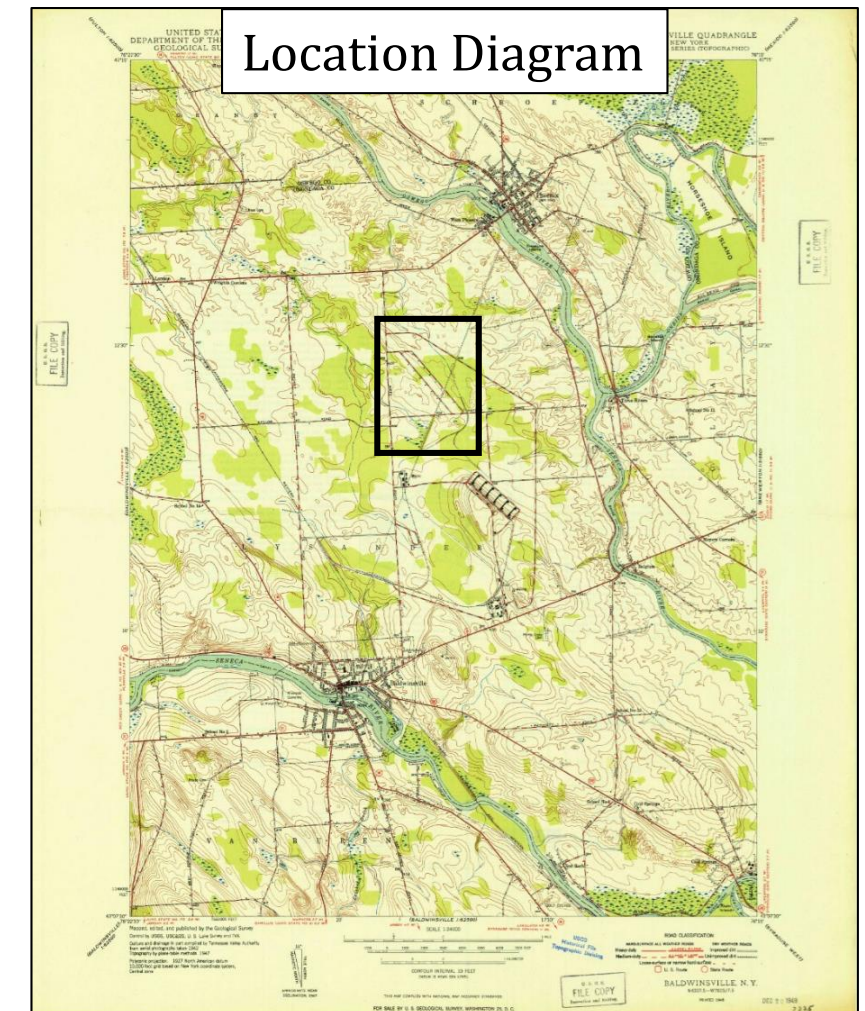
September 05, 1938

The landscape prior to the construction of the bunker area, was primarily agricultural and forested.

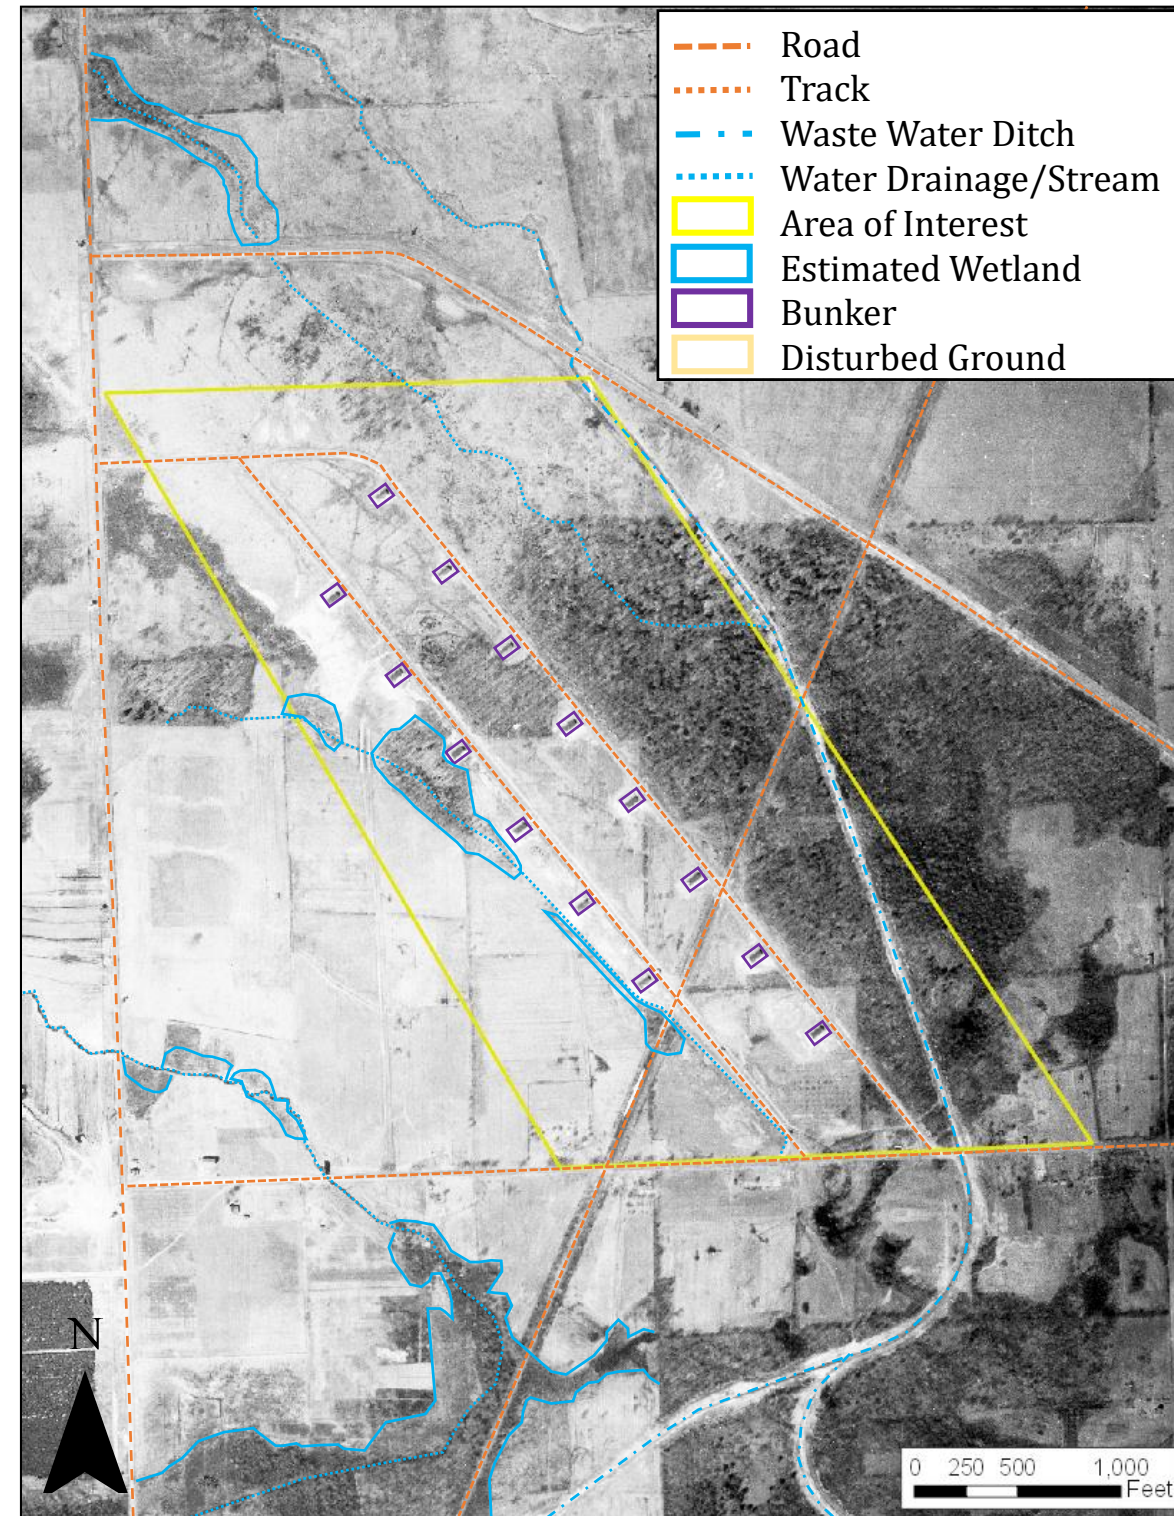
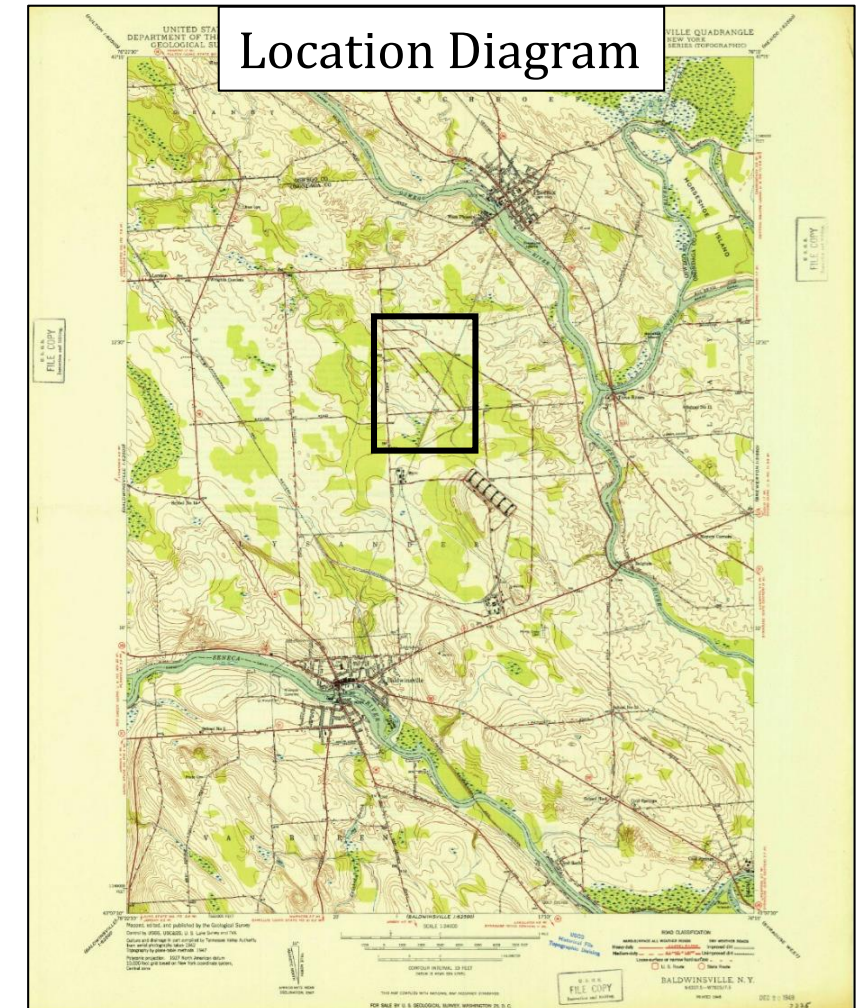
April 11, 1943

By 1943, 14 bunkers were constructed, along with access roads. Disturbed ground associated with the construction of the bunkers and roads is observed. A small area of forest was removed, enough for the construction of the bunkers and roads, however much of the forest remains.

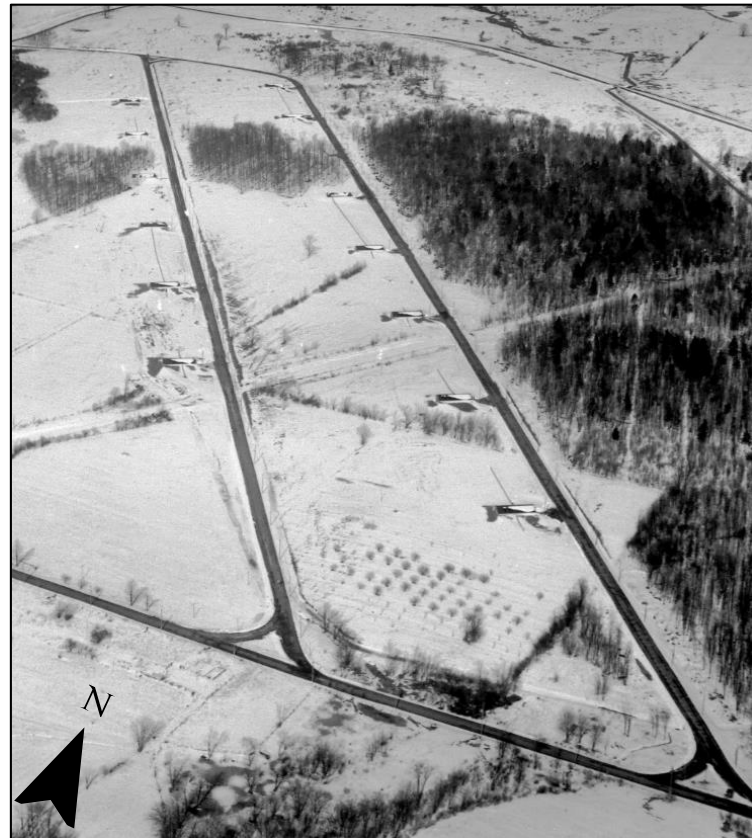
February 25, 1944 Oblique Photograph of Bunker Area
Source: National Archives at College Park

The roads around the bunker area have been cleared of snow, indicating active use. The tracks present between some of the bunkers in 1943 are no longer present, reinforcing that the roads running parallel to the bunkers are being used to access them.

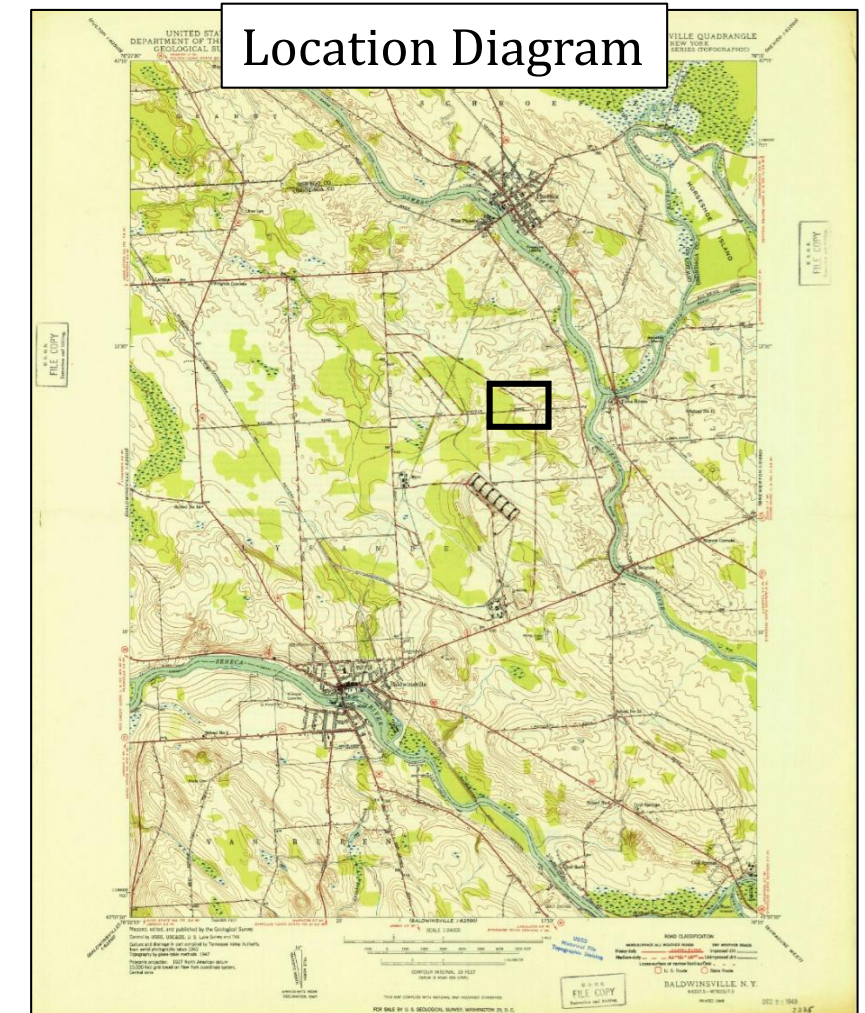
In 1938, the future “Landfill Area” is the location of a residential home and associated small structures, surrounded by agricultural land. A creek runs west-east to the north of this area.

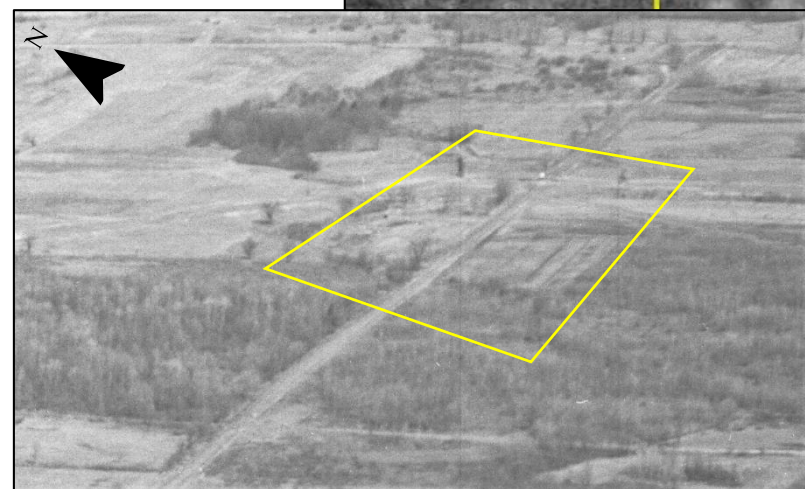
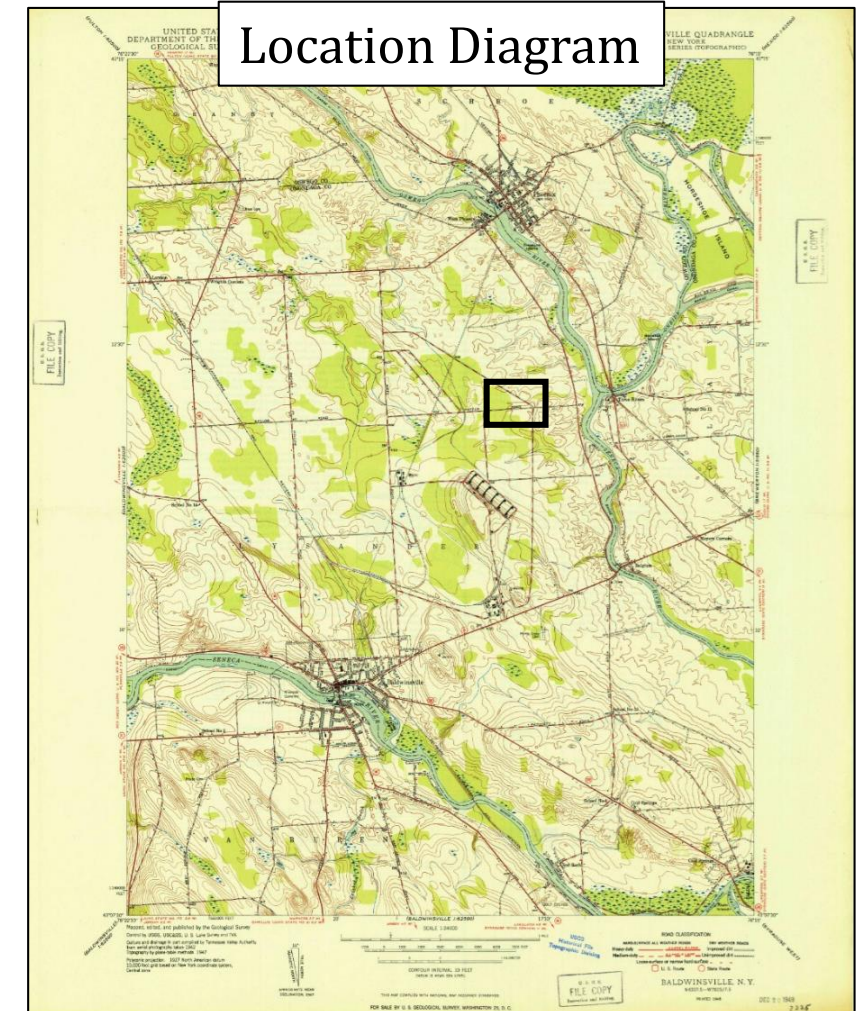
April 18, 1943 Oblique Photograph of Landfill Area
Source: National Archives at College Park

By 1943 the structures have been cleared. Disturbed ground associated with this clearing as well as the construction of a new road (North Patrol Road) is present. A linear feature running diagonal through the southeastern part of the area appears to be a drainage path.

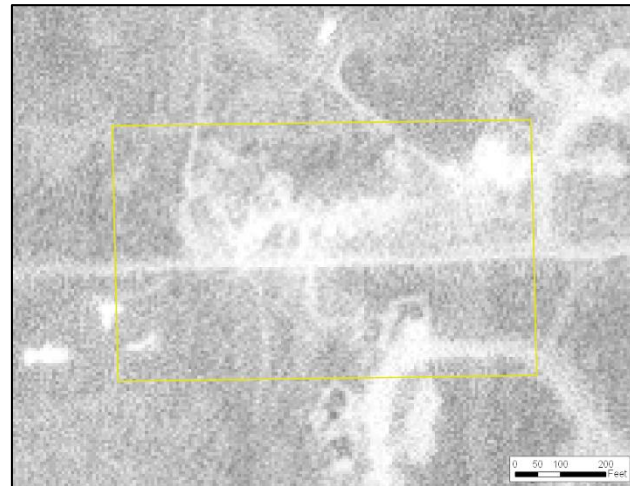
Source: U.S. Geological Survey April 16, 1981

The poor spatial resolution of the 1981 and 1982 aerial photographs prevent confirmation of specific features, but they do reveal construction activities and new housing developments in the area. Development appears to have covered most of North Patrol Road and parts of the creek have been diverted.

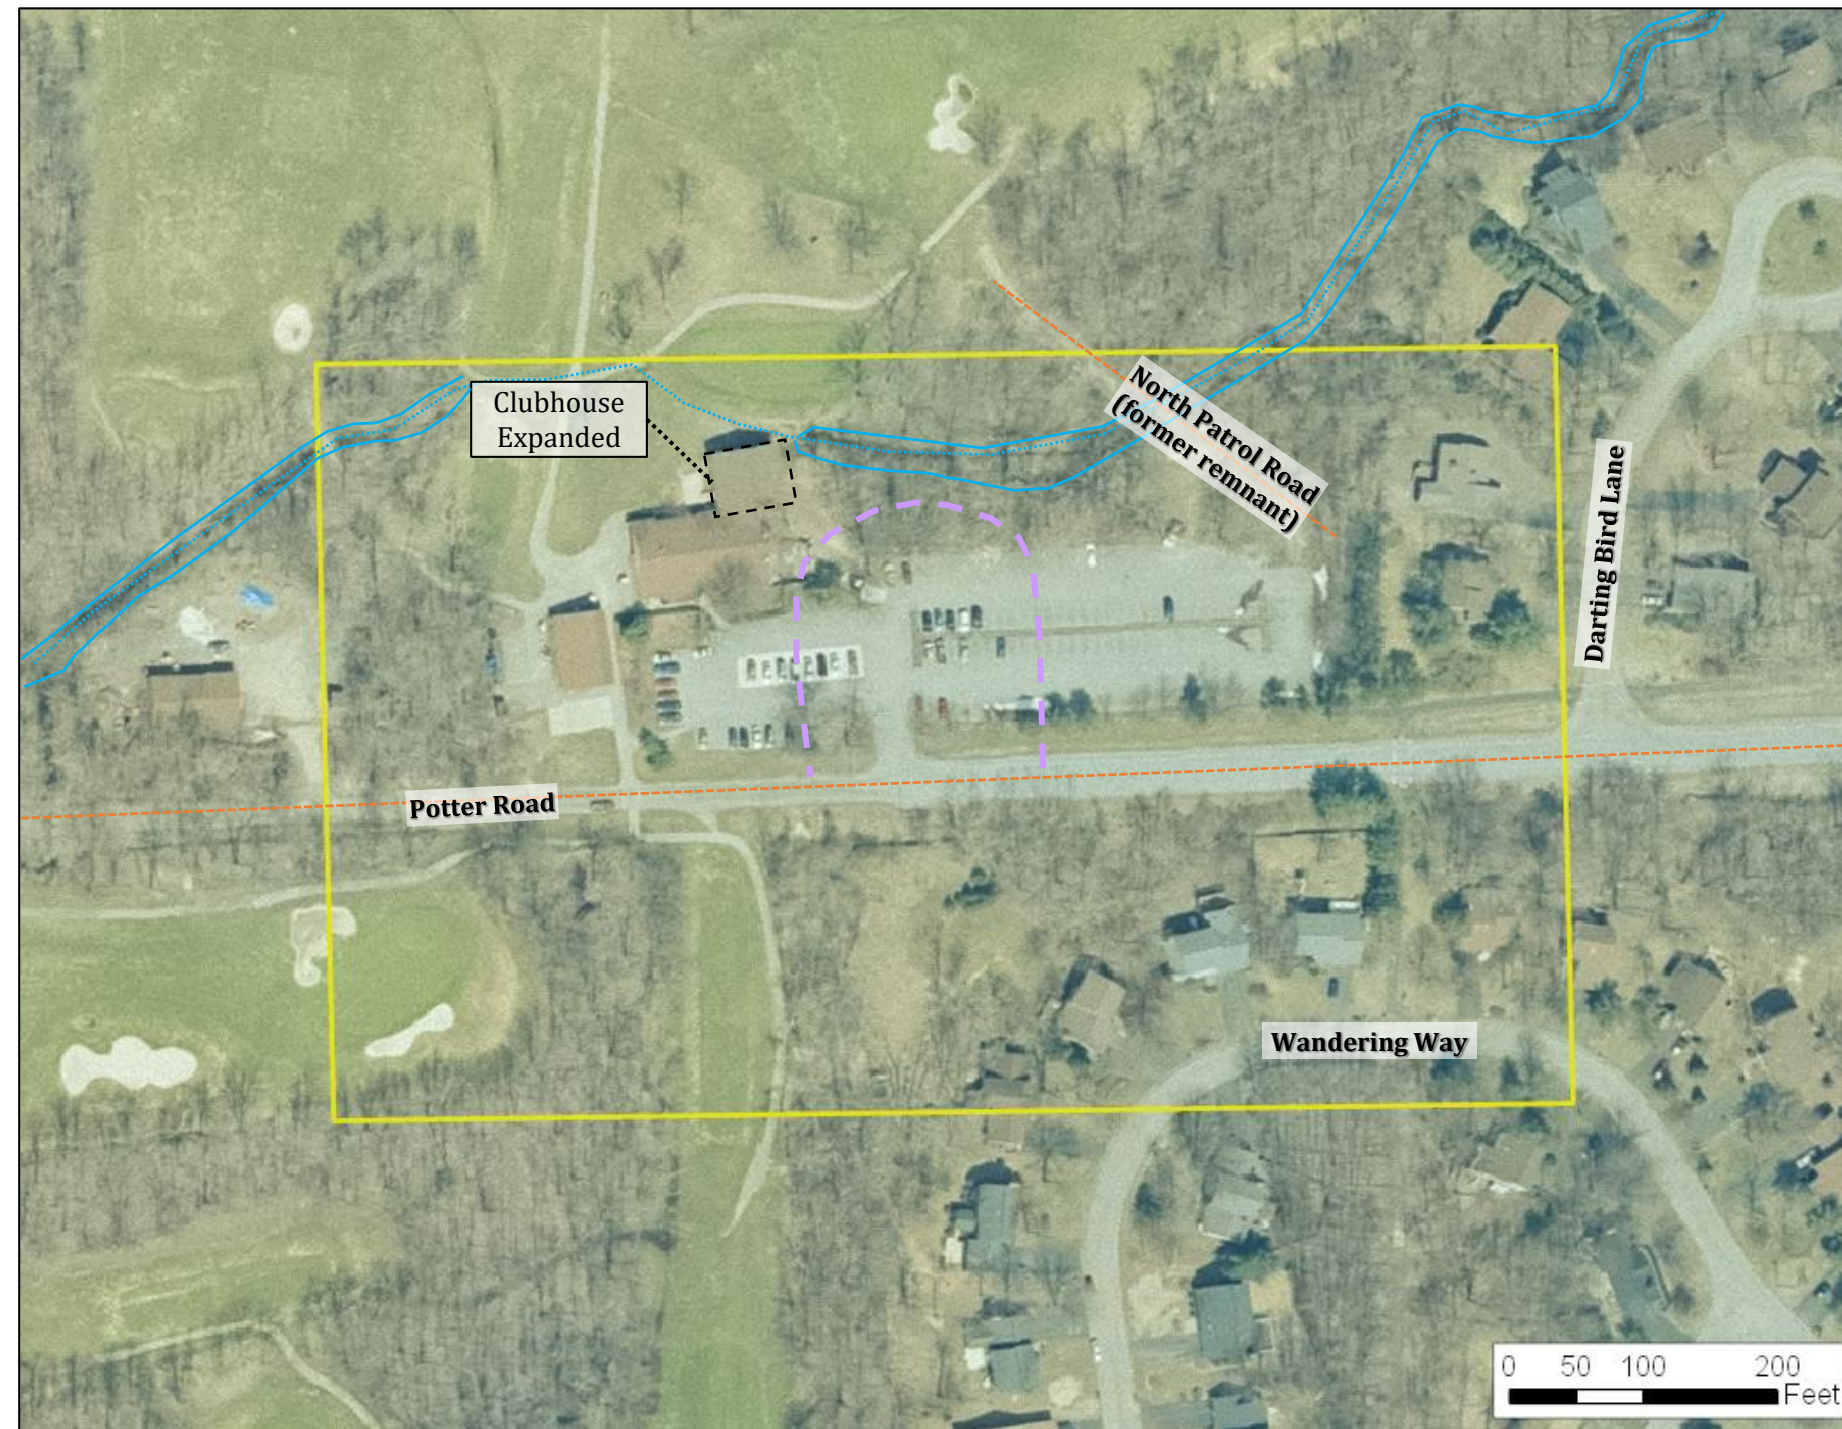
April 14, 2003

An extension to the golf course clubhouse is observed. The remnant of North Patrol Road appears disused.

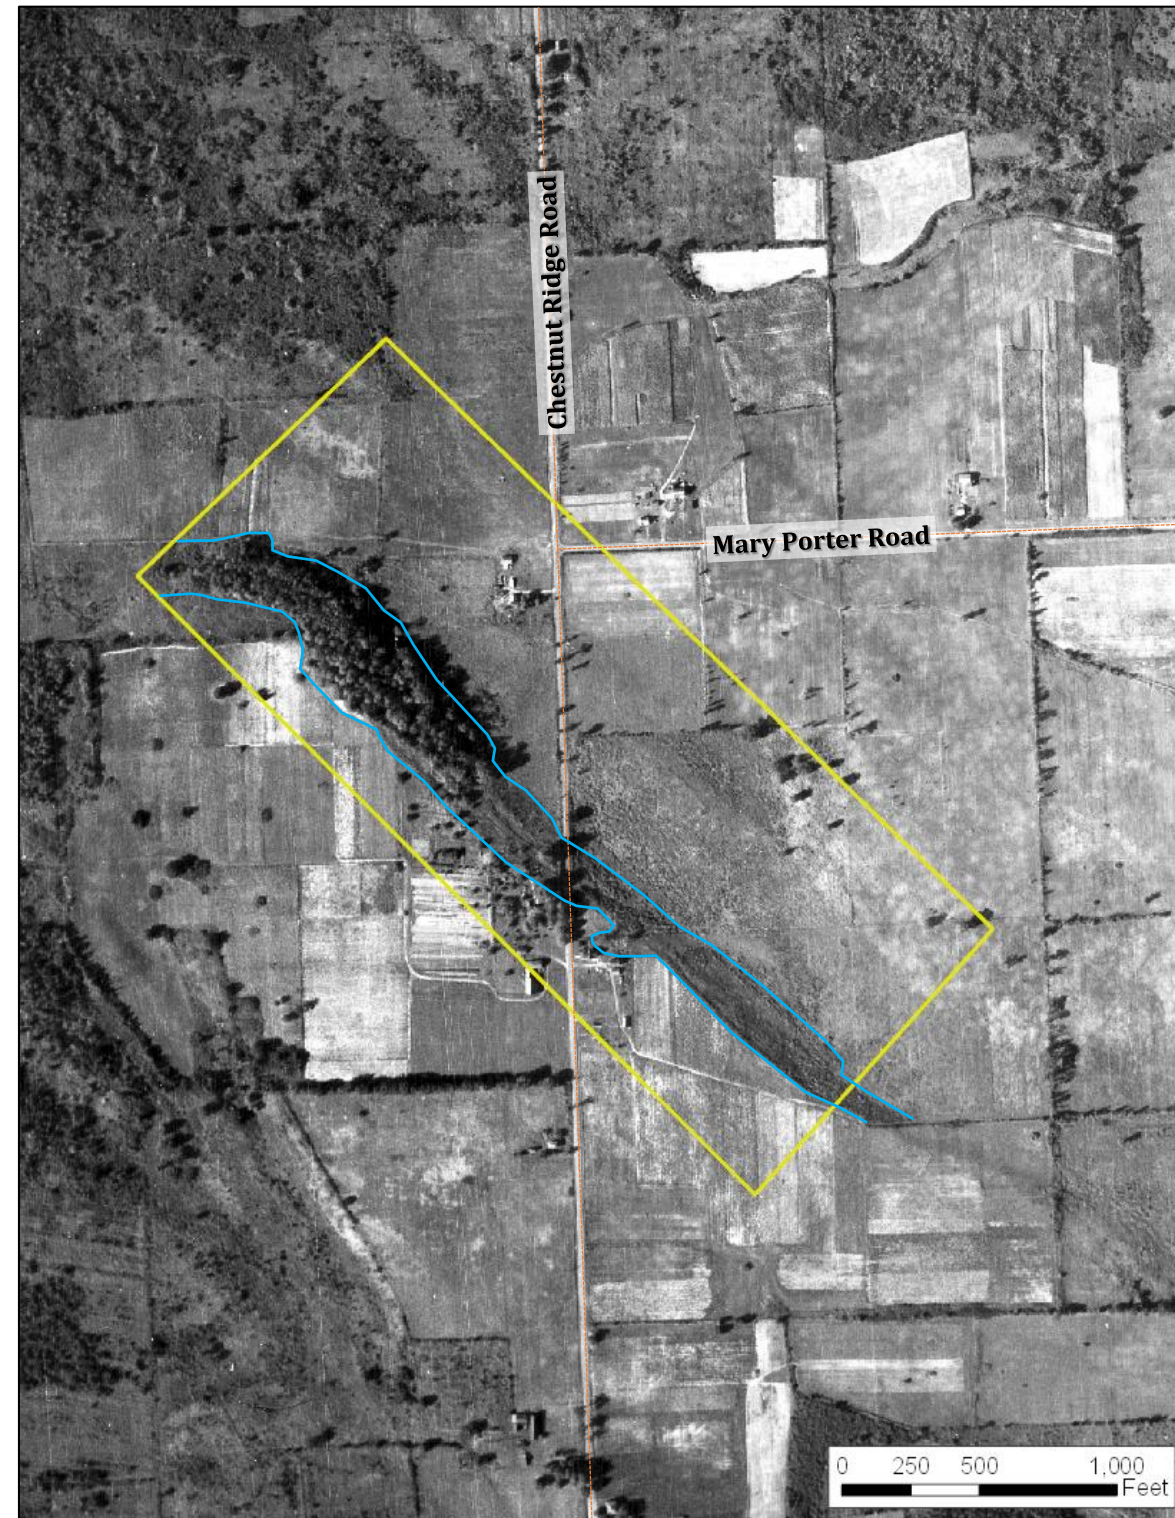
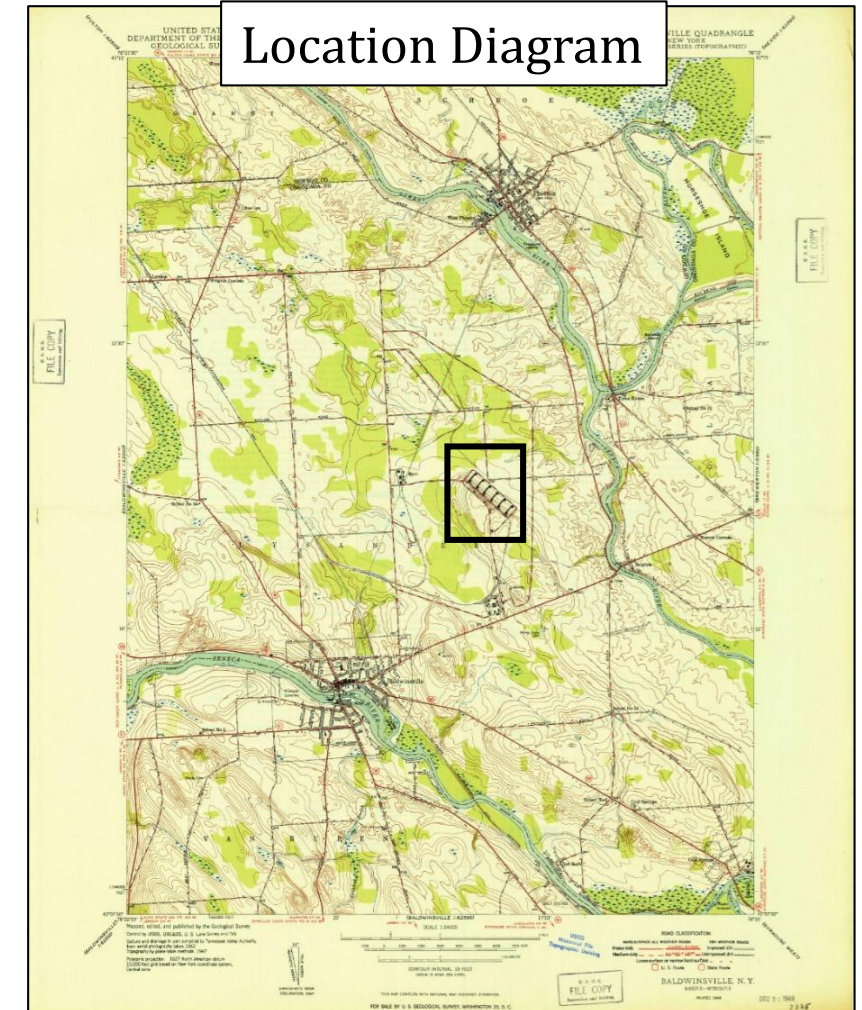
September 05, 1938

The land is primarily agricultural with some forested land cover. A natural ridge runs down near the center of the future Ammonium Picrate area and played a role in the location of this area.

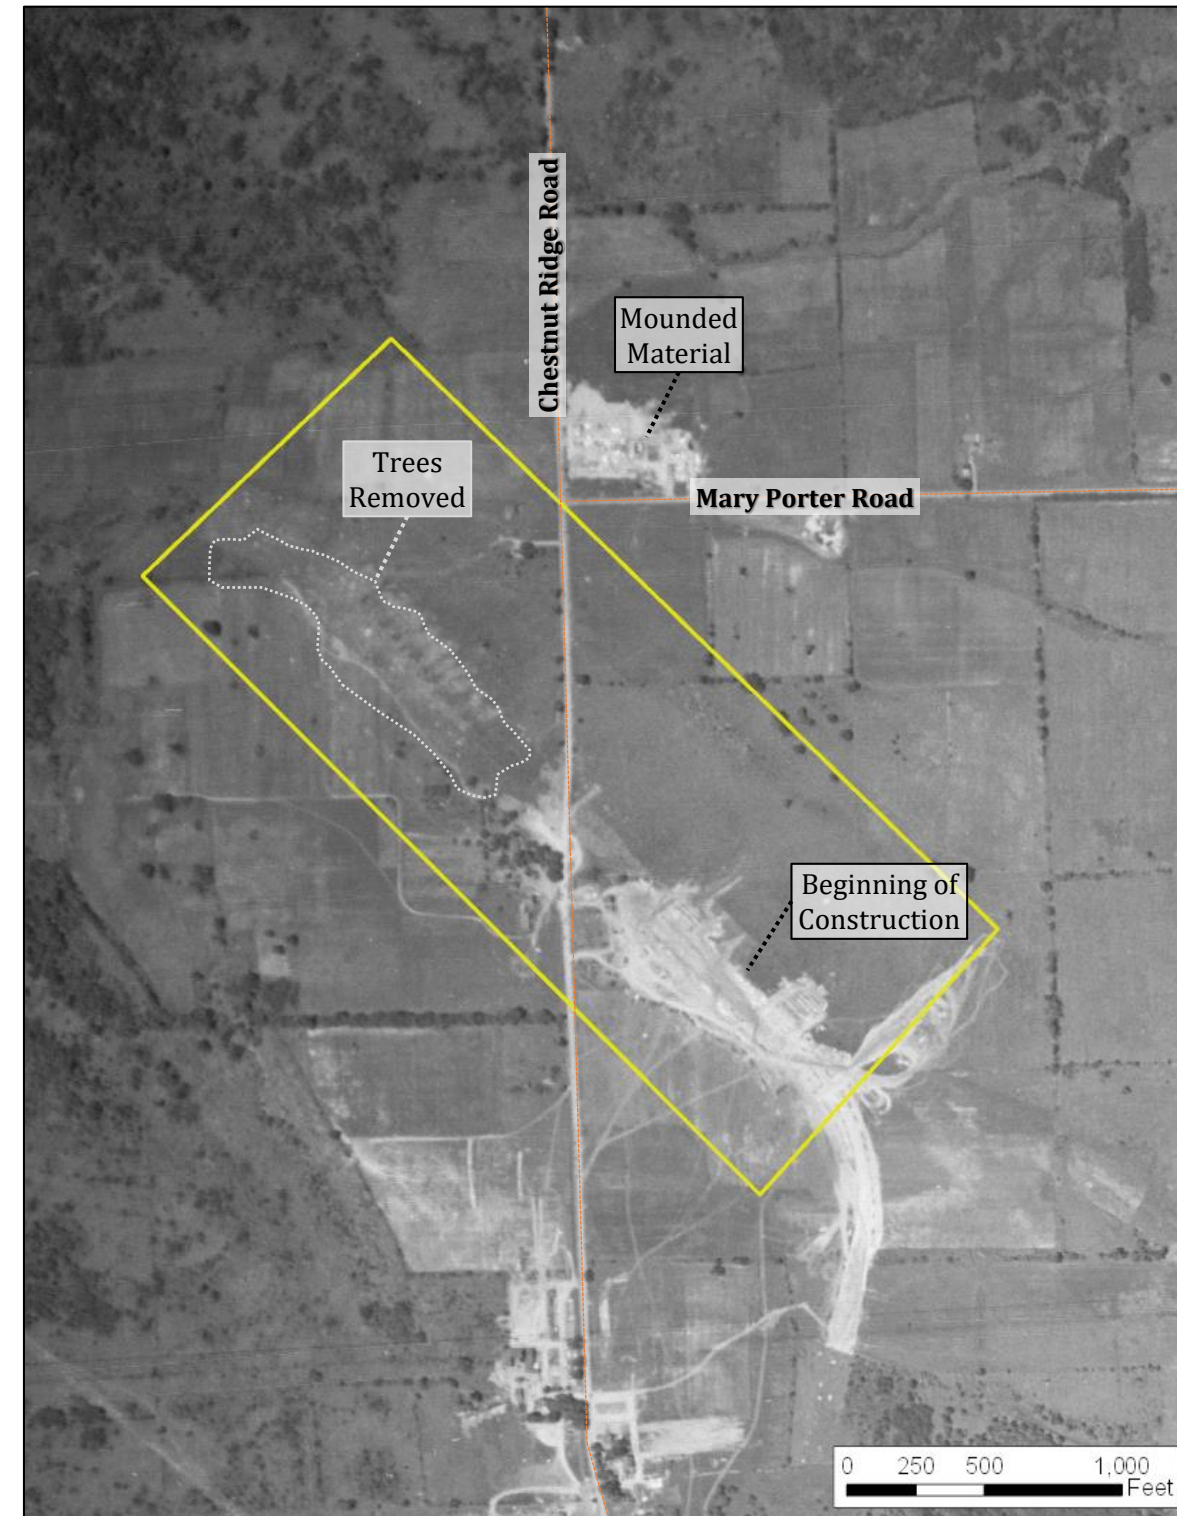
January 15, 1942

By 1942 construction of the Ammonium Picrate area has begun. Disturbed and cleared ground, along with the removal of forested area is visible during this time.

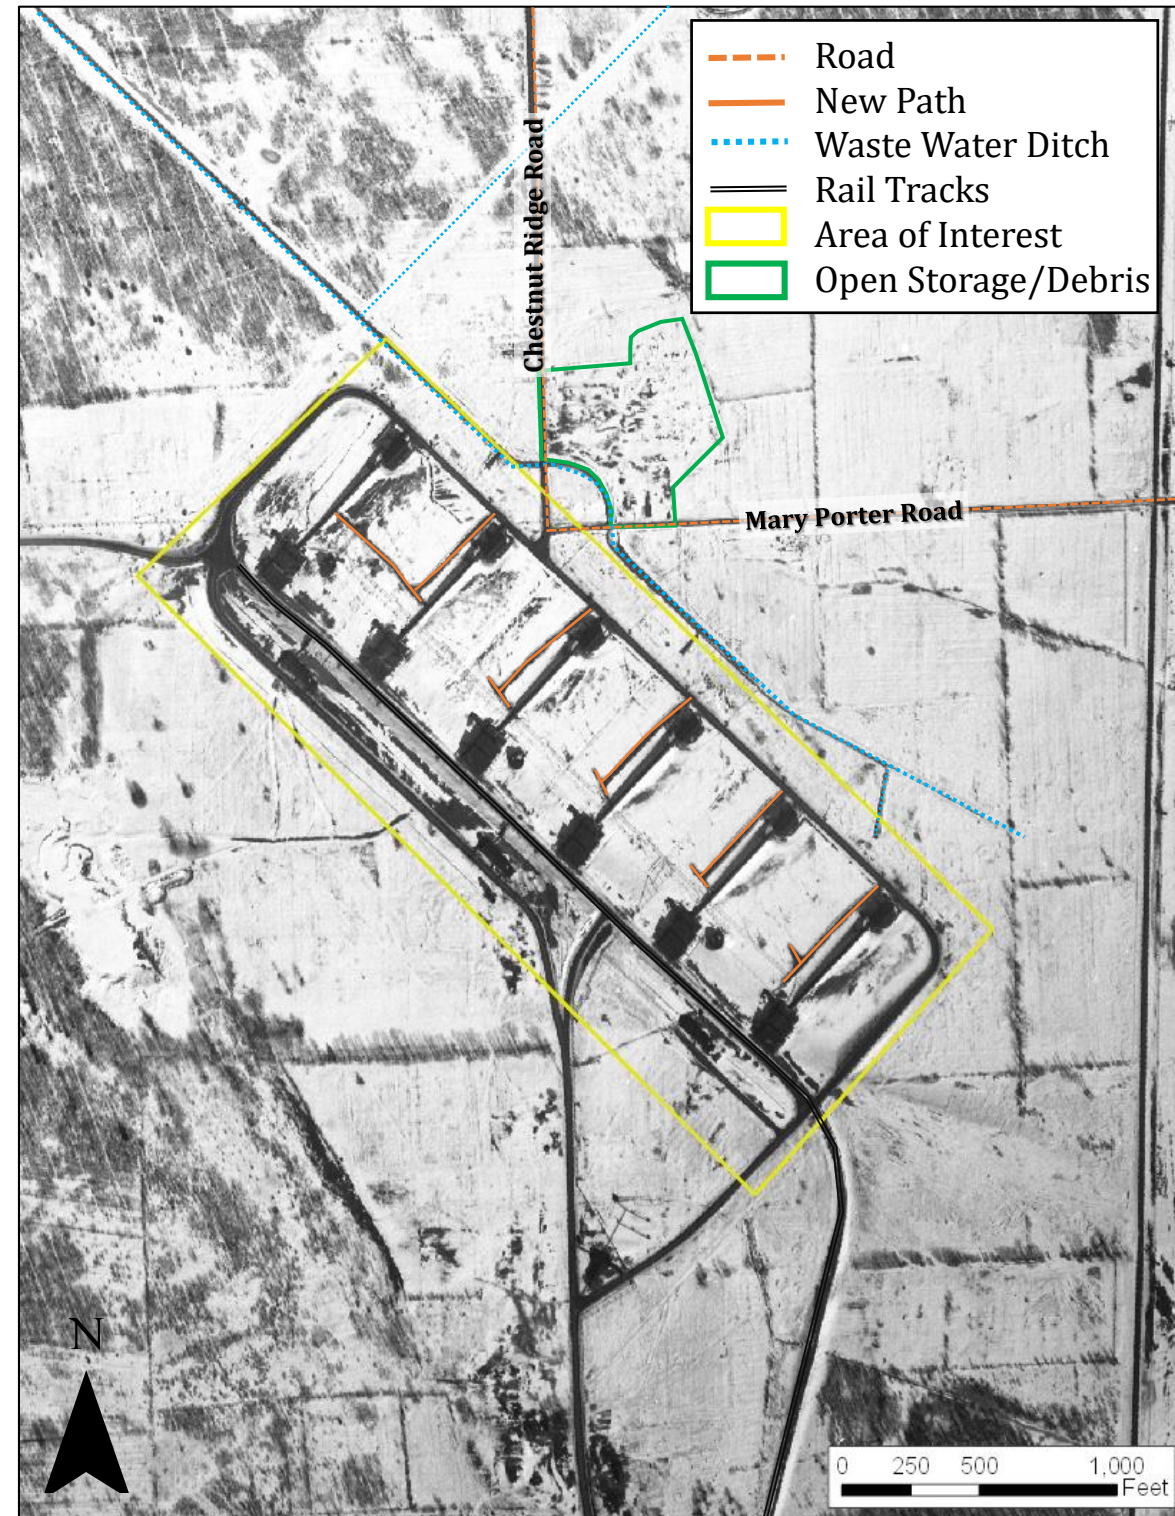
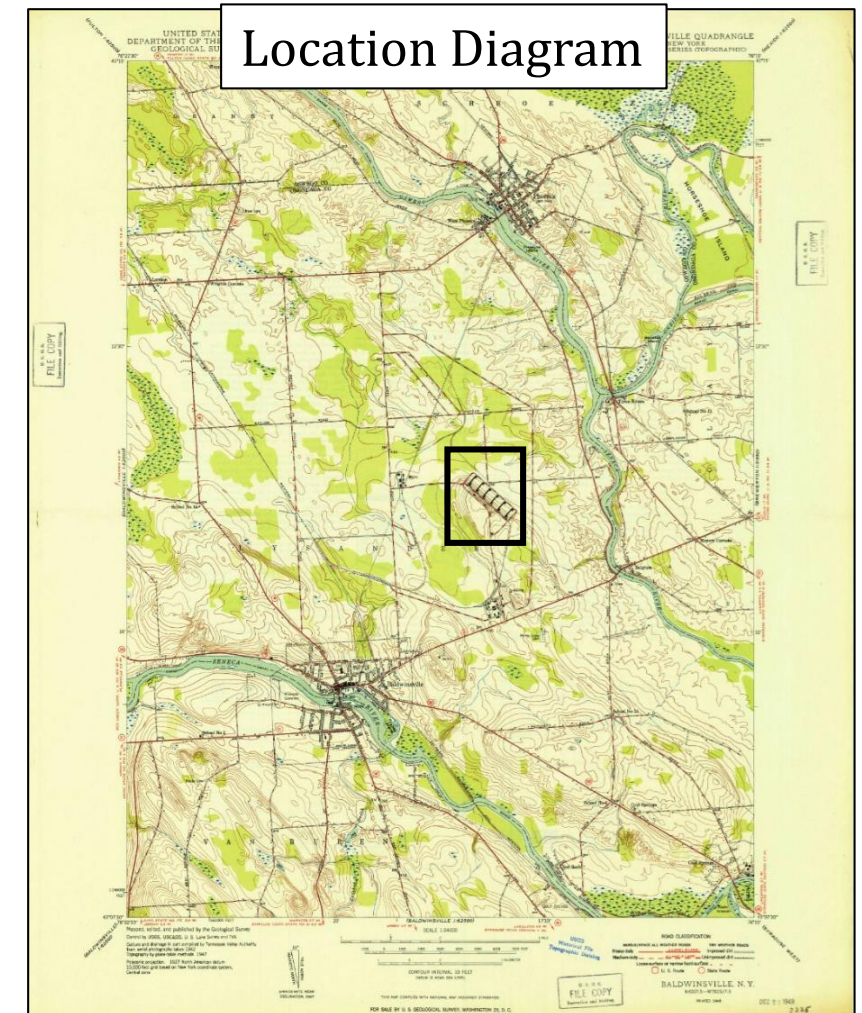
February 25, 1944

Roads around the Ammonium Picrate area are kept clear, to include the road to the borrow pit. Drainage trenches appear alongside the production lines. The open storage/dump area, while covered in snow, is still present.

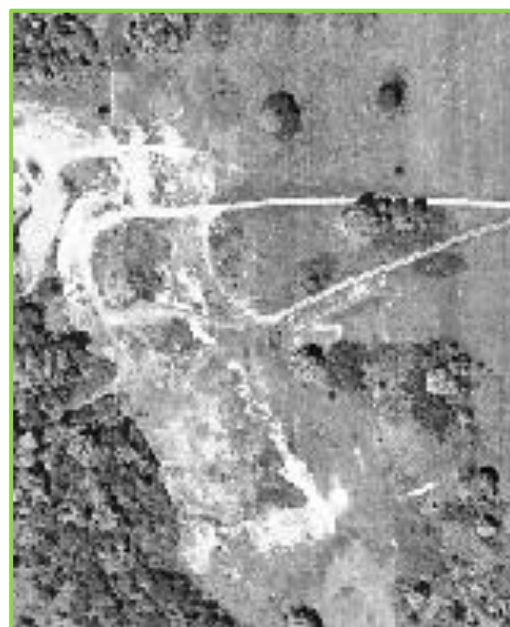
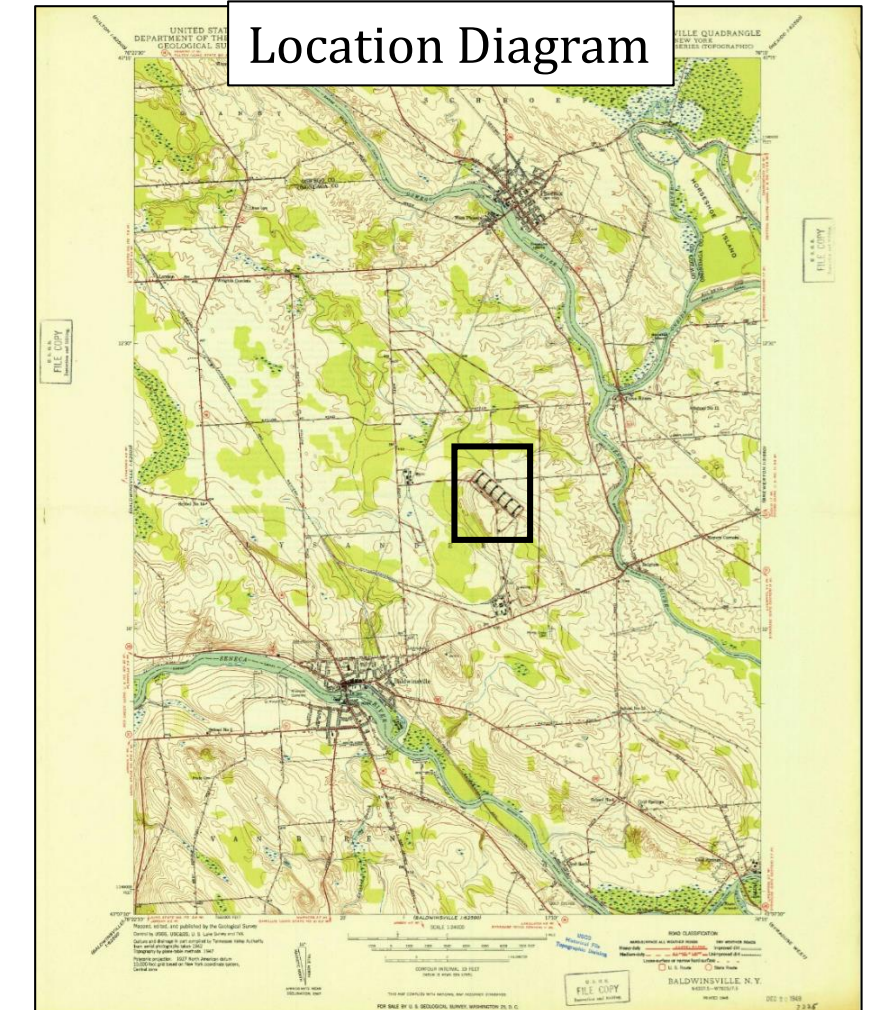
June 01, 1949

By 1949, tracks and trenches between the ammonium picrate production lines are visible and may be associated with the deconstruction of the buildings.

Some of the buildings have been removed, with just foundations remaining. The road to the borrow pit remains active and possible dumping is observed. The open storage/dump area northeast of the site has been cleared of debris and storage. The area is active.

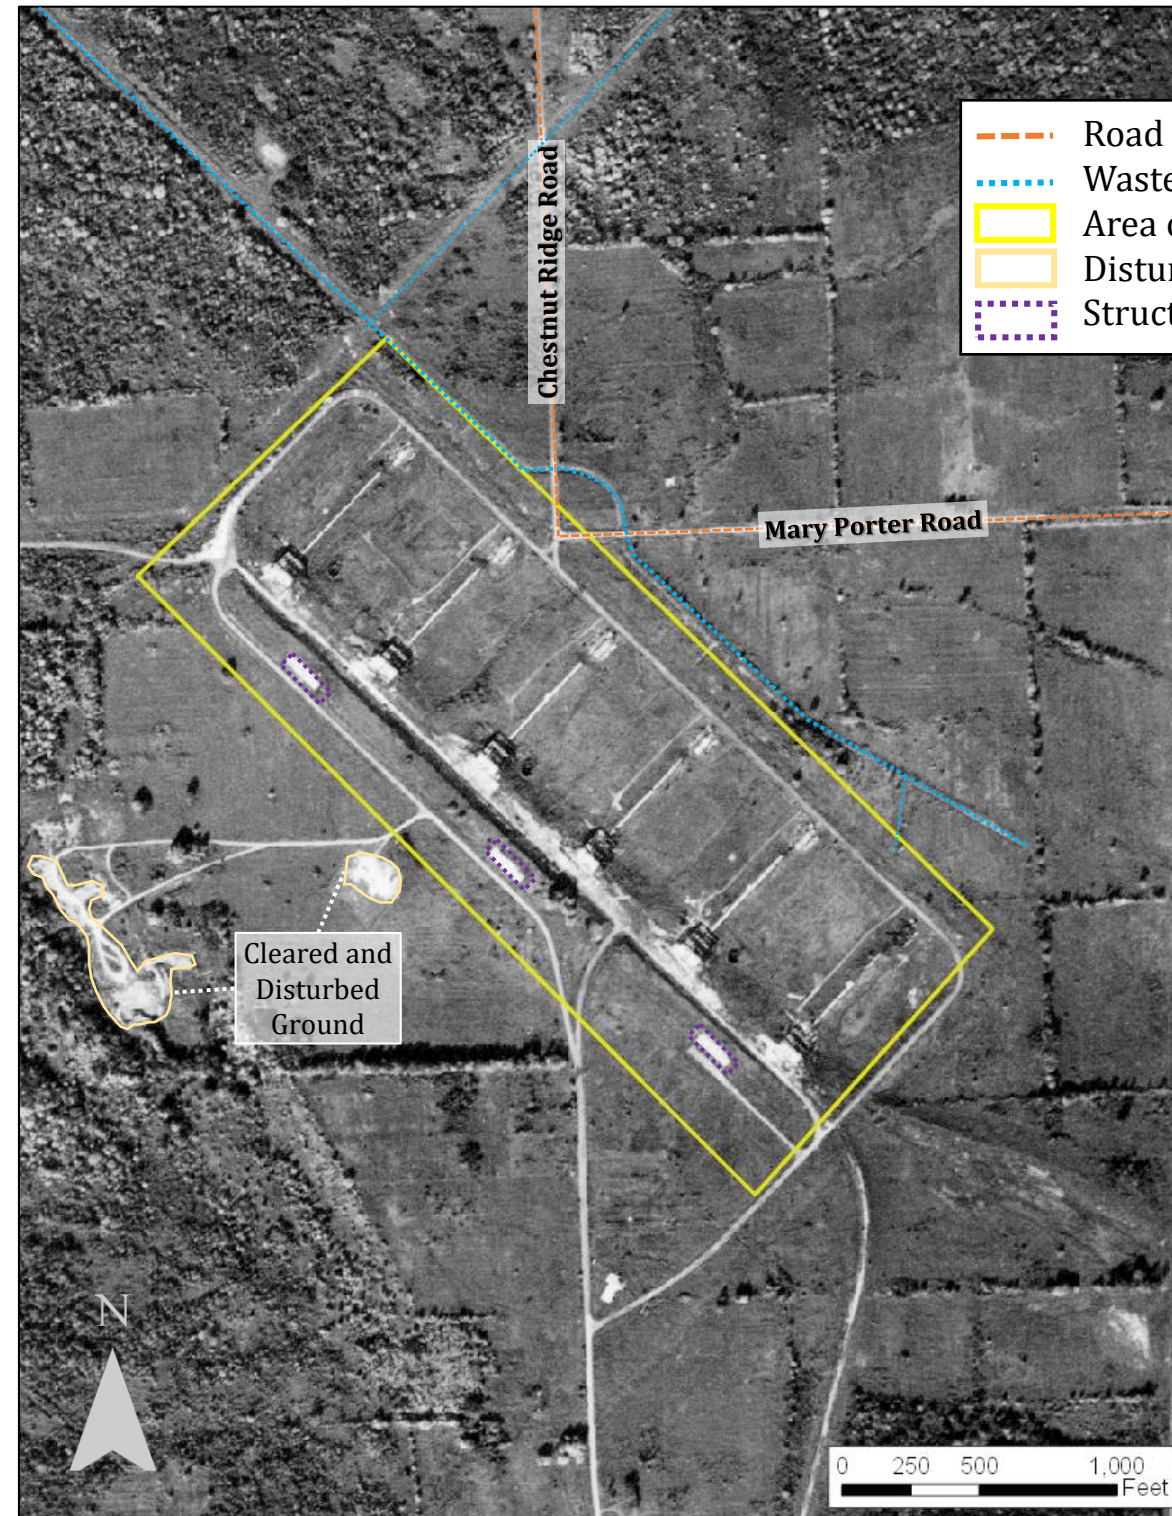
October 05, 1951

Continued use of the borrow pit area is visible. It is unclear from these photographs if the use includes dumping because mounds of material are visible within the borrow pit area. An additional area of cleared ground is visible along the road to the borrow pit. Three of the ammonium picrate buildings have been removed since 1949.
