New York Ordnance Works – Baldwinsville, New York

Historical Photographic Analysis

FINAL REPORT | JANUARY 2020
Prepared for USACE New England District

New York Ordnance Works Baldwinsville, New York Historical Photographic Analysis

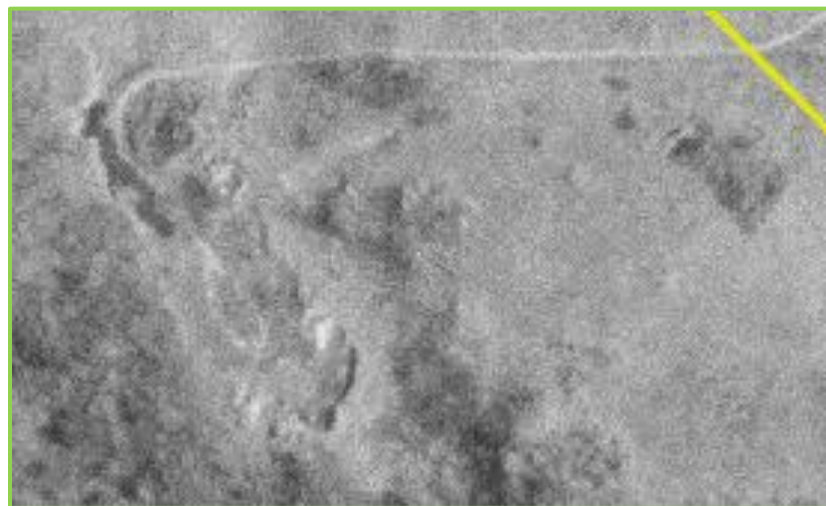
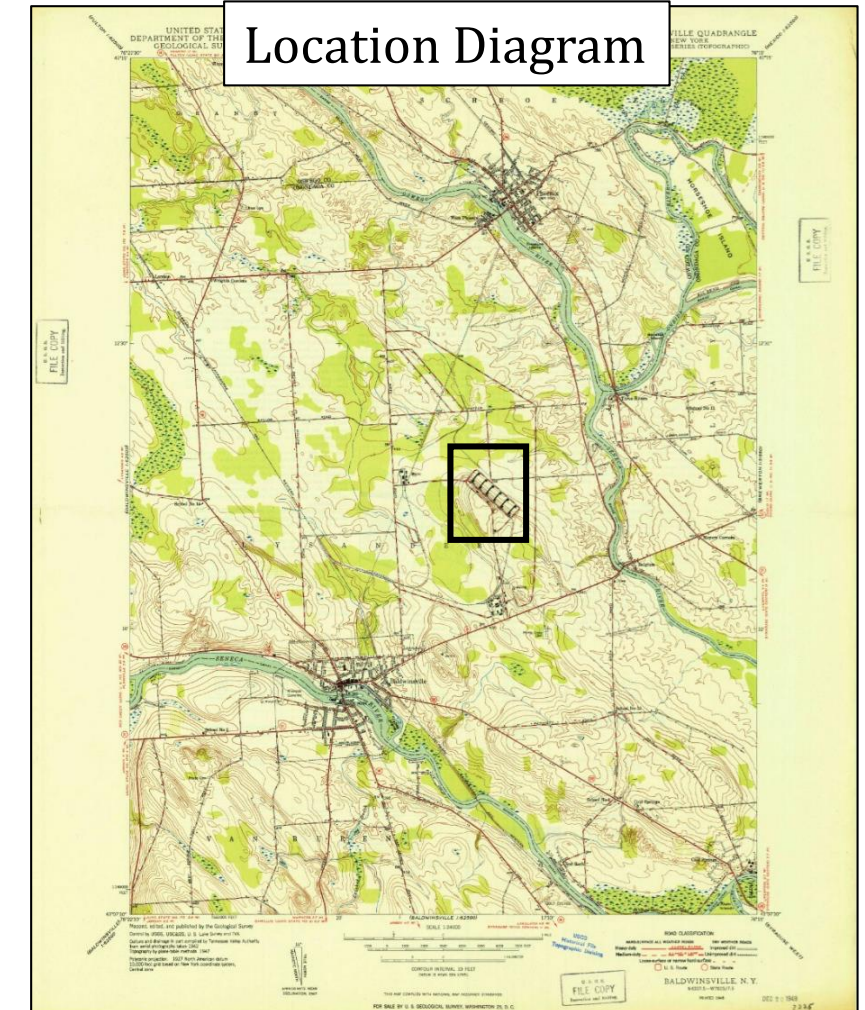
May 07, 1956

By 1956, more Ammonium Picrate buildings have been removed, although their foundations remain. The housing structures have been removed from the three above ground storage tanks within the Ammonium Picrate Area, exposing their cylindrical structures. An enlargement of the borrow pit area shows a varied landscape that could include a mix of borrowing and dumping activity.

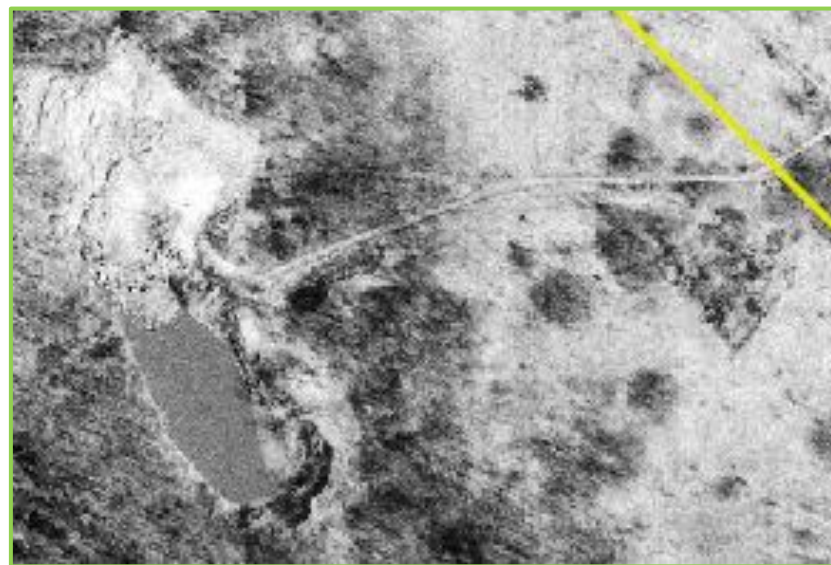
May 06, 1972

Water has filled part of the borrow pit, forming an excavation lake. To the north of this lake, large mounds of material are observed that were not visible in previous years.

A utility clearing is visible crossing northwest to southeast through the northern section of the former Ammonium Picrate area.

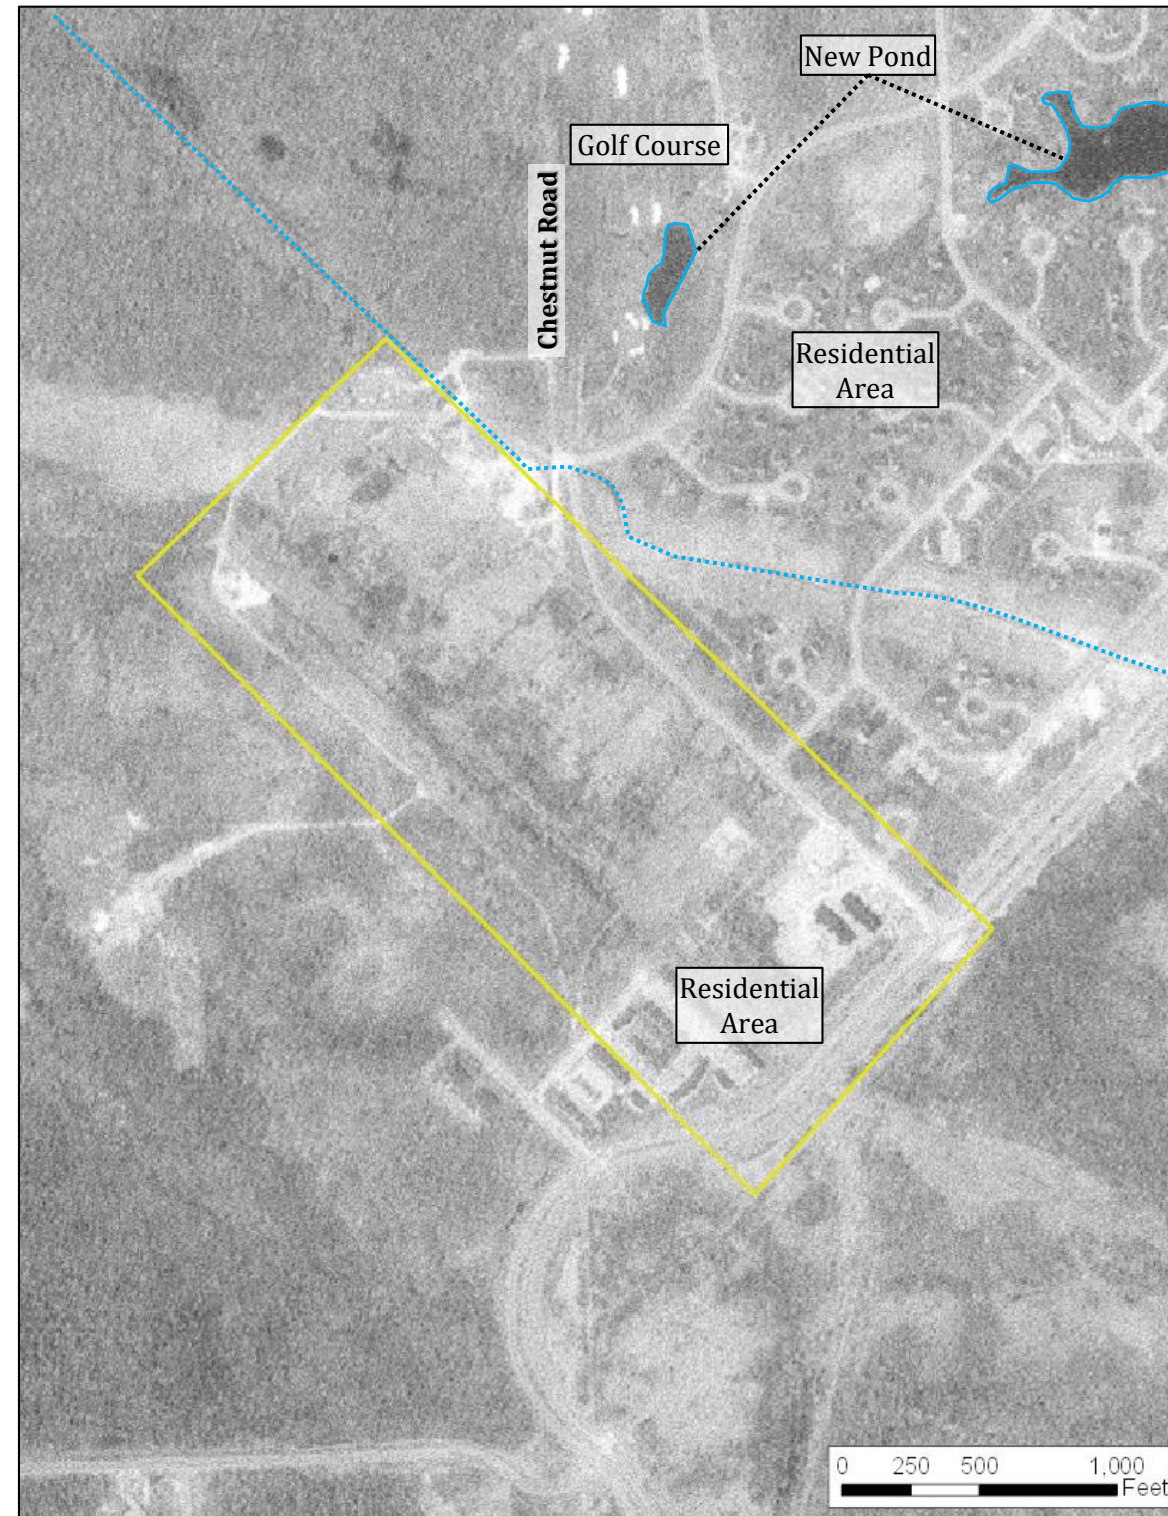
April 16, 1981

The remnants of the ammonium picrate area structures have been removed. Construction of residential roads and homes are observed. The southernmost section of the golf course is visible north of the former Ammonium Picrate area boundary. Carpenter Road no longer exists and has been built over.

Despite the poor spatial resolution of the aerial photography, it is clear that the access road and borrow pit area continue to be utilized. The drainage path to the north of the Area of Interest has been altered with the residential housing development.

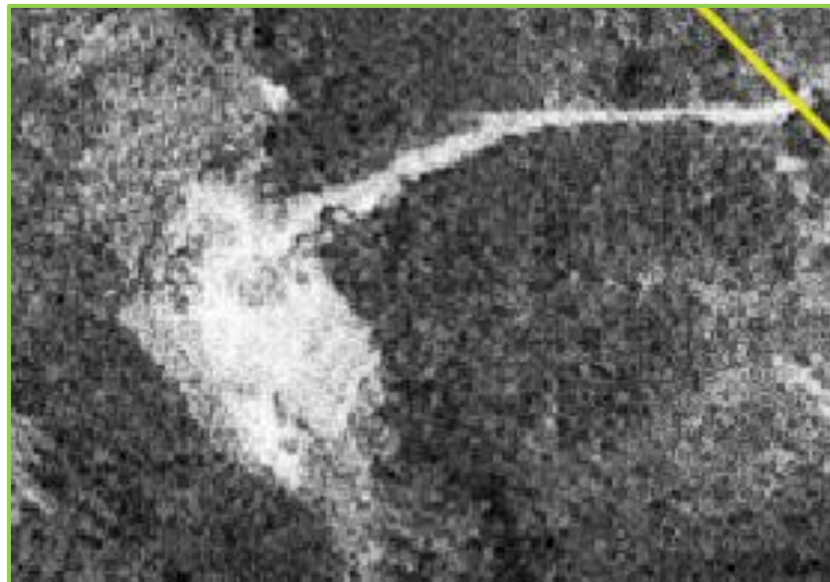
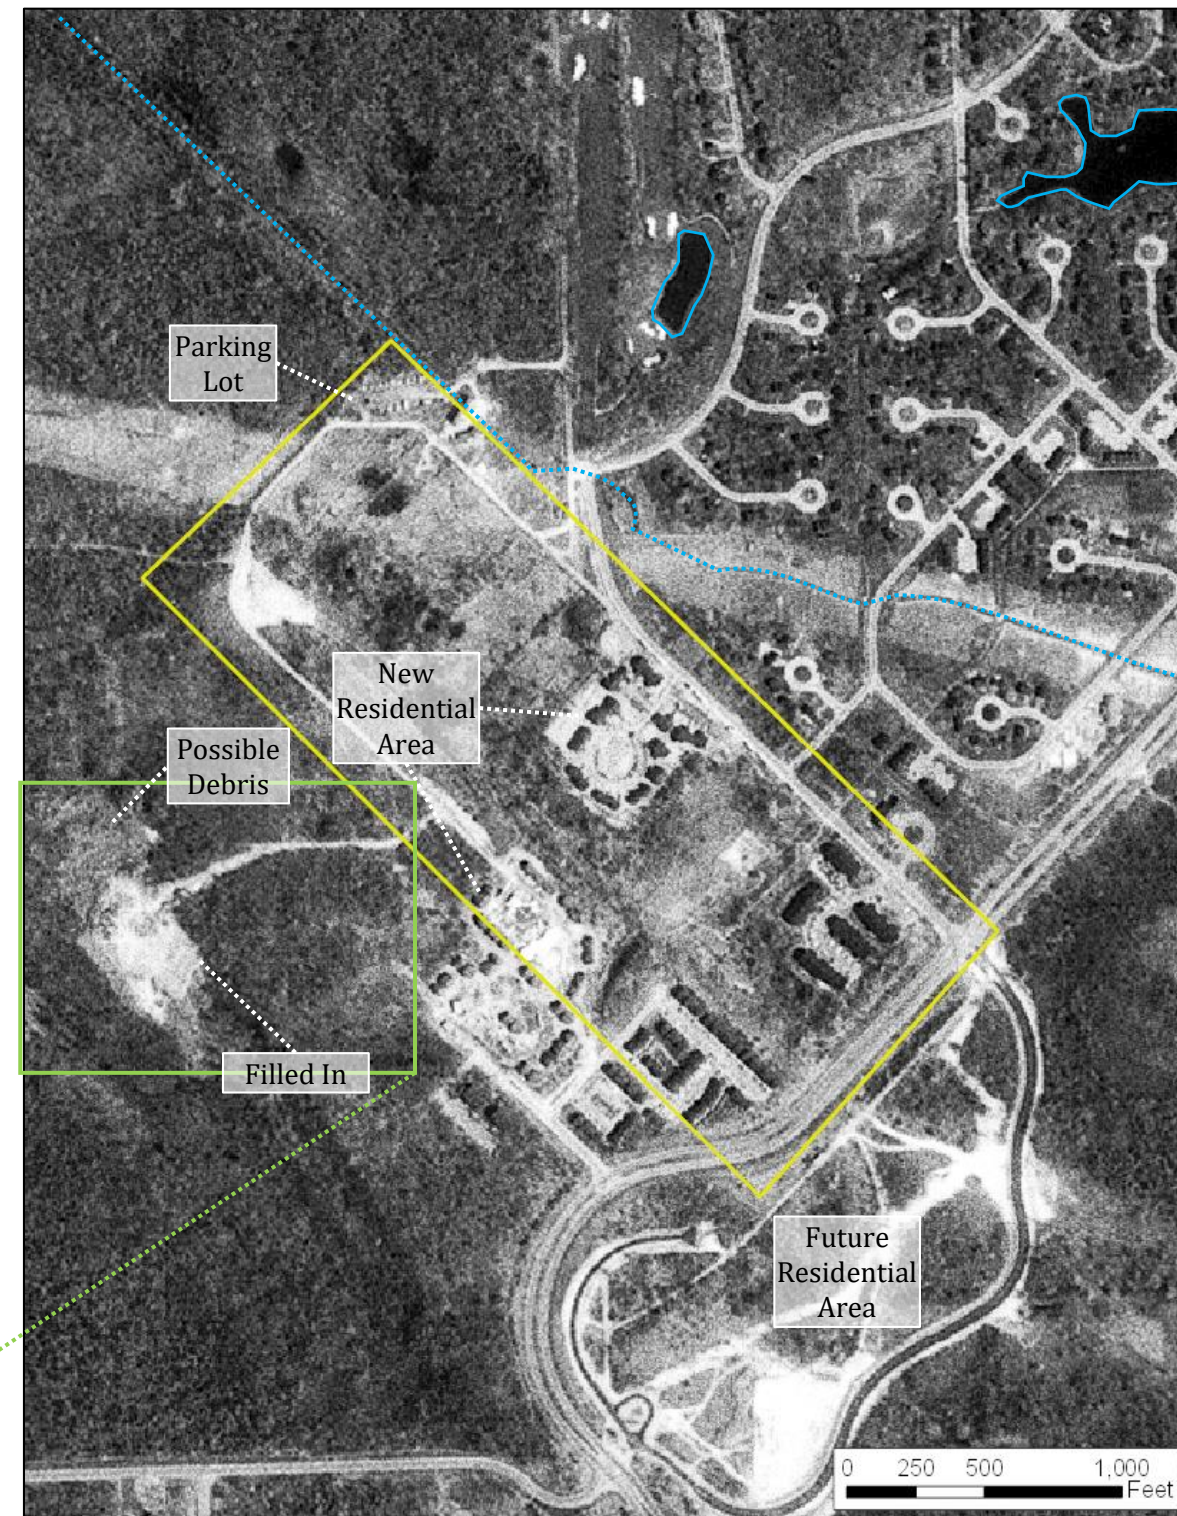
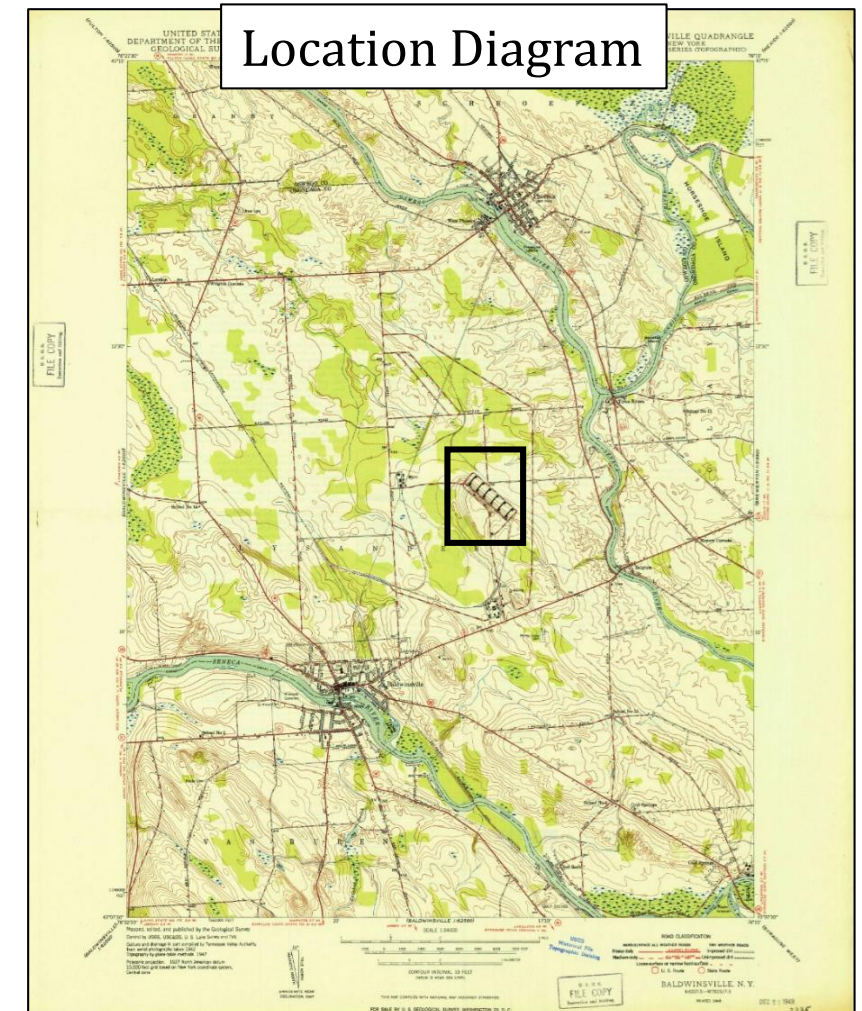
April 29, 1982

New residential housing areas have been constructed within the former Ammonium Picrate area. The access road and borrow pit area continue to be utilized. The excavation lake observed earlier has been filled in, possibly with construction debris.

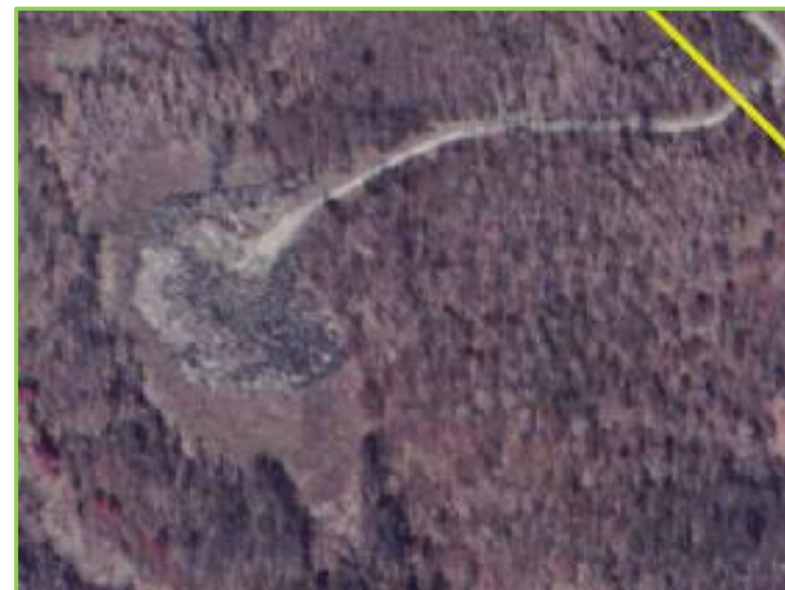
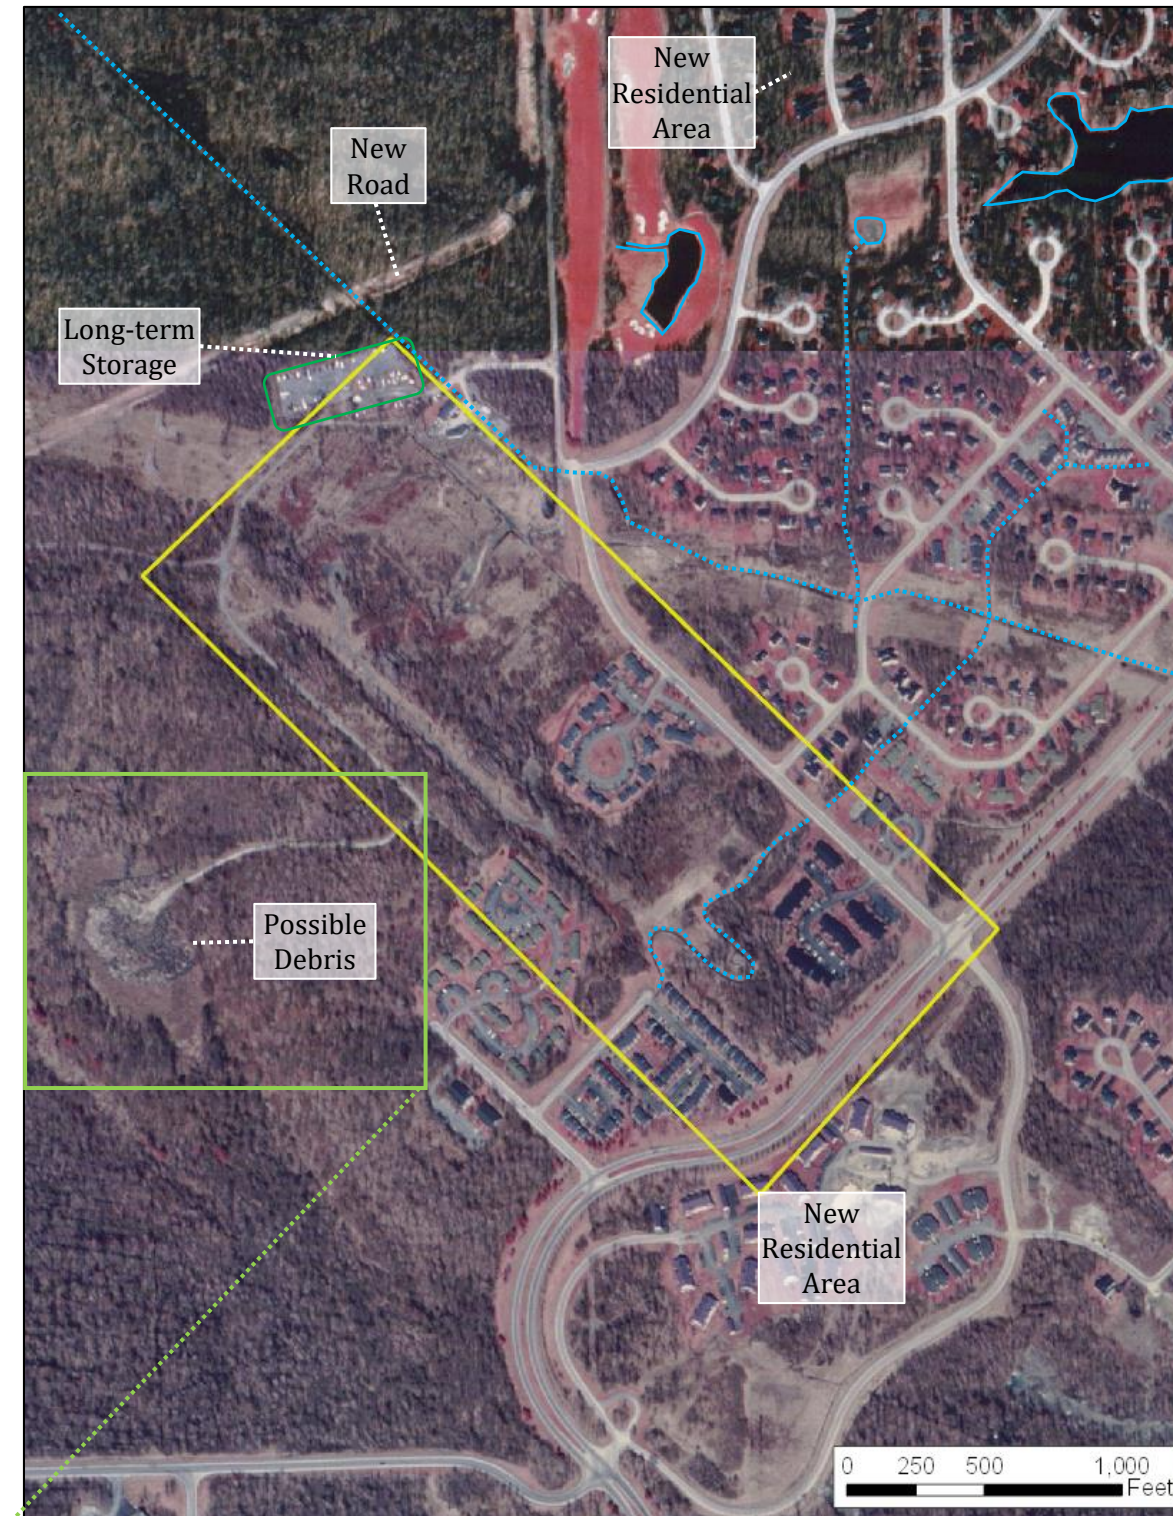
March 27, 1995

Continued development of residential housing is observed southeast of the former Ammonium Picrate area.

A former parking lot has been expanded and turned into long-term storage for large vehicles such as boats and RVs.

The access road to the former borrow pit is still active and large area of material is visible.

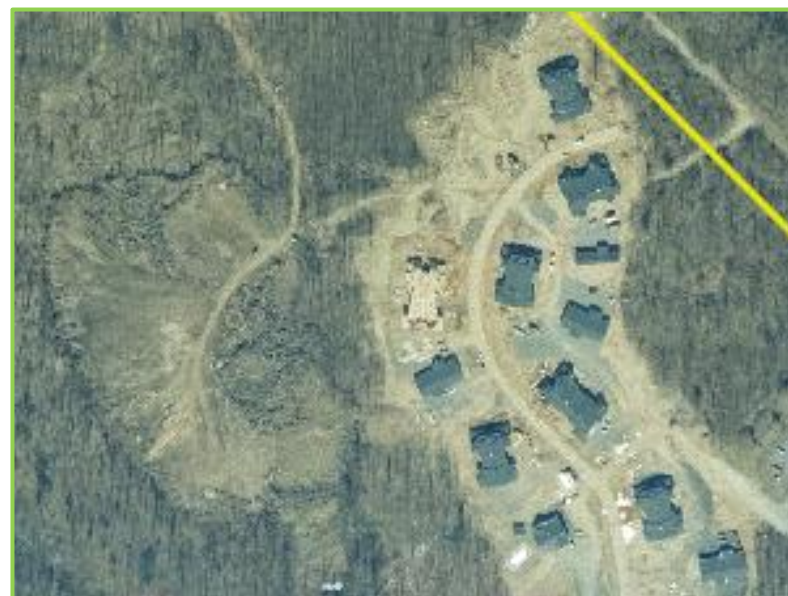
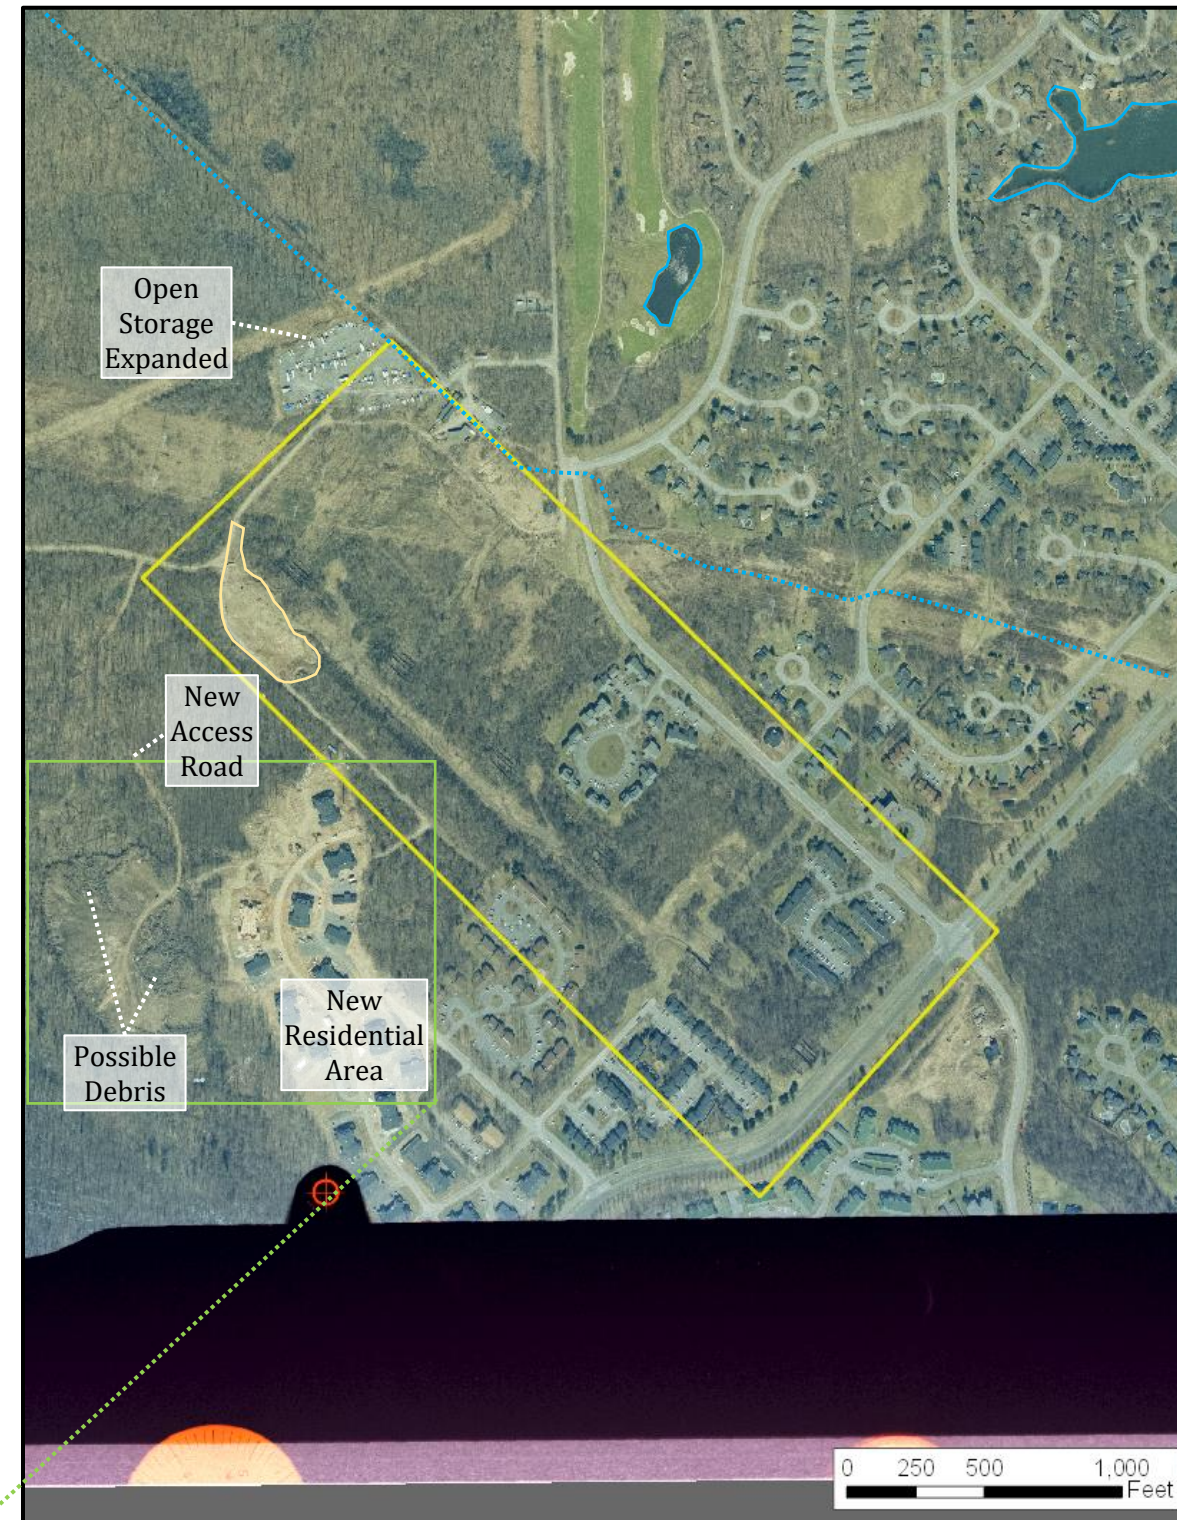
April 14, 2003

By 2003 a new residential housing area is being constructed west of the former Ammonium Picrate area. This new housing area is adjacent to the former borrow pit area. A new access road from the north connects to the former borrow pit area. The long-term open storage area has been expanded upon. An area of disturbed ground can be seen in the northwestern corner of the former Ammonium Picrate area boundary.

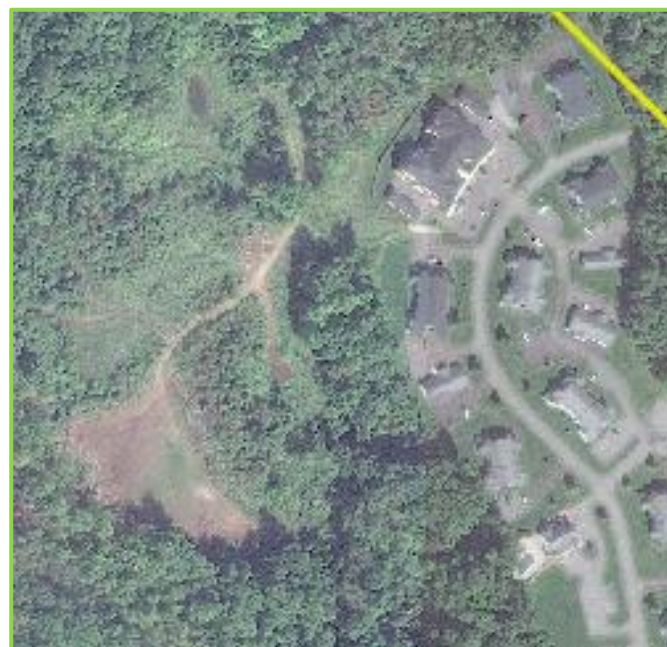
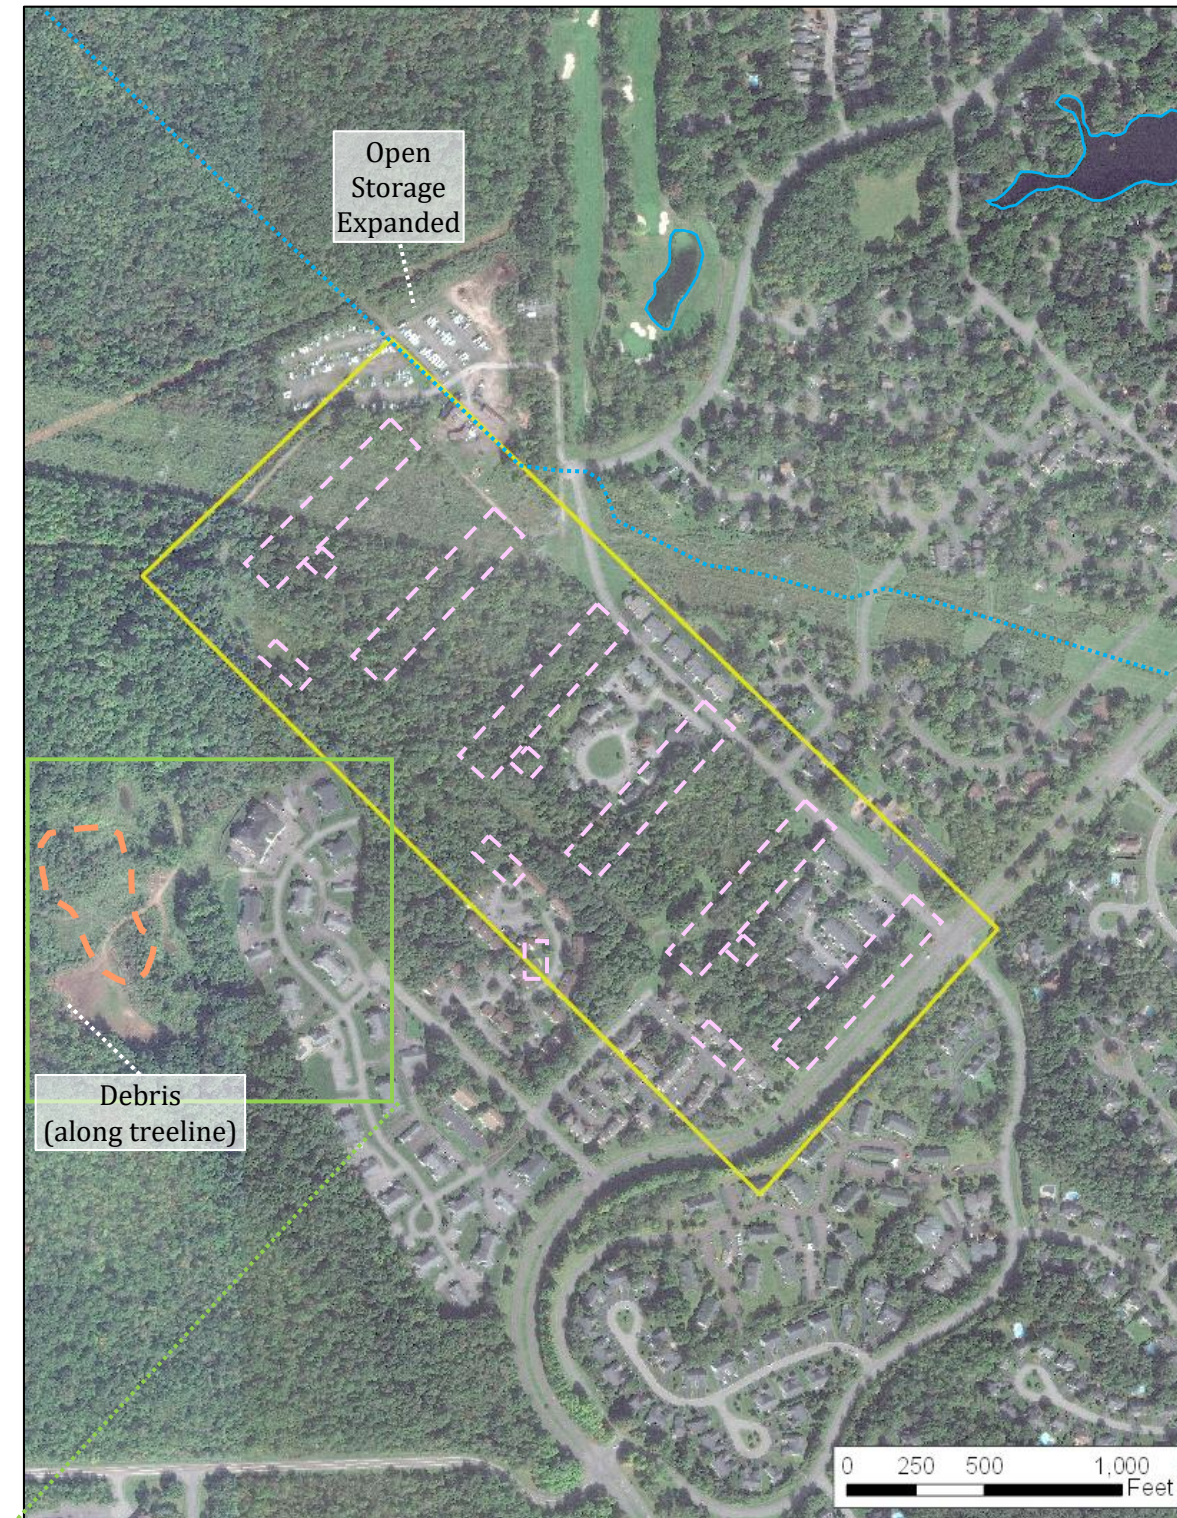
September 25, 2019

The 1943 former Ammonium Picrate area structures, including the borrow pit extent, are overlaying this 2019 image.

The land in and around the former Ammonium Picrate area is mostly residential and forest. The former borrow pit site (and subsequent dumping site) has largely revegetated, however there is still evidence of active use. The long-term open storage area has again been expanded.

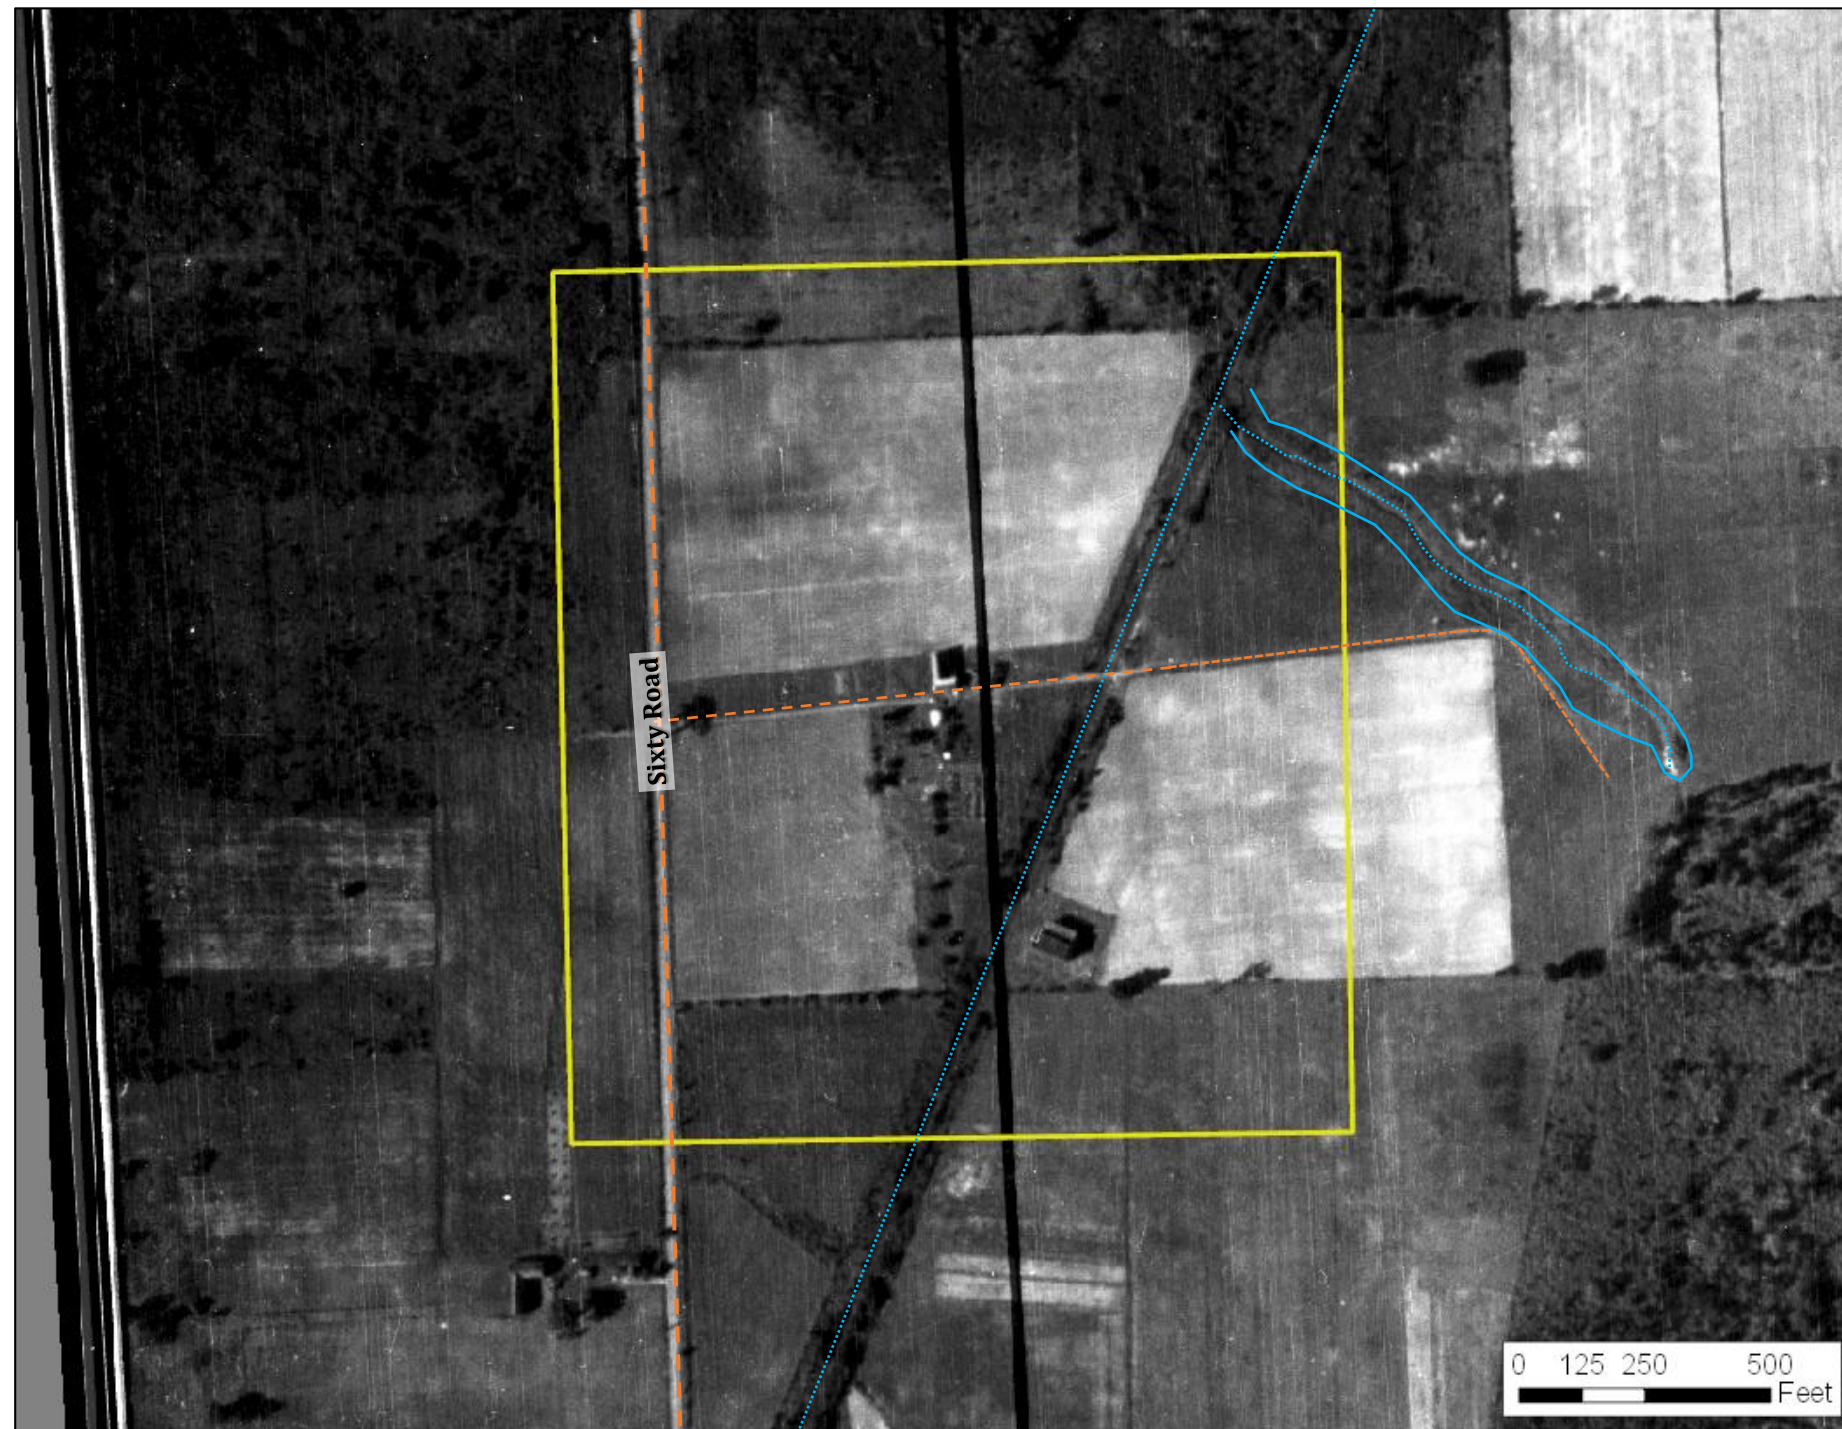
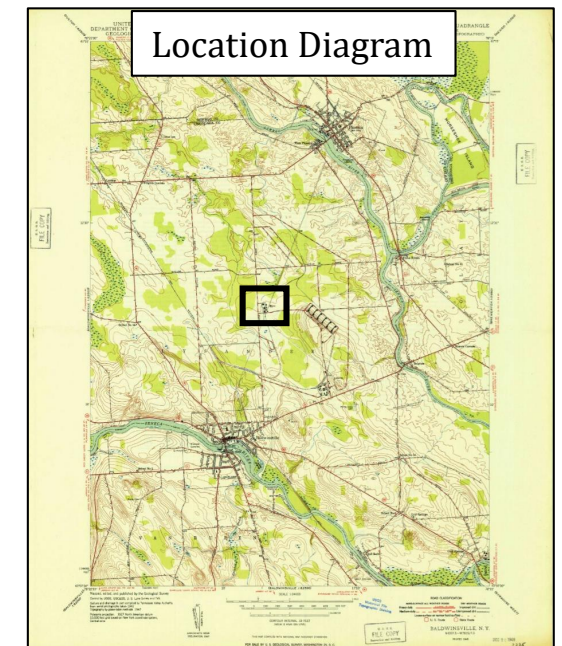
September 05, 1938

The land is primarily agricultural with some farming and residential structures visible.

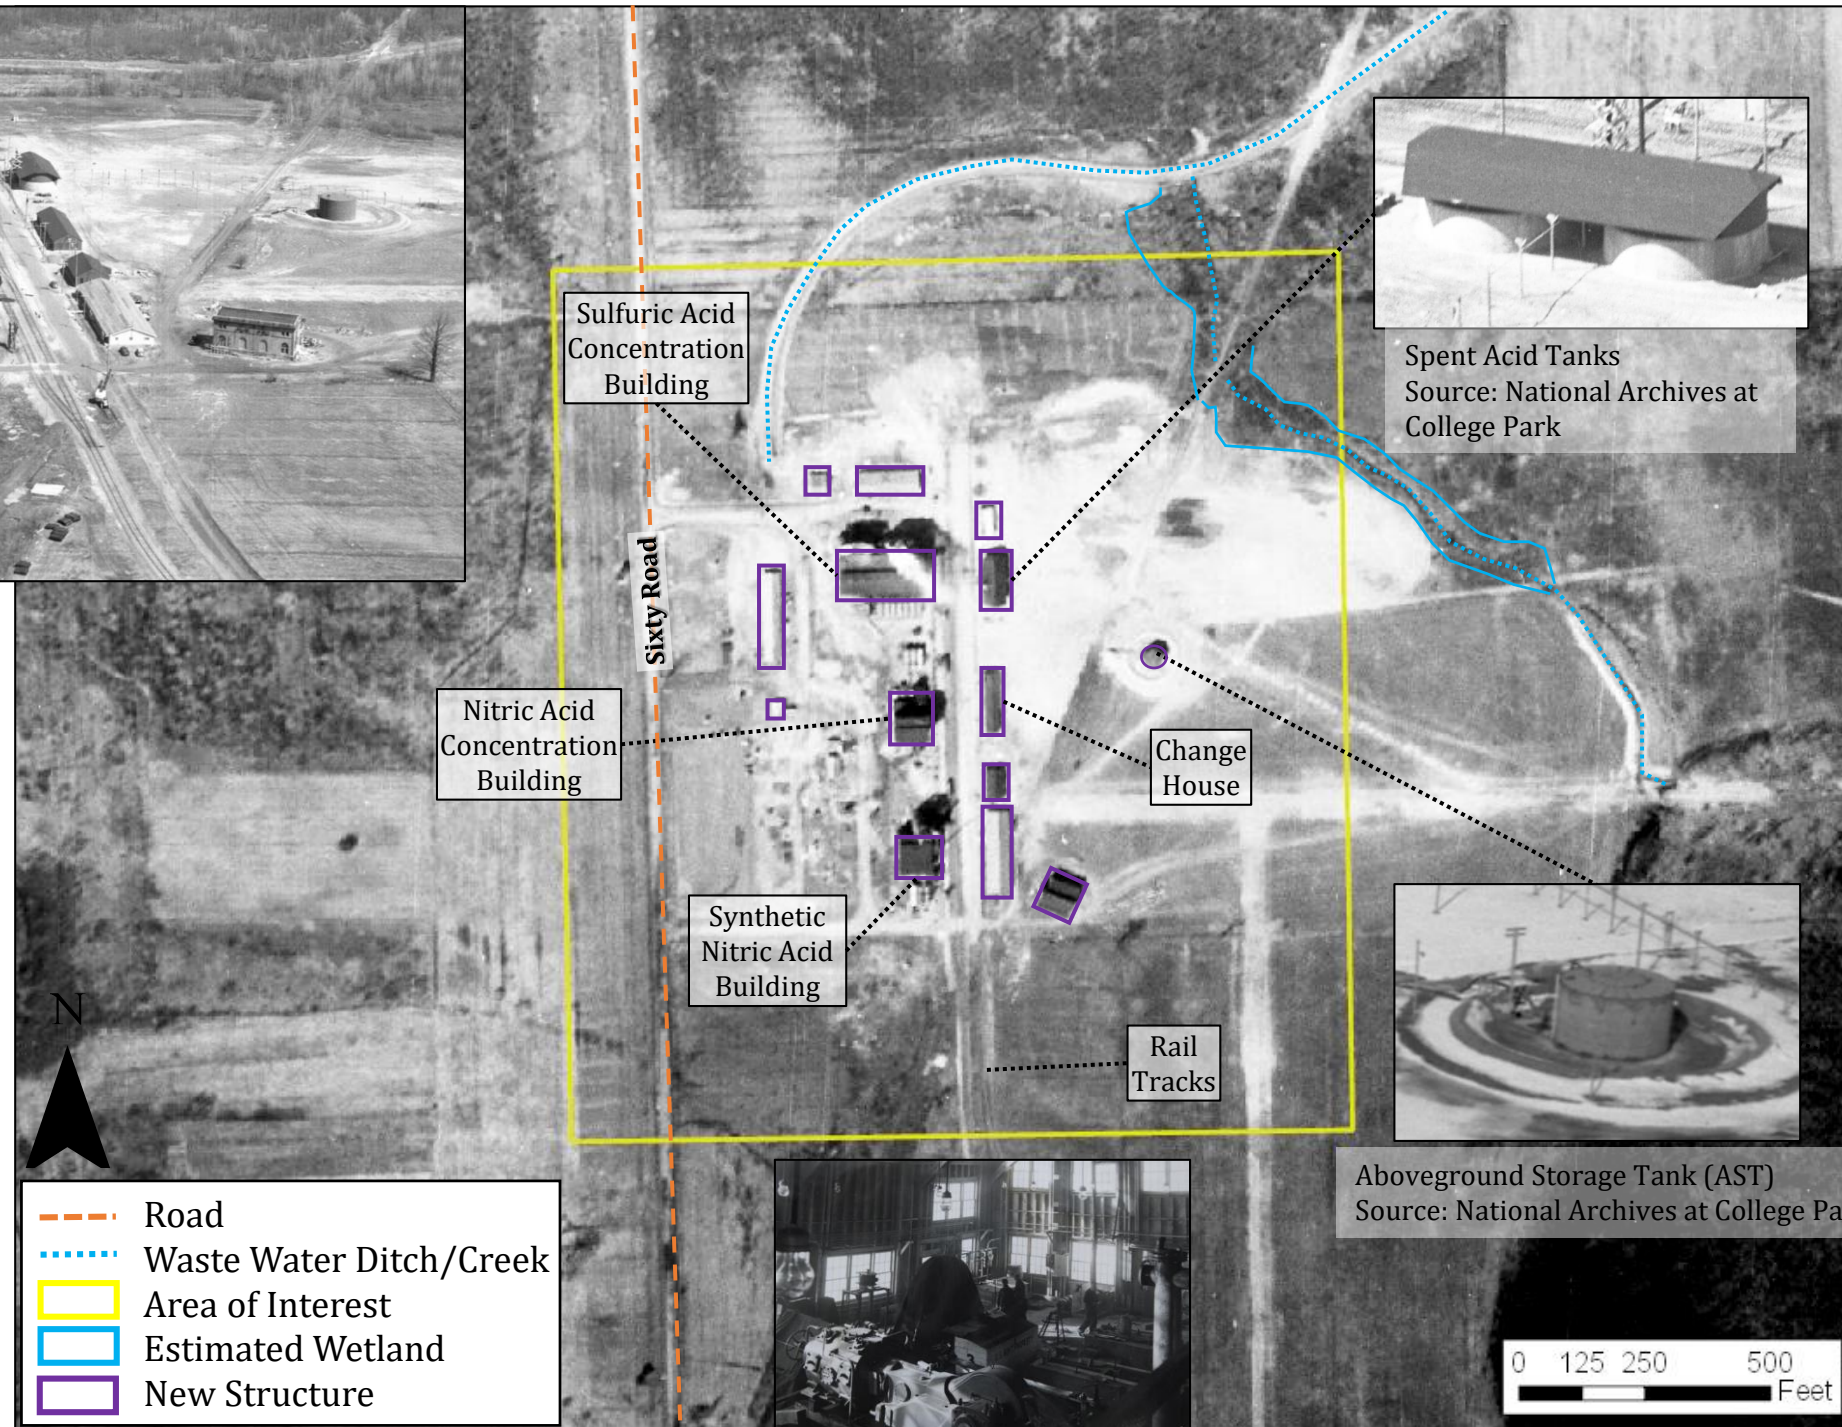
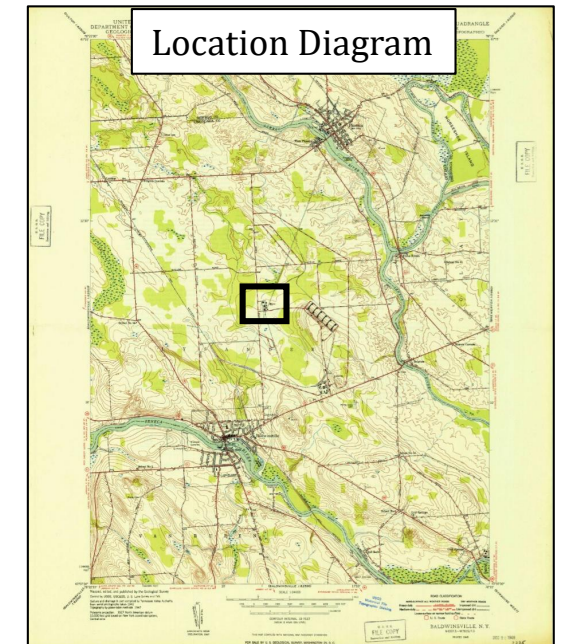
April 11, 1943

By 1943 the buildings and infrastructure making up the Acid Area are visible.

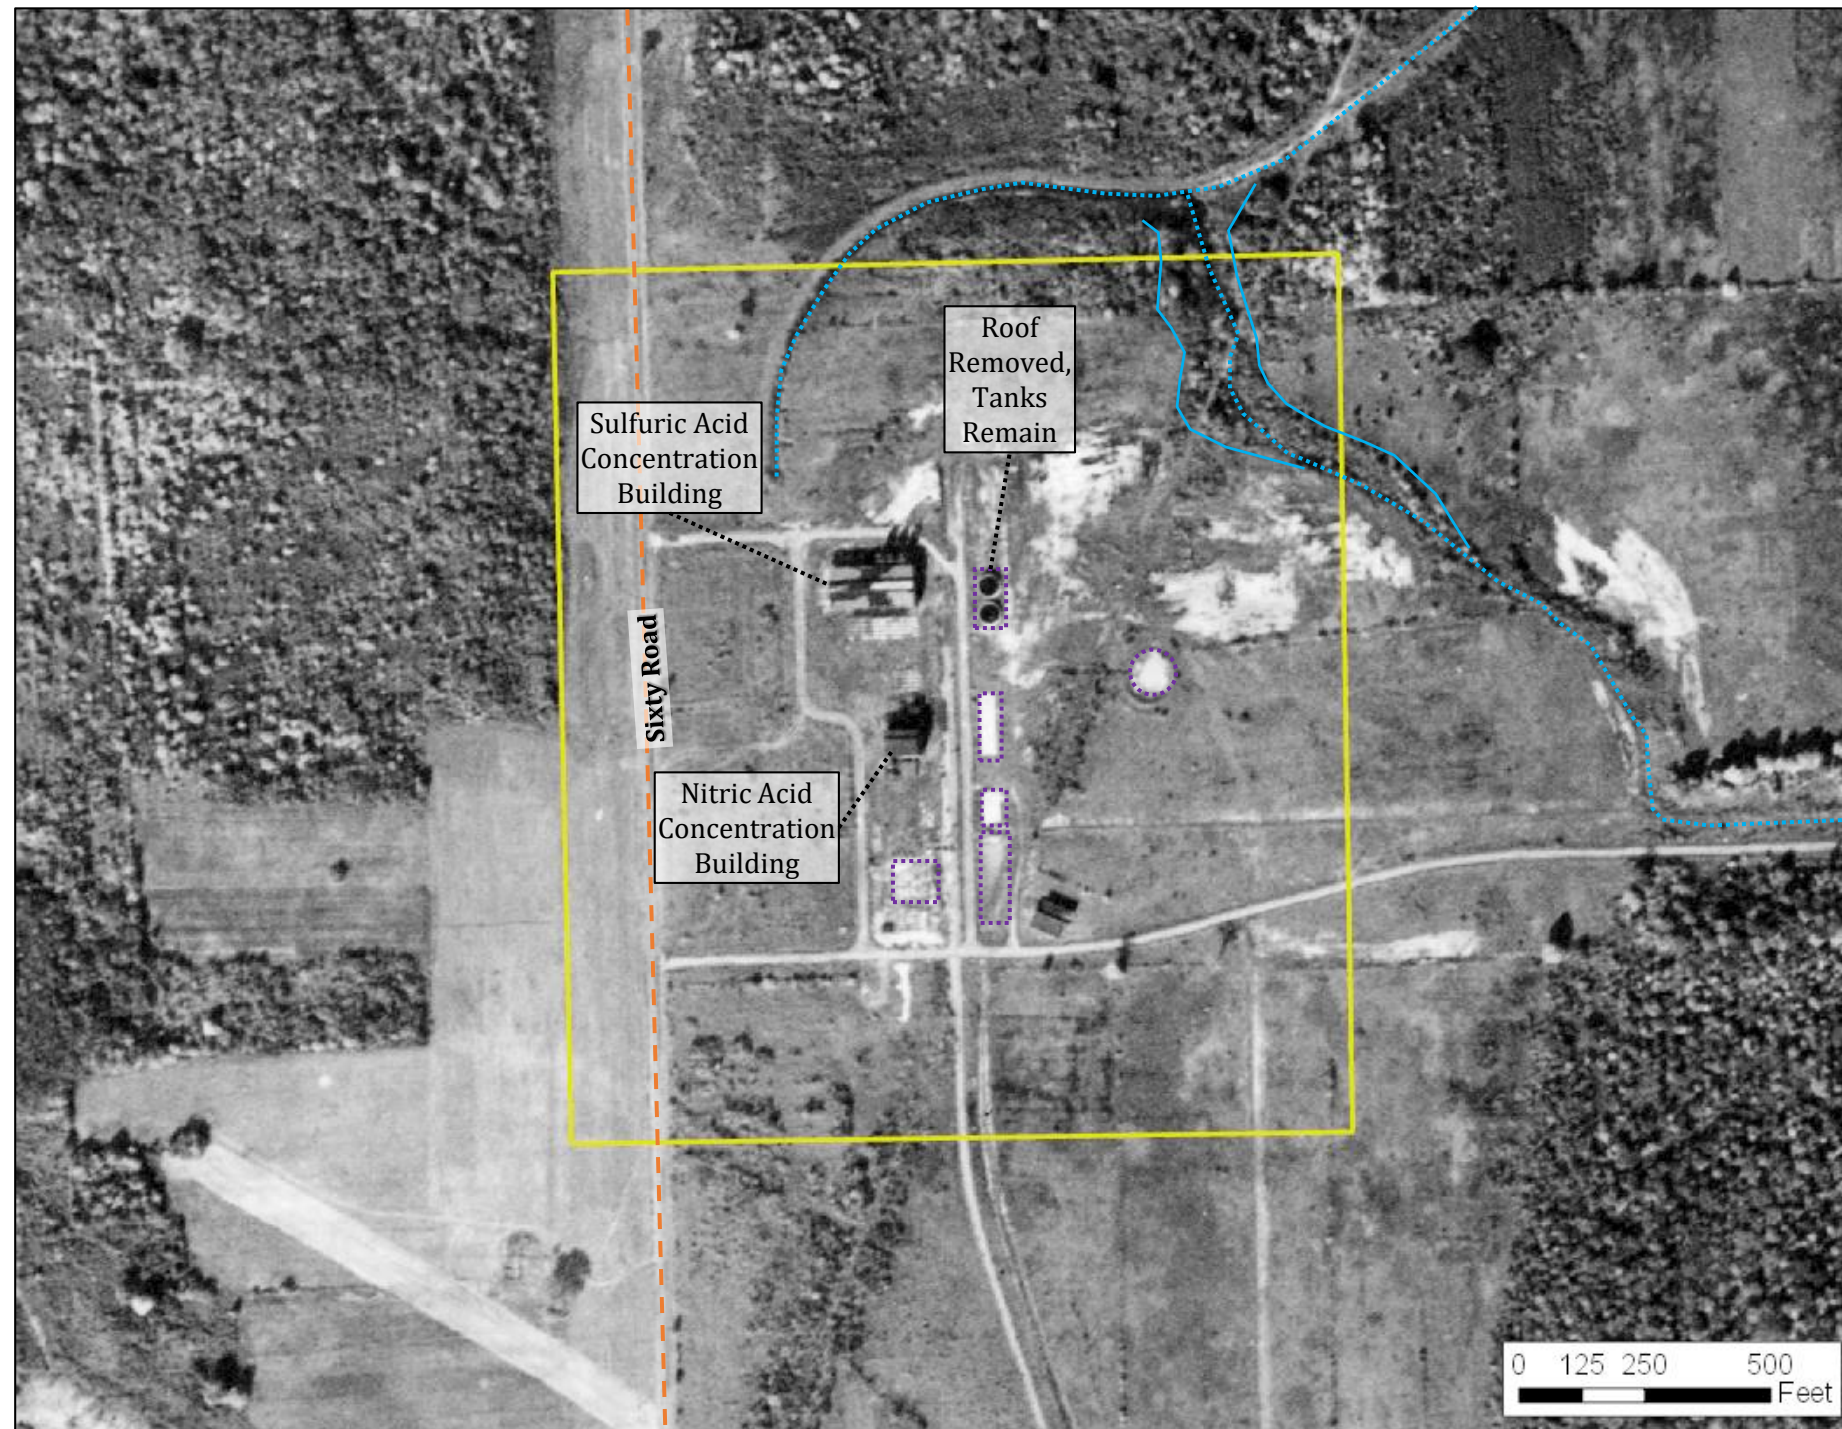
October 05, 1951

Numerous structures have been removed by 1951. The foundations remain for some of these features. The roof over the spent acid tanks has been removed, however the tanks remain.
