New York Ordnance Works – Baldwinsville, New York

Historical Photographic Analysis

FINAL REPORT | JANUARY 2020
Prepared for USACE New England District

New York Ordnance Works Baldwinsville, New York Historical Photographic Analysis

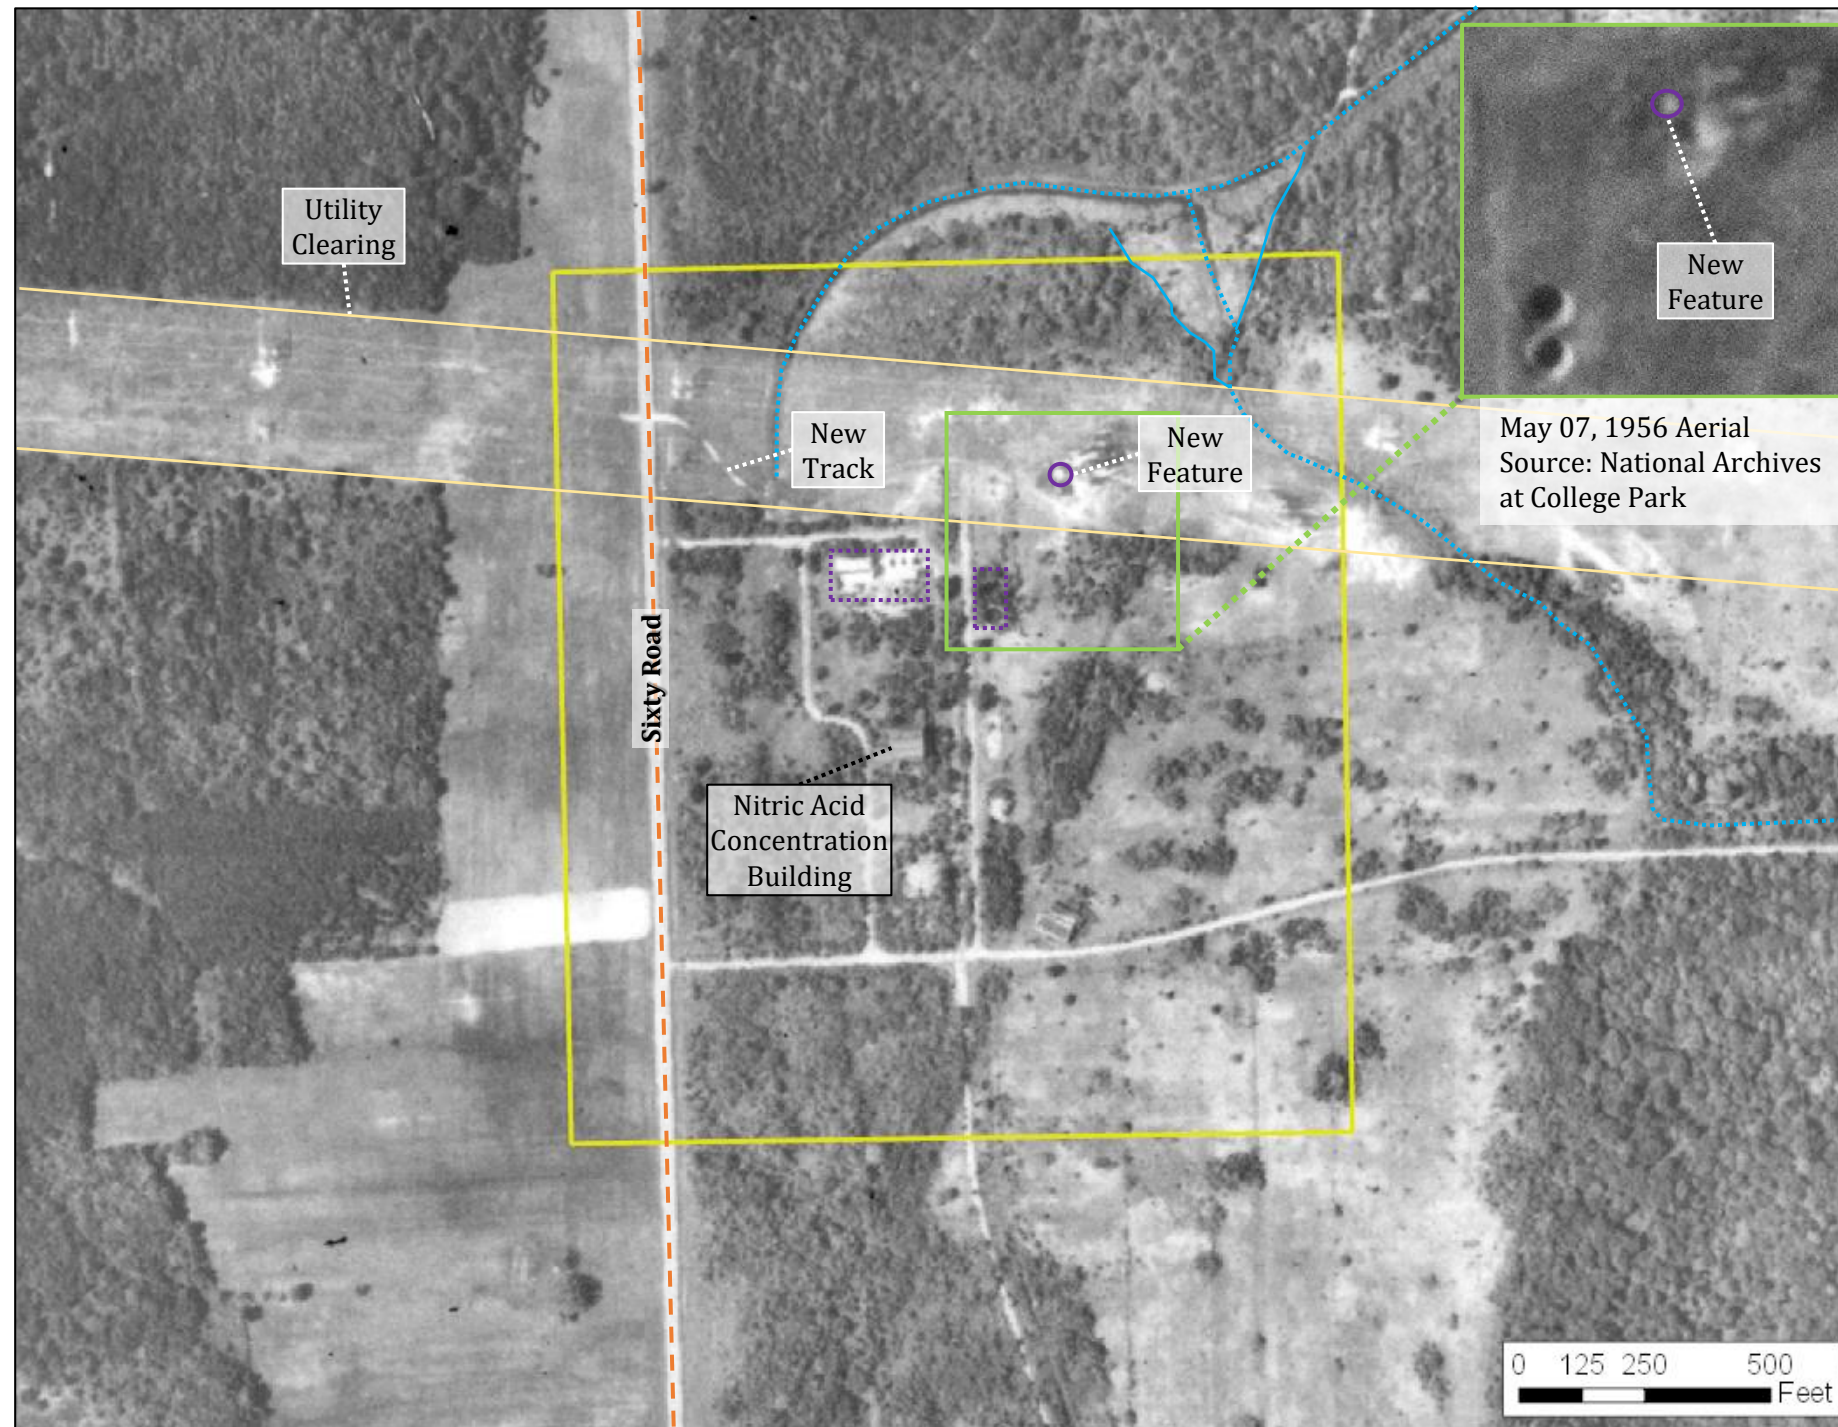
June 22, 1966

The roads are visibly clear, but vegetation is moving into the surrounding areas.

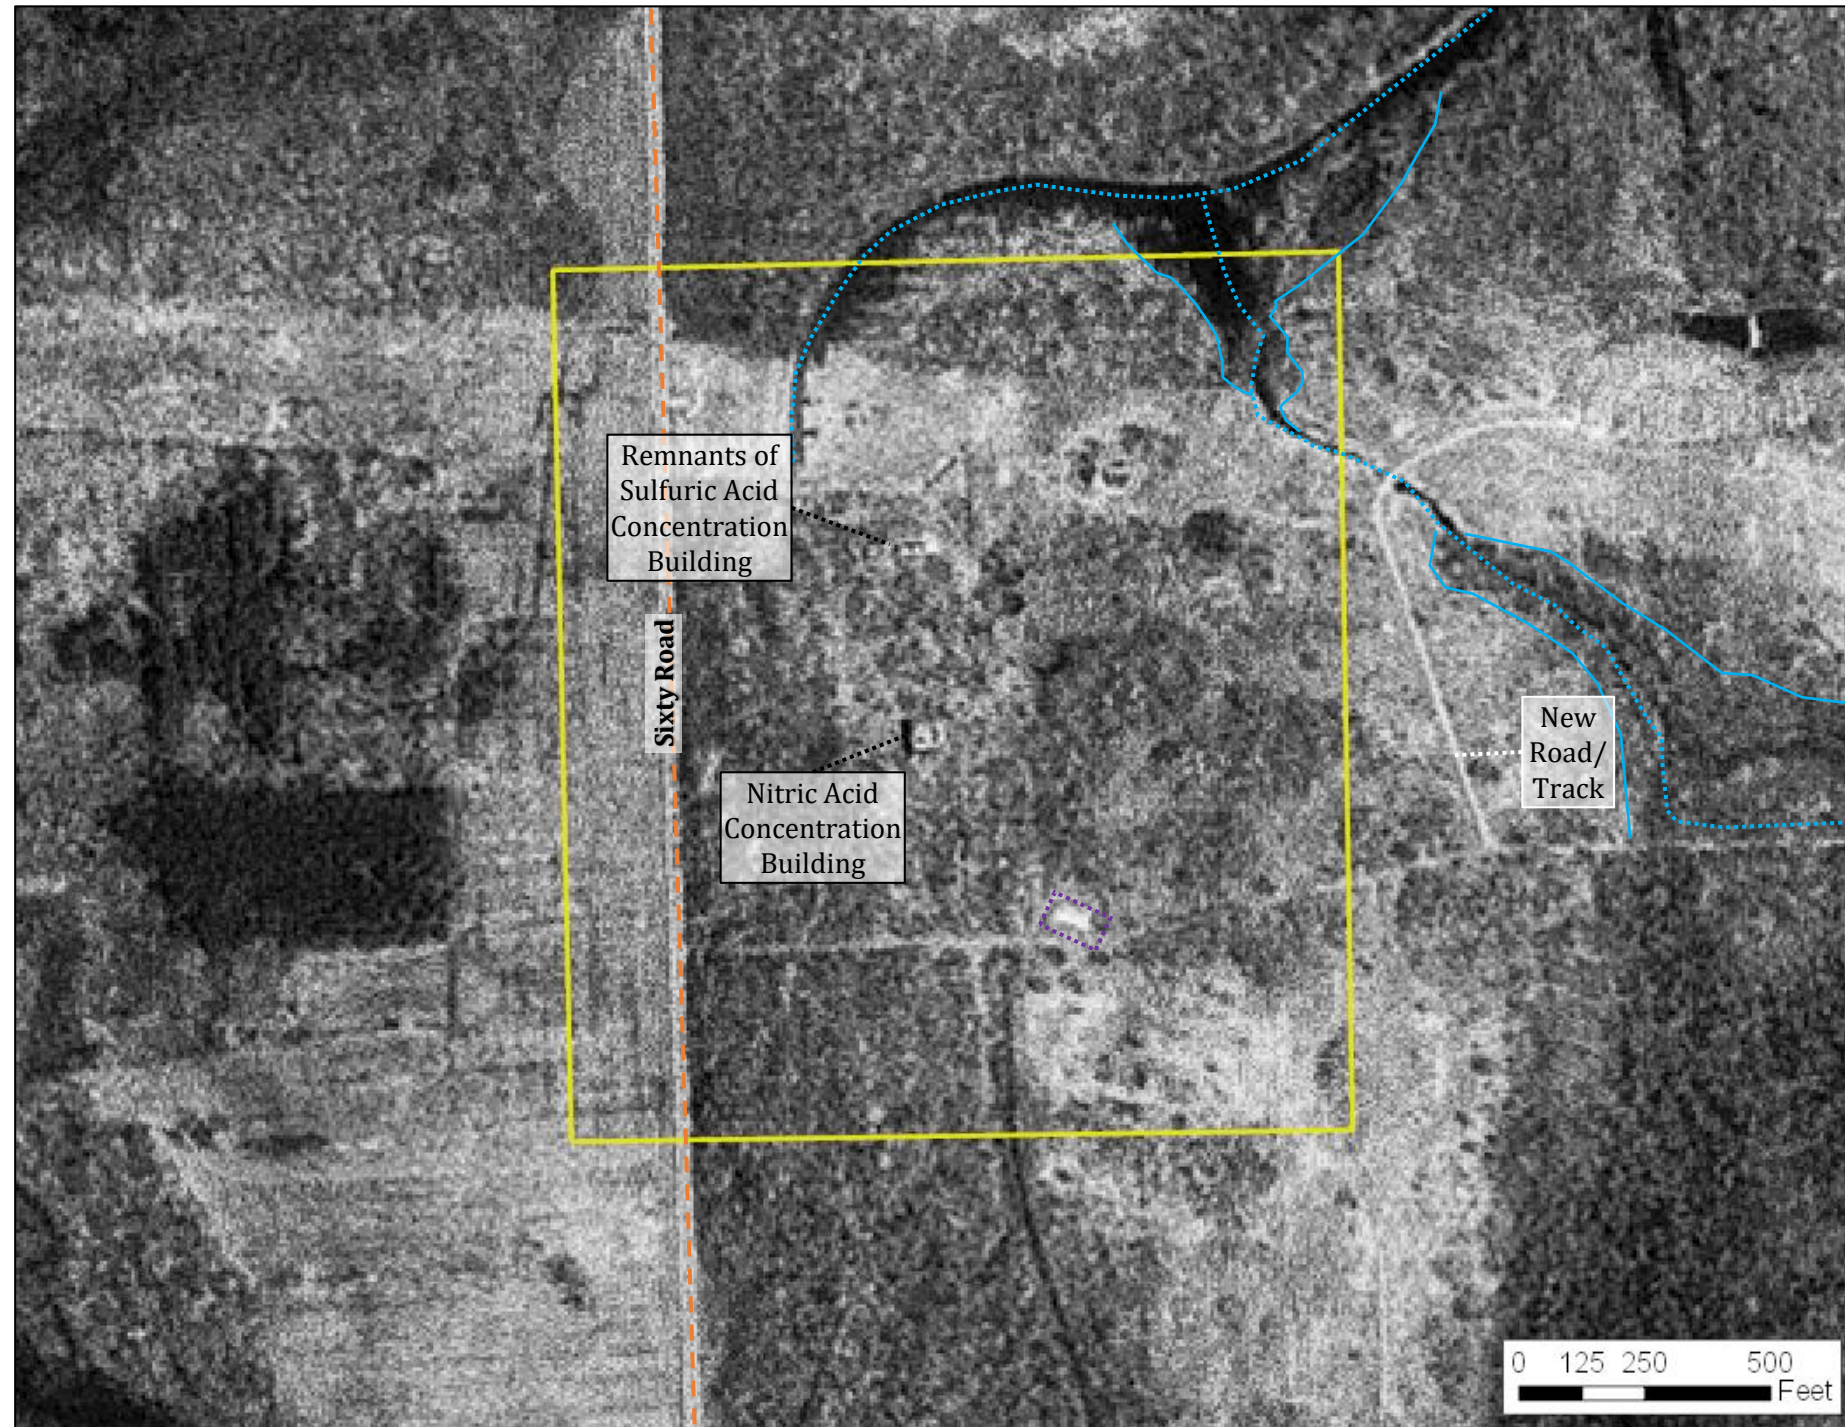
April 29, 1982

This image has poor spatial resolution, but one more building appears to have been removed (the foundation remains), and the remnants of the remaining former Acid Area structures are still visible. Continued regrowth of vegetation is observed.

A new road/track is visible from the east and leading alongside the former Acid Area boundary to the road running east-west through the former Acid Area.

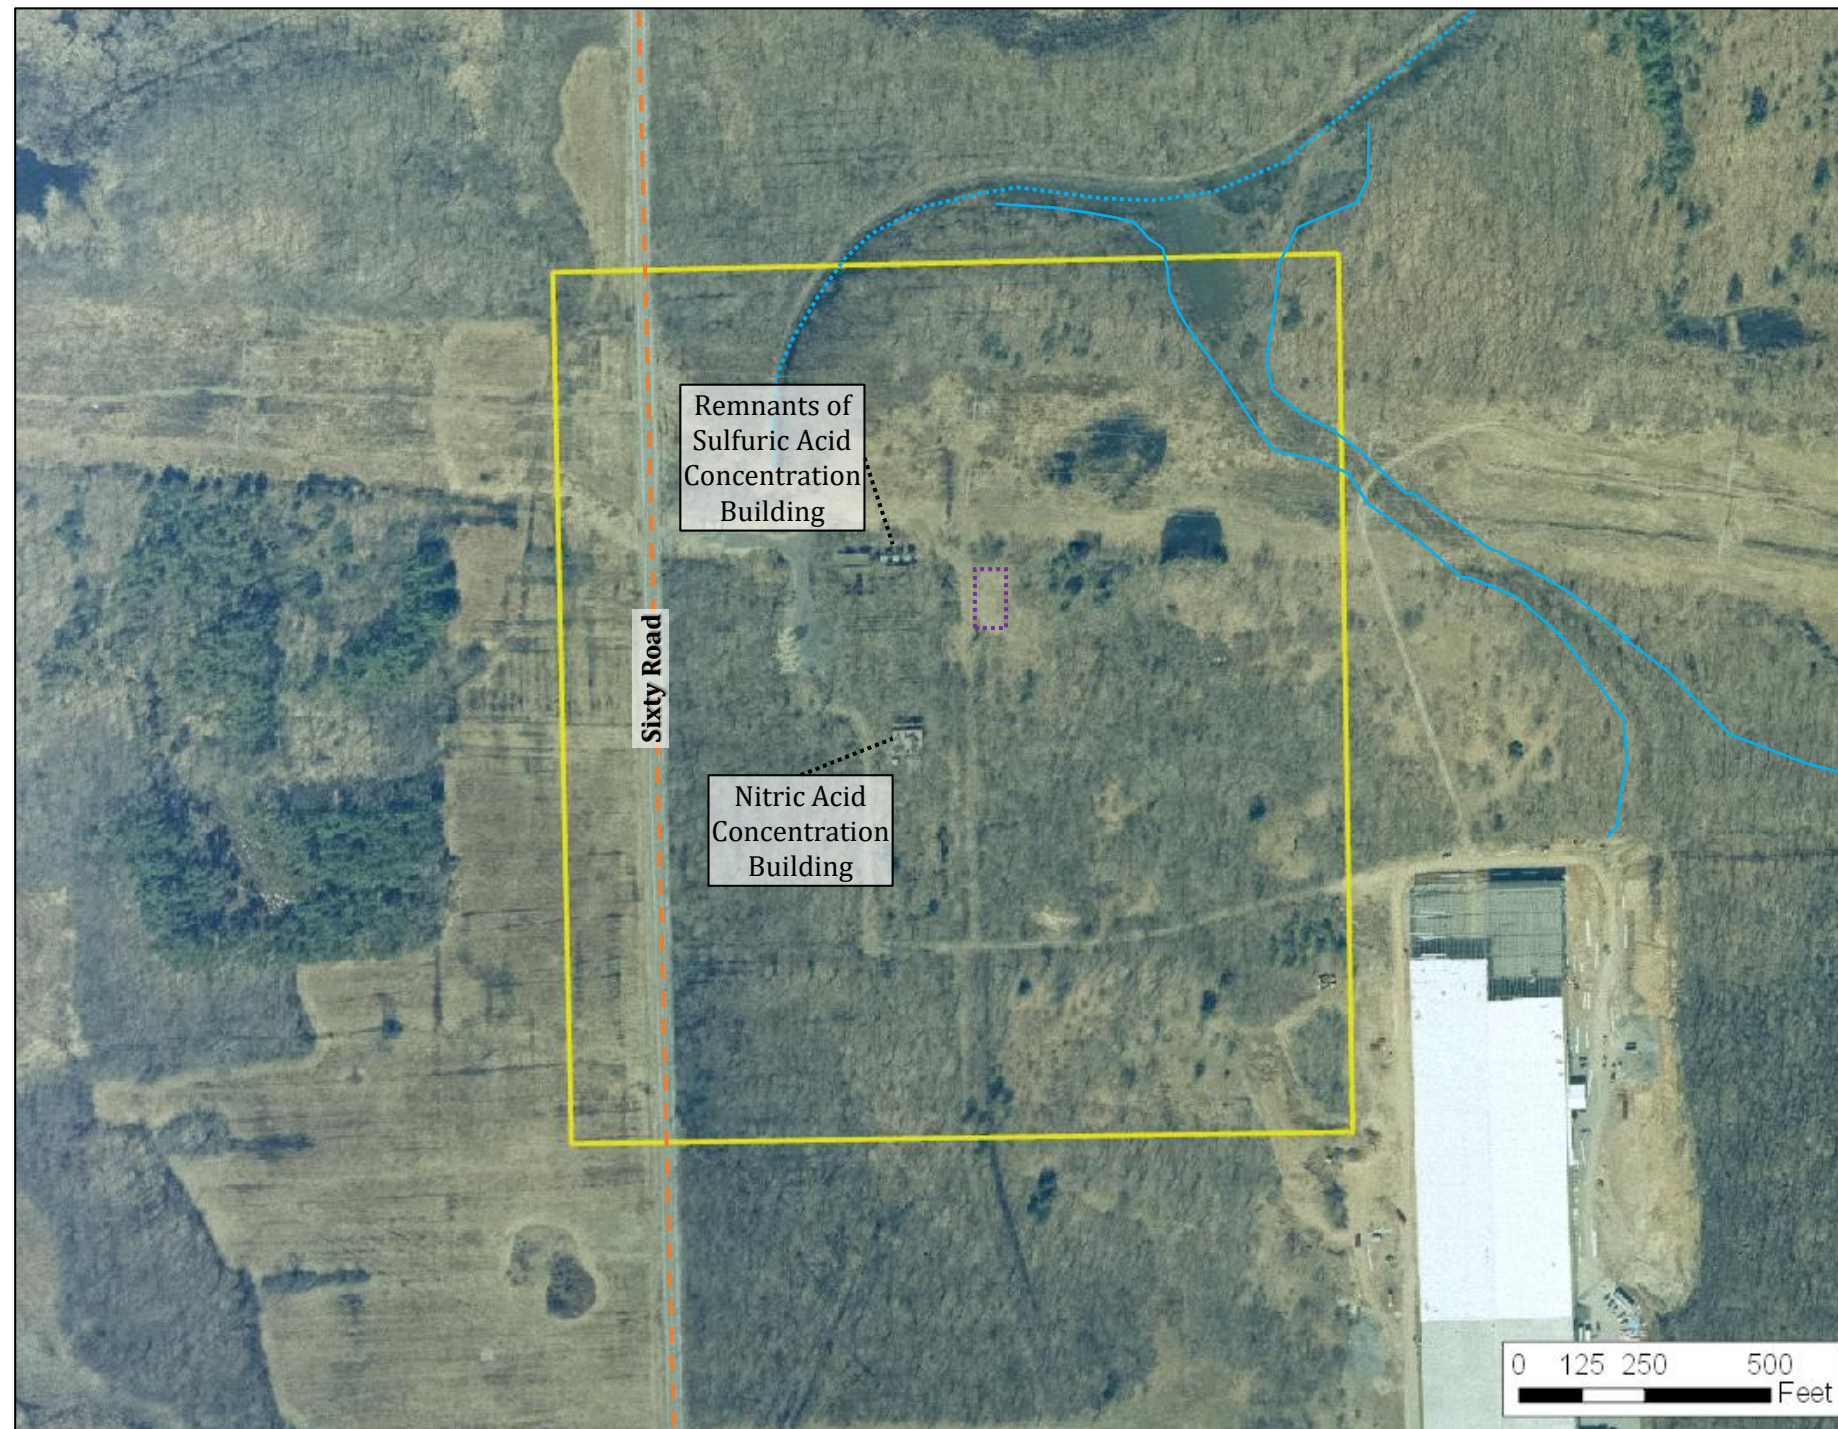
April 14, 2003

The spent acid tanks were removed between 1995 and 2003. Other related structures remain within the Acid Area.

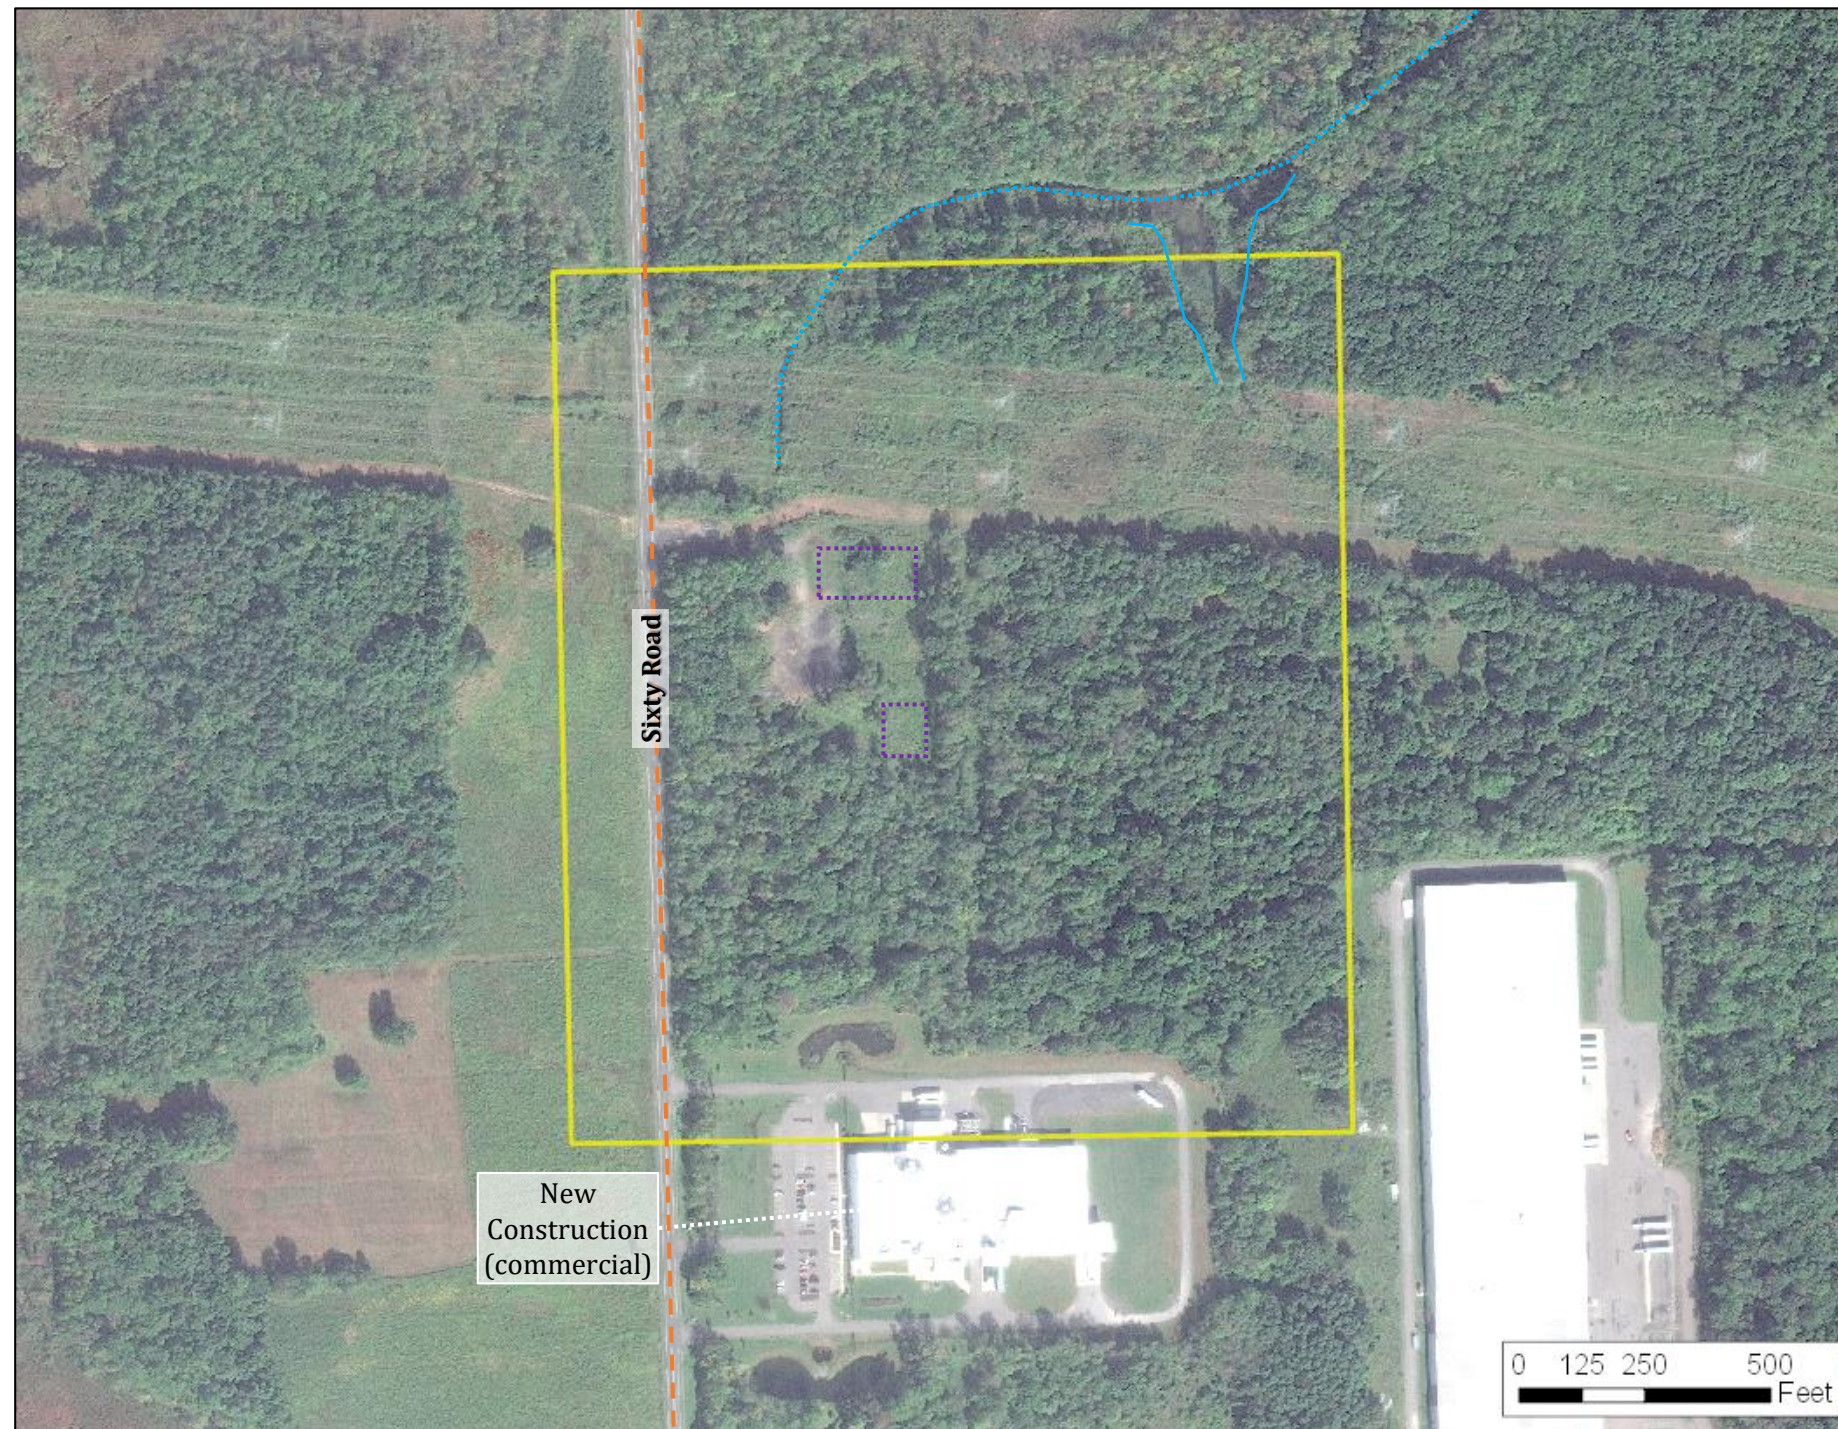
September 25, 2019

All former Acid Area structures have been removed by 2019. A clearing is visible within the former Acid Area.

Continued commercial development is observed south of the study area.

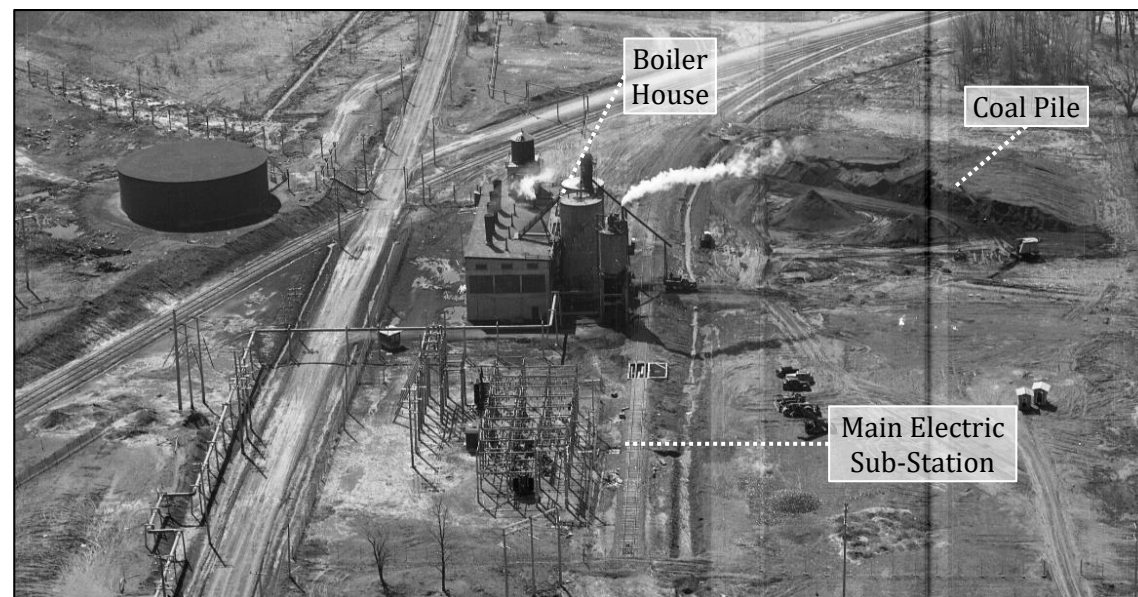
A power plant located just north of the administration area may be of interest for further investigation. This site contains an above ground storage tank, a boiler house, coal storage, and an electric substation. There are also two drainage ditches that run along this property.
