September 2022

2022 SOIL COVER MONITORING AND MAINTENANCE SUMMARY REPORT

**GSA PROPERTY DOMA001902
670 ARSENAL STREET
WATERTOWN, MASSACHUSETTS**

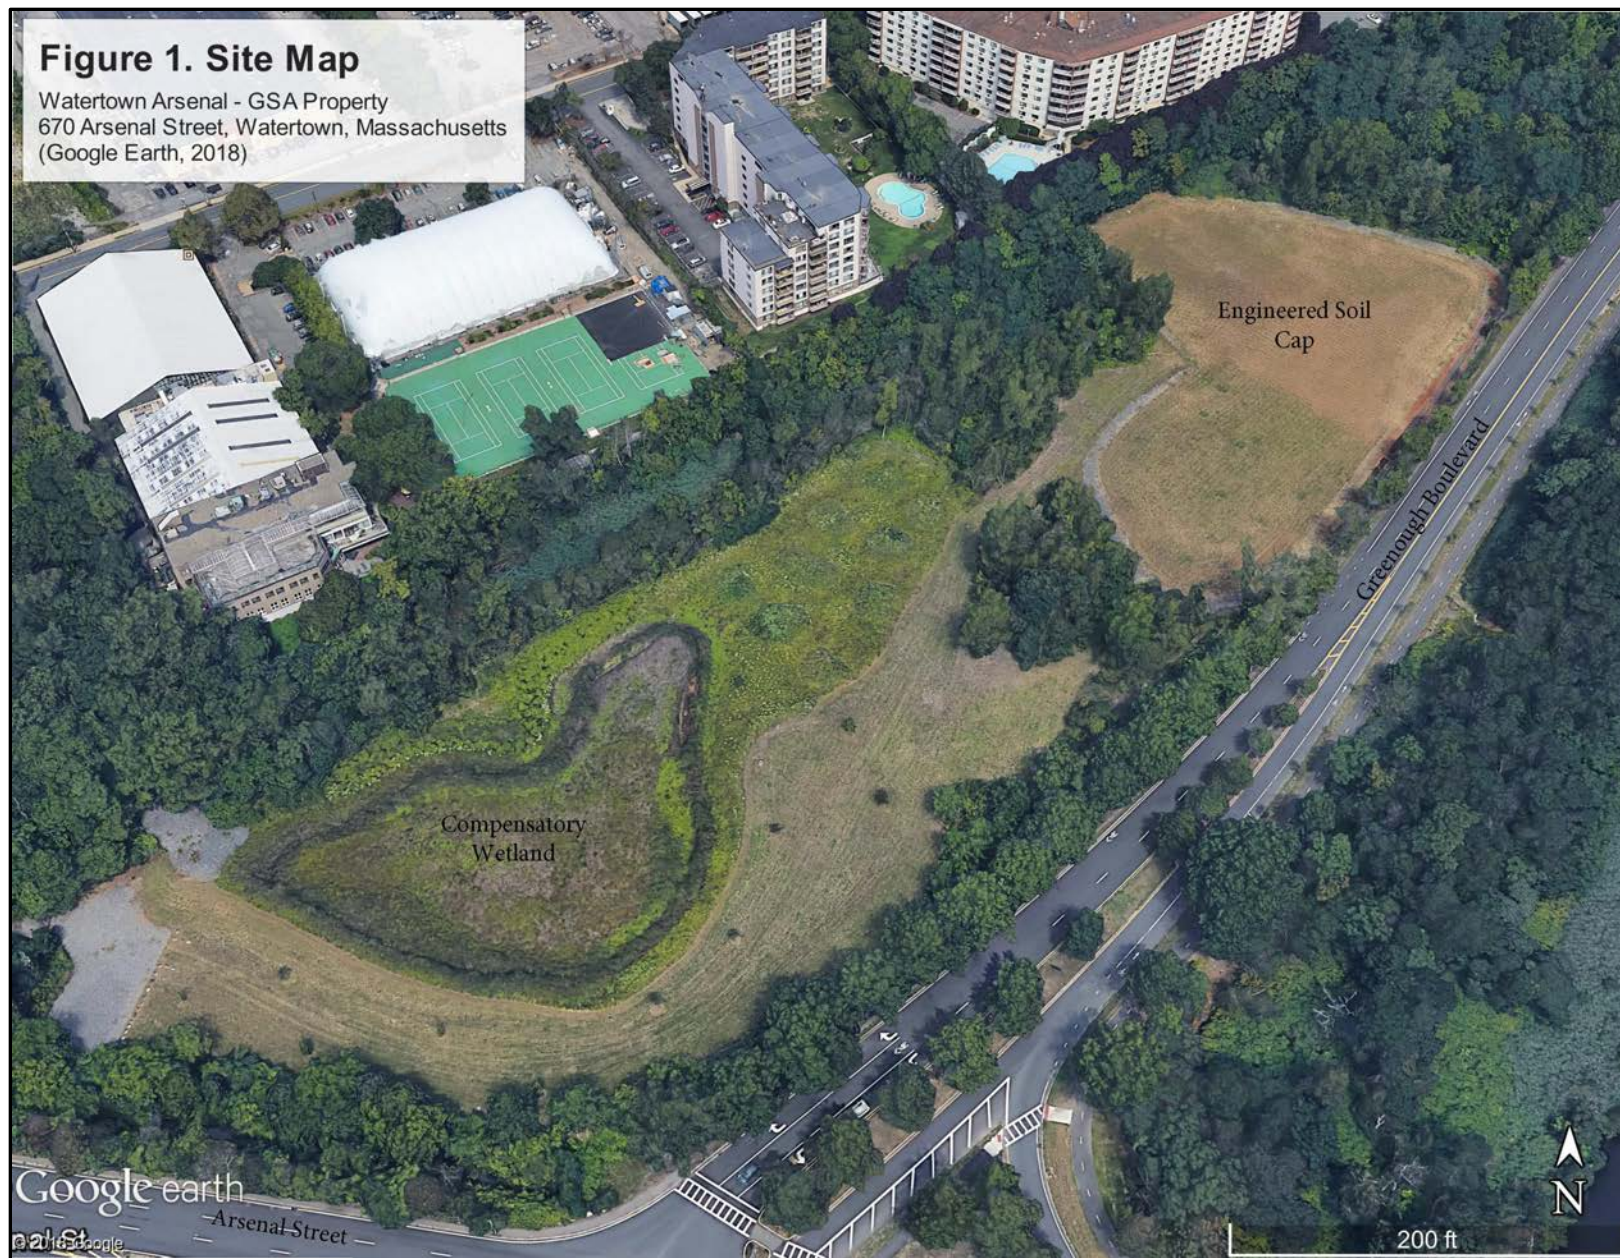
Figure 1. Site Map

Watertown Arsenal - GSA Property
670 Arsenal Street, Watertown, Massachusetts
(Google Earth, 2018)

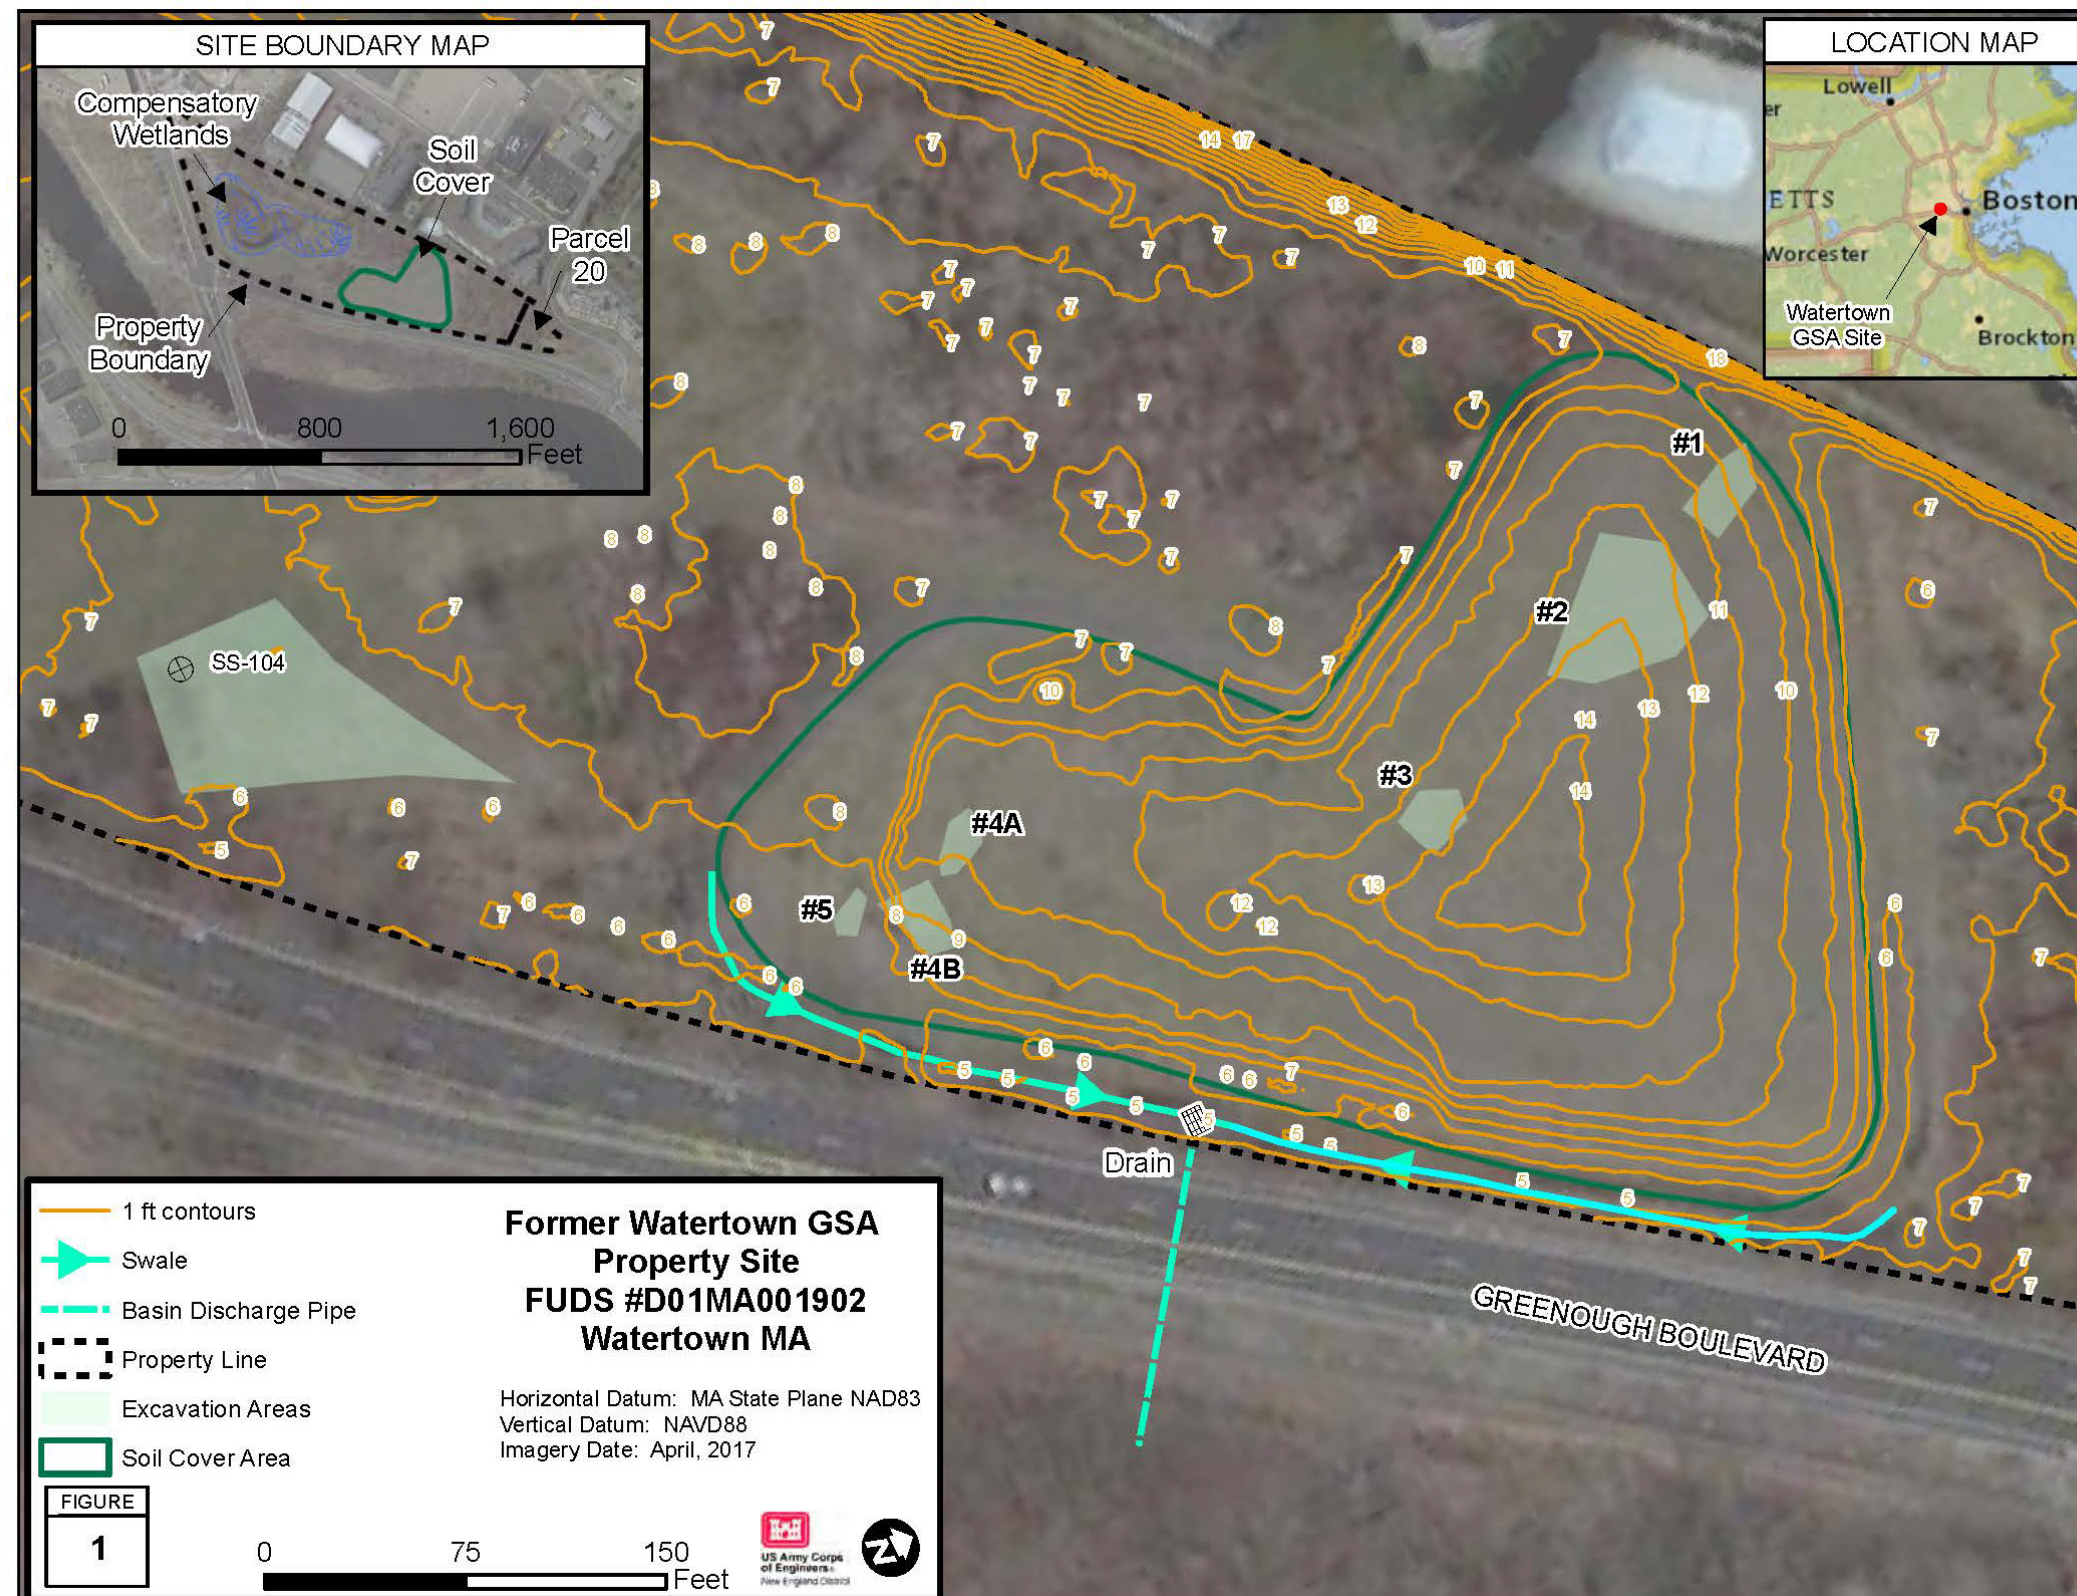
Figure 1. Watertown Arsenal – Former GSA Property, Watertown, Massachusetts (eastern swale highlighted) (Google Earth, 2017, USGS, 2016, Charter, 2014a, b).

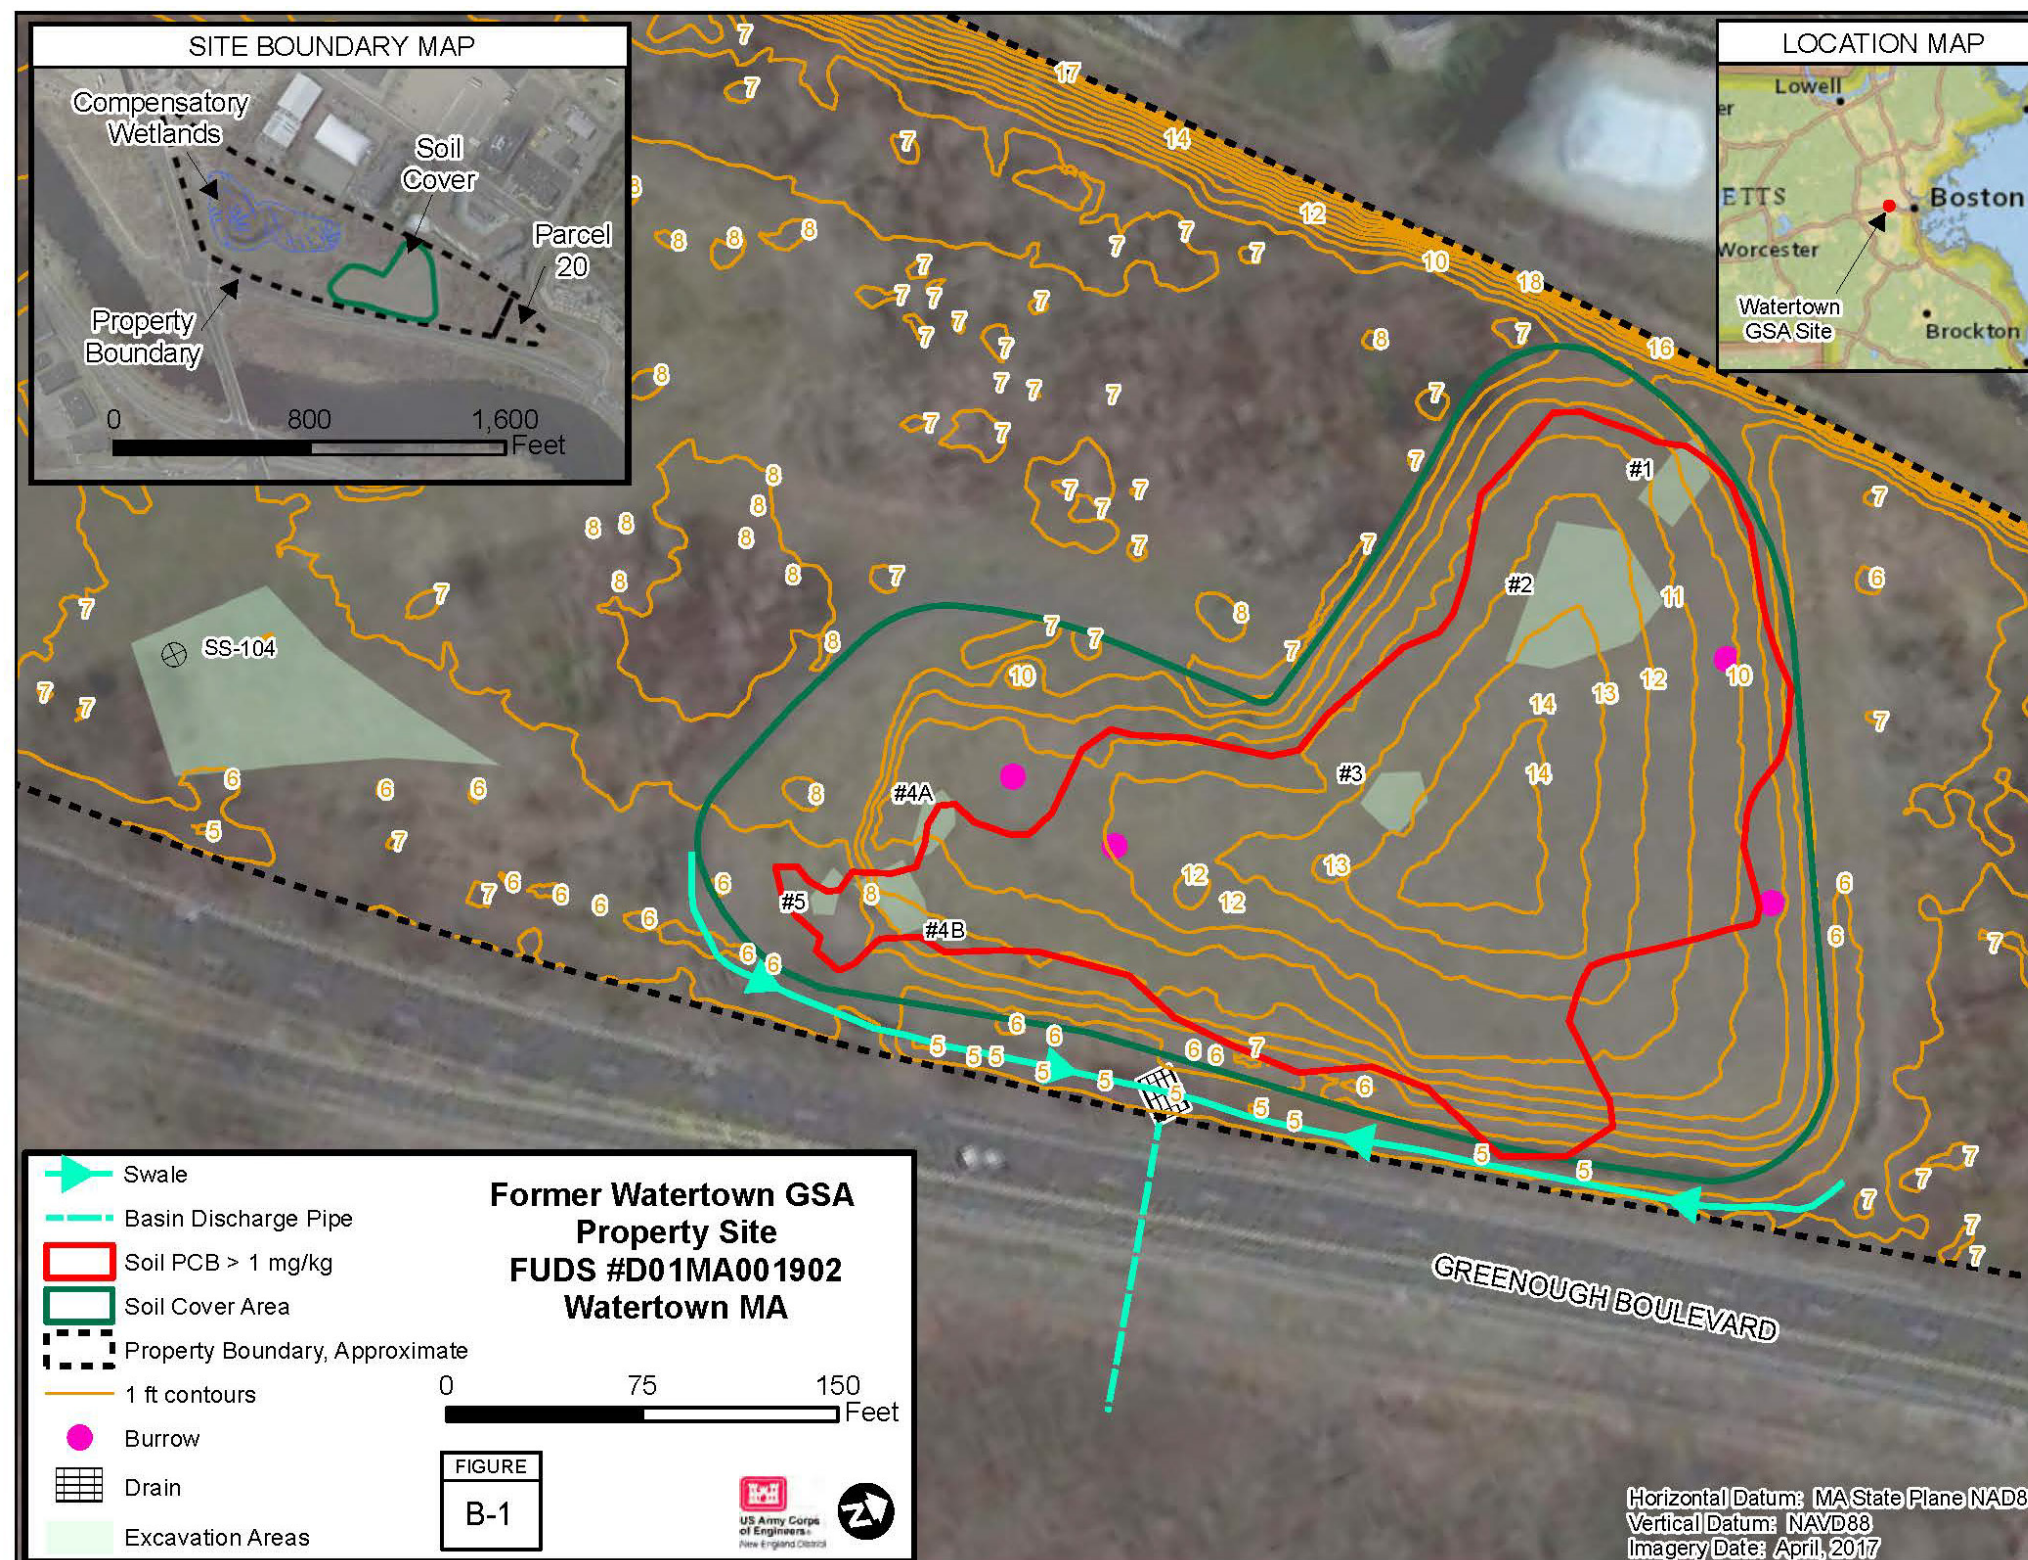
Figure C-1. Site visit map showing excavated areas, PCB and cover extents, highlighted eastern swale with discharge pipe, and site topography as of 2016 (USGS, 2016, Charter, 2014b). Property boundary and burrow locations area approximate (latter from cellphone GPS). PCB excavation areas are georeferenced from drawing and soil borings (Charter, 2013b).
